Rental Assistance Demonstration (RAD): **PHYSICAL CONDITION ASSESSMENT**

727 Miller Avenue, Ann Arbor, Michigan 48103

PROJECT # 8208E

DATE February 10, 2014

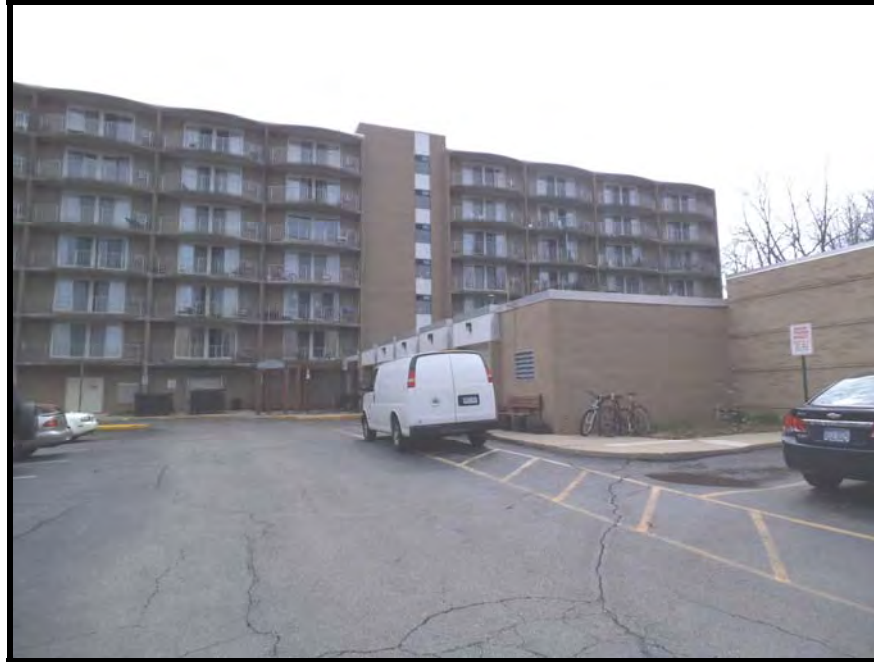
PHOTOGRAPH NO. 1: SUBJECT BUILDING AS VIEWED FACING SOUTHWEST

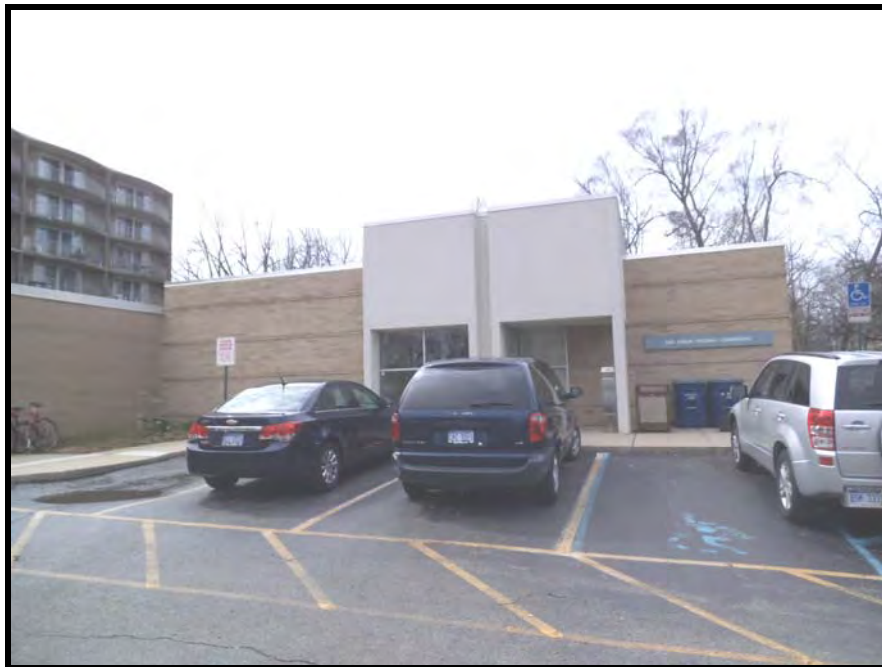
PHOTOGRAPH NO. 2: OFFICE PORTION OF SUBJECT BUILDING AS VIEWED FACING WEST

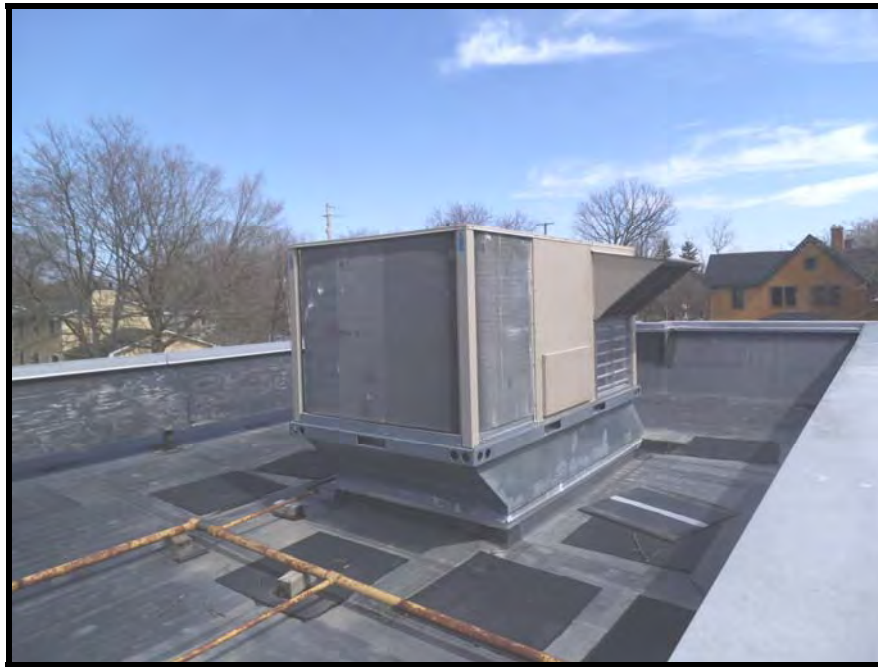
PHOTOGRAPH NO. 3: SUBJECT BUILDING: VIEW OF OFFICE WING PACKAGE RTU

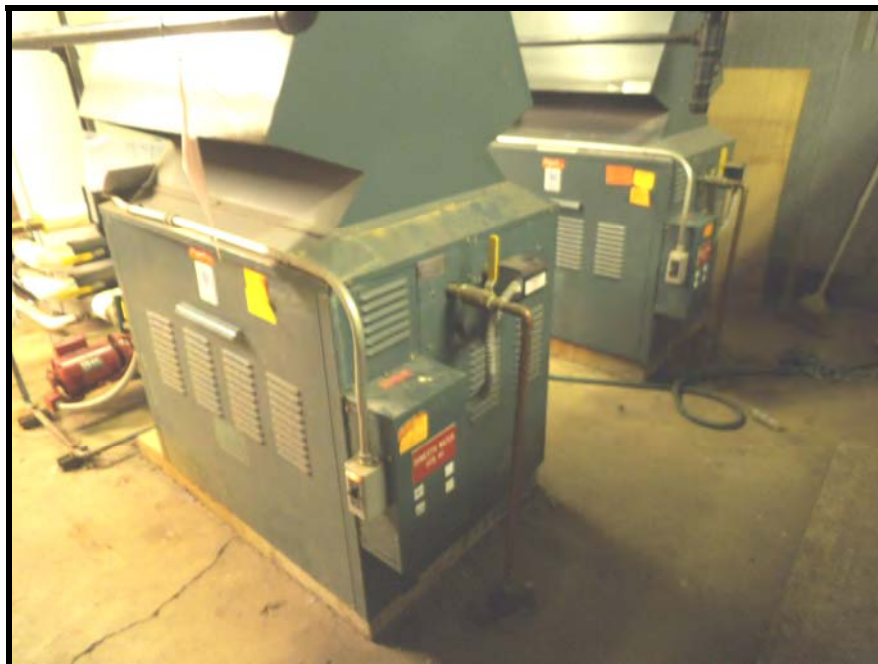
PHOTOGRAPH NO. 4: SUBJECT BUILDING: TYPICAL VIEW OF GAS-FIRED HOT WATER BOILERS

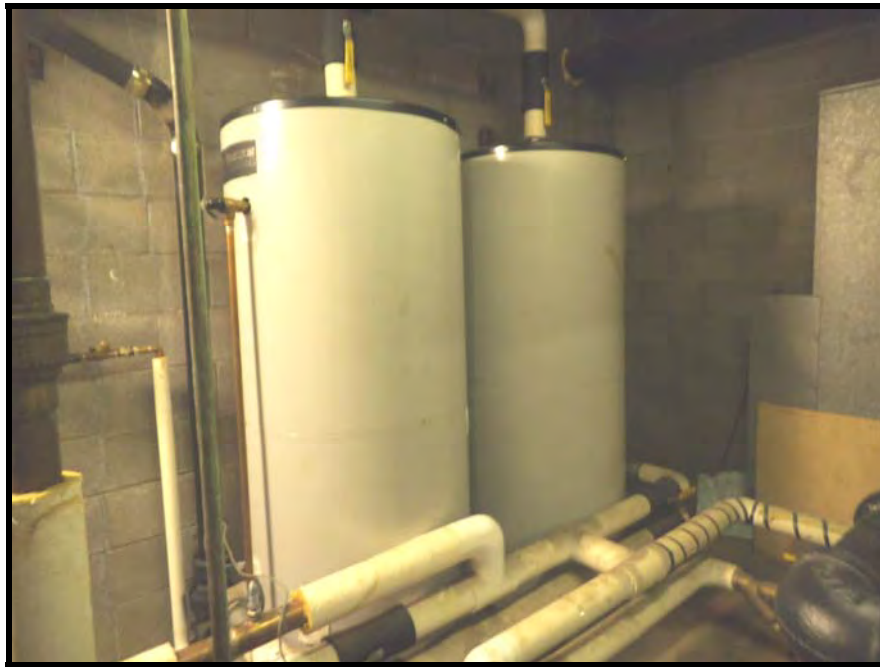
PHOTOGRAPH NO. 5: SUBJECT BUILDING: VIEW OF HOT WATER TANKS

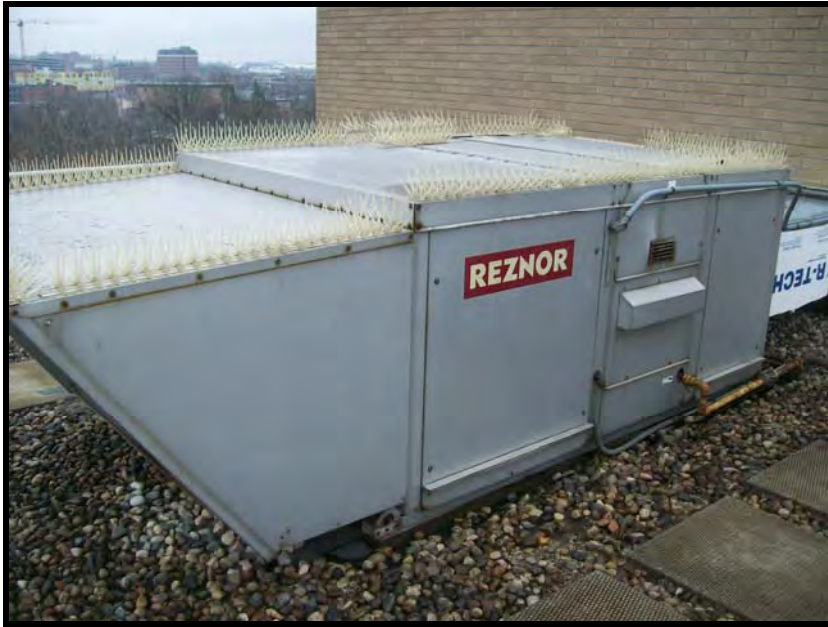
PHOTOGRAPH NO. 7: SUBJECT BUILDING: TYPICAL VIEW OF REZNOR MUA UNIT

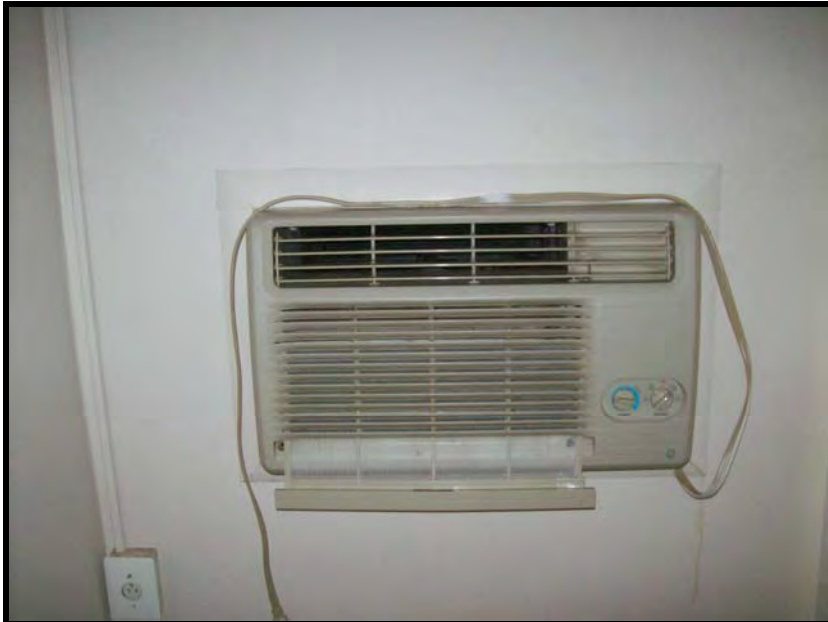
PHOTOGRAPH NO. 8: SUBJECT BUILDING: TYPICAL VIEW OF TENANT UNIT AIR CONDITIONER

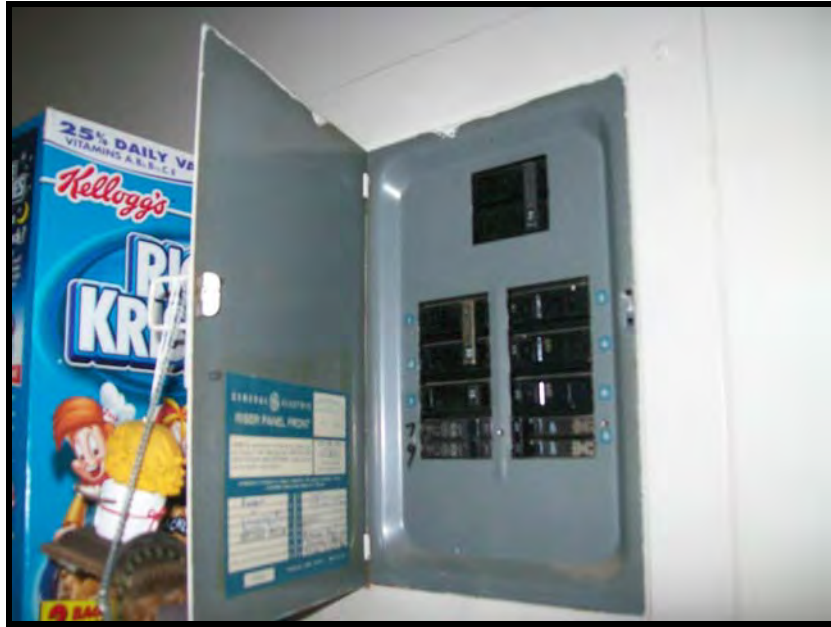
PHOTOGRAPH NO. 9: SUBJECT BUILDING: TYPICAL VIEW OF TENANT UNIT ELECTRICAL PANEL

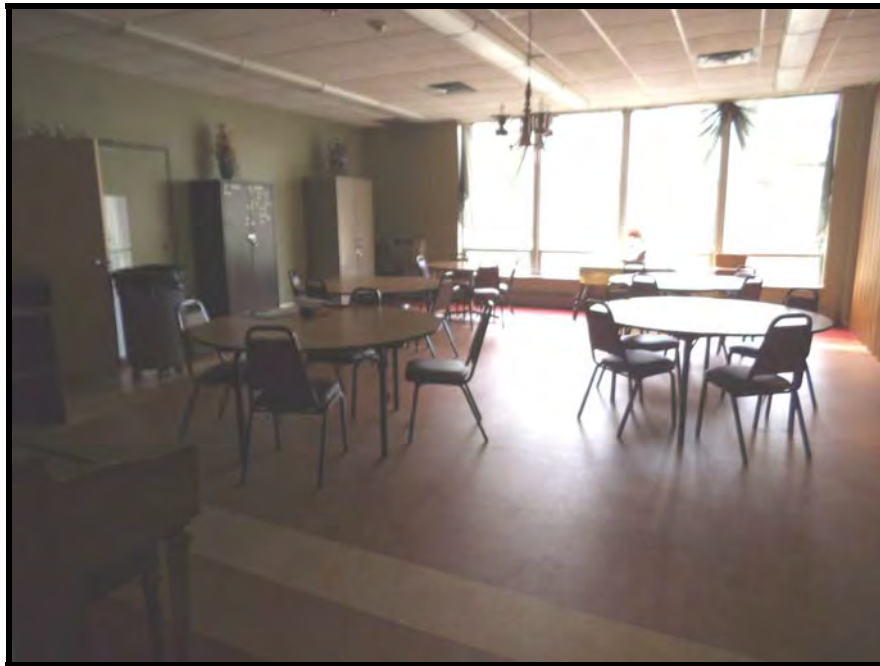
PHOTOGRAPH NO. 10: SUBJECT BUILDING: TYPICAL VIEW OF COMMUNITY ROOM

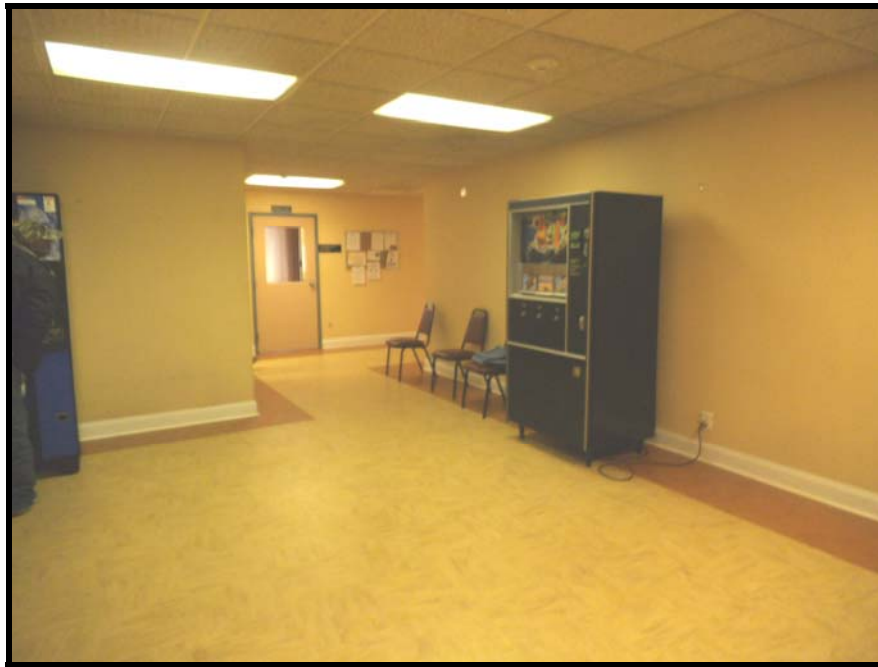
PHOTOGRAPH NO. 11: SUBJECT BUILDING: TYPICAL VIEW OF FIRST FLOOR COMMON AREA HALLWAY

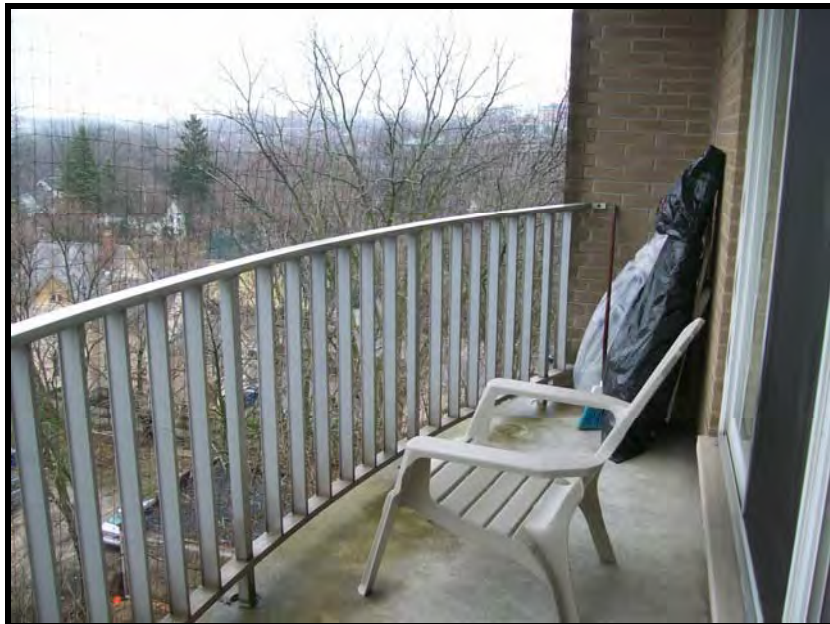
PHOTOGRAPH NO. 12: SUBJECT BUILDING: TYPICAL VIEW OF TENANT UNIT BALCONY

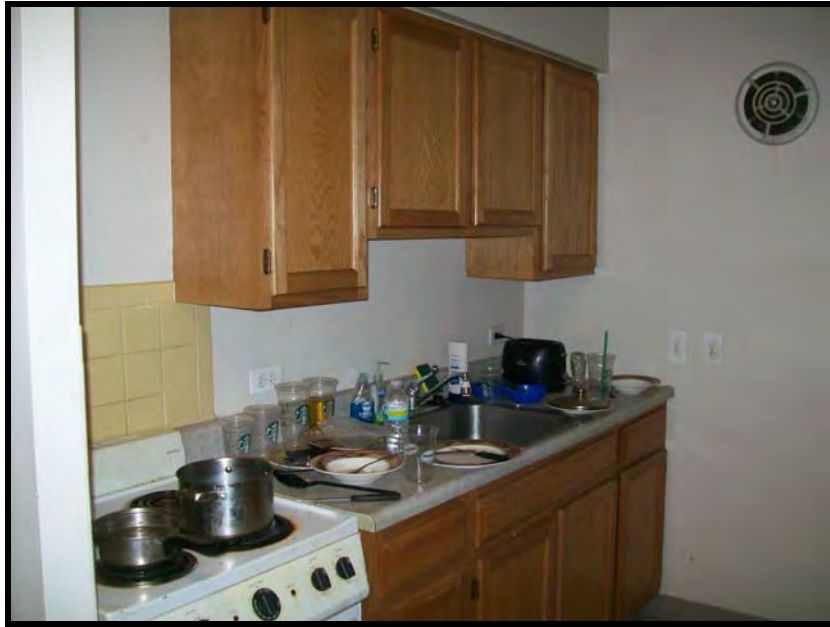
PHOTOGRAPH NO. 13: SUBJECT BUILDING: TYPICAL VIEW OF TENANT UNIT KITCHEN

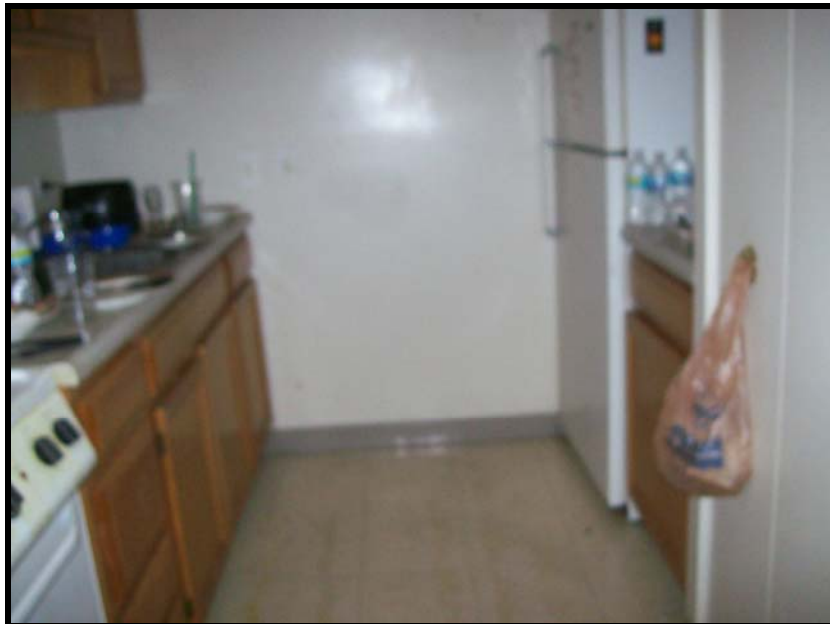
PHOTOGRAPH NO. 14: SUBJECT BUILDING: TYPICAL VIEW OF TENANT UNIT KITCHEN

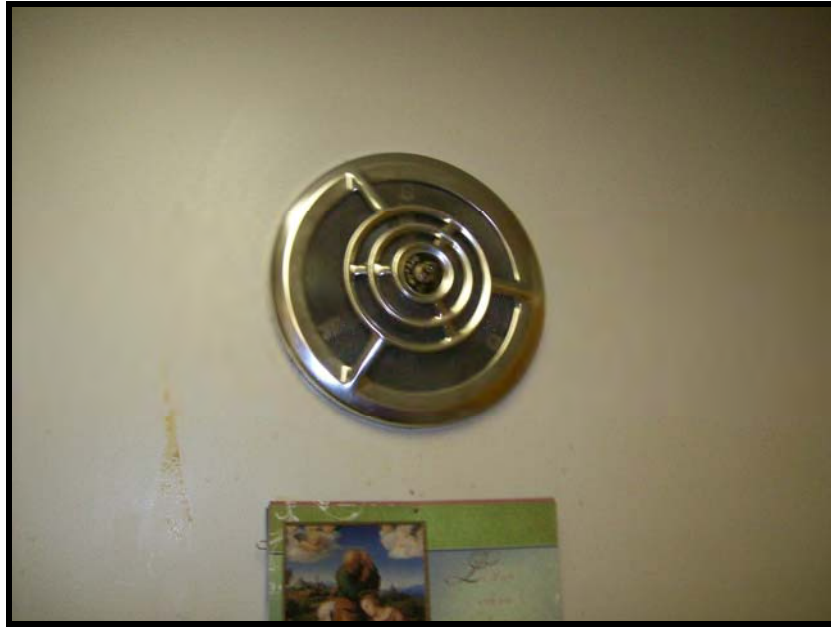
PHOTOGRAPH NO. 15: SUBJECT BUILDING: TYPICAL VIEW OF TENANT UNIT EXHAUST FAN (KITCHEN)

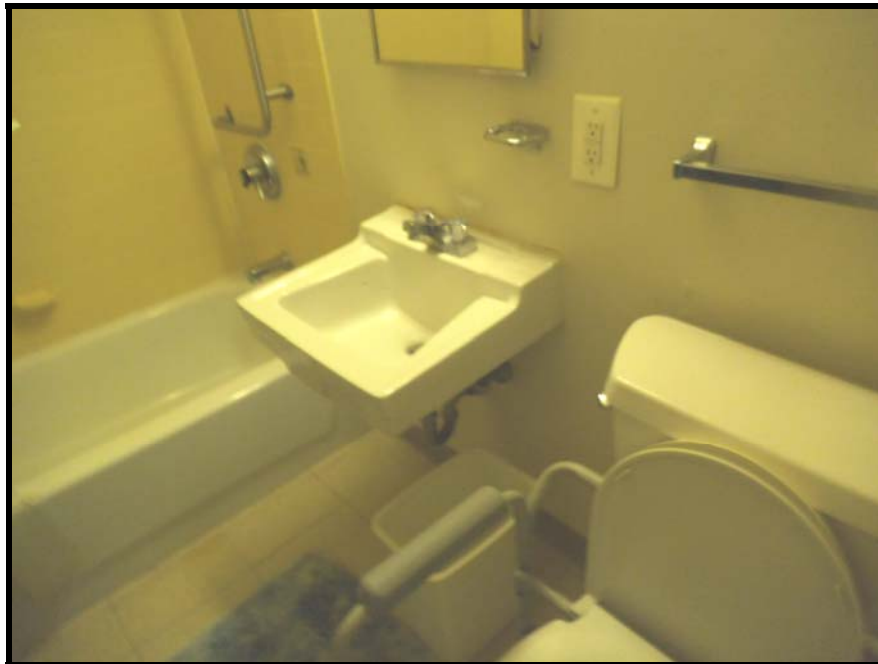
PHOTOGRAPH NO. 16: SUBJECT BUILDING: TYPICAL VIEW OF TENANT UNIT BATHROOM

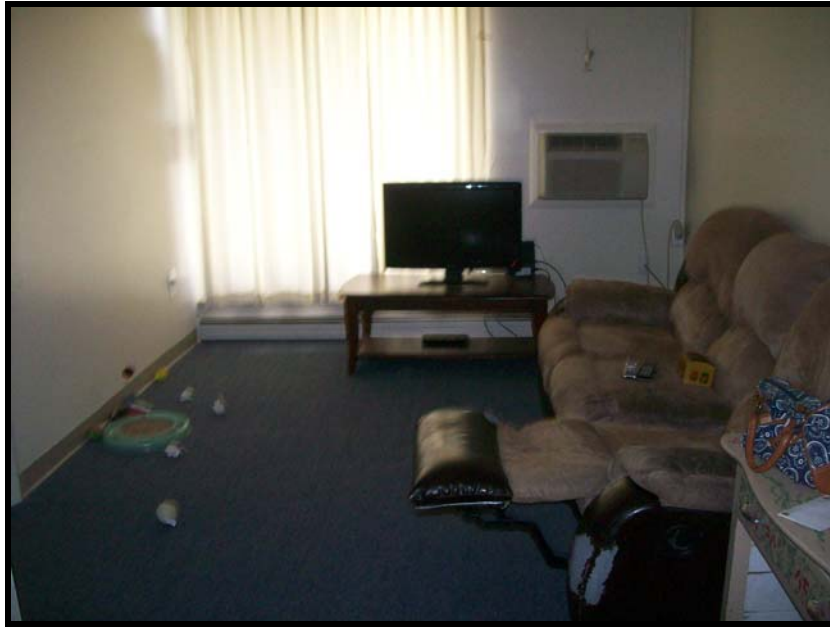
PHOTOGRAPH NO. 17: SUBJECT BUILDING: TYPICAL VIEW OF TENANT UNIT LIVING ROOM

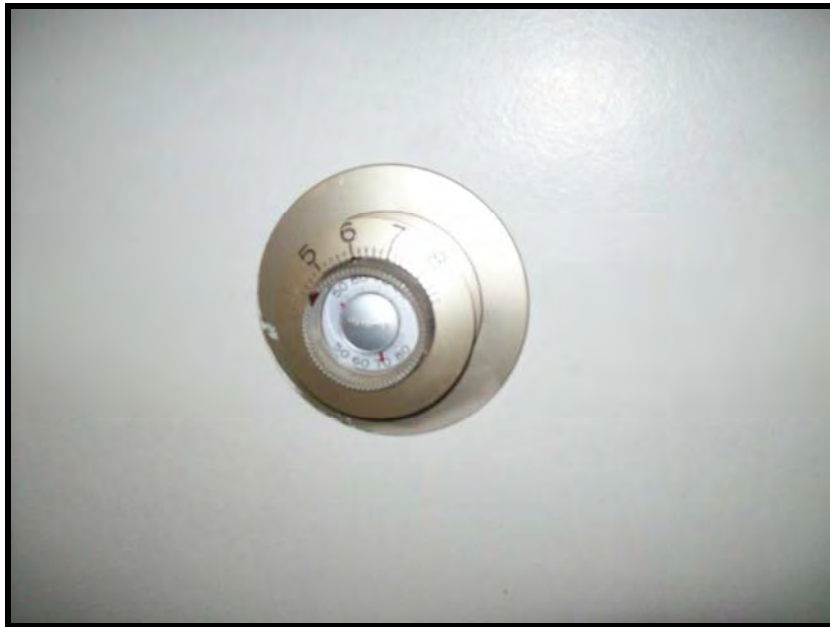
PHOTOGRAPH NO. 18: SUBJECT BUILDING: TYPICAL VIEW OF TENANT UNIT THERMOSTAT

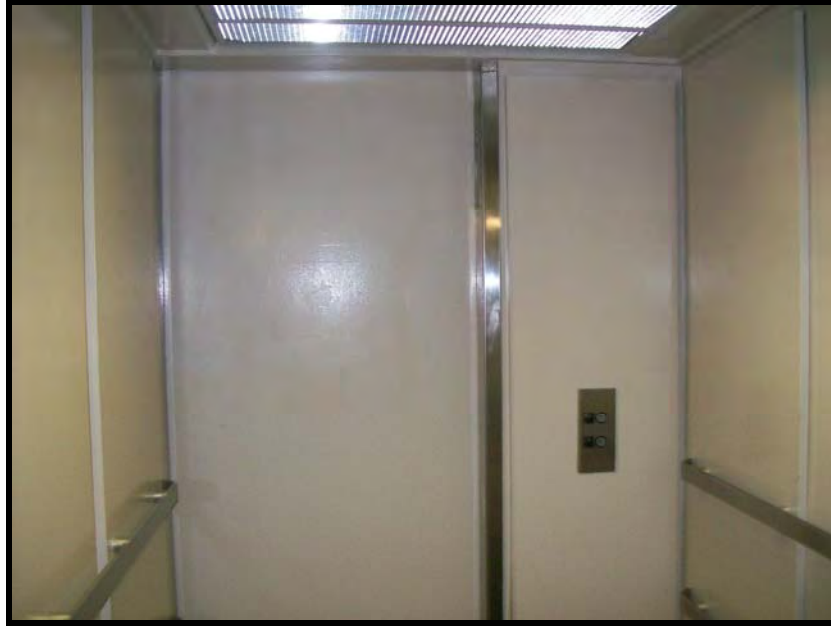
PHOTOGRAPH NO. 19: SUBJECT BUILDING: VIEW OF ELEVATOR INTERIOR

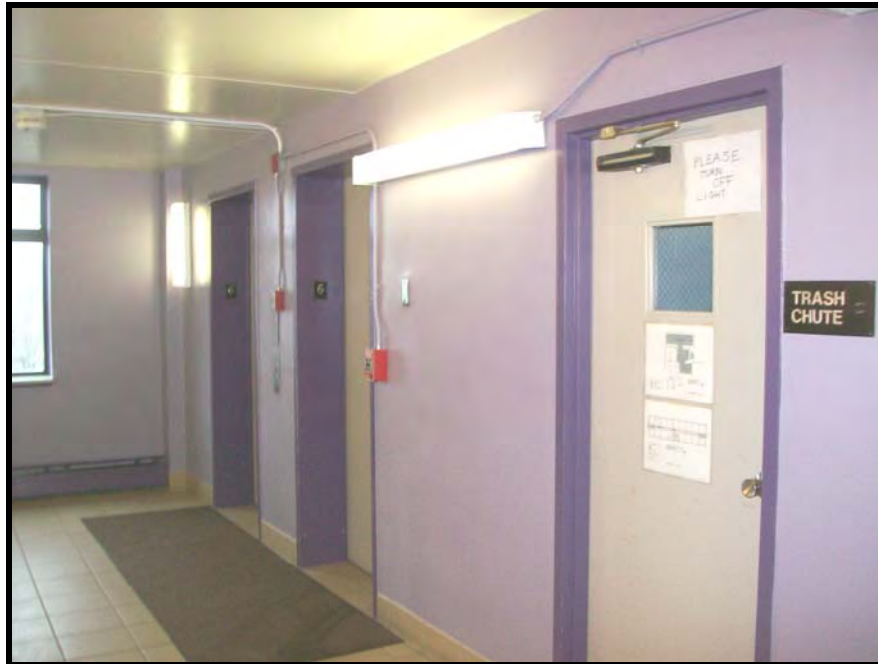
PHOTOGRAPH NO. 20: SUBJECT BUILDING: TYPICAL VIEW OF ELEVATORS AND TRASH CHUTE ACCESS

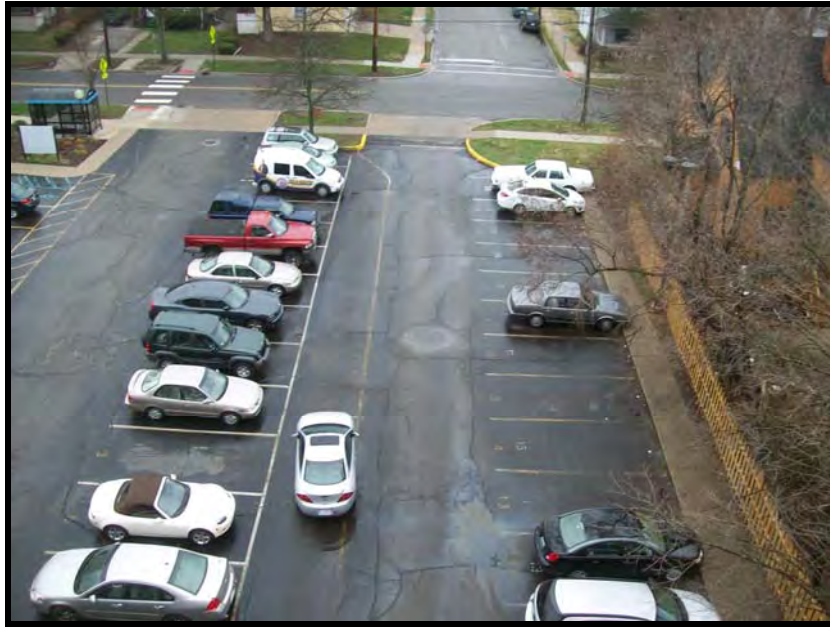
Overall, the asphalt and concrete paved areas appear to be in fair condition. However, longitudinal cracking and localized delamination was observed on the asphalt pavement drives and parking areas. Longitudinal cracking and movement along engineered seams was also observed on the concrete paved sidewalk. The concrete curbing and concrete approach were observed to be in good condition.

PHOTOGRAPH NO. 21: SUBJECT BUILDING: VIEW OF PARKING LOT

Replacement of address and site signage (accessibility, entry, and/or directional) is recommended as a rehab item. Continued maintenance of paved areas is recommended. In addition, capital reserves should be considered for future maintenance and/or replacement and repair of paved areas. Please refer to the attached Capital Needs Input, 20 Year Detail, 20 Year Schedule and Rehab Specifications for additional information on condition, rehab costs and capital reserves.

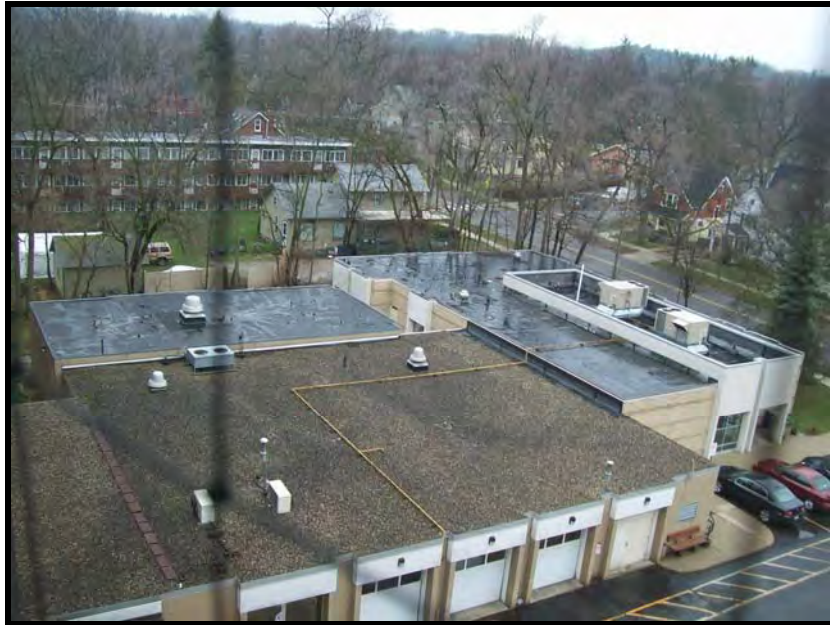
The roof system appeared to be in good condition with no obvious evidence of leaks. Evidence of ponding was observed on the northern portion of the roof above the common areas/offices.

PHOTOGRAPH NO. 22: SUBJECT BUILDING: VIEW OF ROOF OVER OFFICE WING
