April 22, 2013

**Re: Hazardous Materials Survey
415 W. Washington Street, Ann Arbor, Michigan**

HAZARDOUS MATERIALS SURVEY
415 W. WASHINGTON STREET
ANN ARBOR, MICHIGAN 48103

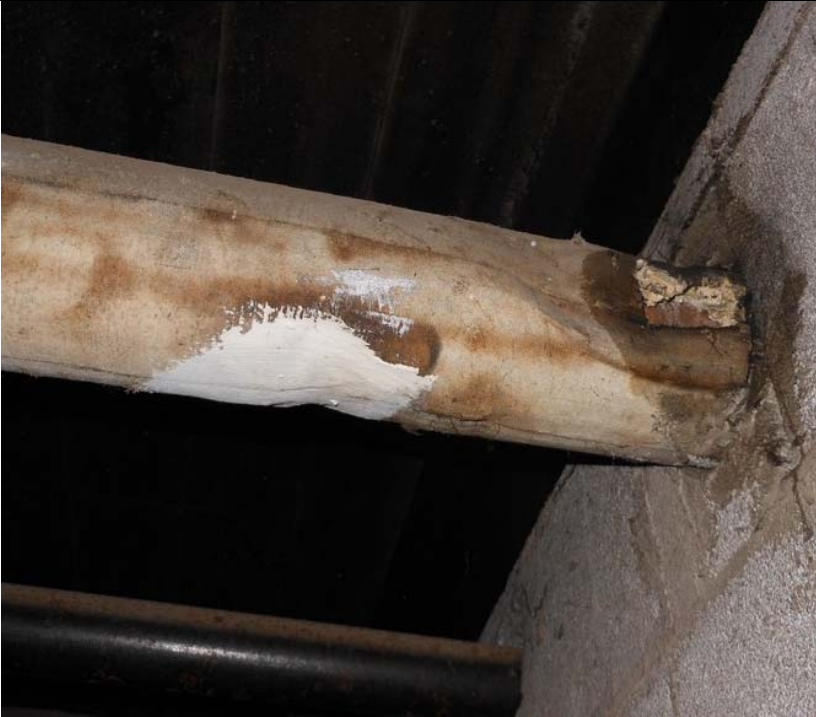
Photo #: 1

Direction: Looking North	
Description: HA-04: Pipe straight insulation in North Garage area, observed in the High Bay, restrooms, and second floor near the elevator (outer wrap did not contain asbestos)	
10% Asbestos	
Sample HA-04-01	
Date: 1/15/2013

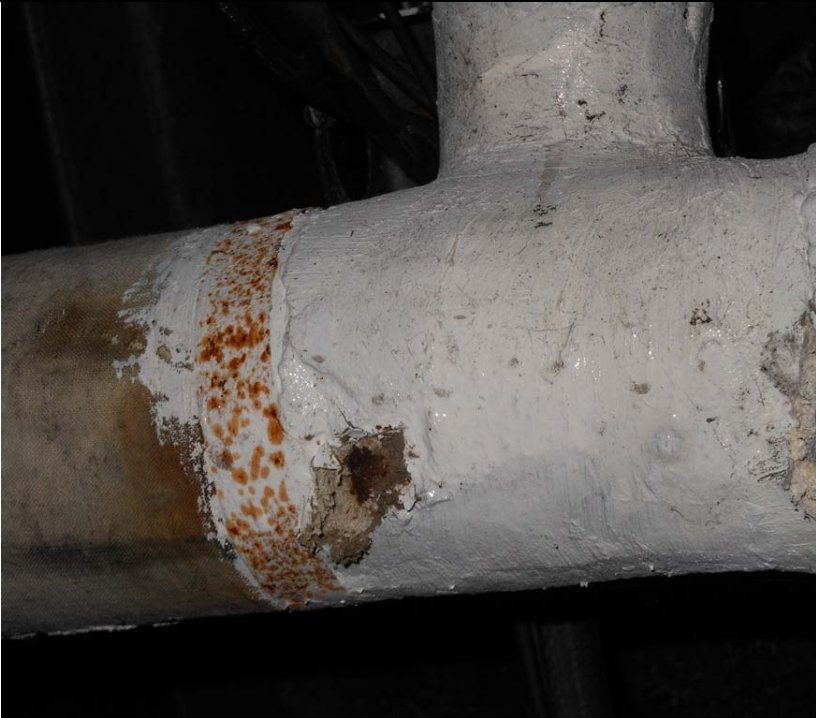
Photo #: 2

Direction: Looking North	
Description: HA-05: Pipe joint insulation (associated with HA-04) in North Garage area, observed in the High Bay, restrooms, and second floor near the elevator (outer wrap did not contain asbestos).	
20% Asbestos	
Sample HA-05-01	
Date: 1/15/2013

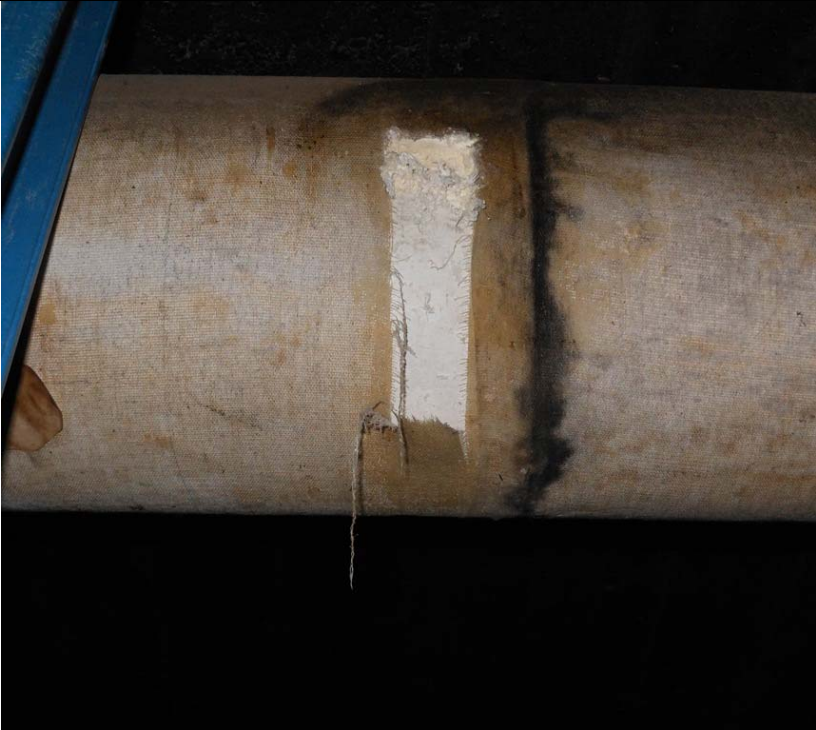
Photo#: 3

Direction: Looking North	
Description: <u>HA-06:</u> Pipe straight insulation in North Garage area, observed in the High Bay, restrooms, and overhead piping boiler room (same as HA-23) (outer wrap did not contain asbestos).	
20% Asbestos	
Sample HA-06-01	
Date: 1/15/2013

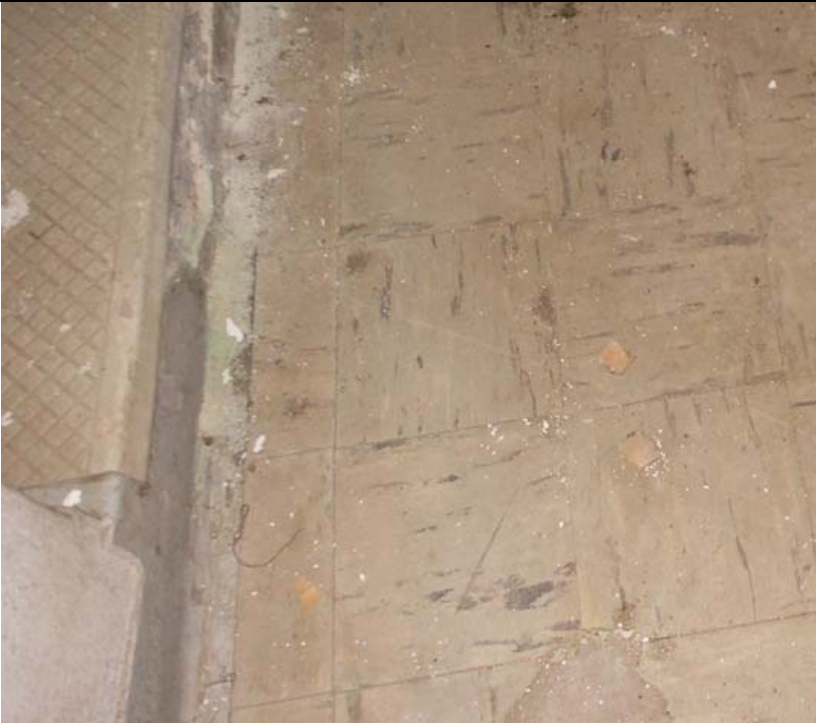
Photo #: 4

Direction: NA	
Description: <u>HA-09:</u> Mastic beneath 12" x 12" tan floor tile with brown streaks in northwest hallway of North Garage near offices (floor tile did not contain asbestos).	
4% Asbestos (mastic layer only)	
Sample HA-09-01	
Date: 1/15/2013

Tetra Tech also recommends that the floor tile mastic (HA-09) and associated floor tile be removed by a certified asbestos abatement contractor. Although the floor tile does not contain asbestos above 1%, the mastic will adhere to the floor tile as it is removed. Therefore, a certified asbestos abatement contractor must remove the overlying floor tile. Furthermore, removing the floor tile and mastic reduces training and monitoring requirements and management considerations of the renovation or demolition contractor.

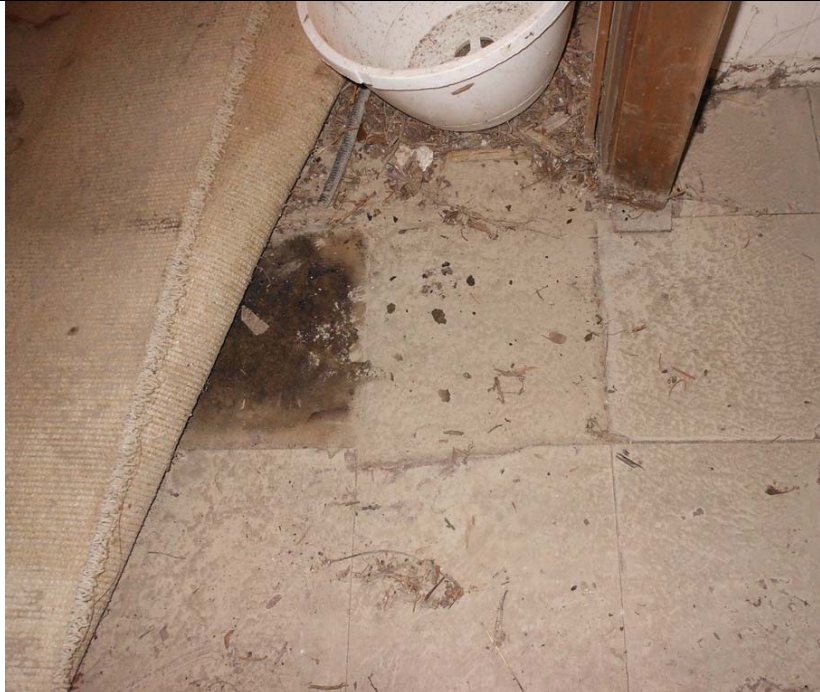
Photo #: 5

Direction: NA	
Description: <u>HA-17</u> : Reddish brown 9" x 9" floor tile in the Millet Office on the west side of the North Garage (mastic layer did not contain asbestos)	
3% Asbestos Sample HA-17-01	
Date: 1/15/2013

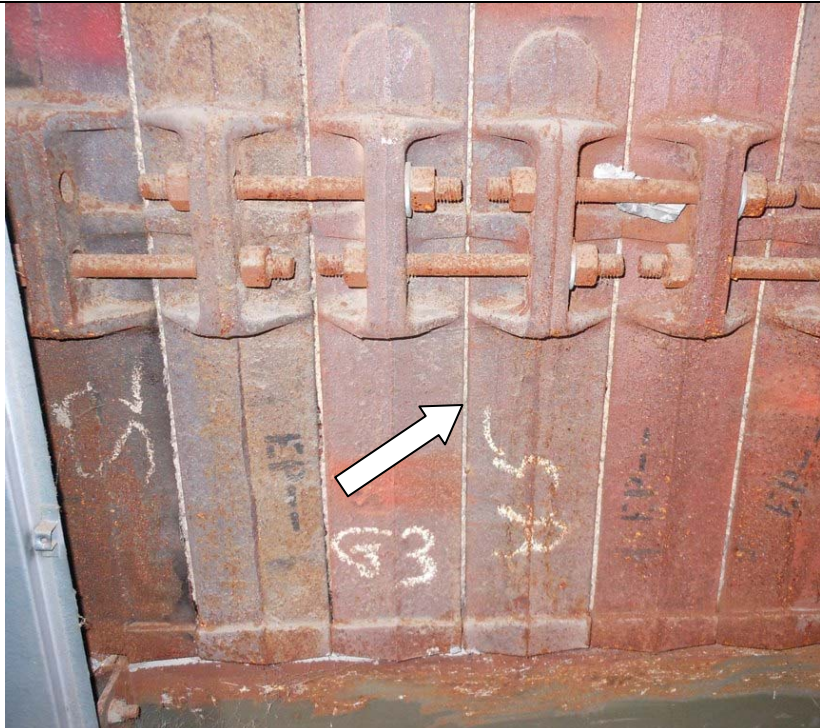
Photo #: 6

Direction: Looking West	
Description: <u>HA-19</u> : White insulation material between boiler plates, Boiler Room.	
13% Asbestos Sample HA-19-01	
Date: 1/15/2013

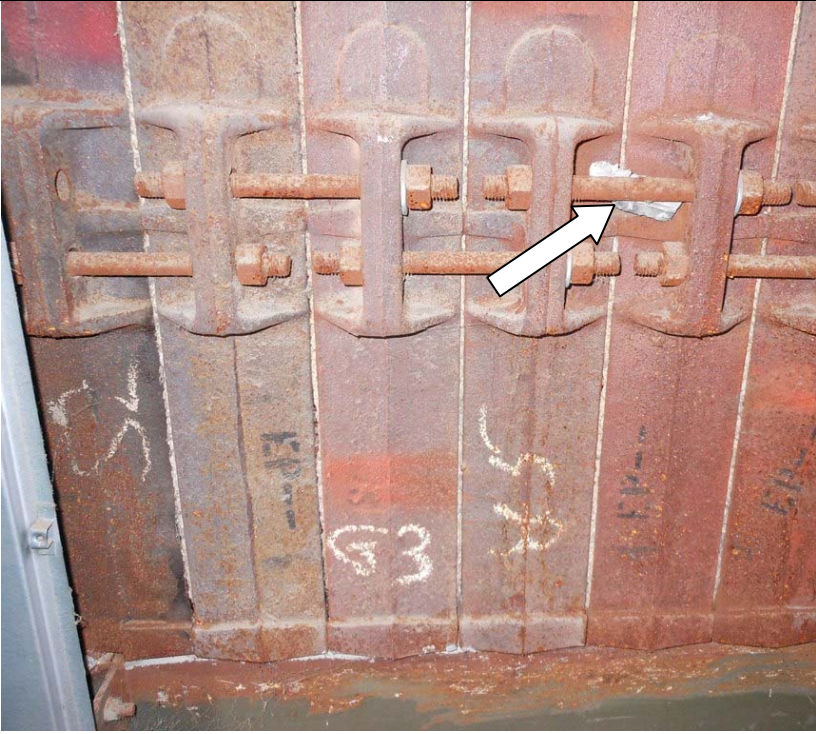
Photo #: 7

Direction: Looking West	
Description: <u>HA-21</u> : Refractory cement inside boiler, Boiler Room, observed on upper and lower perimeter of boiler plates. 2% Asbestos Sample HA-21-01	
Date: 1/15/2013

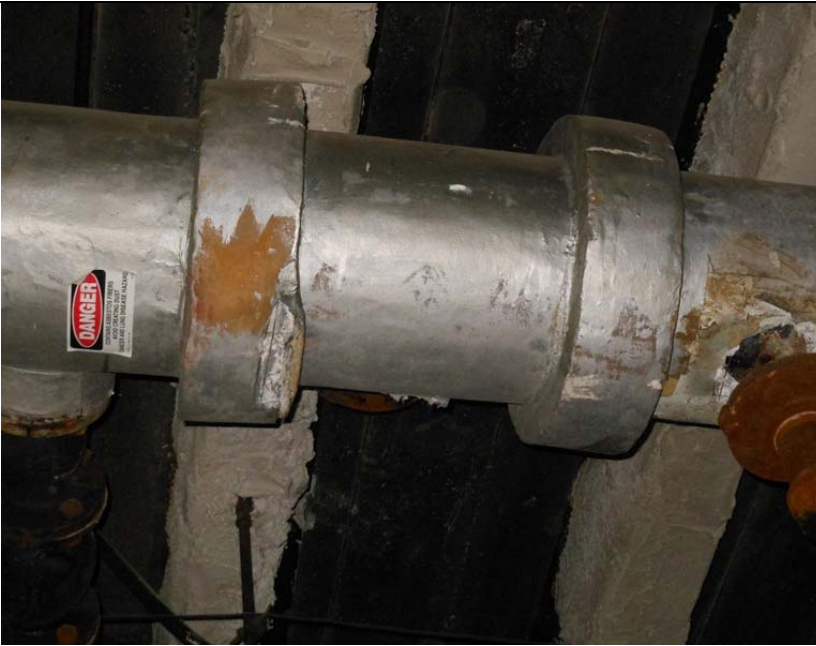
Photo #: 8

Direction: Looking South	
Description: <u>HA-23</u> : Pipe straight insulation in Boiler Room of North Garage area (same as HA-06)(outer wrap did not contain asbestos). 12% Asbestos Sample HA-06-01	
Date: 1/15/2013

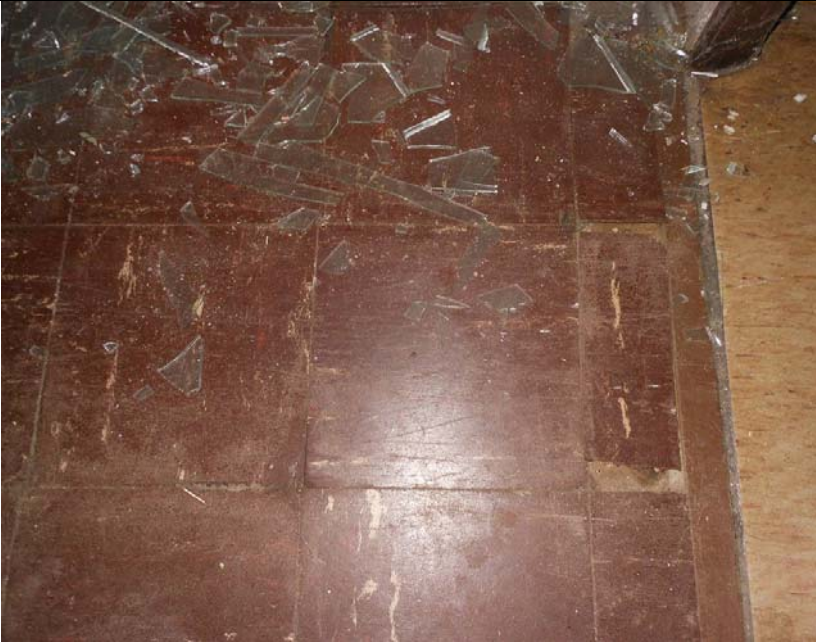
Photo #: 9

Direction: NA	
Description: <u>HA-33</u> : Red 9" x 9" floor tile with tan streaks in Second Floor hallway (mastic layer did not contain asbestos)	
3% Asbestos	
Sample HA-33-01	
Date: 1/15/2013

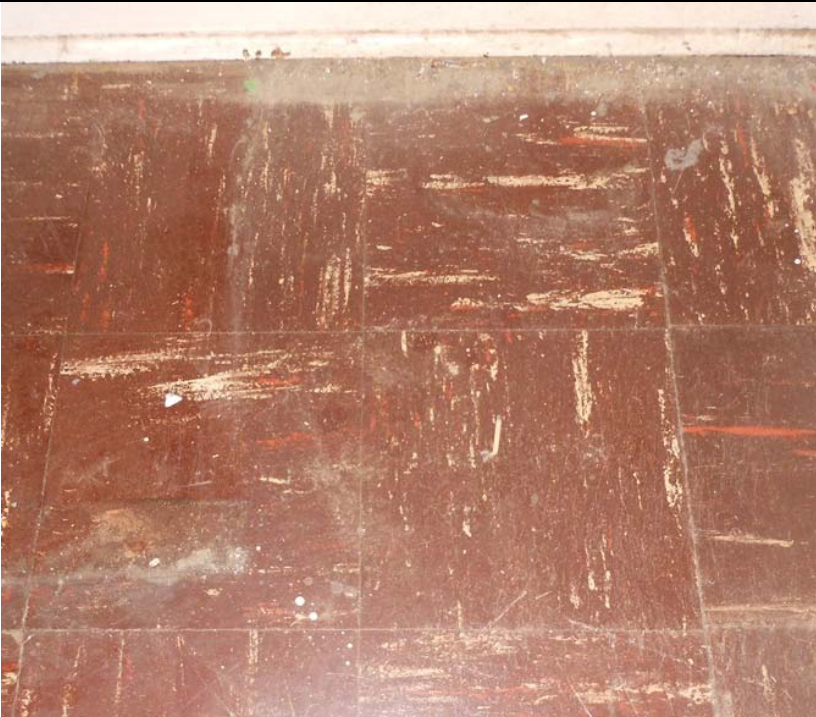
Photo #: 10

Direction: NA	
Description: <u>HA-34</u> : Dark red 9" x 9" floor tile with tan and red streaks in Second Floor offices (mastic layer did not contain asbestos)	
4% Asbestos	
Sample HA-34-01	
Date: 1/15/2013

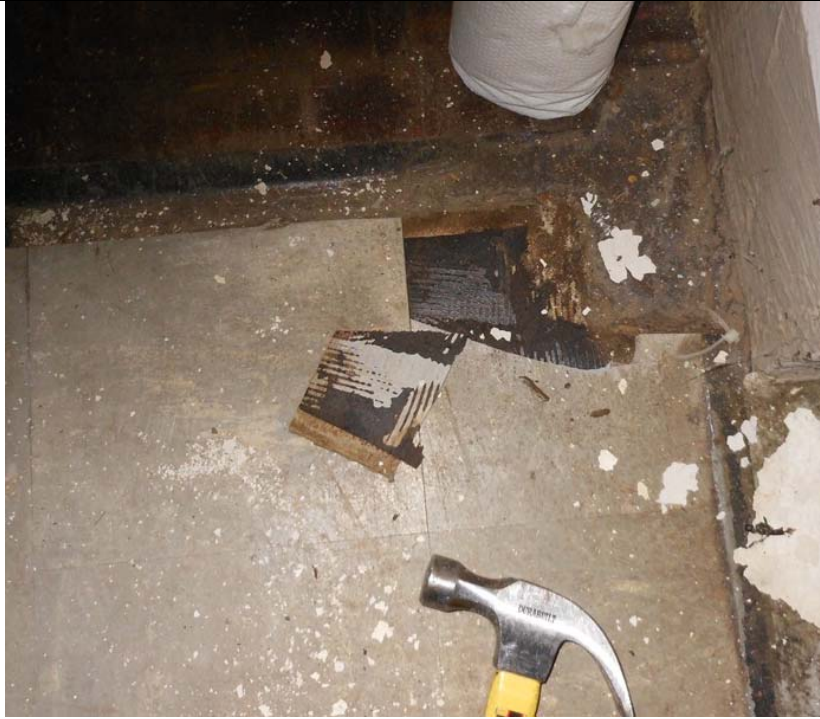
Photo #: 11

Direction: NA	
Description: <u>HA-42</u> : Gray 9" x 9" floor tile on landing of staircase, Second Floor Offices (mastic layer did not contain asbestos) 3% Asbestos Sample HA-42-01	
Date: 1/16/2013
