APPENDIX I
Photograph

Appendix I
Phase I ESA Photographs
721 North Main Street
Ann Arbor, MI

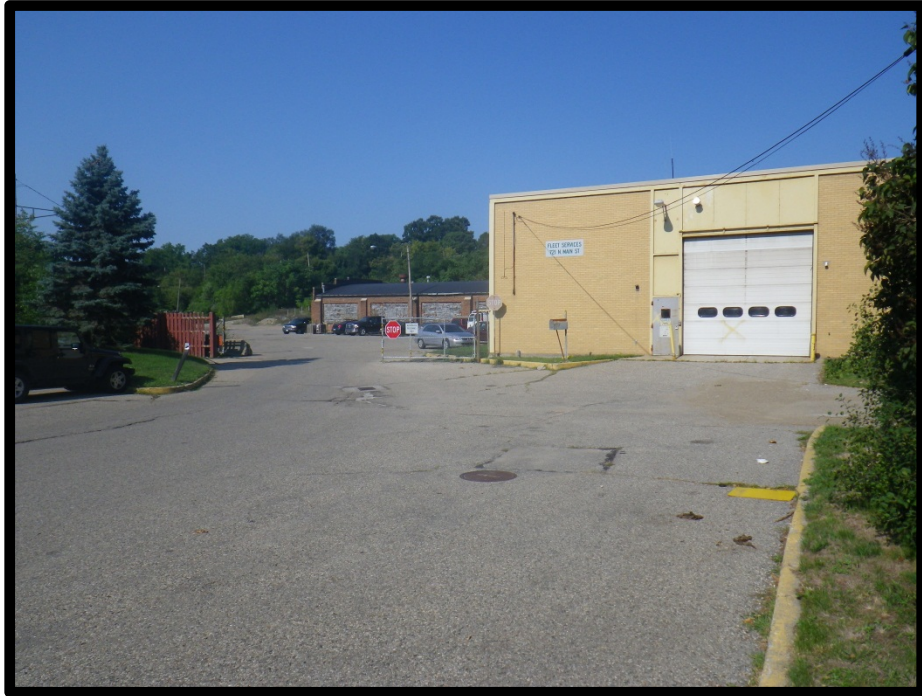
Looking west at the subject property

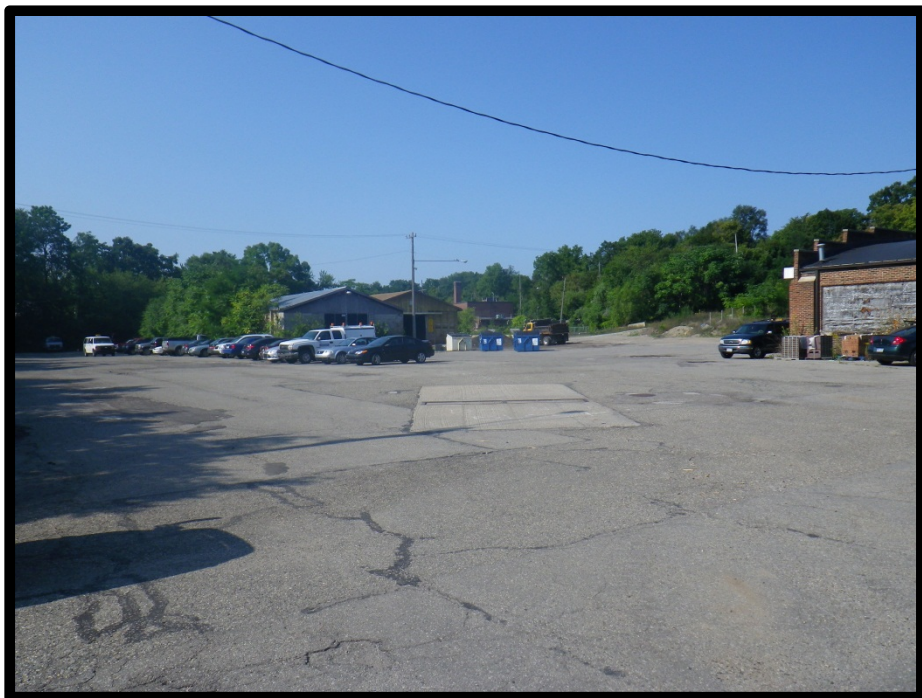
Looking southwest at the subject property

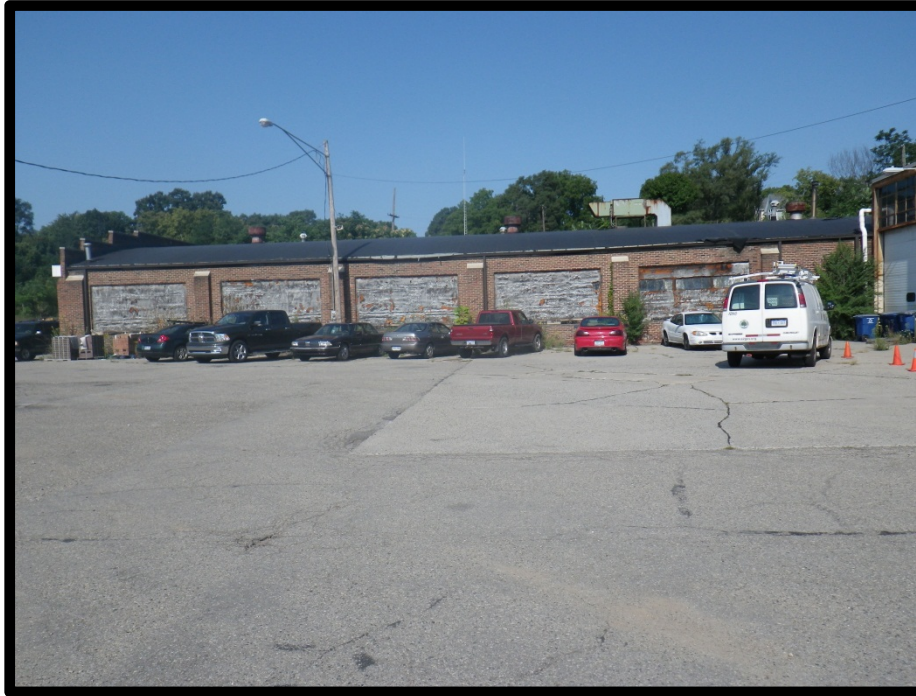
Looking west at the southern end of the maintenance building

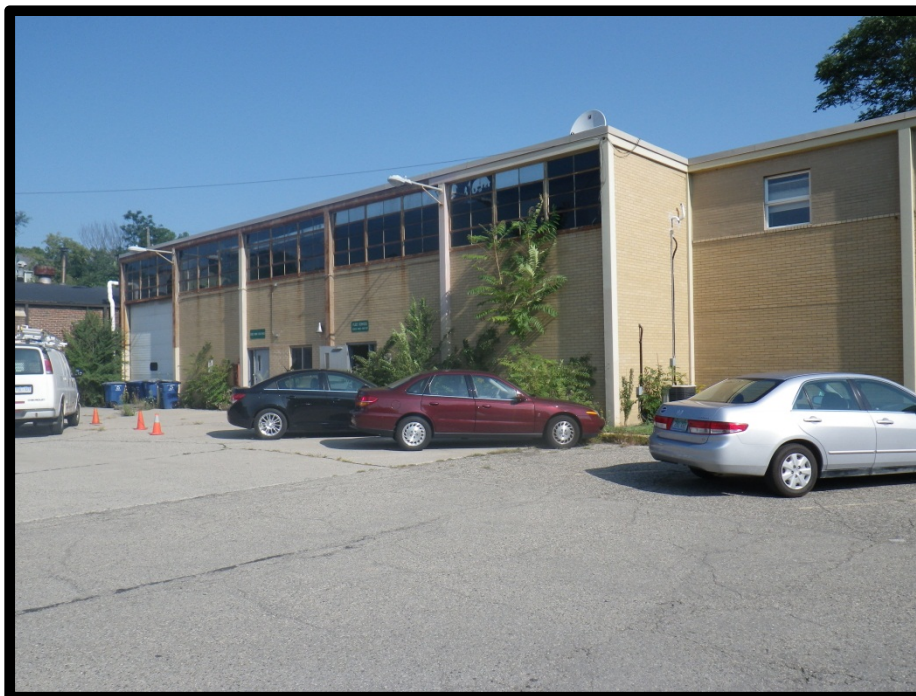
Looking northwest at the northern section of the maintenance building

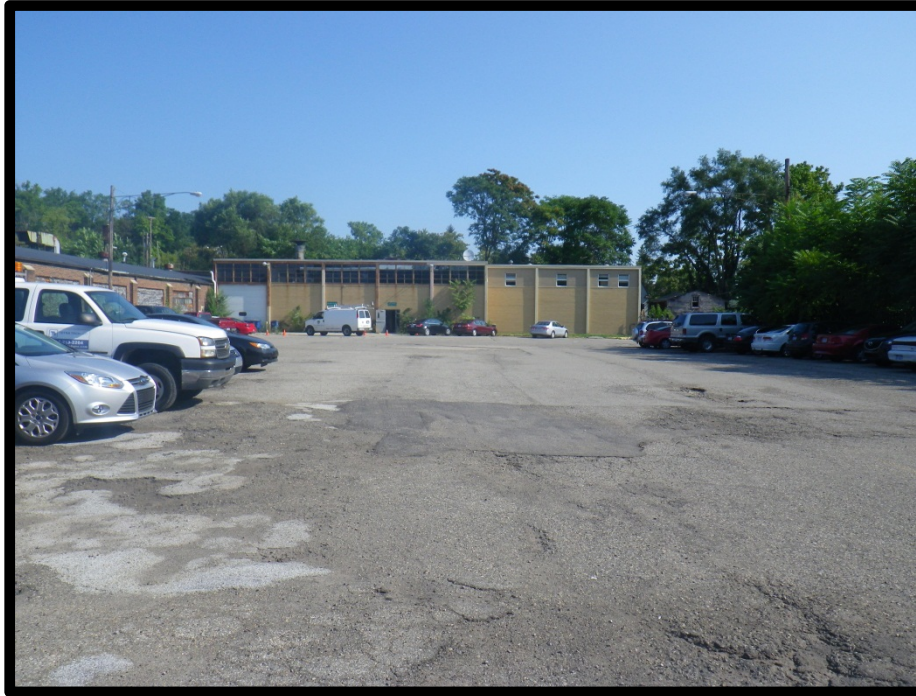
Looking north at the parking lot area

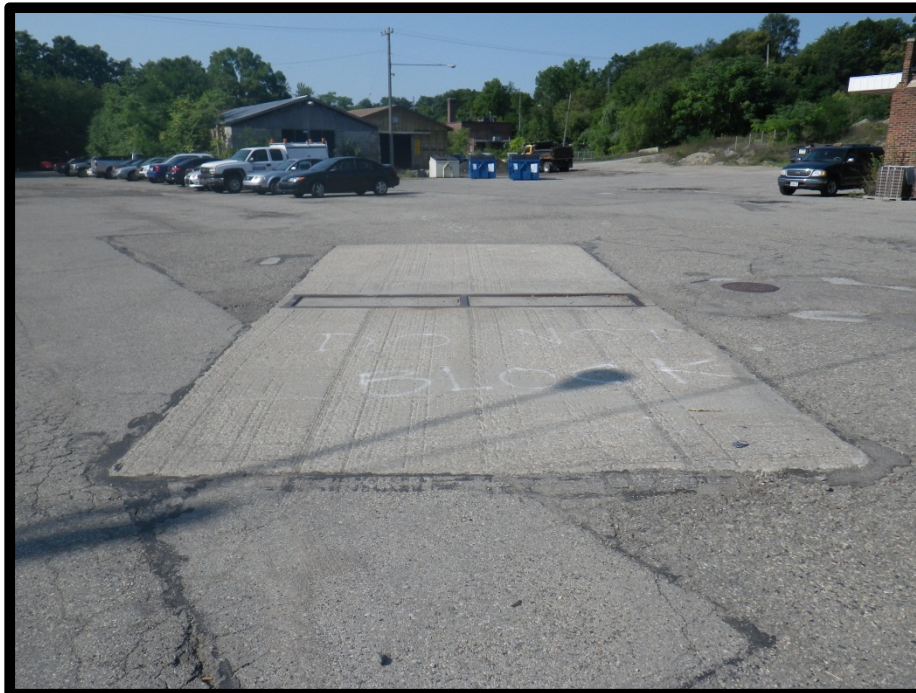
Looking southwest at former weigh scale

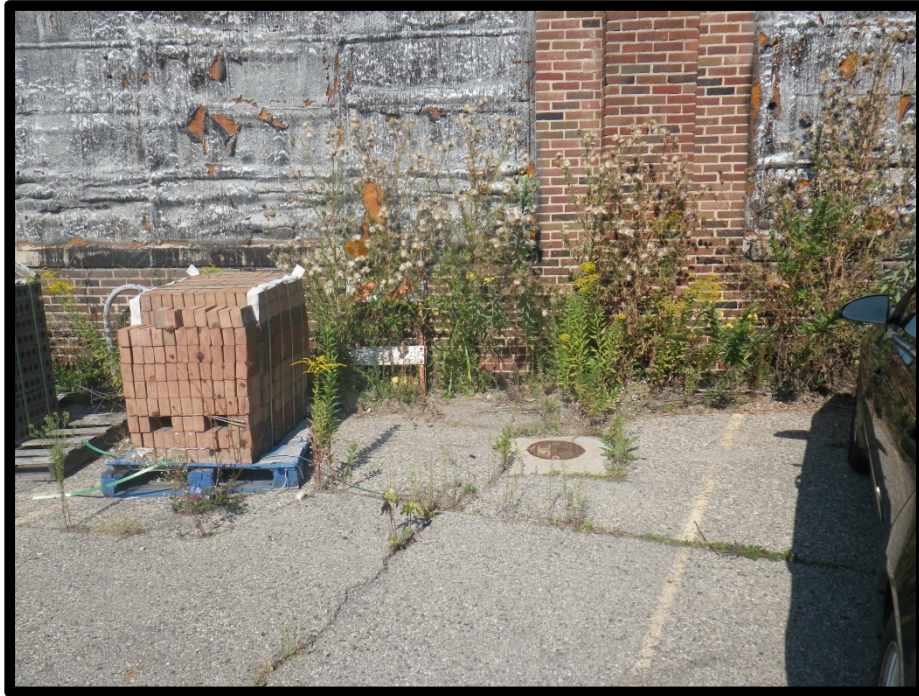
A monitoring well located east of the maintenance building

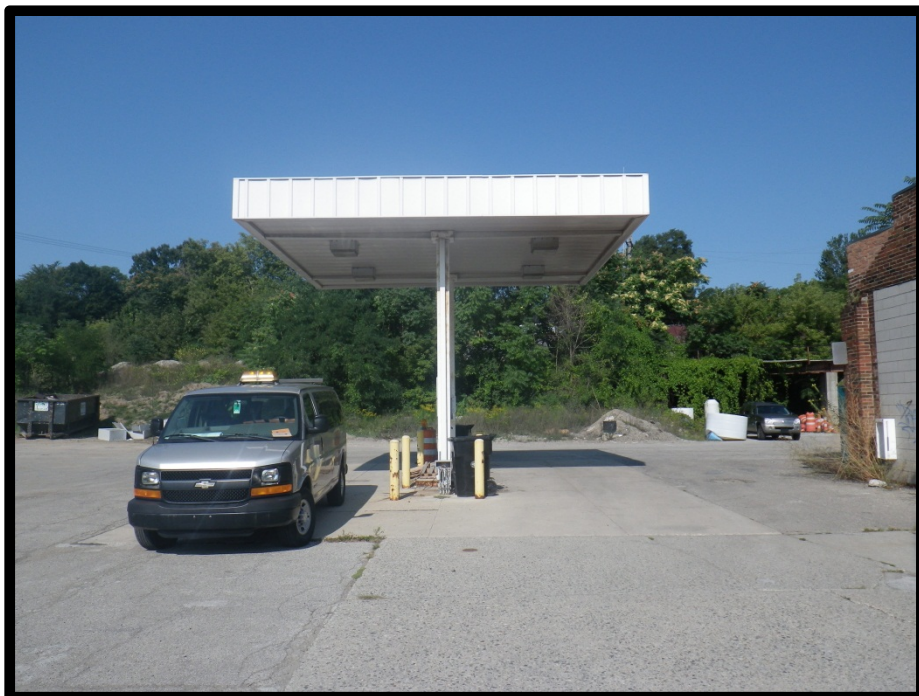
Looking west at the former fuel dispenser island
