Rental Assistance Demonstration (RAD): **PHYSICAL CONDITION ASSESSMENT**

1701-1747 Green Road, Ann Arbor, Michigan 48105

PROJECT # 8213E

DATE February 21, 2014

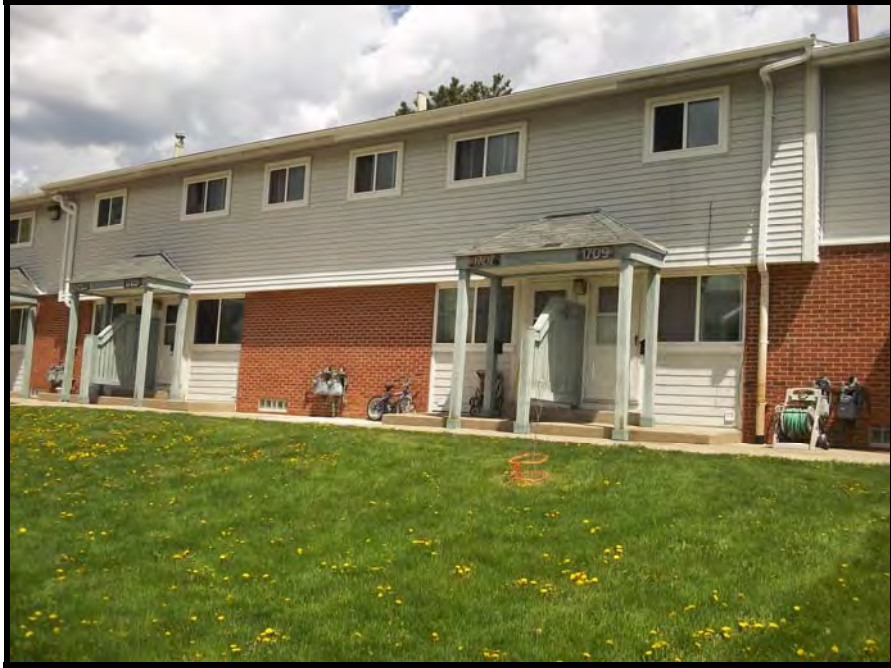
PHOTOGRAPH NO. 1: TYPICAL VIEW OF TENANT UNIT BUILDING

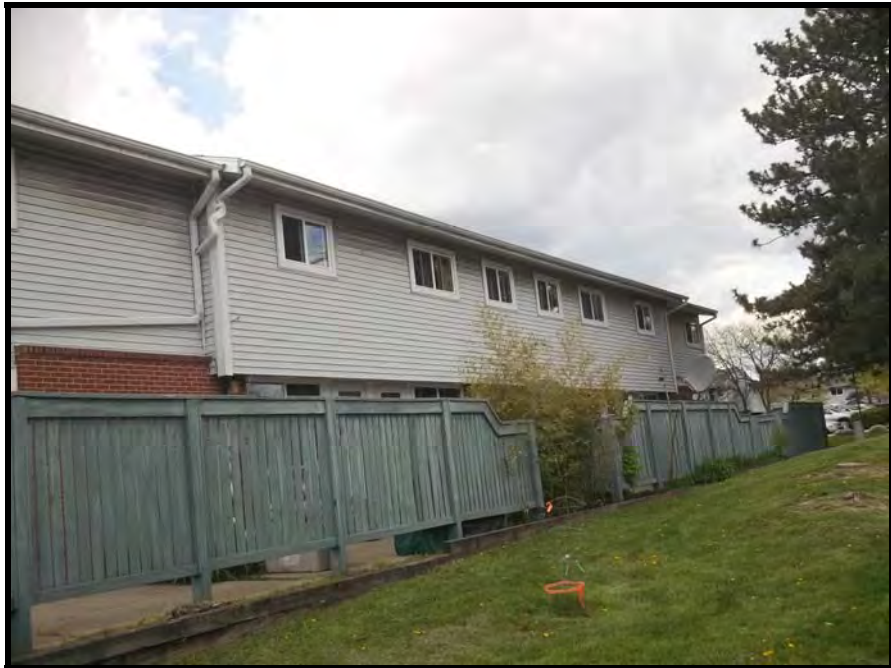
PHOTOGRAPH NO. 2: TYPICAL VIEW OF SUBJECT PROPERTY EXTERIOR

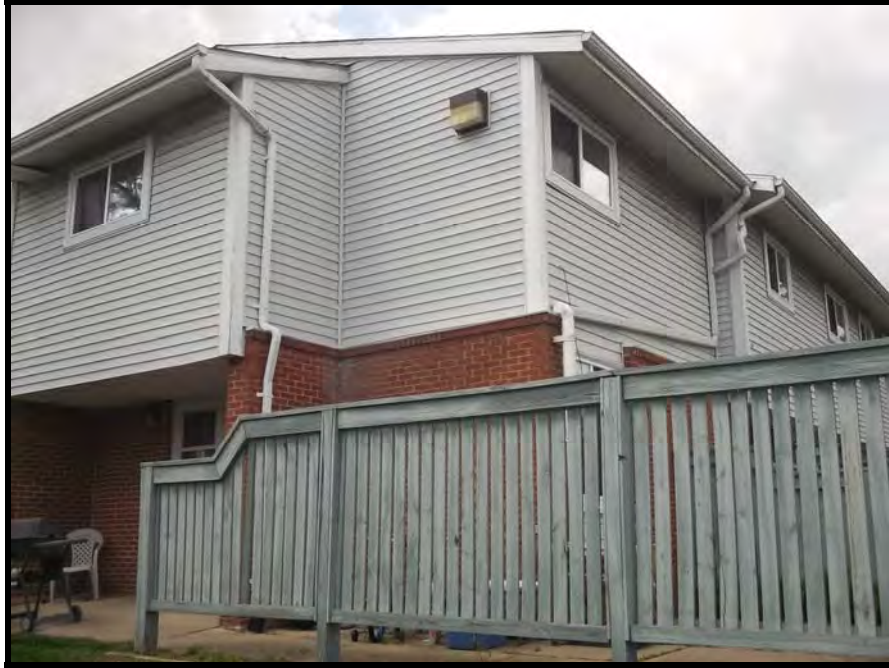
PHOTOGRAPH NO. 3: TYPICAL VIEW OF WOODEN PRIVACY FENCES

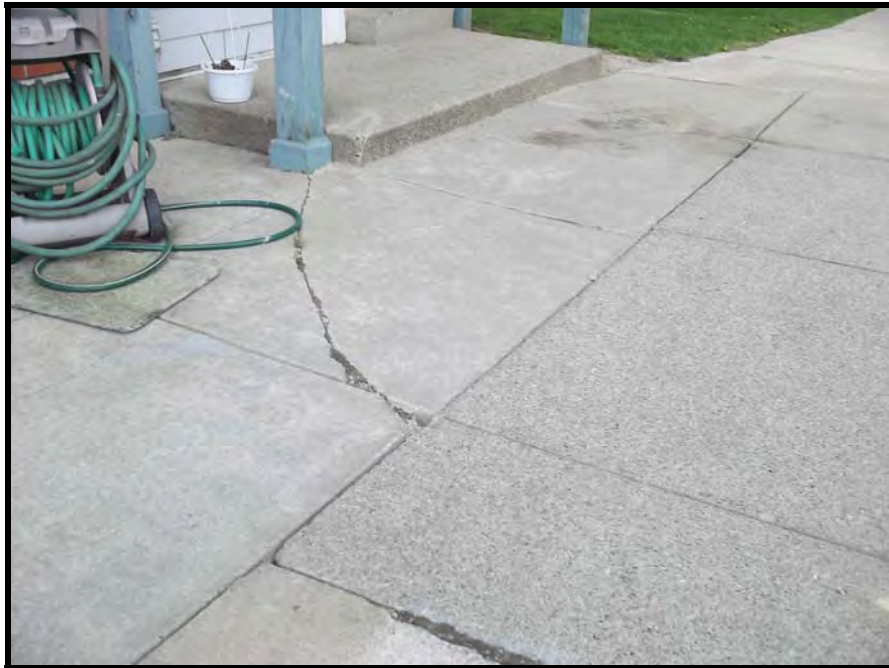
The flat work surrounding the building was observed to be in fair condition with some cracking and separation at engineered seams observed. The steps at resident entries may not meet tread depth and riser height requirements and restrictions.

PHOTOGRAPH NO. 4: TYPICAL VIEW OF FLATWORK THROUGHOUT SUBJECT PROPERTY

Repair and maintain broken concrete walkways around the subject property to avoid continued degradation and a possible trip hazard are recommended as rehab items. Please refer to the attached Capital Needs Input, 20 Year Detail, 20 Year Schedule and Rehab Specifications for additional information on condition, rehab costs and capital reserves.

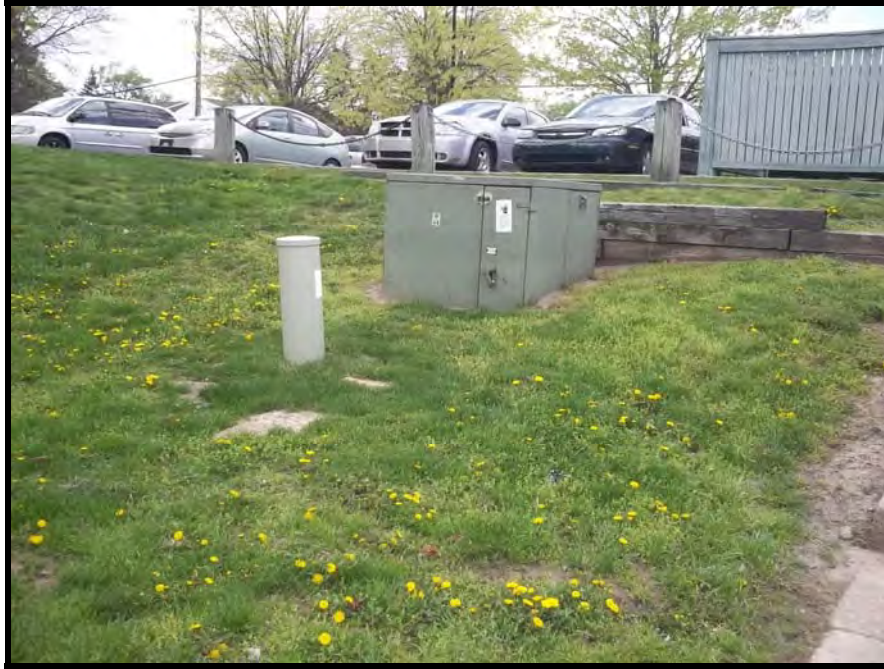
PHOTOGRAPH NO. 5: TYPICAL VIEW OF WOODEN RETAINING WALL

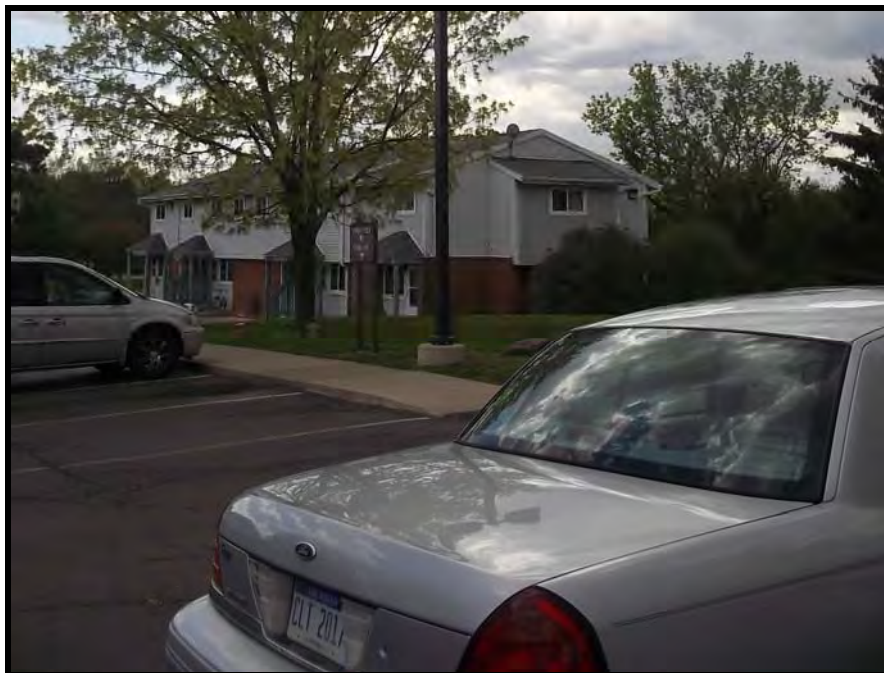
Overall, the asphalt and concrete paved areas appear to be in fair condition. However, longitudinal cracking and localized delamination was observed on the asphalt pavement drives and parking areas. Longitudinal cracking and movement along engineered seams was also observed on the concrete paved sidewalk. The concrete curbing and concrete approach were observed to be in fair condition.

PHOTOGRAPH NO. 6: TYPICAL VIEW OF SUBJECT PROPERTY PARKING LOT

Repair, patch and sealcoat asphalt pavement in the parking area is recommended as a rehab item. Continued maintenance of paved areas is recommended. In addition, capital reserves should be considered for future maintenance, and/or replacement and repair of paved, future maintenance, and/or replacement and repair of paved areas. Please refer to the attached Capital Needs Input, 20 Year Detail, 20 Year Schedule and Rehab Specifications for additional information on condition, rehab costs and capital reserves.

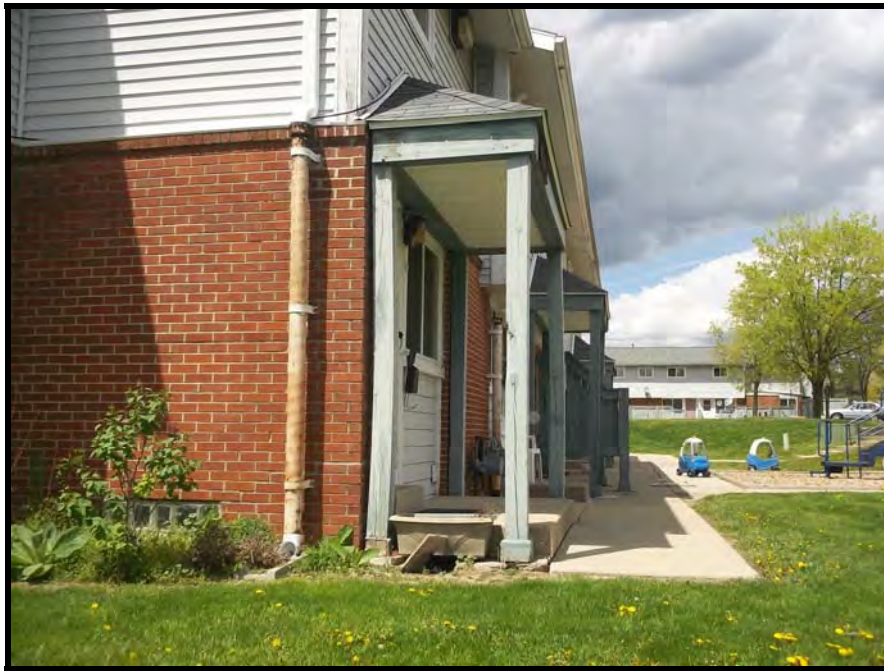
The concrete board, vinyl siding, and sliding double-paned vinyl windows generally appeared to be in good condition. However, the screen doors, entry doors, and porches are beyond their EUL and/or damaged. In addition, some mortar associated with the masonry veneer was observed to be missing.

PHOTOGRAPH NO. 7: TYPICAL VIEW OF PORCHES ASSOCIATED WITH TENANT UNITS

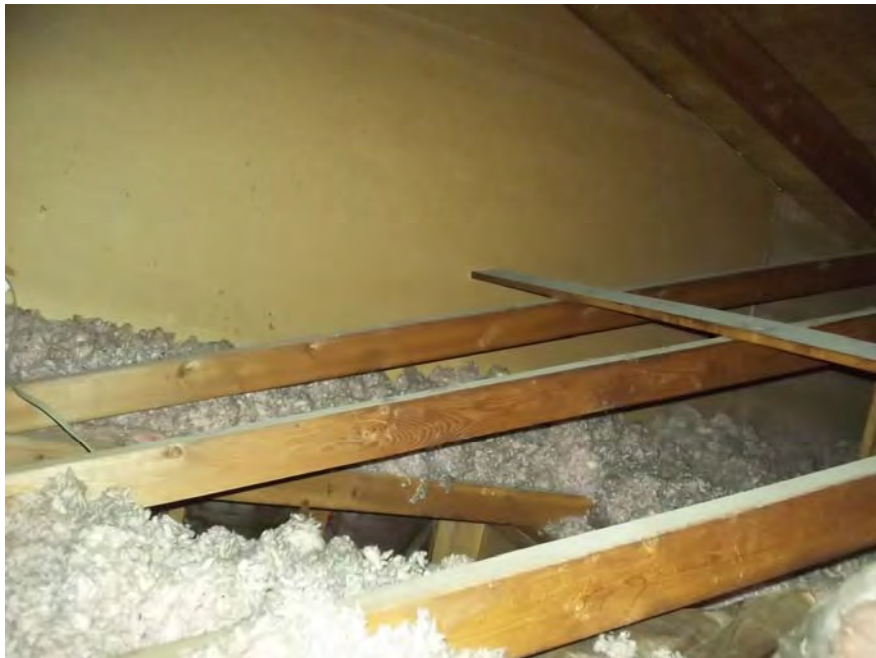
PHOTOGRAPH NO. 8: TYPICAL VIEW OF ATTIC INSULATION IN SUBJECT BUILDINGS

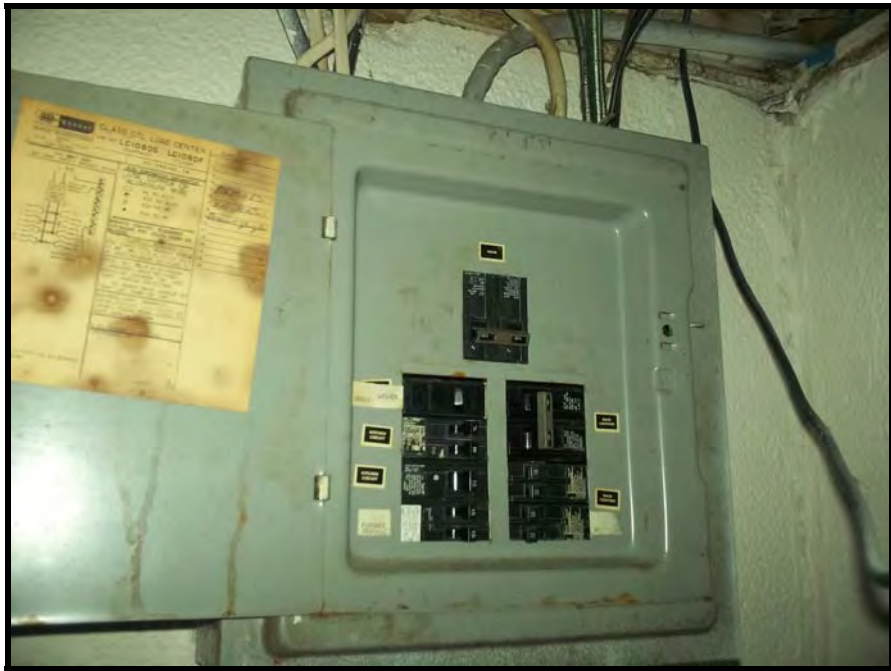
PHOTOGRAPH NO. 9: TYPICAL VIEW OF ELECTRICAL PANELS IN TENANT UNITS

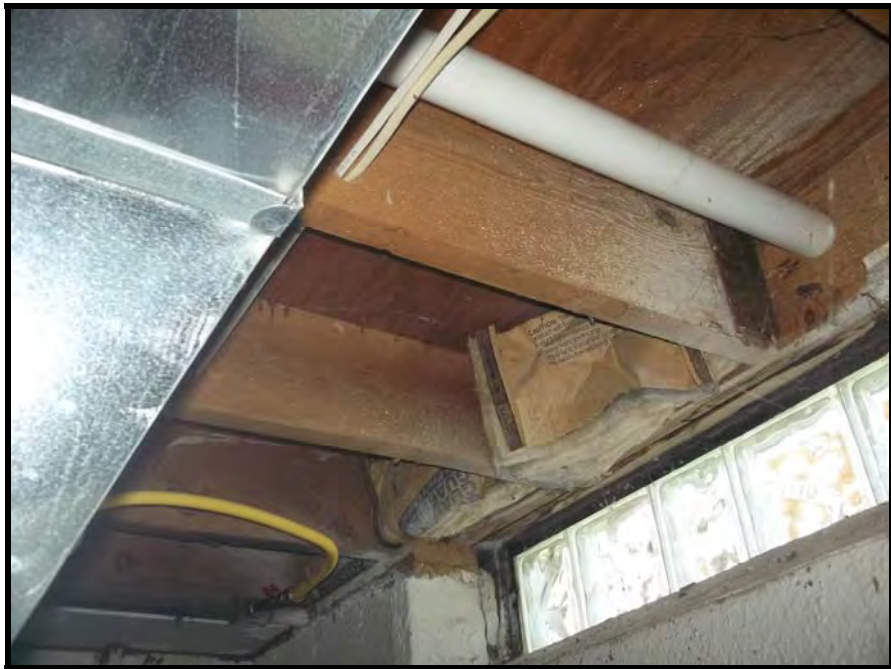
PHOTOGRAPH NO. 10: TYPICAL VIEW OF DUCTWORK AND JOIST BRACING IN TENANT UNIT BASEMENT

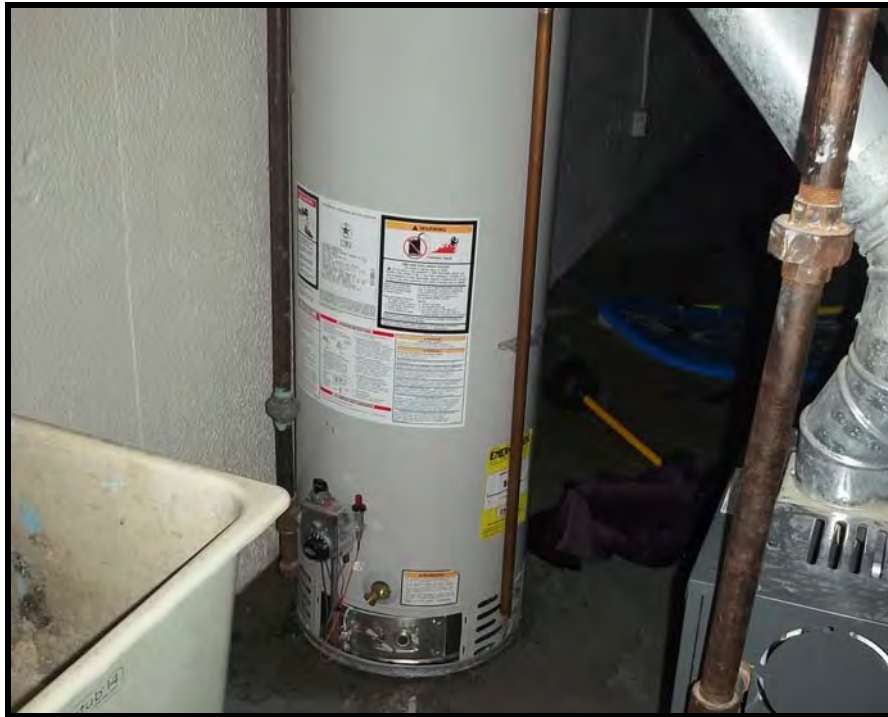
PHOTOGRAPH NO. 11: TYPICAL VIEW OF HOT WATER HEATERS IN TENANT UNITS

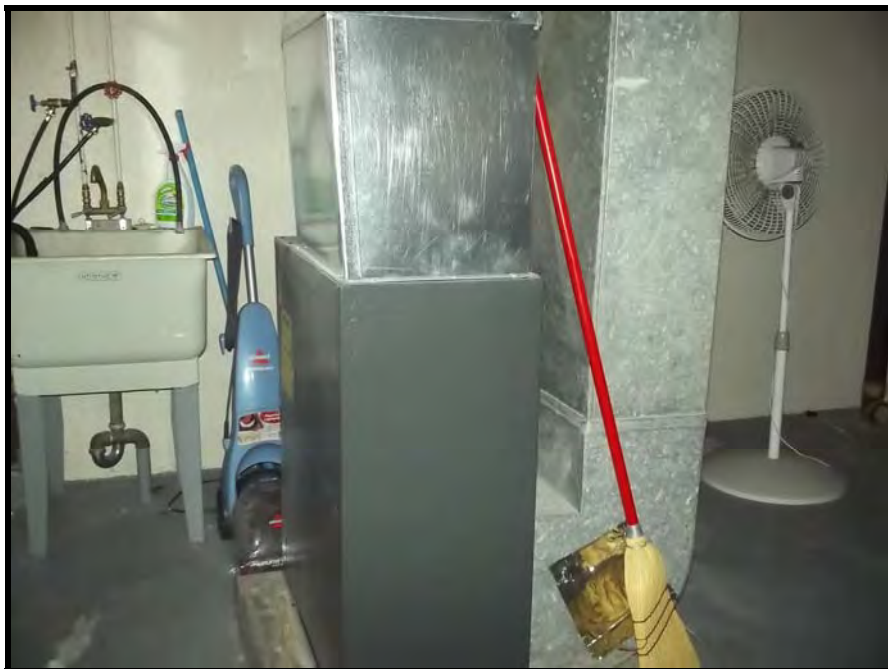
PHOTOGRAPH NO. 12: TYPICAL VIEW OF TENANT UNIT FURNACE

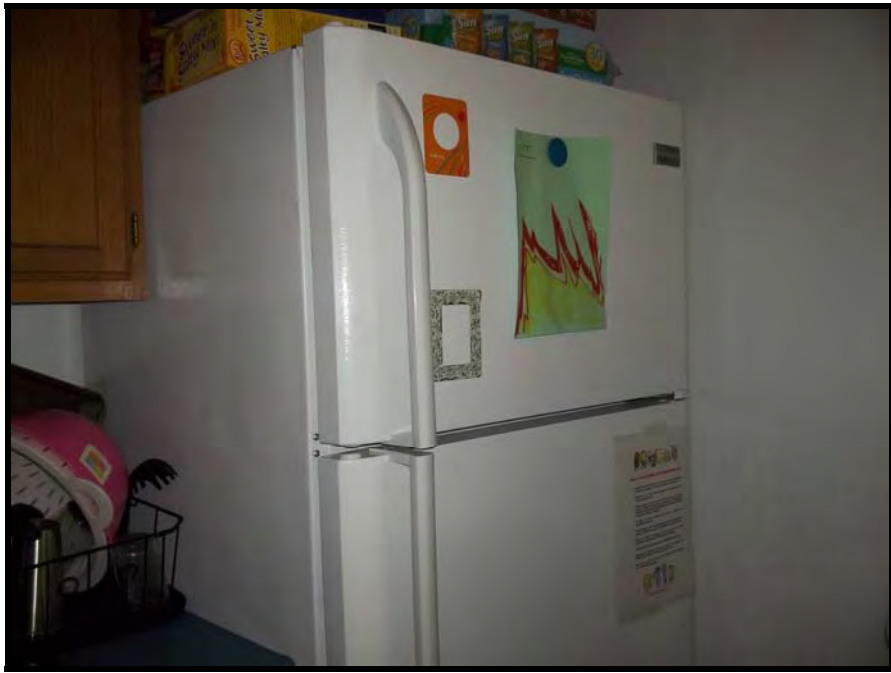
PHOTOGRAPH NO. 13: TYPICAL VIEW OF TENANT REFRIGERATOR

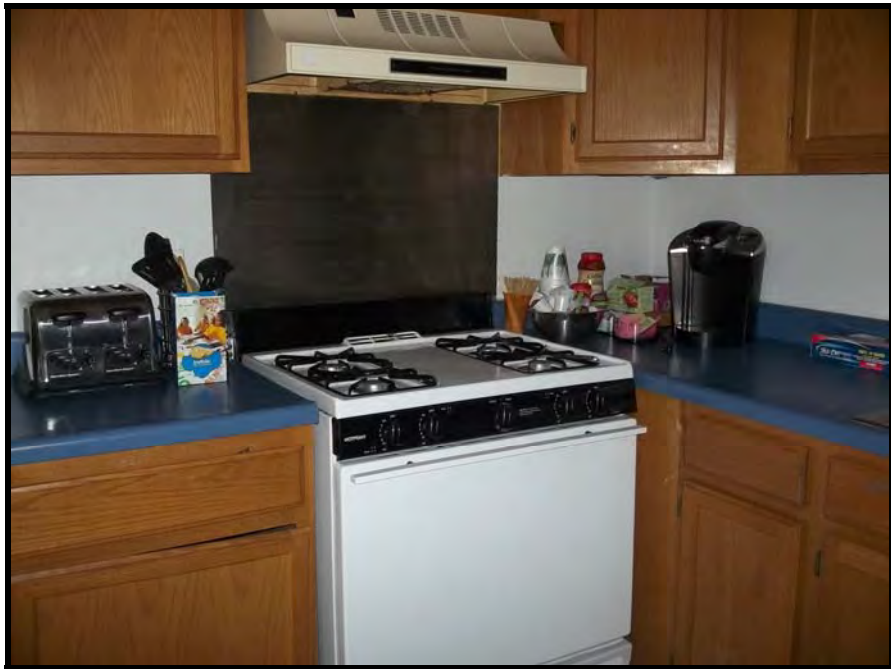
PHOTOGRAPH NO. 14: TYPICAL VIEW OF TENANT UNIT KITCHEN

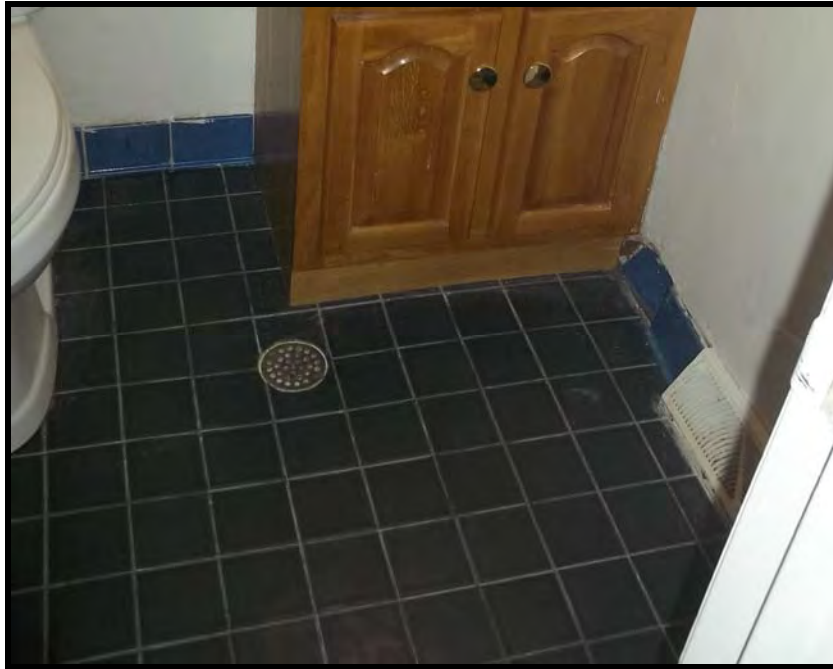
PHOTOGRAPH NO. 15: TYPICAL VIEW OF FLOORING IN TENANT UNIT BATHROOMS

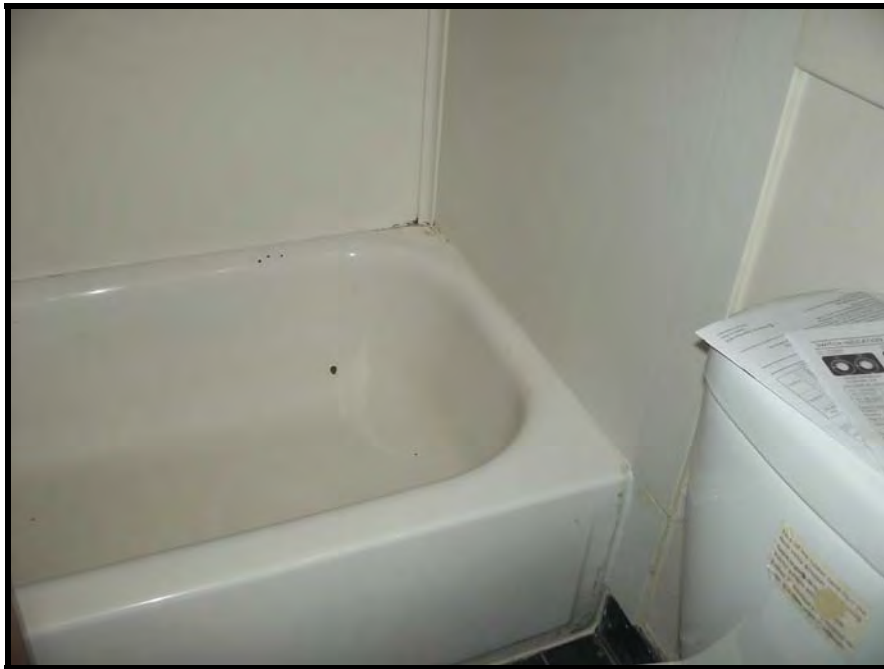
PHOTOGRAPH NO. 16: TYPICAL VIEW OF BATHTUB AND ASSOCIATED VINYL ENCLOSURE

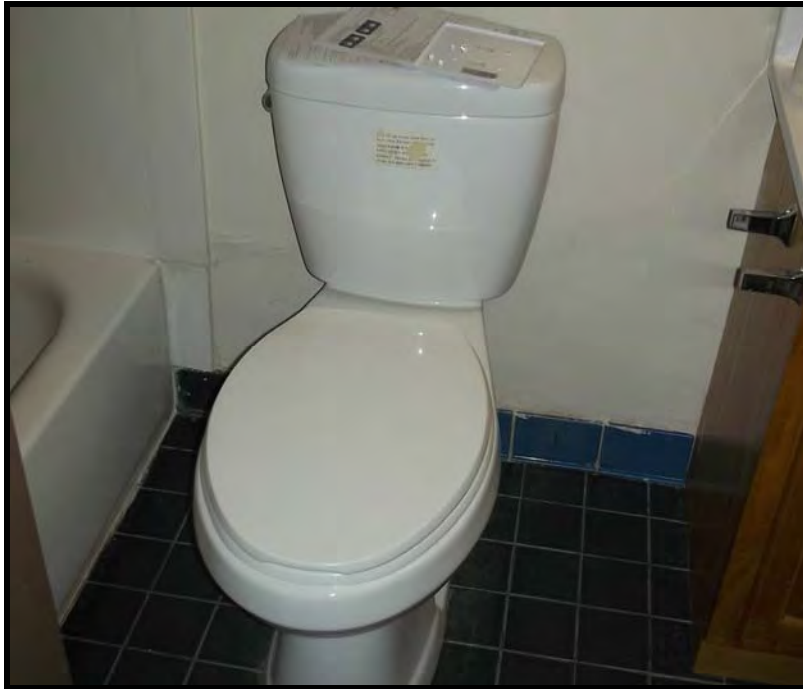
PHOTOGRAPH NO. 17: TYPICAL VIEW OF TOILET FIXTURE IN BATHROOM

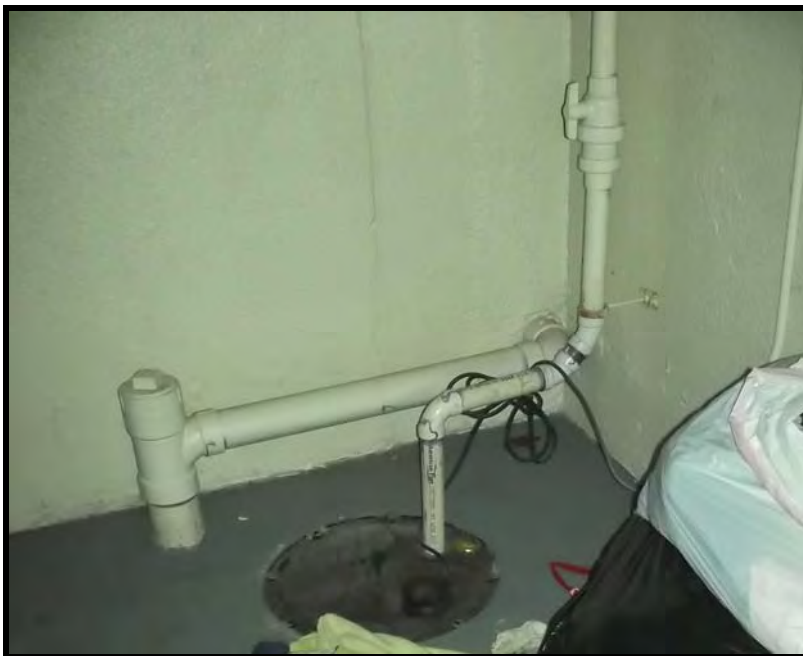
PHOTOGRAPH NO. 18: TYPICAL VIEW OF SUMP PUMP IN BASEMENT

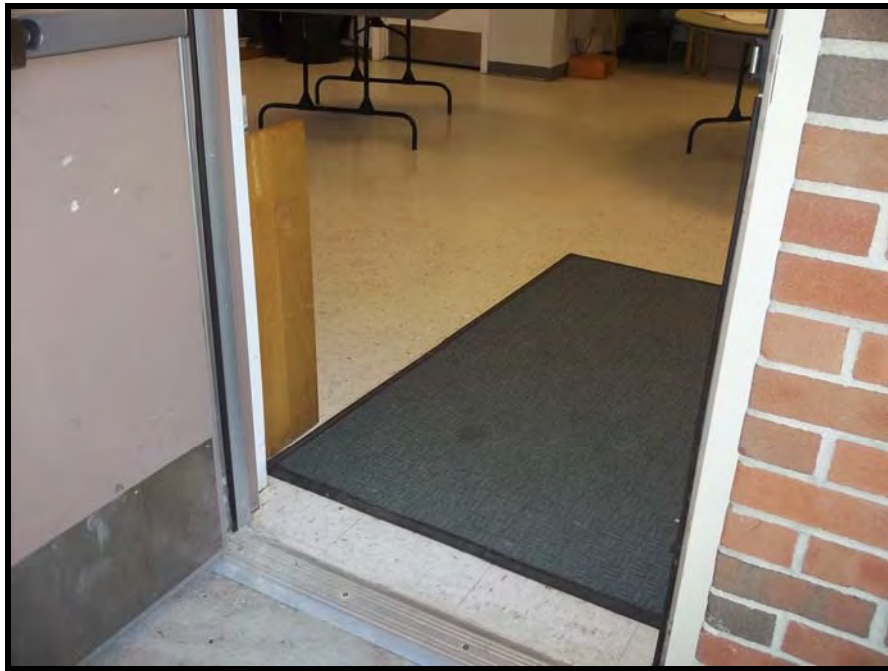
PHOTOGRAPH NO. 19: VIEW OF TYPICAL EXISTING FLOORING

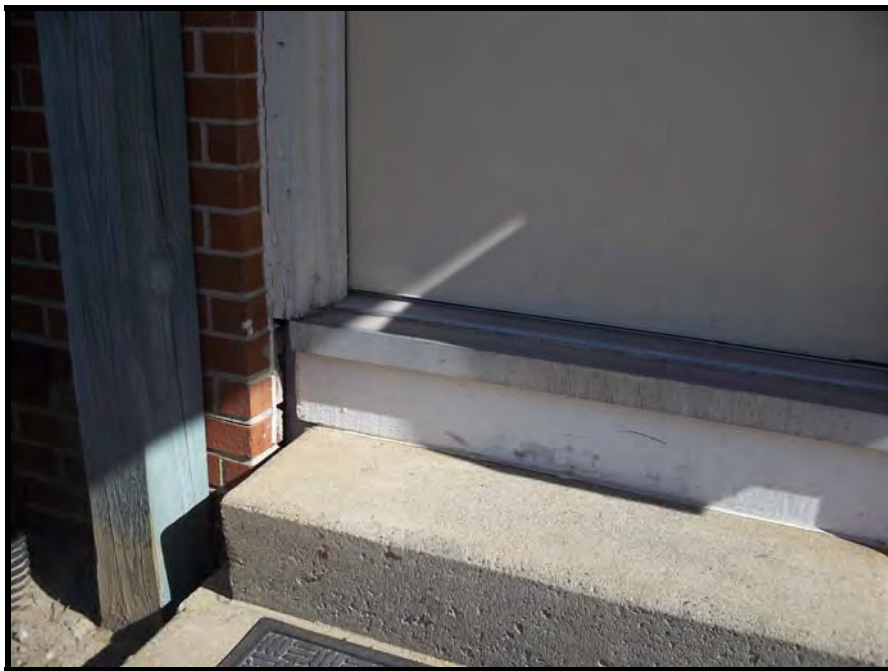
PHOTOGRAPH NO. 20: TYPICAL VIEW OF CONCRETE STEP TO UNIT ENTRANCE

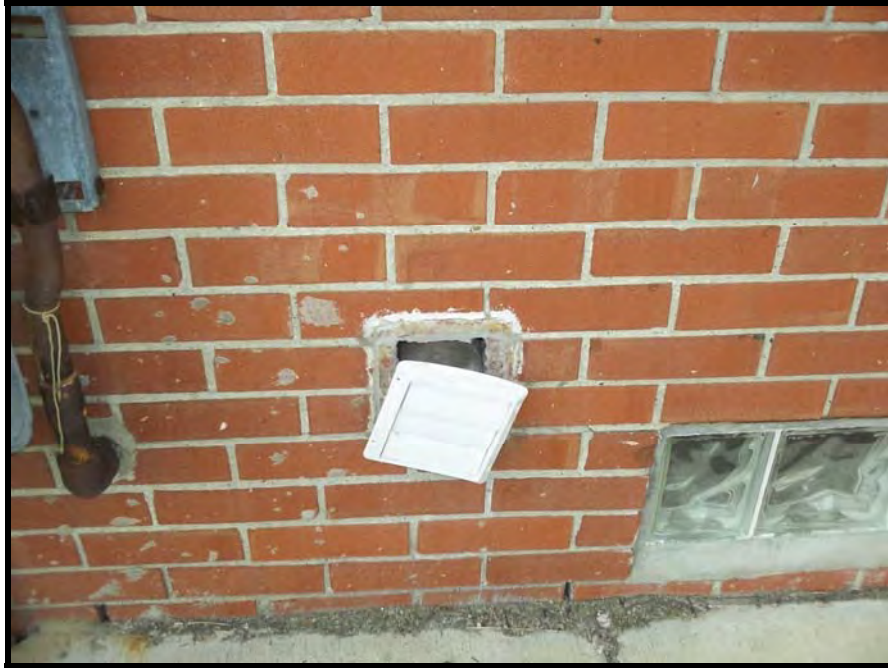
PHOTOGRAPH NO. 21: VIEW OF DAMAGED VENT PLATE ON EXTERIOR OF BUILDING

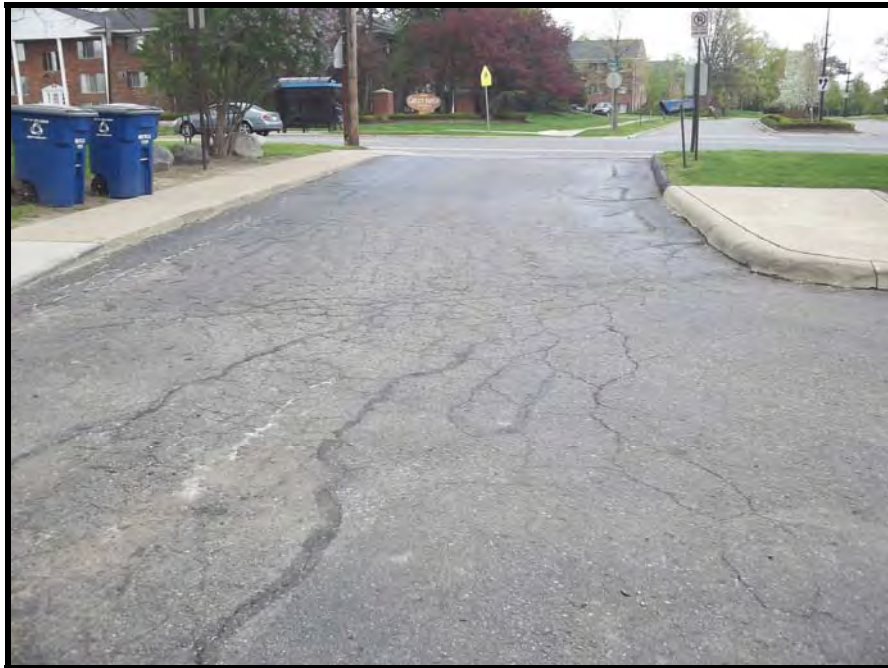
PHOTOGRAPH NO. 22: VIEW OF ASPHALT PAVEMENT IN PARKING LOT
