**Re: Lead Based Paint Inspection and Risk Assessment
Miller Manor
727 Miller Avenue, Ann Arbor, Michigan
ERG Project 1126.003**

LEAD BASED PAINT INSPECTION AND RISK ASSESSMENT

Miller Manor
727 Miller Ave.
Ann Arbor, Michigan 48103

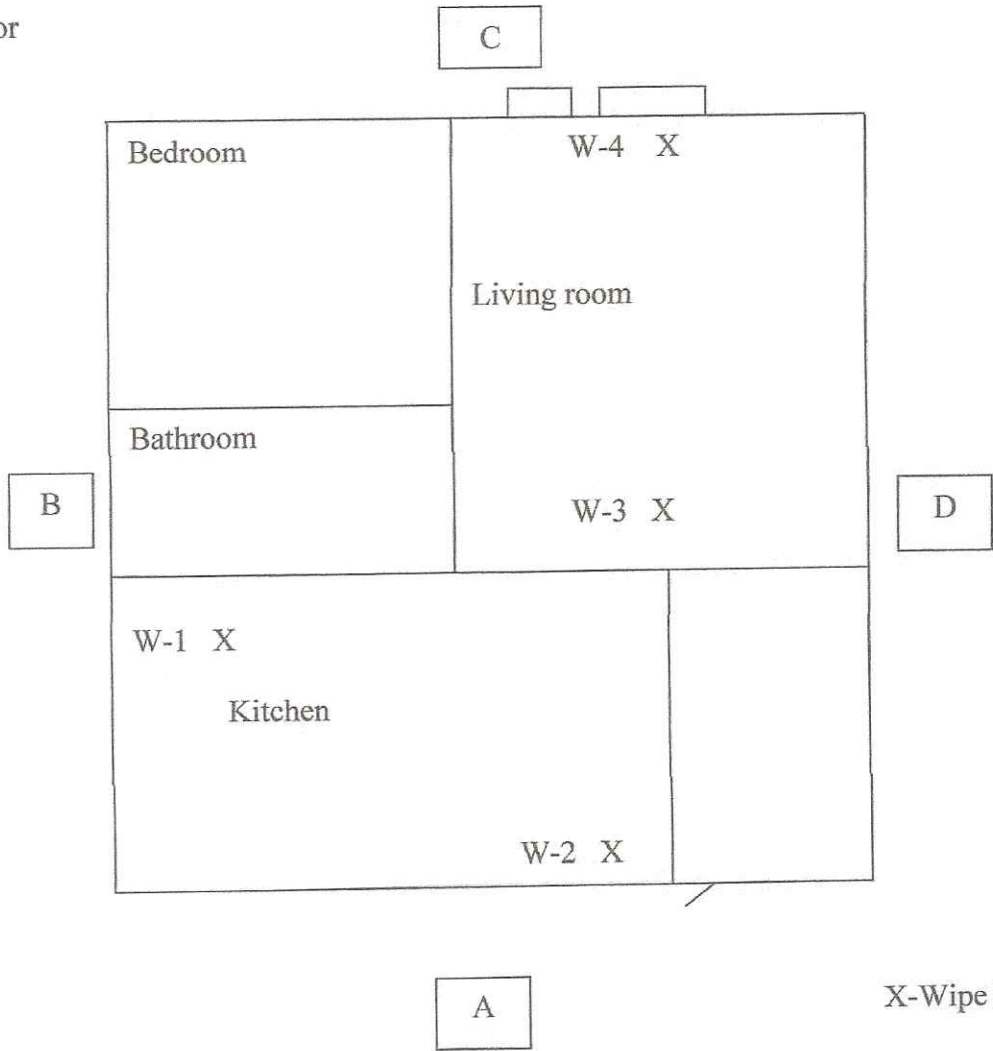
Miller Manor
Unit 408

X-Wipe Samples
