ADDENDUM No. 2

MATERIALS RECYCLING FACILITY CONTRACT DEVELOPMENT

City of Ann Arbor MRF Audit

Company/Dept.: CP MFG / Customer Service		Title: System Audit		Document Number: Audit-002

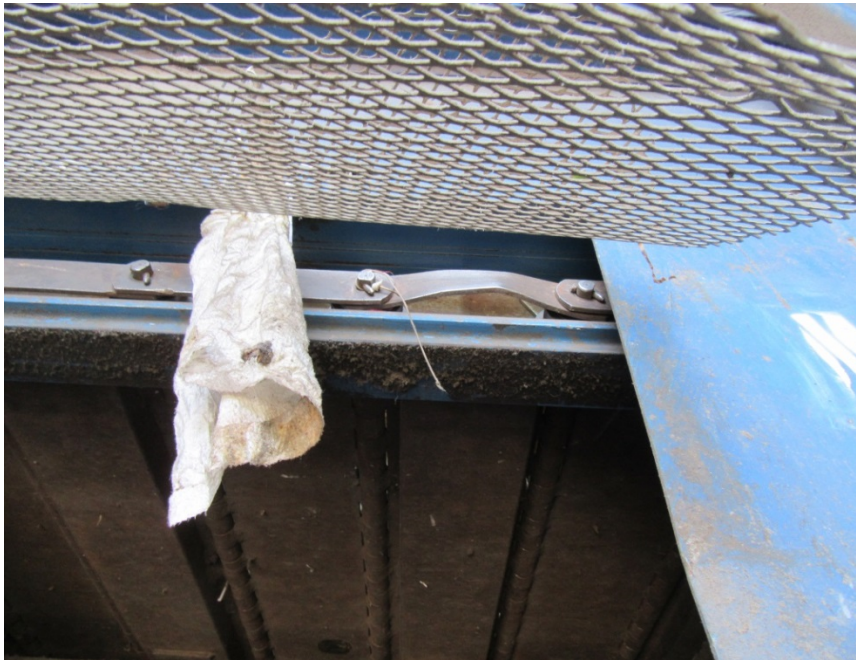
Photo A shows the damaged link in the belting. We recommend fixing the damaged links to prevent further damage to the belt.

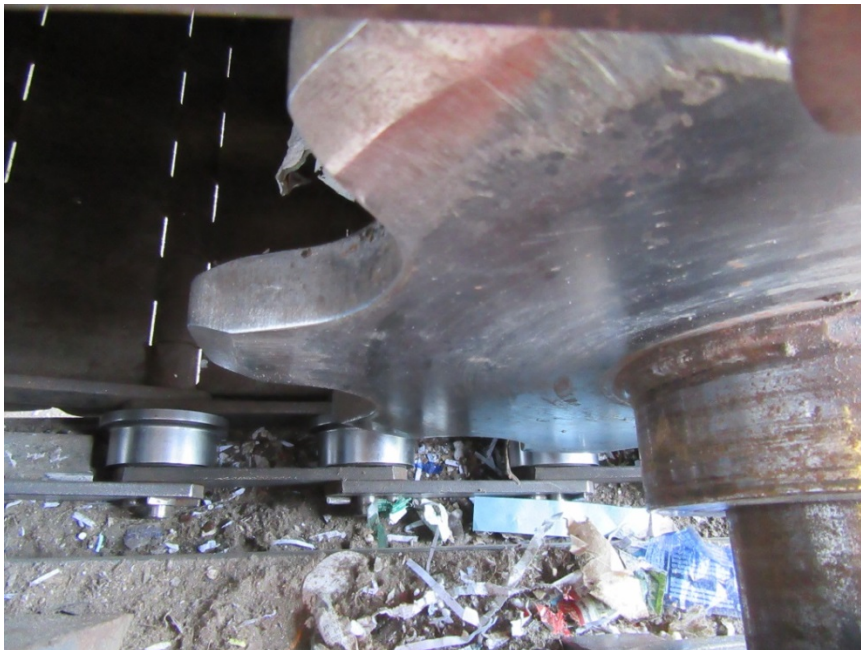
Photos A & B show the lack of tensioning on the belt. We recommend tensioning the belting on a regular basis to prevent premature wear of the belting and sprockets.

3. Steel Belt Conveyors are running with too much slack. The steel belt conveyor for the Incline Conveyor C-2 is in need of tensioning to prevent costly belt and sprocket damage.

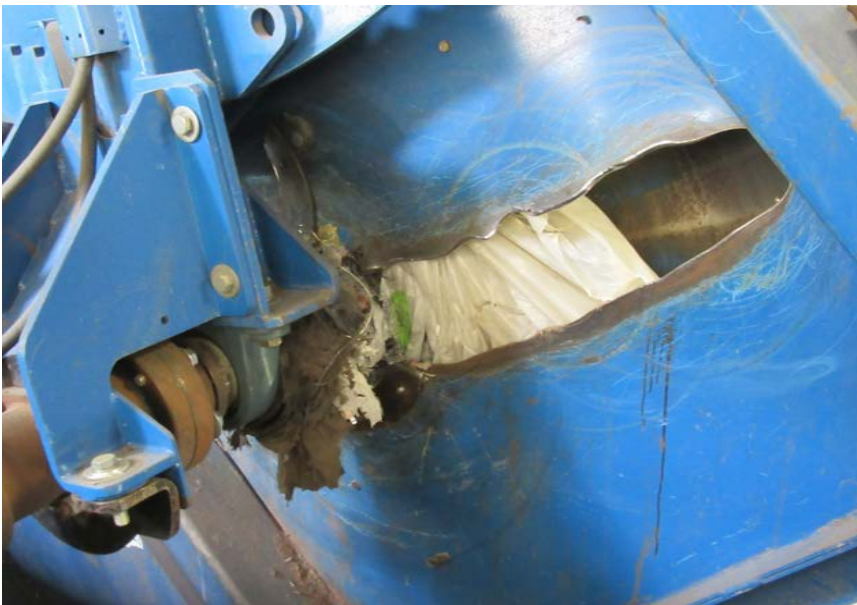
Photos A & B show the excessive wrapping around the Metering Drum shafts. We recommend removing these wrappings on a regular basis to prevent damage to the drum or to the support walls.

5. The Metering Drum needs some maintenance attention. The shaft wrappings that were seen during our inspection are causing damage to the sidewalls of the Metering Drum.

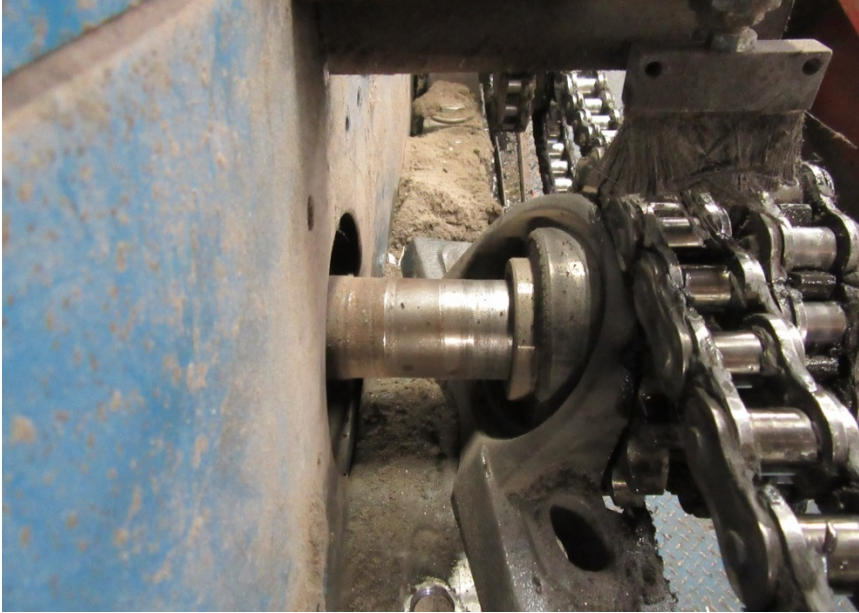
Photos A & B show damage to the bearings. These damaged bearings are a result of the misaligned rotors. Out of time rotors can cause material jams, damaging the bearings as shown. We recommend that the rotors are properly clocked on a regular basis to prevent this problem.

1. The OCC Screen requires some maintenance attention as soon as possible. There are multiple bearings that require replacement immediately. We recommend that these shafts are clocked accordingly as soon as possible.

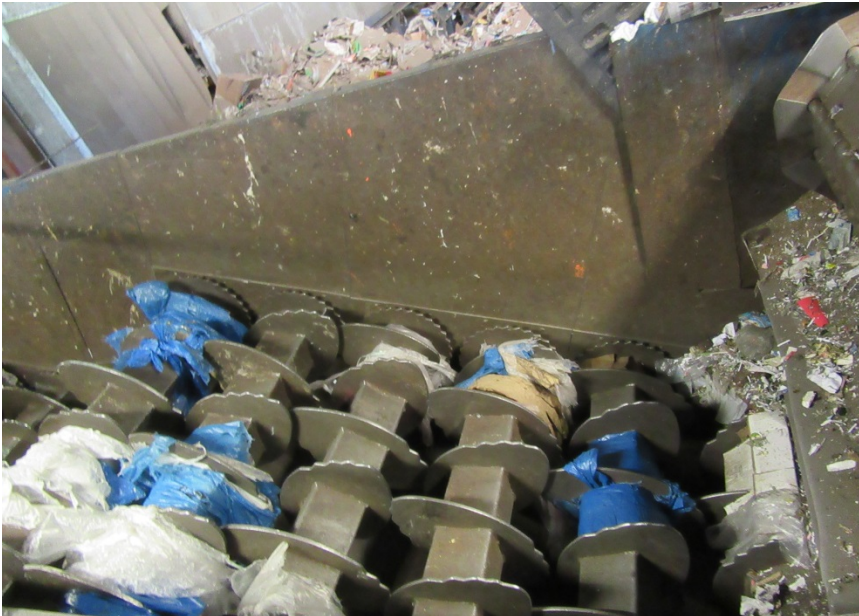
Photo C shows the misalignment of the rotors. This photo also shows the wrappings on the rotors. These wrappings can also lead to material jams resulting in damage to the shafts and bearings. We recommend removing all wrappings on a regular basis.

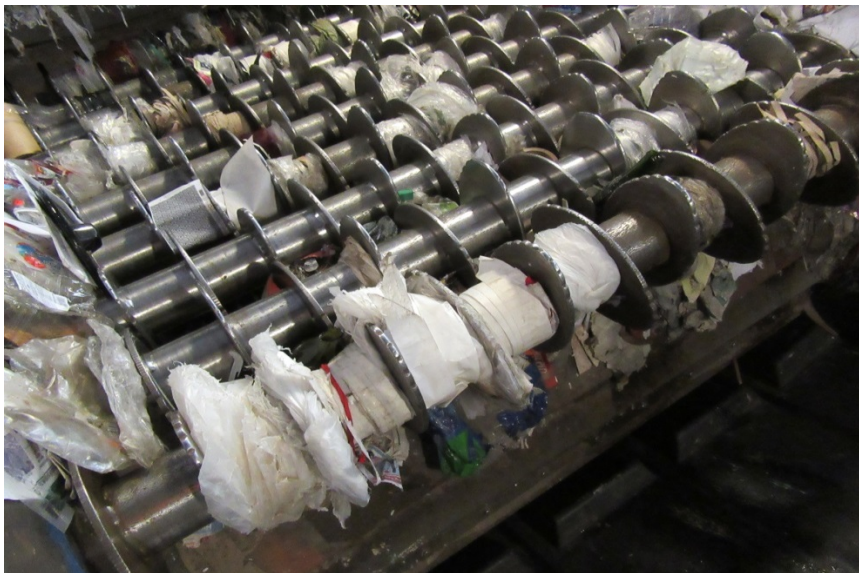
Photos A & B show the worn condition of the rotors. We recommend replacing these rotors to increase the separation performance of this screen. We also recommend removing the wrappings from the rotors on a regular basis to insure maximum separation performance and to prevent material jams.

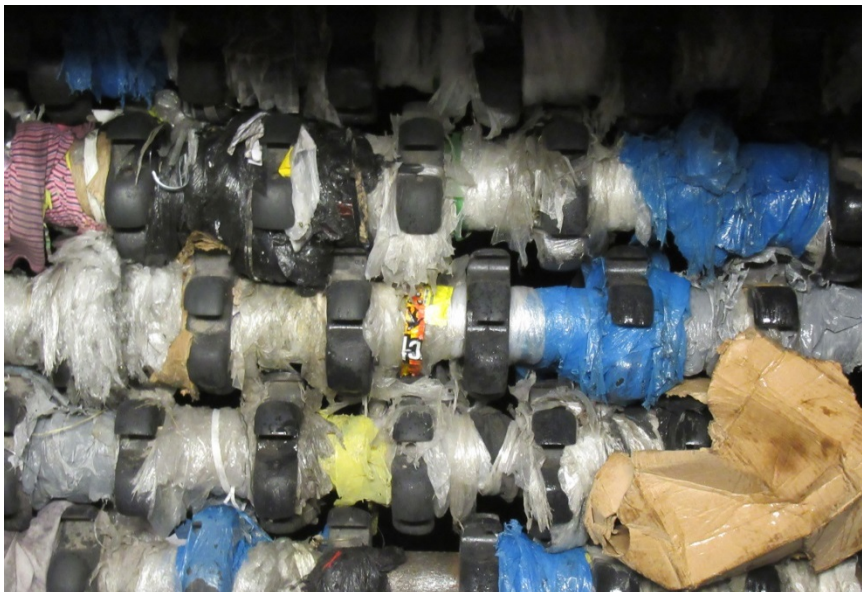
Photos A & B show the worn and missing finger discs. These discs are crucial to maximizing the material separation for this screen. We recommend replacing all of the finger discs on this screen. Also, the photos show the excessive amount of wrappings on the rotors. We recommend removing the wrappings on a regular basis to help maximize material separation.

2. The Newscreen should have all of the rubber finger discs replaced as soon as possible to maximize material separation. These discs are crucial in optimizing the screens performance.

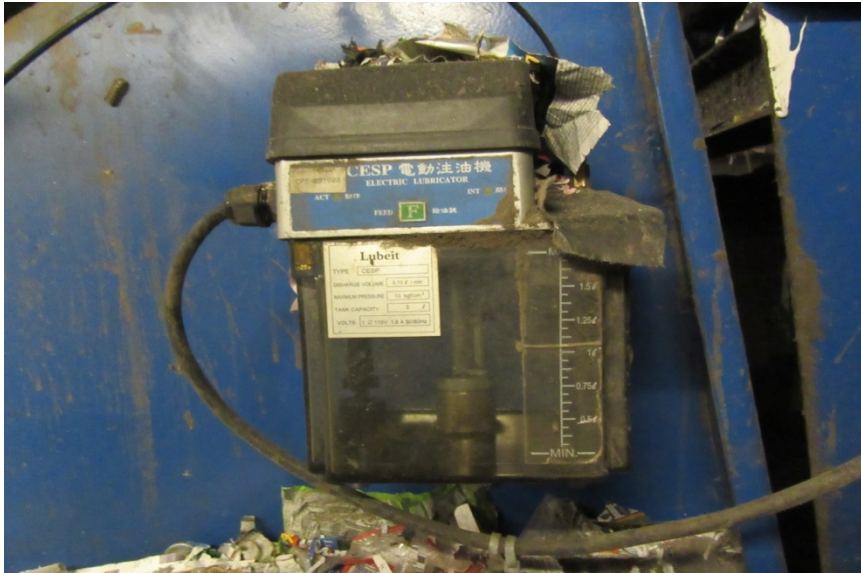
Photo B shows the empty oiler. We recommend that the oiler is filled and put back into use.

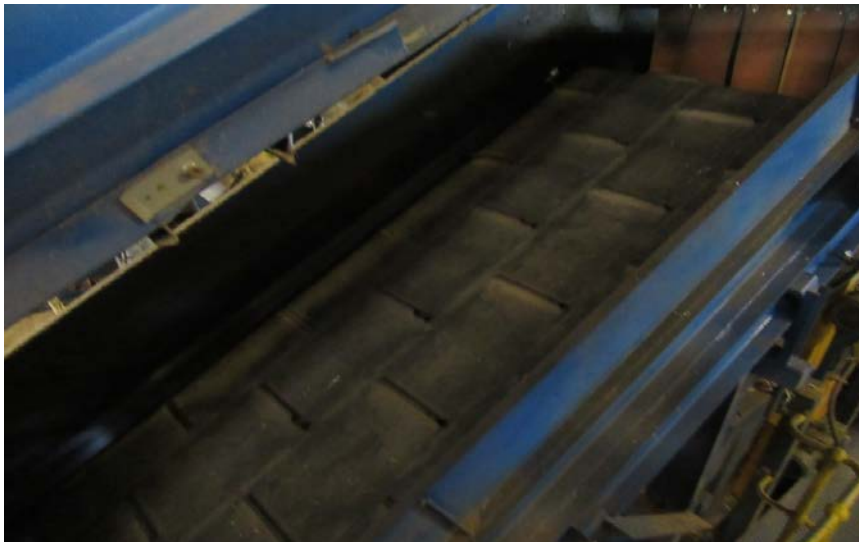
Photo A shows the worn condition of the belting. We recommend replacing this belt when possible.

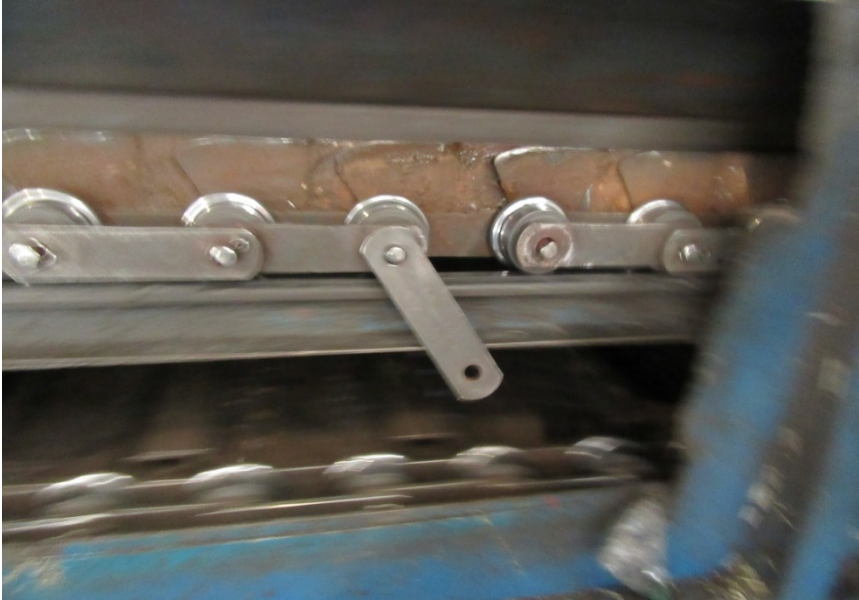
Photos A & B show the missing or damaged belting sections. We recommend replacing this belt when possible.

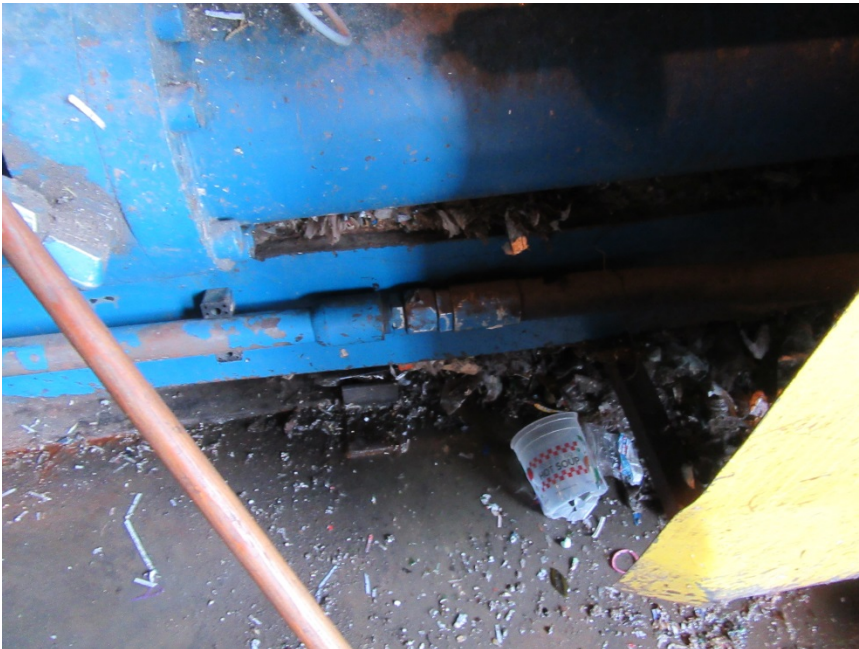
The overall condition of the baler is good. There is a ¼” knife gap that should be monitored. We also recommend flipping the blades. Shim and adjustment is also recommended. The door ram area needs to be cleaned and there is a radiator leak that was being repaired while we were on site.
