**2012
BRIDGE INSPECTION PROGRAM**

TREATMENT PLANT DRIVE OVER HURON RIVER

CITY OF ANN ARBOR

Prepared by
DLZ Michigan, Inc.
1425 Keystone Avenue
Lansing, MI 48911

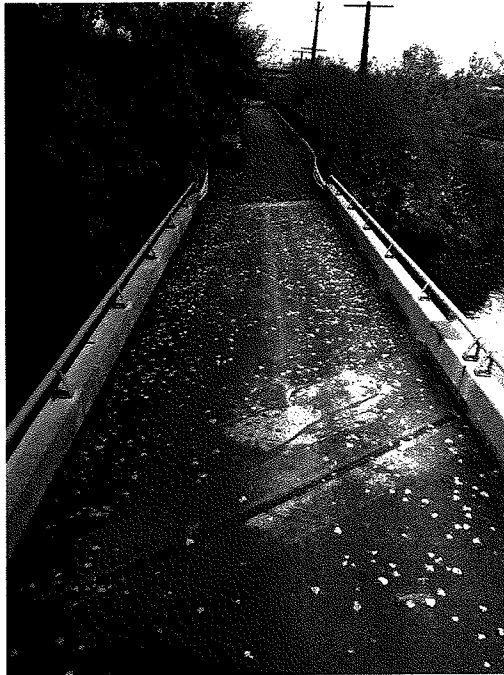
Photograph No. 7
West End of the Deck Looking West

The concrete deck is in fair condition. There are multiple cracks, delaminations, spalls, and concrete patches present, totaling approximately 8.5% of the deck area (Photos 7-12). The bottom side of the deck has over 5% of the total area containing transverse and longitudinal cracks with efflorescence, some delaminations, and rust stains (Photos 17-19).

According to MDOT's Bridge Deck Preservation Matrix, for a structure with a deck surface rating of 5 with less than 10% deficiencies and a bottom surface rating of 5, the recommended repair option is deck patching. Deck patching and joint repair can be performed while maintaining access to the Wastewater Treatment Plant (WWTP). Treatment Plant Drive is the only access road into and out of the plant. Maintaining access to the plant is required. The repairs can be coordinated with the WWTP to be performed on the weekends between shift changes and trucks. High early strength concrete will be required. Deck patching will extend the service life 3 to 10 years. The shallow overlay performed in 2000 met its life expectancy of 10 to 15 years. This repair should be performed within the next 5 years.

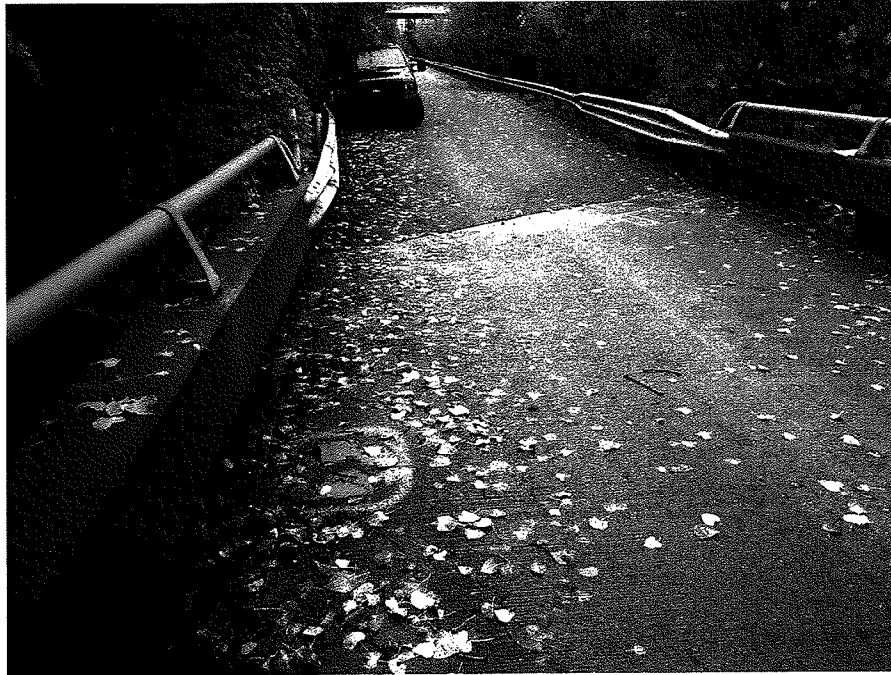
Photograph No. 9

Ponding Water on West Half of West Span Looking West

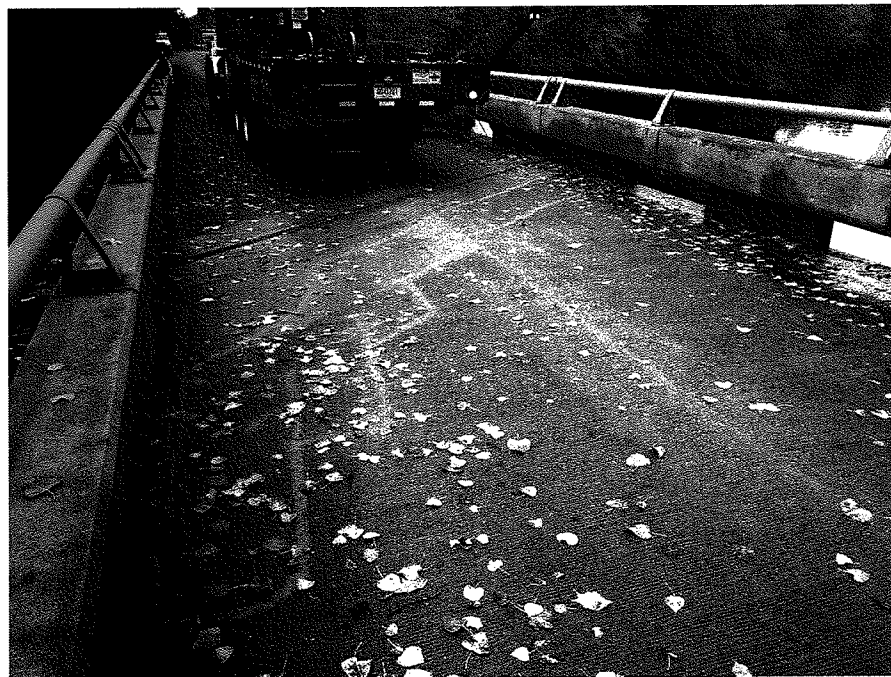
Photograph No. 10

East Half of West Span Looking East

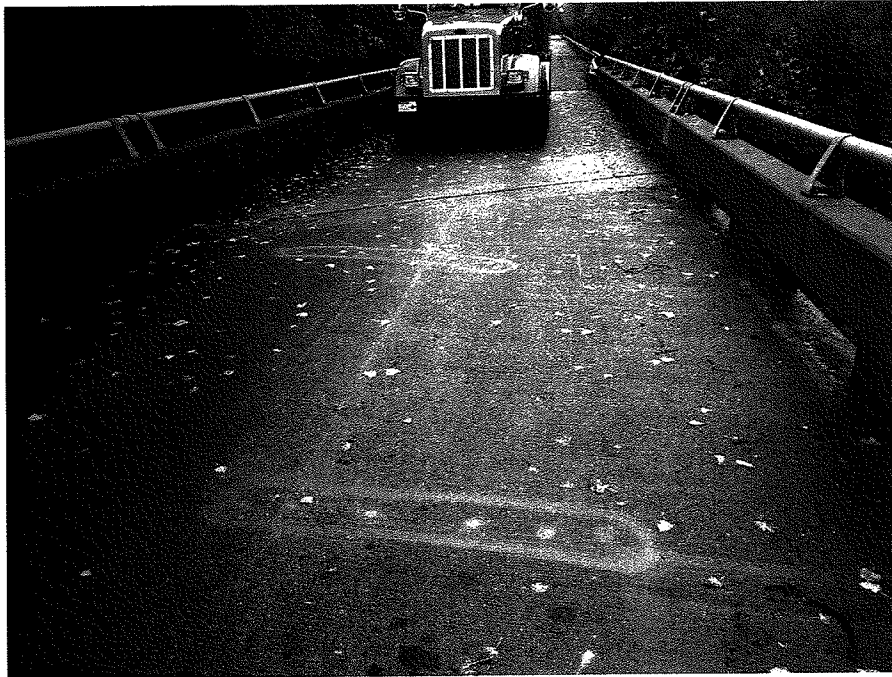
Photograph No. 11
West Half of East Span Looking West

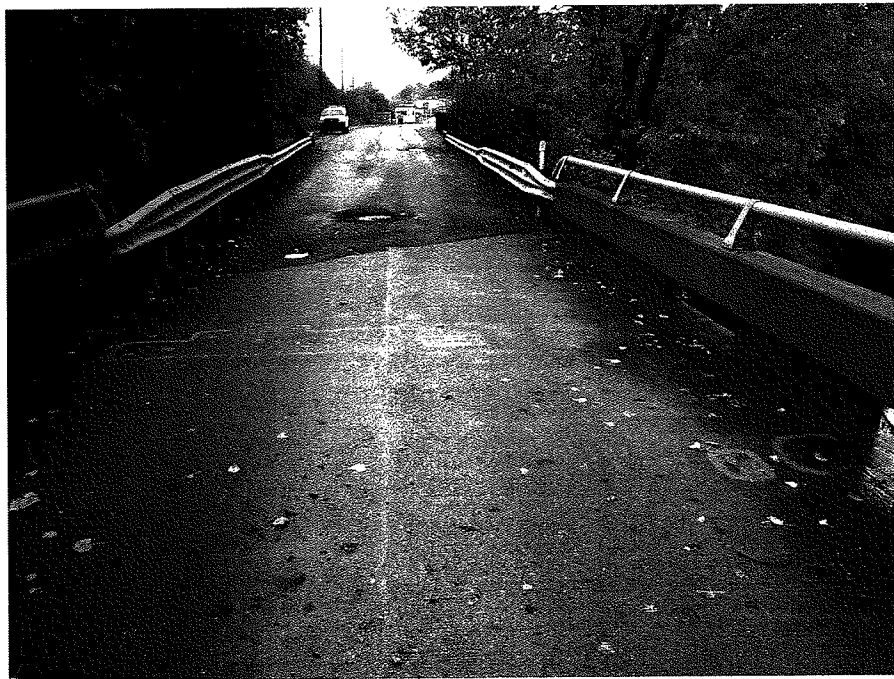
Photograph No. 12
East Half of East Span Looking East

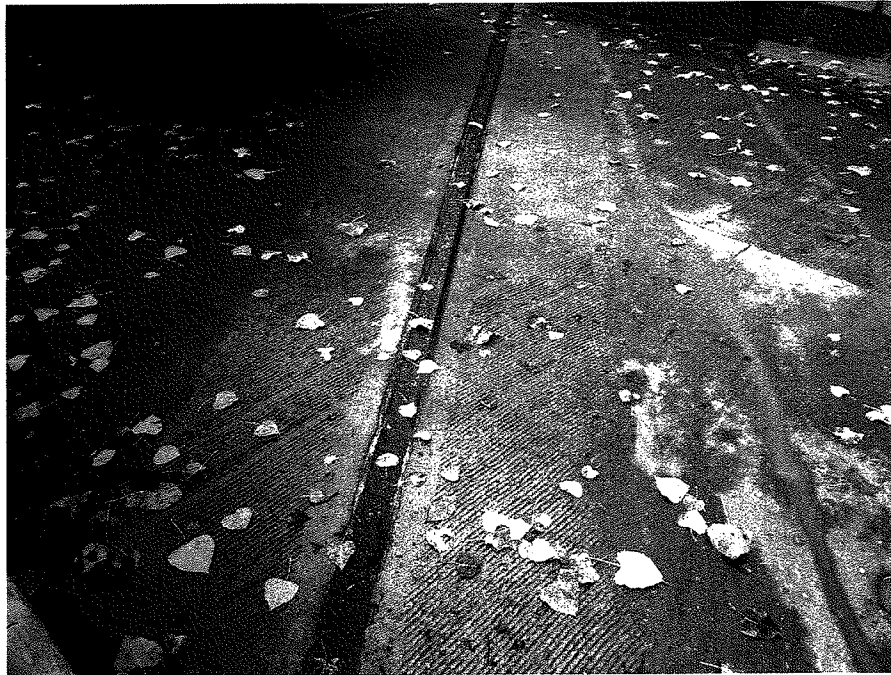
2. Expansion Jts	8	7	7	Debris present. Rust on beam ends indicate joint leakage. (12) Debris present. Evidence of leaking at pier. (10) Some accumulated debris in expansion joints. (08)

Photograph No. 13
Dirt and Debris in Deck Joint

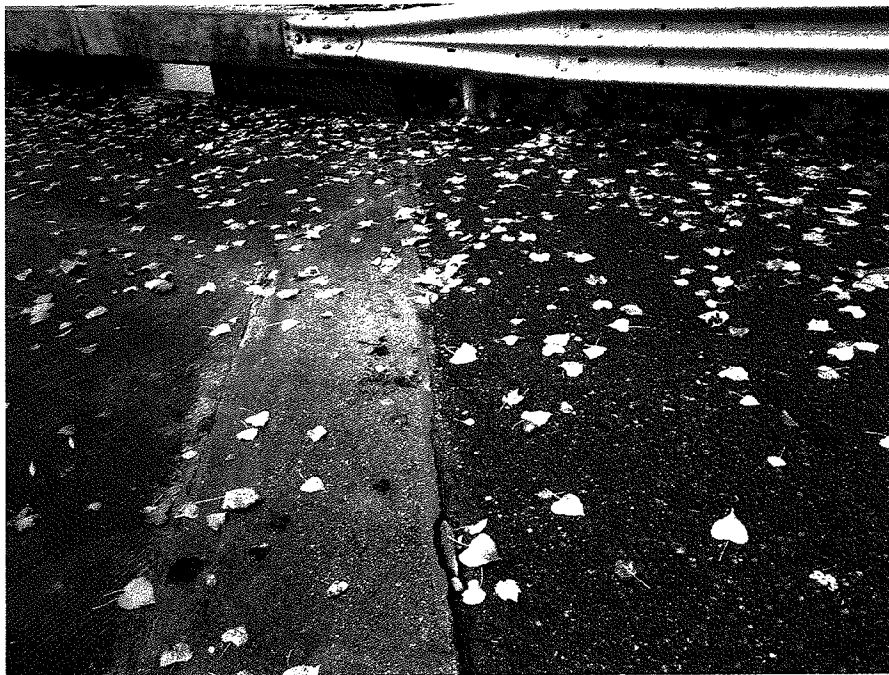
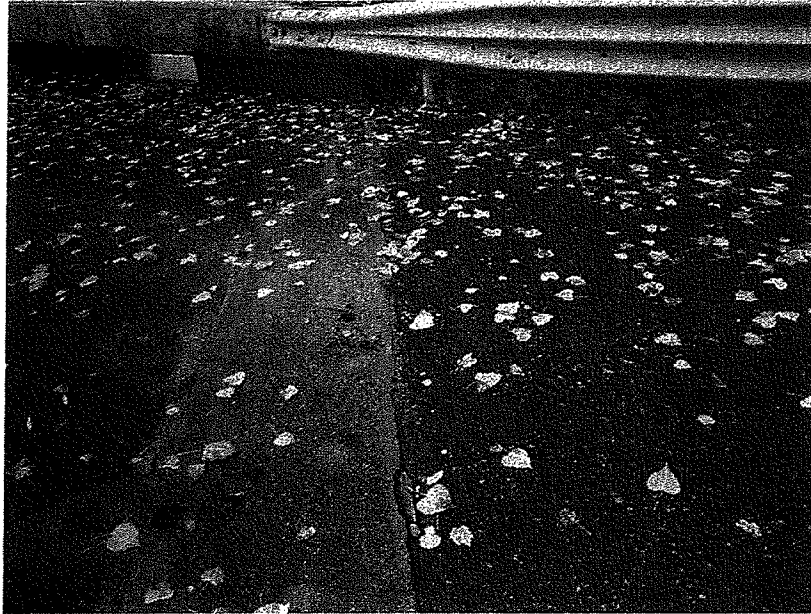
Photograph No. 15
Concrete Delaminations along West Reference Line

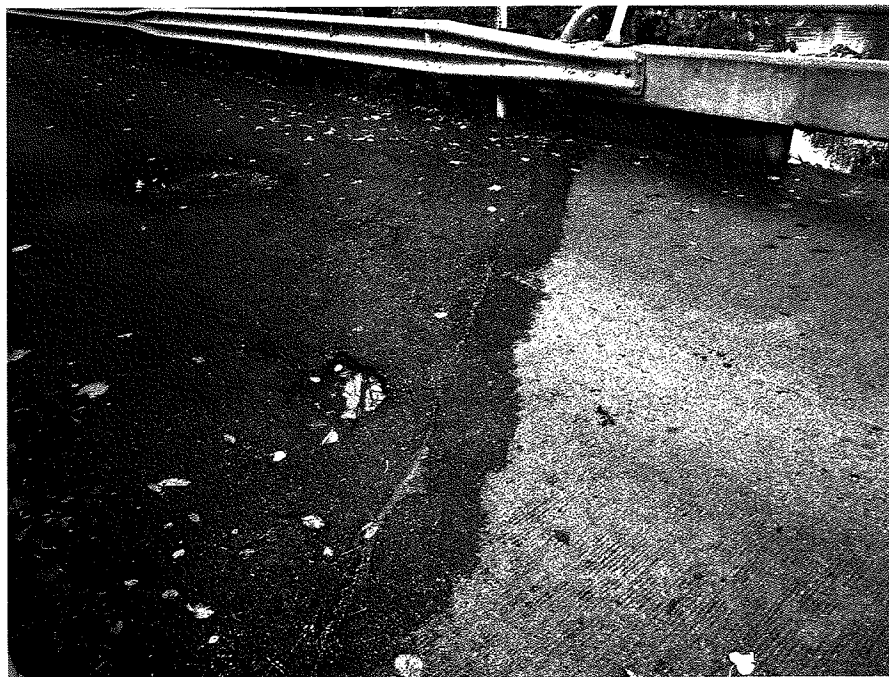
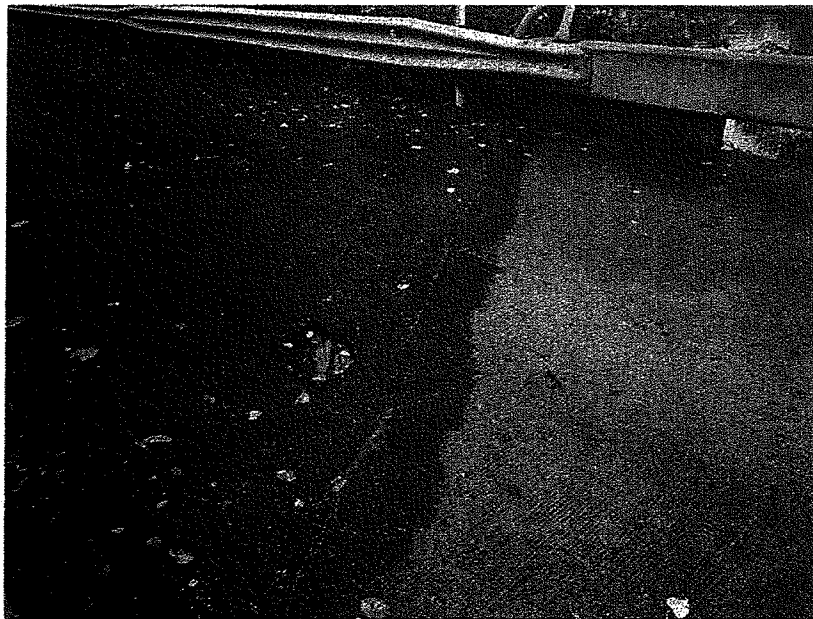
Photograph No. 16
Cracking and Pothole in Approach Pavement near East Reference Line

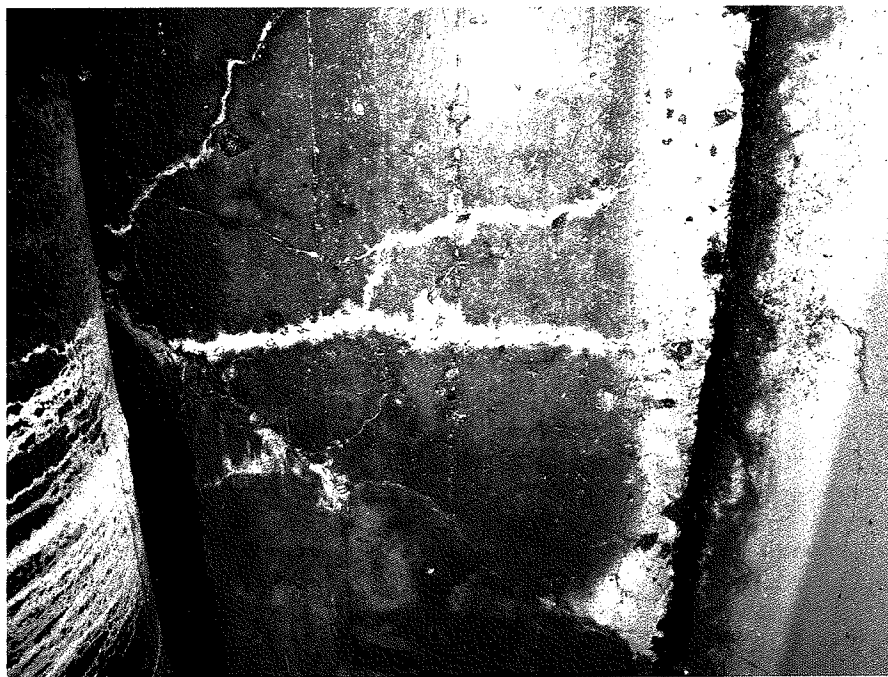
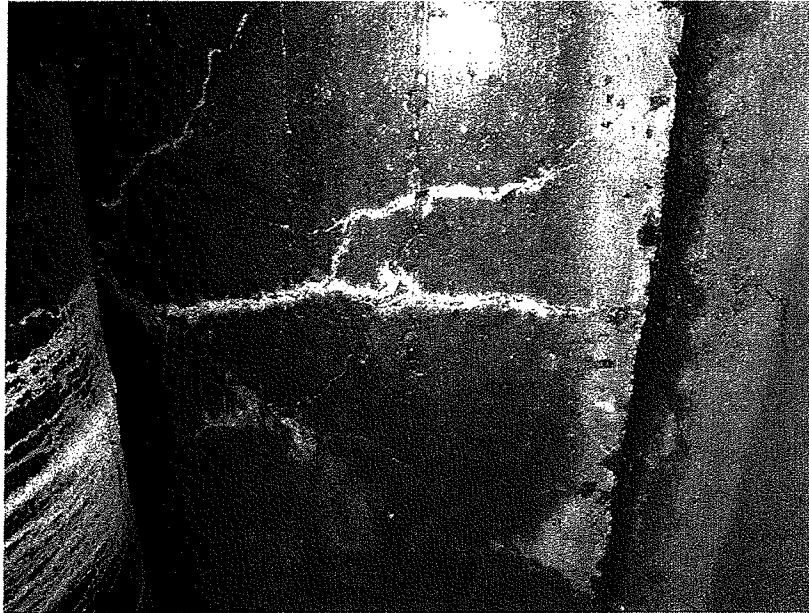
Photograph No. 17

Moisture and Cracking with Efflorescence near Previously Patched Area
on the Underside of Deck

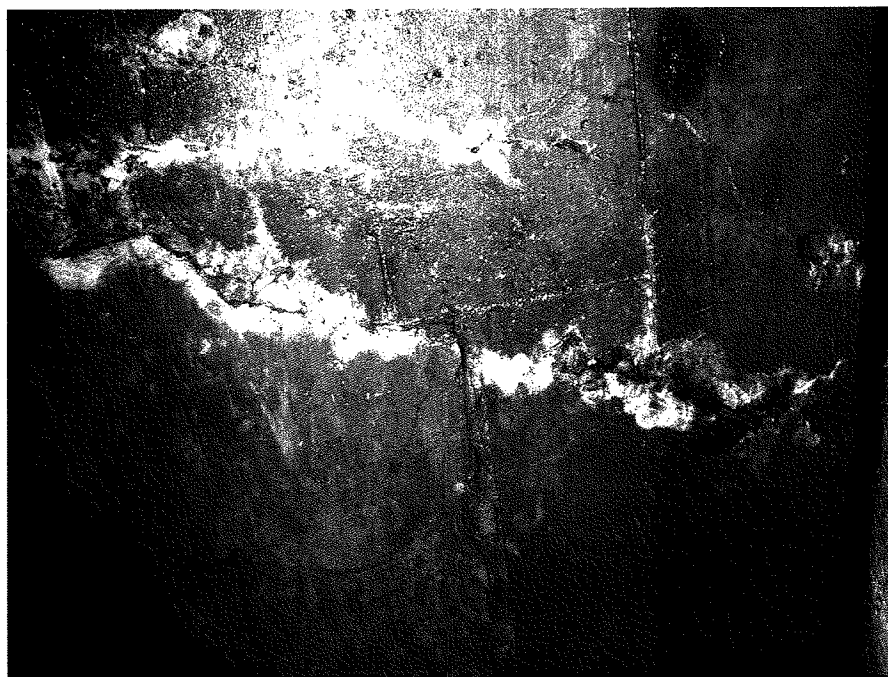
Photograph No. 18

Rusting, Moisture, Cracking with Efflorescence near Previously Patched Area, Underside of Deck

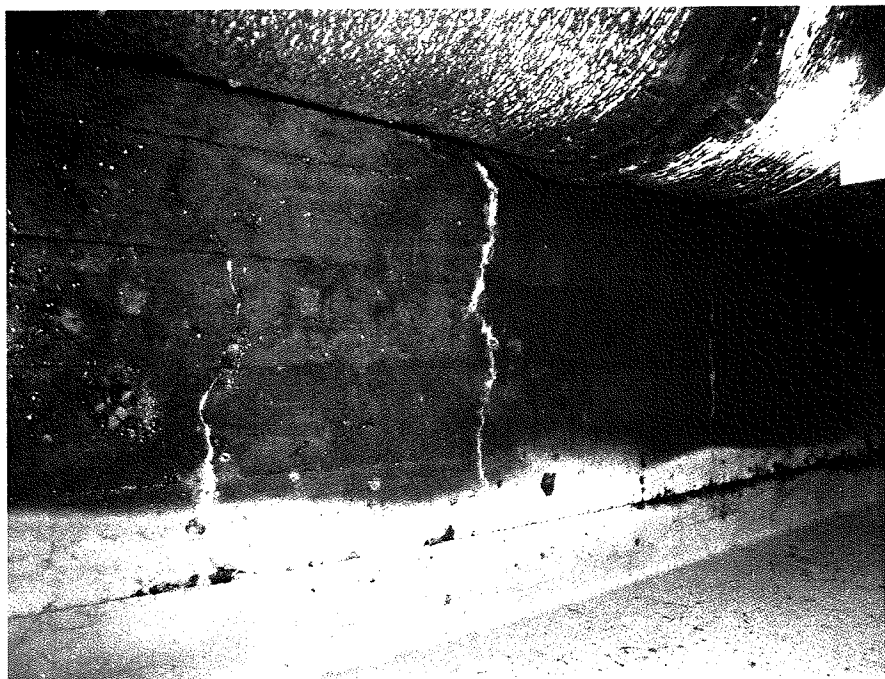
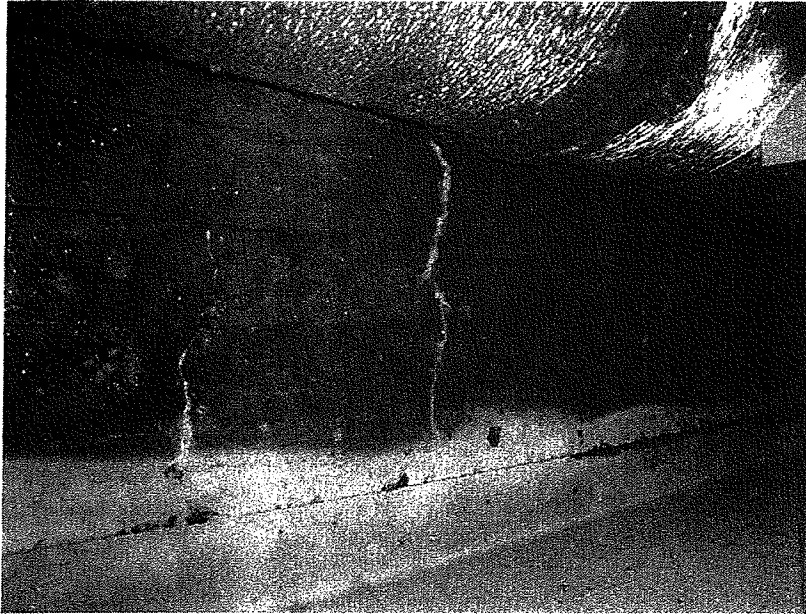
Photograph No. 19

Transverse Cracking with Efflorescence on the Underside of Deck

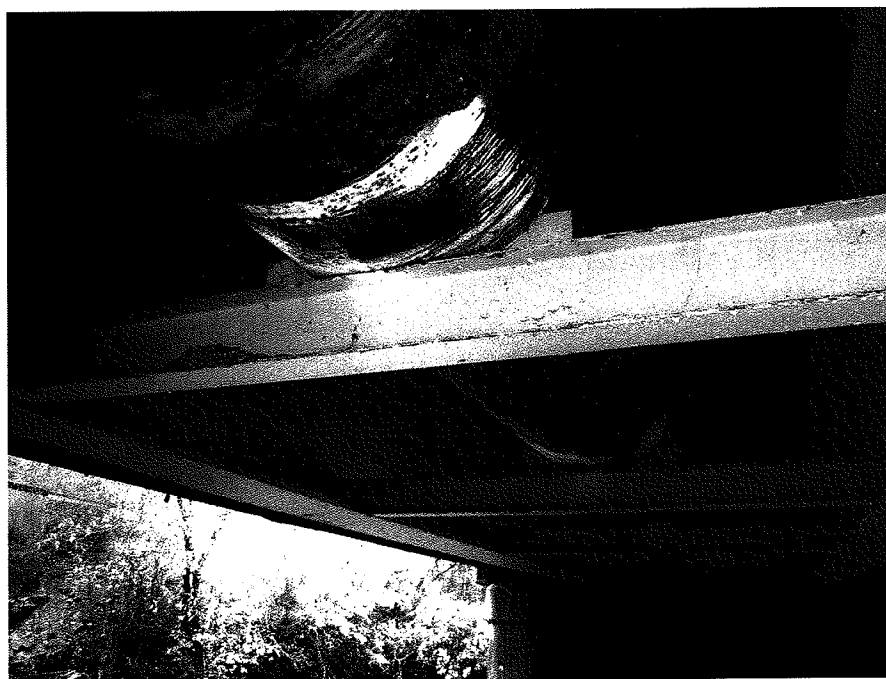
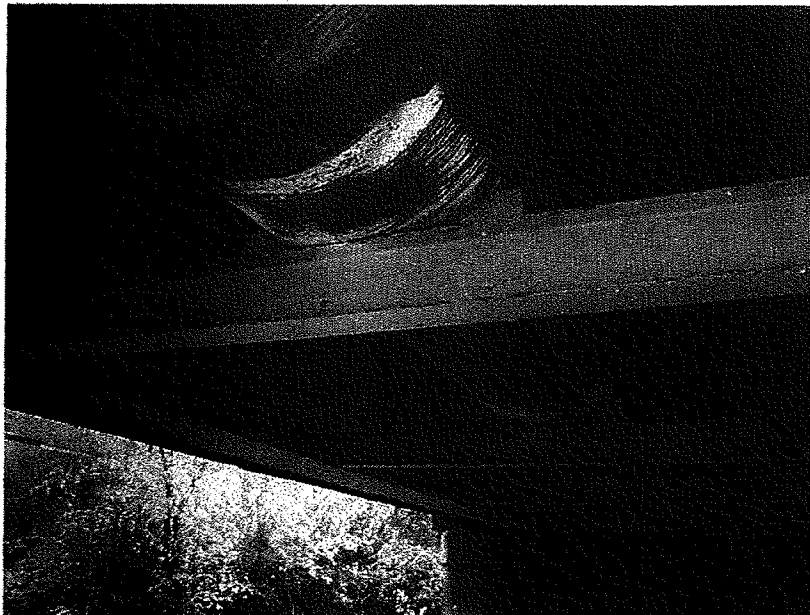
Photograph No. 20

The existing structural steel is in good condition (Photo 20). There is surface rust on the fascia beams and at the beam ends. Minor coating failure, but primary members retain section properties (Photo 21). The beams are simple spans that are fixed at the pier. The beam ends are in contact with one another at the pier (Photos 23-25). There are no signs of overstress caused by the beam ends in contact during expansion times (warm weather).

Structural Steel in Good Condition with Minor Surface Rusting (North Bay)

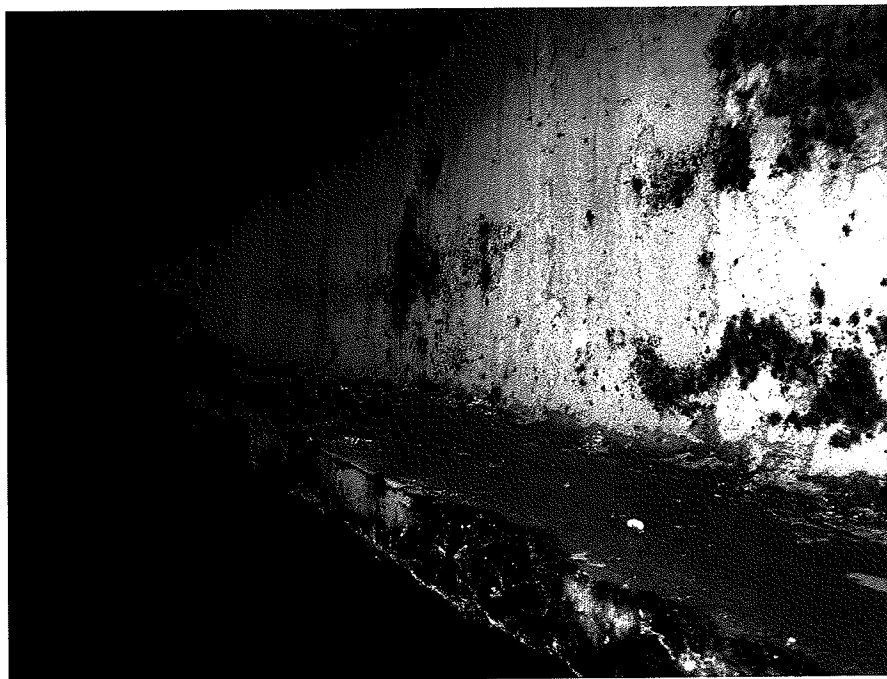
Photograph No. 21

10. Paint SIA-59A	5	5	5	Approximately 5% of steel is exposed. Surface rust noted along fascia and at beam ends. (12) Approximately 5% of steel is exposed. Surface rust noted along fascia and at beam ends. (10) About 5% of the steel is exposed. (08)

Signs of Paint Failing along South Fascia Beam (West)

Beyond the deck condition and geometric constraints, the existing structural steel has surface rust which is the beginning sign of paint system failure. Each bay and fascia conveys utilities across the structure. The beams are difficult to access due to utilities for painting. Removal of the deck will assist with painting. If the deck is removed and the utilities relocated to the new portion of the bridge, the beams could be temporarily moved off the substructure to be cleaned

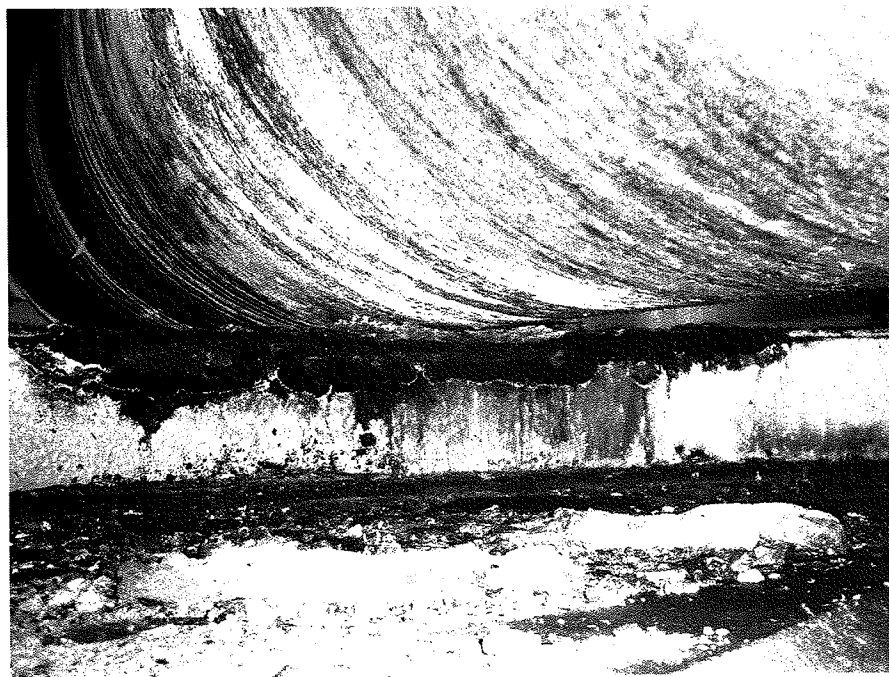
Photograph No. 22

The utility diaphragms located at the pier have heavy rusting and holes in the web (Photo 22).

Deterioration and Holes in Utility Diaphragm at Pier

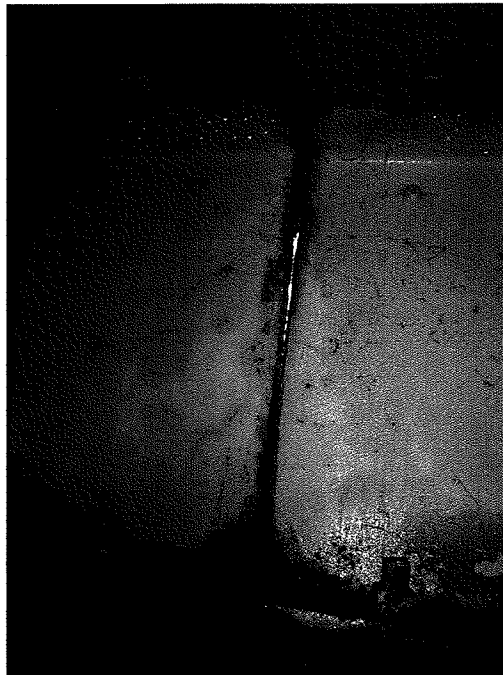
Photograph No. 25

There is evidence of leaking at all joints. The bearings at the abutments are corroded from water penetration (Photos 26-28). The beam ends and bearings at the piers also exhibit surface corrosion caused from moisture. (Photos 23-25).

Surface Rusting at South Beam Ends, Minor Gap Between Beams at Pier

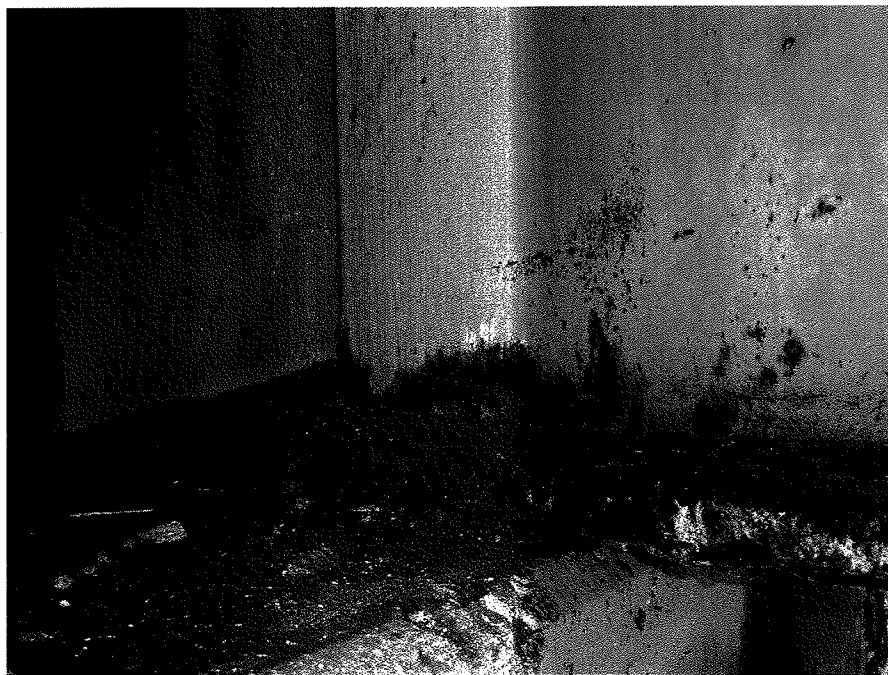
Photograph No. 26

12. Bearings	5	5	5	Bearings have pack rust showing signs of leaking joints. SE bearing is covered in debris and has deterioration from leaking along abutment. (12) Bearings have pack rust and showing signs of leaking joints. SE bearing has significant deterioration from leaking along abutment. (10) SE bearing showed significant deterioration from leaking backwall. Other bearings have minimal section loss. (08)

Surface Rusting and Minor Deterioration at West Abutment, North Beam Bearing

and coated while the bearings and sole plates are replaced. The bearings are rated a 5 due to pack rust, exposed shims, and deterioration. There is no method for repairing the bearings. Bearing replacement can only be accomplished by raising the beams. If this were to be done with the deck patching option, the raising of the beams through the use of jacks would damage concrete in the deck and backwalls. With the structure widening, the deck and beams would be removed. The backwalls would be cut down and the bearing assemblies could be easily replaced.

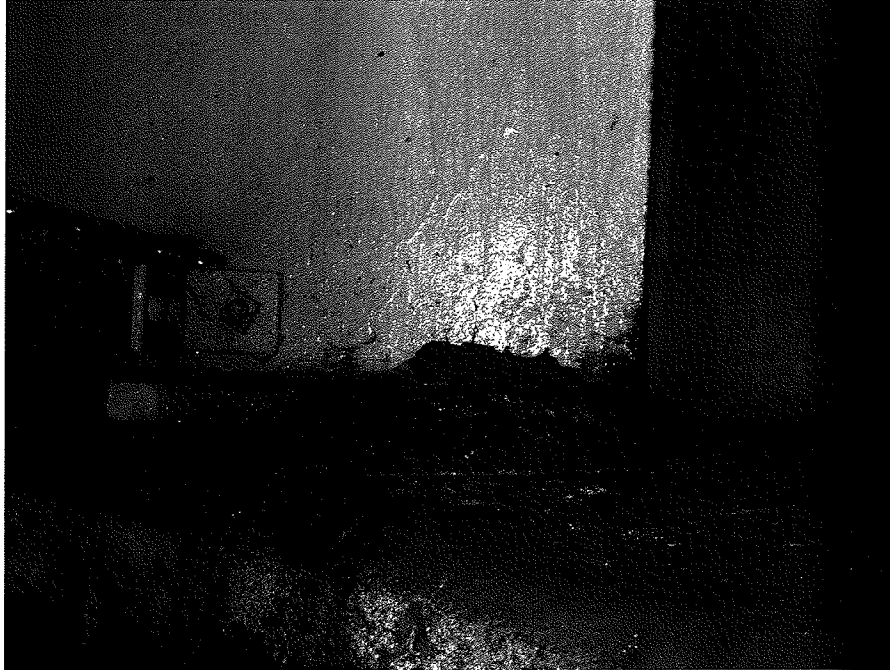
Photograph No. 27

Surface Rusting and Minor Deterioration at West Abutment, Center Beam Bearing

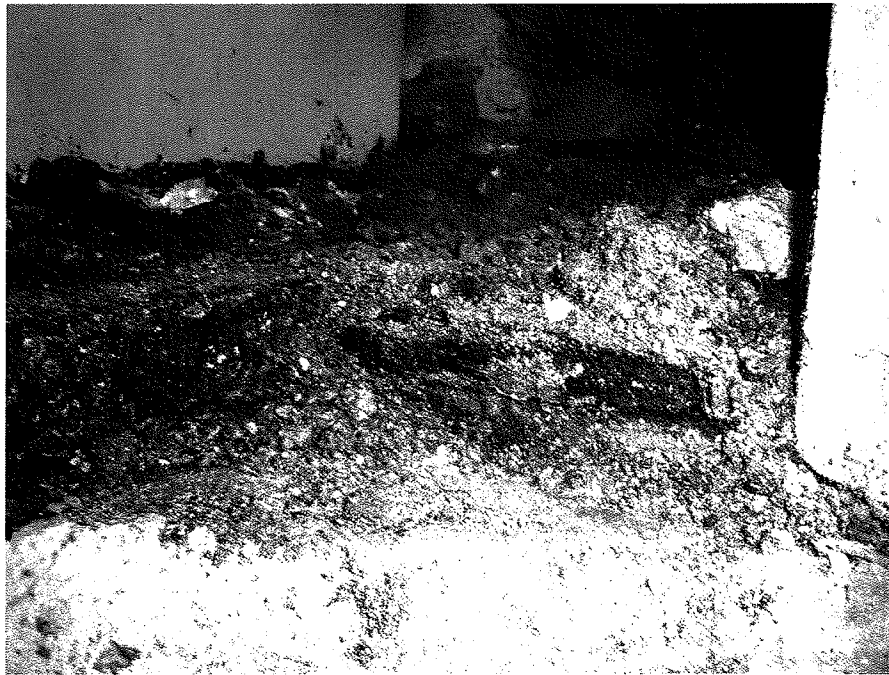
Photograph No. 28

Debris, Surface Rusting, Minor Deterioration at East Abutment, South Beam Bearing

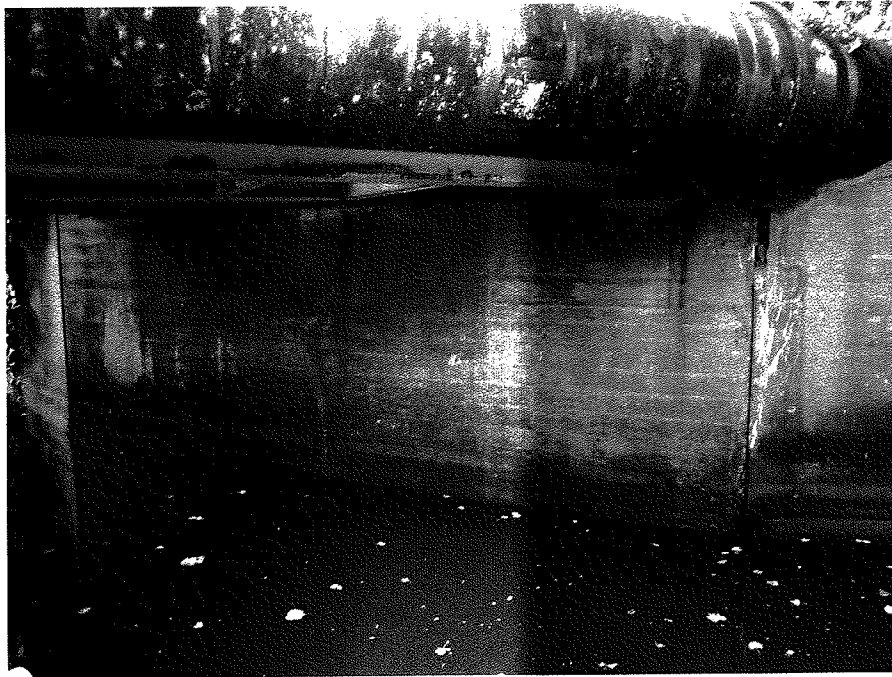
Photograph No. 29

Vertical Crack and Delaminations on West Abutment

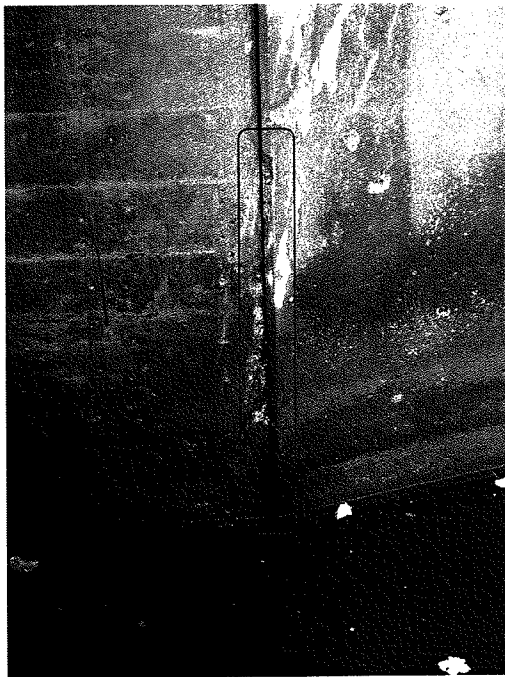
Photograph No. 30

Delamination along Northwest Wingwall Extending to Water Line

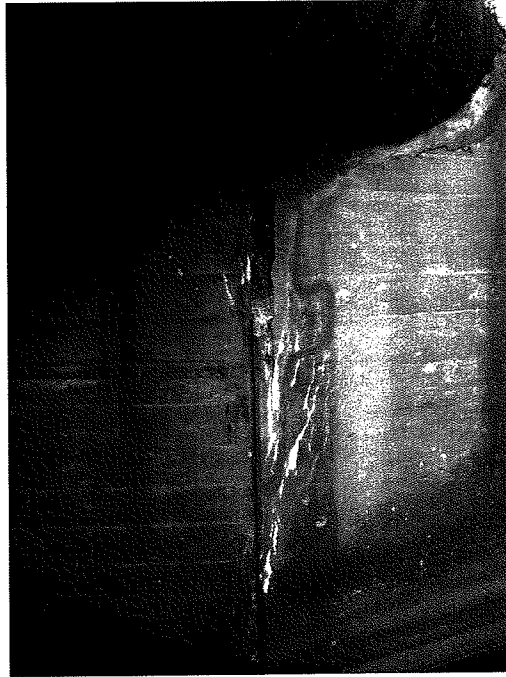
Photograph No. 31

West Abutment Delaminations and Spalls at Northwest Wingwall

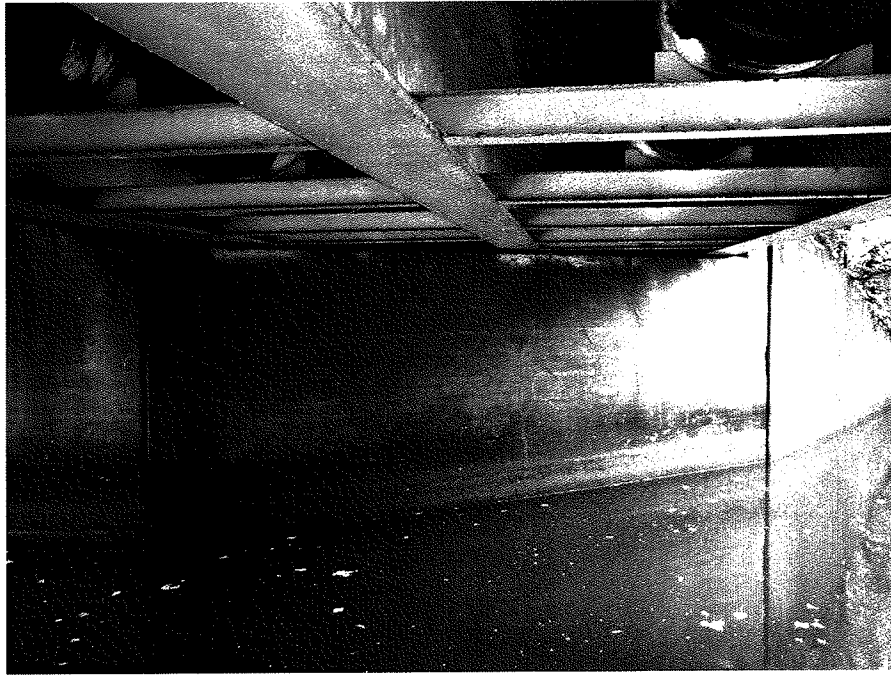
Photograph No. 33

The east abutment has vertical cracking and a 1 sft delamination under the center beam (Photo 33). There are minor cracks under the bearings. The southeast cheekwall has a horizontal crack at the abutment (Photo 34). There is a large gap between the abutment and south wingwall with vegetation. There is 1 sft of spalled concrete along the abutment at the south joint. There are spalls in the northeast abutment corner. The east backwall has minor cracking, spalls and delaminations totaling 2sft (Photo 36). Minor delaminations were found on the west and east abutments totaling 8sft and 4sft, respectively.

Vertical Crack and Delaminations on East Abutment

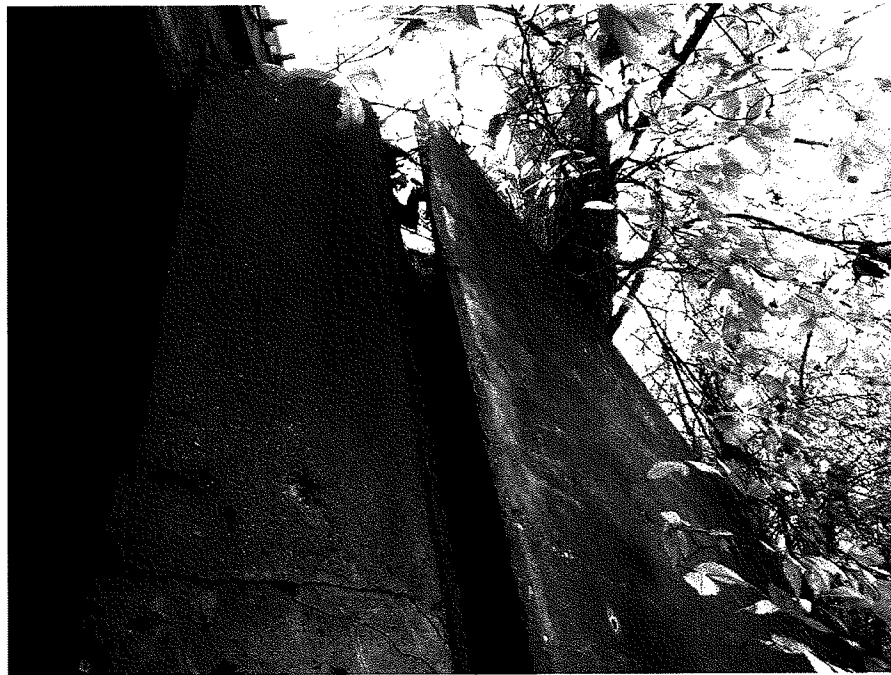
Photograph No. 34

Cracking at Cheekwall and Gap at East Abutment and South Wingwall

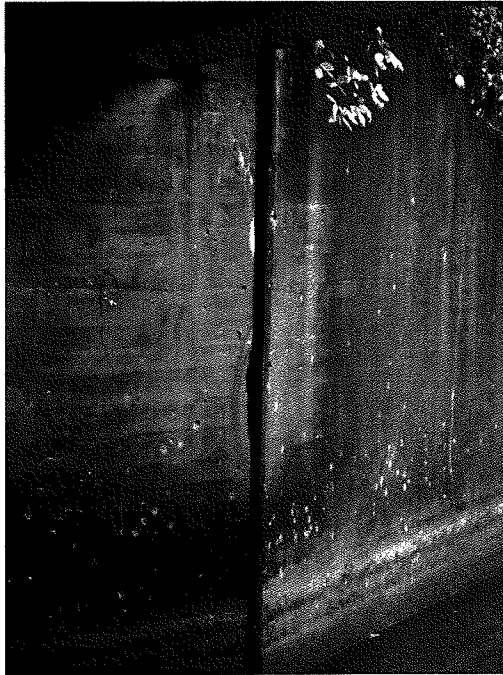
Photograph No. 35
Spalling at East Abutment and South Wingwall

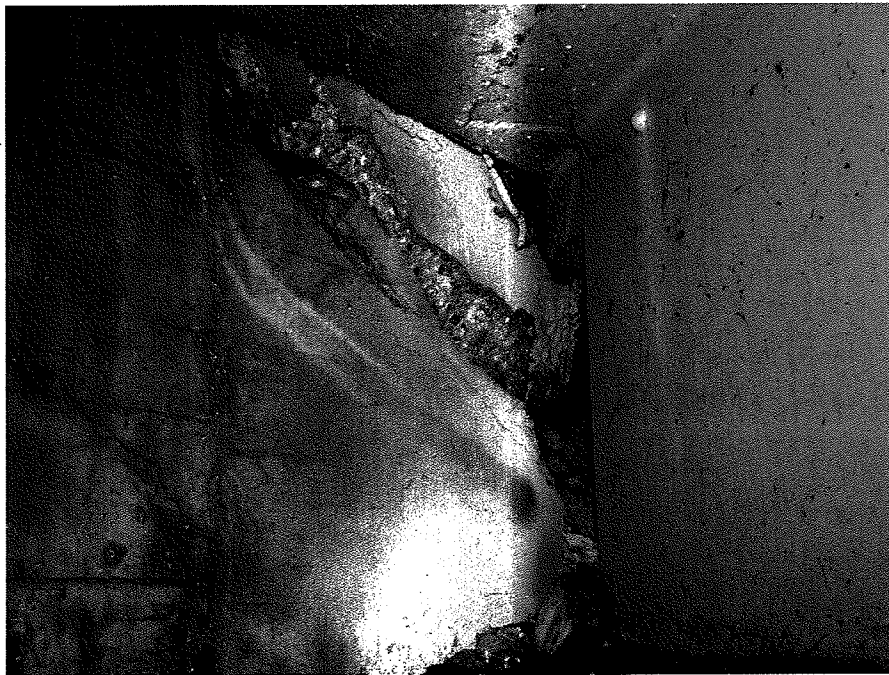
Photograph No. 36
Spalling and Cracking at Southeast Corner of East Backwall

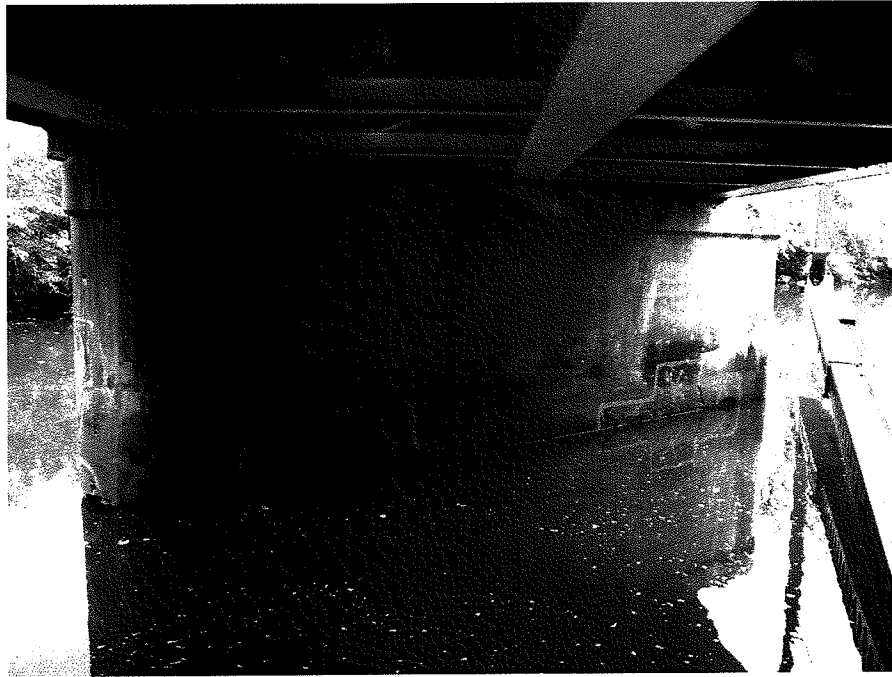
Photograph No. 37

On the west side of the pier, there are four areas of delaminated and spalled concrete totaling 76 sft (Photo 37). Two areas are located in previous patched areas at the waterline (Photos 41 and 42). The southwest portion of the pier cap is spalled with exposed, rusted reinforcing steel (Photos 38 and 39). The concrete remaining on the pier cap under the south fascia bearing is delaminated.

Delaminations on the West Side of the Pier

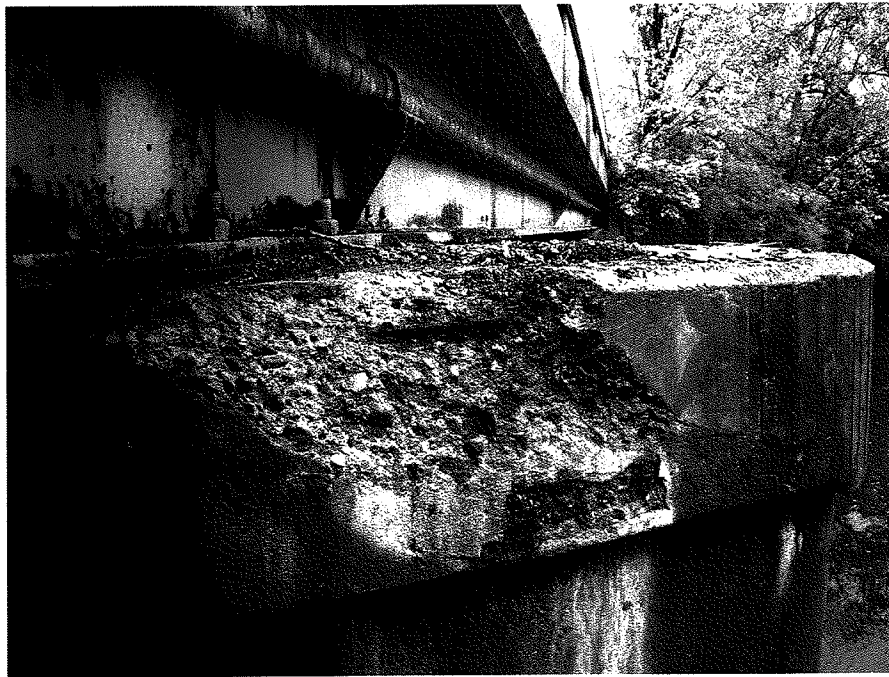
Photograph No. 38

Delamination, Spalling and Exposed Reinforcement on Southwest Corner of Pier, West Side

The spalled and delaminated pier cap requires hand chipping, possibly placement of new reinforcing steel, the placement of embedded galvanic anodes, and concrete placement. The spalled and delaminated area extends from under the south fascia beam (Beam B3) to the end of the cap. To perform this repair, temporary support of the south fascia beams will be required. Embedded galvanic anodes are typical on repairs where new and old concrete as well as reinforcement are joined. Anodes are recommended in the areas of substructure and joint repairs because the bridge repair service life is greater than 10 years.

Repairing the pier cap spalls under the south fascia beam at the bearing is an immediate repair item. The spalled and delaminated pier cap requires hand chipping, possibly placement of new reinforcing steel, the placement of embedded galvanic anodes, and concrete placement. The spalled and delaminated area extends from under the south fascia beam (Beam B3) to the end of the cap. To perform this repair, temporary support of the south fascia beams will be required. Embedded galvanic anodes are typical on repairs where new and old concrete as well as reinforcement are joined. Anodes are recommended in the areas of substructure and joint repairs because the bridge repair service life is greater than 10 years. This repair should be made now, while the concrete spall repairs at the waterline areas can be repaired at the time of the structure widening and existing deck replacement.

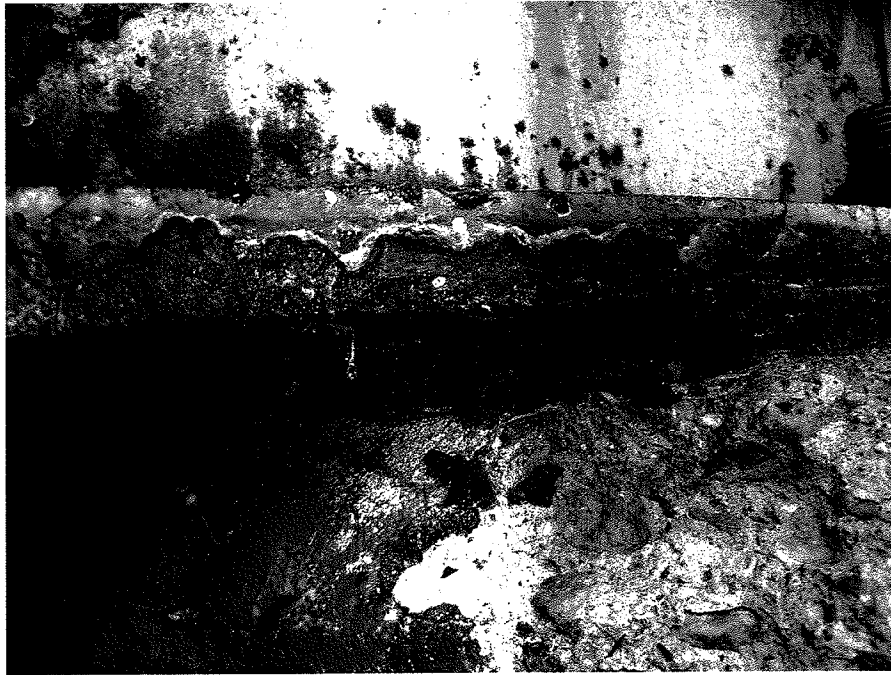
Photograph No. 39
Spalling at South Fascia Bearing at West Side of Pier

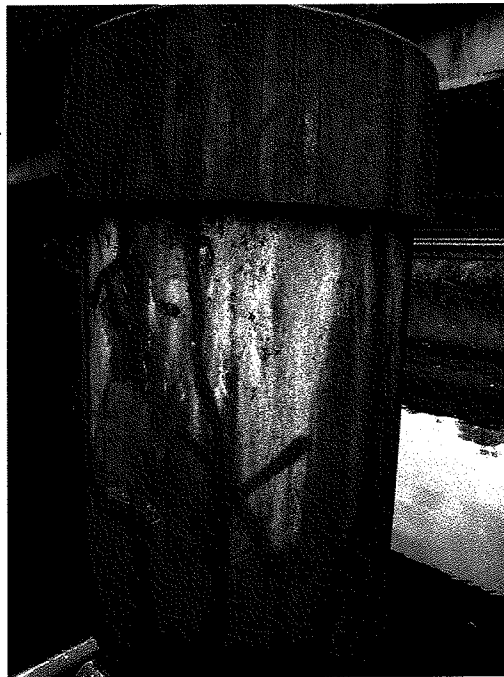
The upstream (north) pier end is delaminated (Photo 40). The pier delaminations and spalls total 110sft which is approximately 20% of the total exposed pier surface.

Photograph No. 40
Delaminations and Cracking on North End of Pier

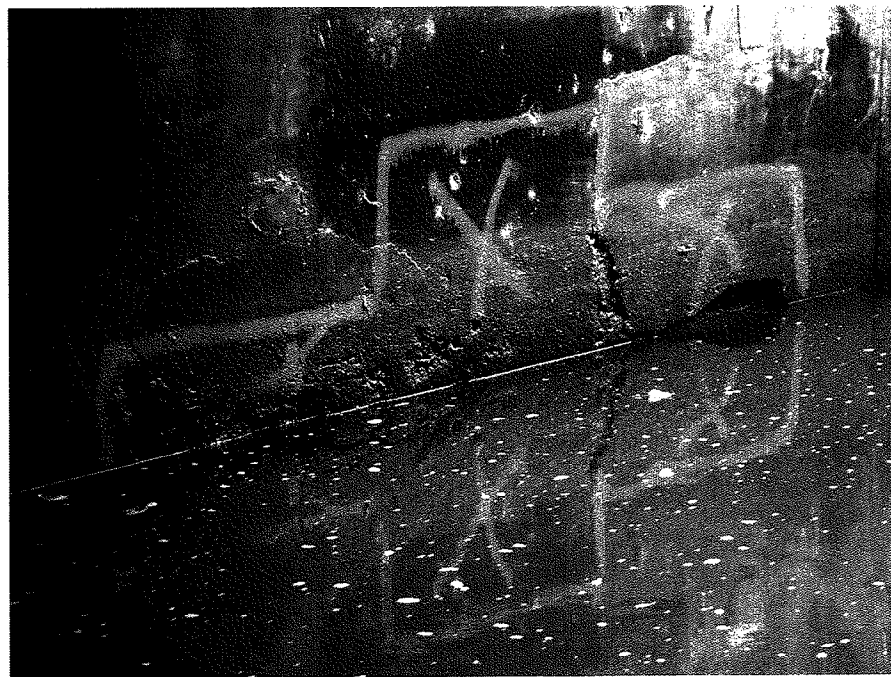
The wall pier, which is supported on piles, is in fair condition. When the structure was rehabilitated in 2000 concrete patches were placed at the water line where concrete had spalled. The patches located at the waterline have spalled (Photos 41 and 42).

Photograph No. 42
Spalling and Delaminations Water line on Southwest Side of Pier

Concrete spalls at the waterline are areas of previous repairs that should be patched again to protect the structural integrity of the pier. It is difficult to assess if the spalls extend to the streambed or are concentrated at the waterline elevation. However, if the deck and superstructure are in place, a cofferdam cannot be driven using conventional methods. It is impractical to repair the pier when water levels are low since the Huron River water levels are controlled by a dam at this location. Therefore, it will be difficult to patch the spalls along the waterline and impossible to repair the concrete below the water line without installing a cofferdam to allow for dewatering.

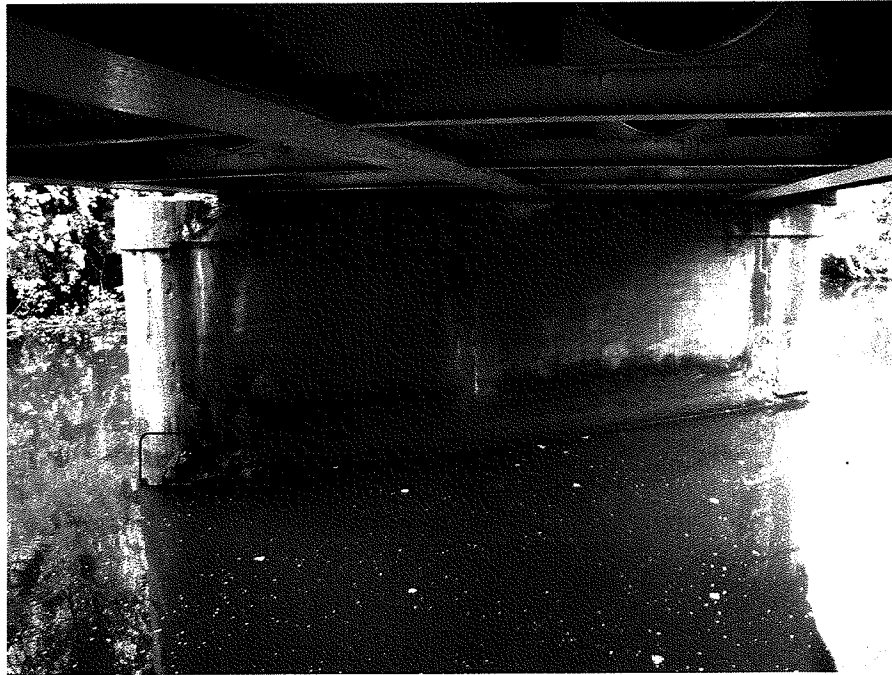
Photograph No. 43

There are five delaminated areas on the east side of the pier totaling 34 sft (Photo 43). There is spalled concrete under the south fascia beam (Beam B3) (Photo 44). There are two spalled areas at the waterline, one of which has exposed reinforcement (Photos 45 and 46).

Spalls and Delaminations on East Side of Pier
