**2012
BRIDGE INSPECTION PROGRAM**

TREATMENT PLANT DRIVE OVER HURON RIVER

CITY OF ANN ARBOR

Prepared by
DLZ Michigan, Inc.
1425 Keystone Avenue
Lansing, MI 48911

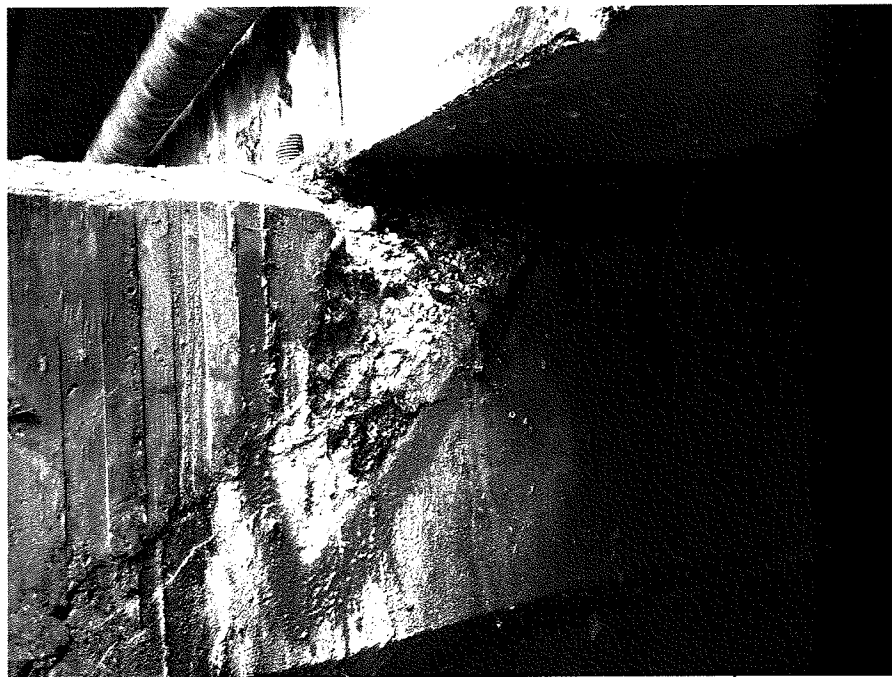
Photograph No. 44

There are five delaminated areas on the east side of the pier totaling 34 sft (Photo 43). There is spalled concrete under the south fascia beam (Beam B3) (Photo 44). There are two spalled areas at the waterline, one of which has exposed reinforcement (Photos 45 and 46).

Spalling Underneath the South Fascia on East Side of Pier

Repairing the pier cap spalls under the south fascia beam at the bearing is an immediate repair item. The spalled and delaminated pier cap requires hand chipping, possibly placement of new reinforcing steel, the placement of embedded galvanic anodes, and concrete placement. The spalled and delaminated area extends from under the south fascia beam (Beam B3) to the end of the cap. To perform this repair, temporary support of the south fascia beams will be required. Embedded galvanic anodes are typical on repairs where new and old concrete as well as reinforcement are joined. Anodes are recommended in the areas of substructure and joint repairs because the bridge repair service life is greater than 10 years. This repair should be made now, while the concrete spall repairs at the waterline areas can be repaired at the time of the structure widening and existing deck replacement.

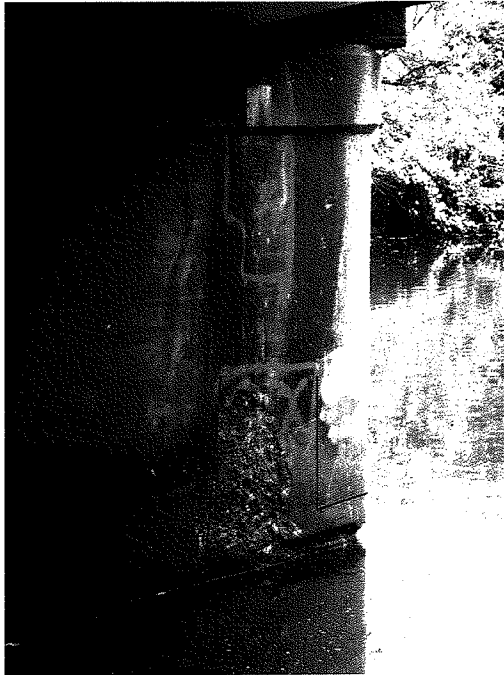
Photograph No. 45

Spalling, Delaminations and Scaling at Water line on Northeast Side of Pier

Concrete spalls at the waterline are areas of previous repairs that should be patched again to protect the structural integrity of the pier. It is difficult to assess if the spalls extend to the streambed or are concentrated at the waterline elevation. However, if the deck and superstructure are in place, a cofferdam cannot be driven using conventional methods. It is impractical to repair the pier when water levels are low since the Huron River water levels are controlled by a dam at this location. Therefore, it will be difficult to patch the spalls along the waterline and impossible to repair the concrete below the water line without installing a cofferdam to allow for dewatering.

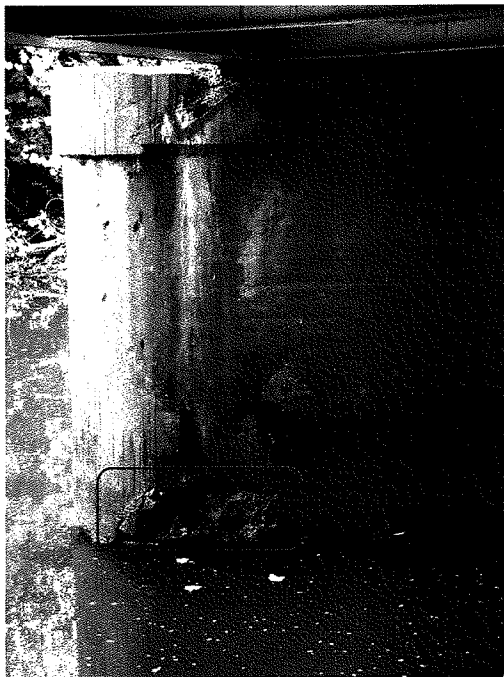
Photograph No. 46

Spalling and Exposed Reinforcement at Water line on Southeast Side of Pier
