Rental Assistance Demonstration (RAD): PHYSICAL CONDITION ASSESSMENT

2702-2760 Hikone Drive, Ann Arbor, Michigan 48108

PREPARED FOR Norstar Development USA, LP

DATE February 21, 2014

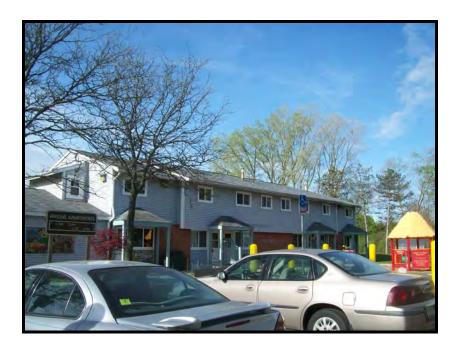
PHOTOGRAPH NO. 1: TYPICAL VIEW OF TENANT UNIT BUILDING

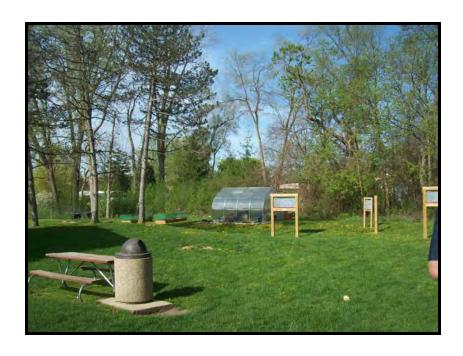
PHOTOGRAPH NO. 2: TYPICAL VIEW OF SUBJECT PROPERTY EXTERIOR

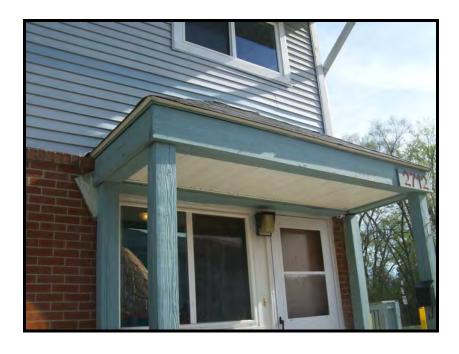
PHOTOGRAPH NO. 3: TYPICAL VIEW OF WOODEN PORCHES ASSOCIATED WITH TENANT UNITS

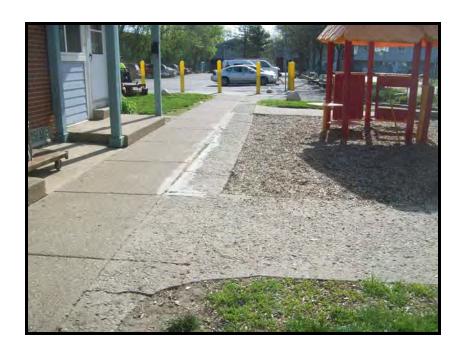
PHOTOGRAPH NO. 4: TYPICAL VIEW OF FLATWORK THROUGHOUT SUBJECT PROPERTY

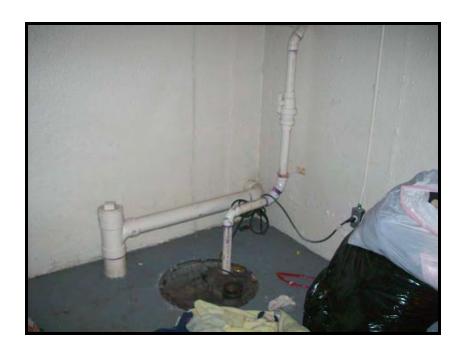
PHOTOGRAPH NO. 6: TYPICAL VIEW OF SUMP LOCATED WITHIN TENANT BUILDING

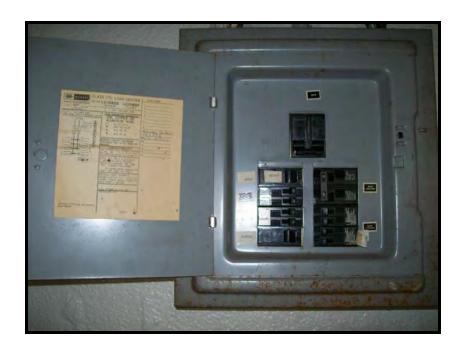
PHOTOGRAPH NO. 7: TYPICAL VIEW OF ELECTRICAL PANELS IN TENANT UNITS

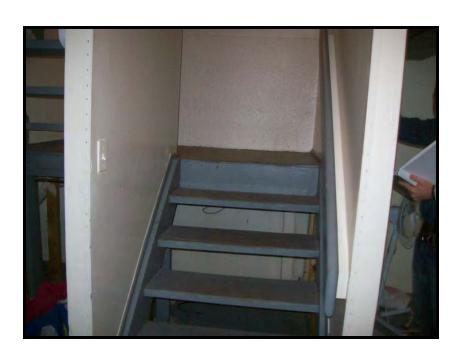
PHOTOGRAPH NO. 8 TYPICAL VIEW OF BASEMENT STAIRS IN TENANT UNITS

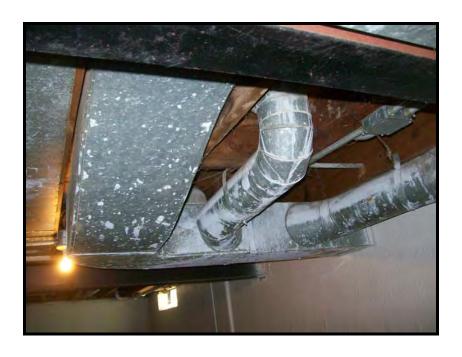
PHOTOGRAPH NO. 12: TYPICAL VIEW OF DUCTWORK AND IN TENANT UNIT BASEMENT

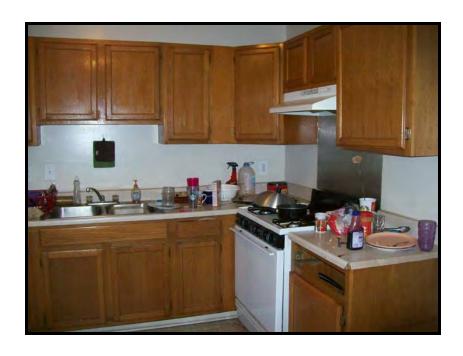
PHOTOGRAPH NO. 13: TYPICAL VIEW OF TENANT UNIT KITCHEN

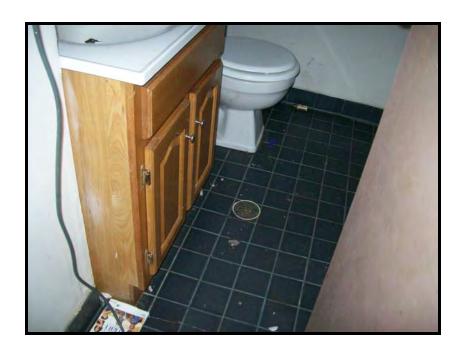
PHOTOGRAPH NO. 15: TYPICAL VIEW OF TENANT UNIT BATHROOMS

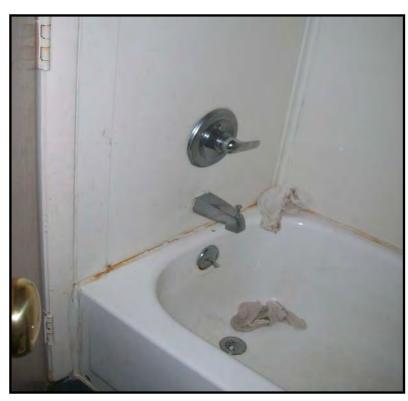
PHOTOGRAPH NO. 16: TYPICAL VIEW OF TENANT UNIT TUB AND ASSOCIATED VINYL ENCLOSURE

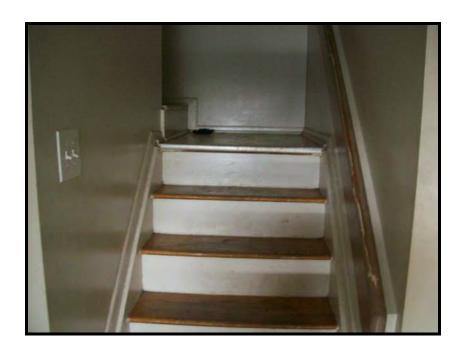
PHOTOGRAPH NO. 17: TYPICAL VIEW OF SECOND STORY TENANT UNIT STAIRS
