# NARROW GAUGE CREEK INSPECTION

Prepared By: Hubbell, Roth & Clark  
September 2024

ANN ARBOR  
**WATER**

# NARROW GAUGE CREEK INSPECTIONS

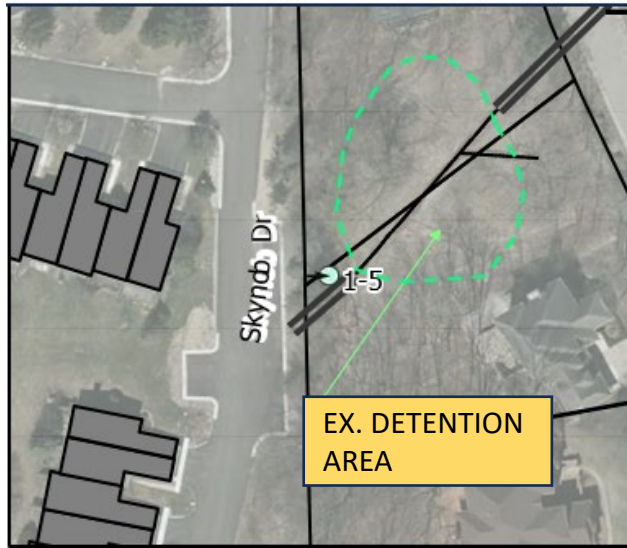
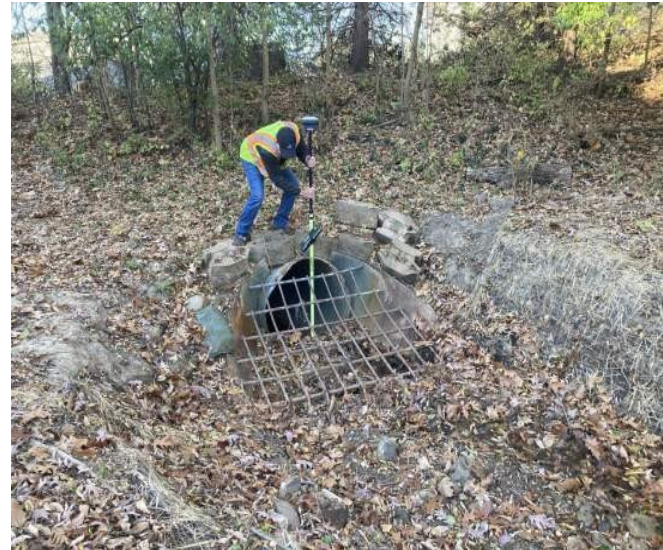
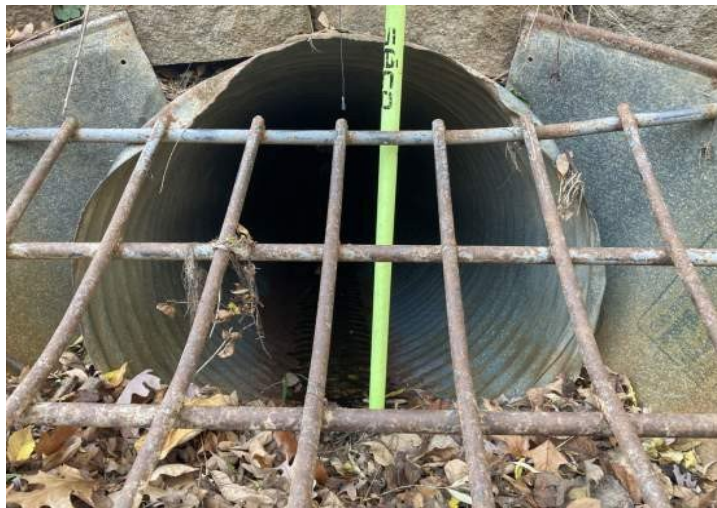
Surface Inlet Pipe 1-5 Inspected November 2022

- A pipe that collects stormwater run-off from the roads and sidewalks and directs the water flow to a detention basin.
  - Detention basins allows excess sediment and pollutants to settle out before it reenters our water systems.
- Pipes can be made of Metal (CMP), Concrete (RCP), or Plastic (HDPE)
  - The pipe seen in the above photos is made of CMP with a 36-inch diameter.

- The pipe is in fair condition, no proposed repairs needed at this time.

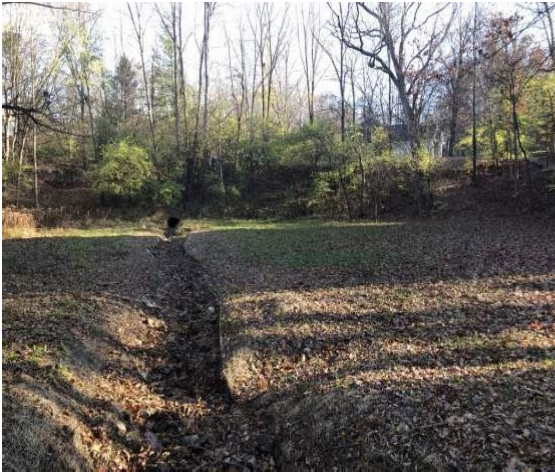
Photo 1 Direction: Northeast

The above photos show an existing dry detention area that contains 4' stone lined on the bottom of the creek.

Stabilization methods are put in place with straw blankets in this area.

- Add Creek Stabilization.

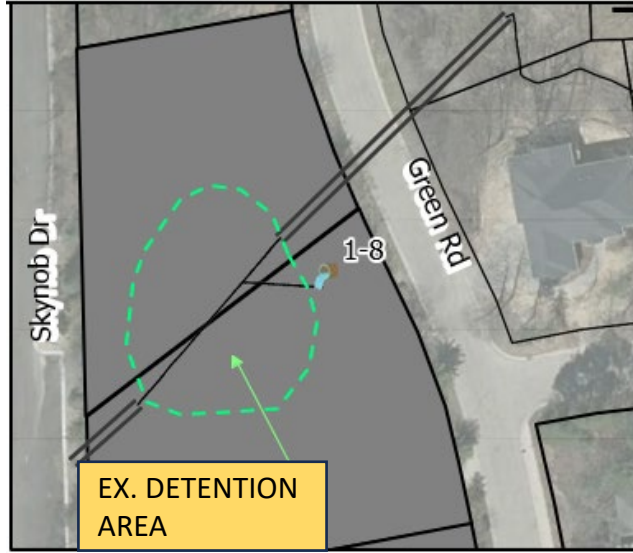
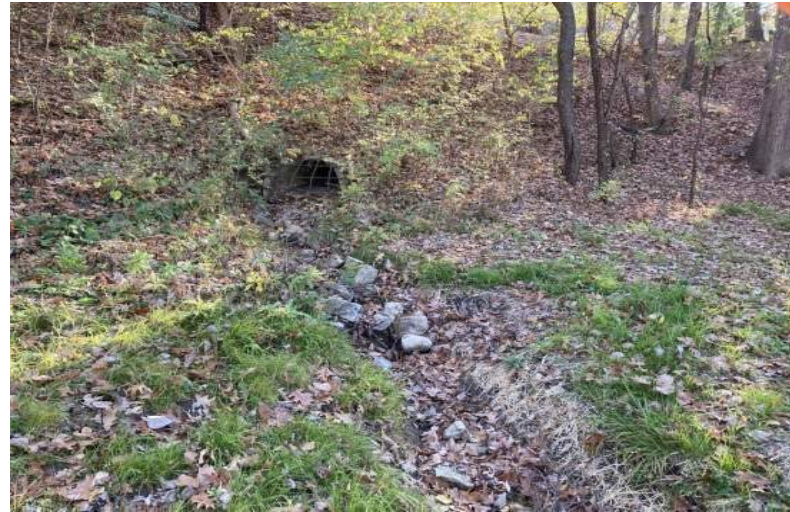
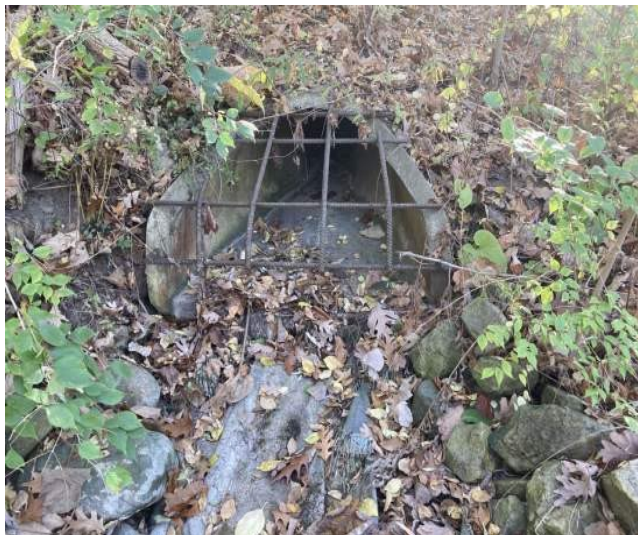
Surface Outlet Pipe 1-8 Inspected November 2022

The above photos contain an 18-inch Diameter RCP (Concrete) Outlet Pipe with grates.

- None – pipe and gates are in fair condition.

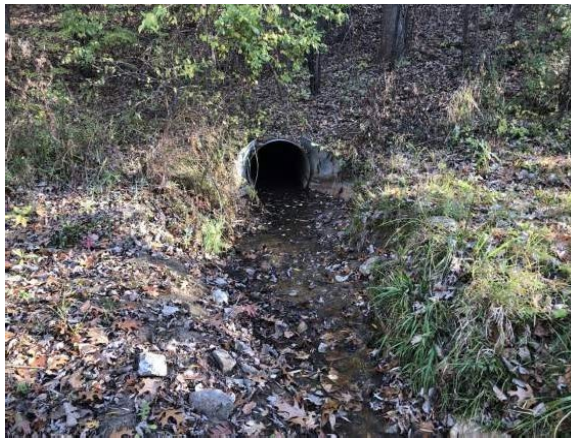
Photo 1 Direction: Facing Upstream

The above photos contain a culvert crossing in severe condition under Green Rd. The crossing is made of a Corrugated Metal Pipe with a bituminous surface (asphalt or tar).

- Cracks
- Breaks
- Rust spots
- Debris buildup upstream

- Clean and CCTV culvert
- Based on CCTV investigation, additional measures may be needed

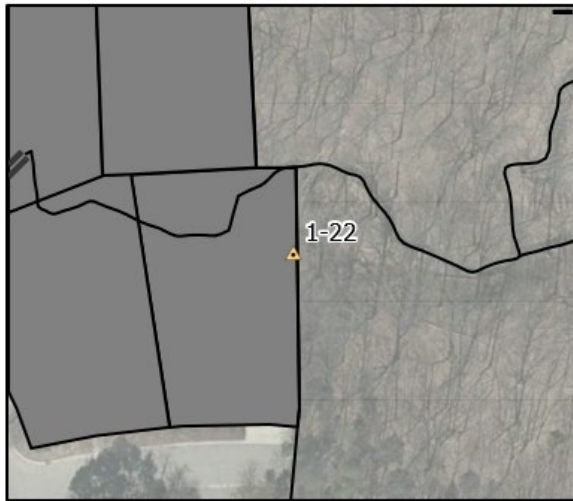
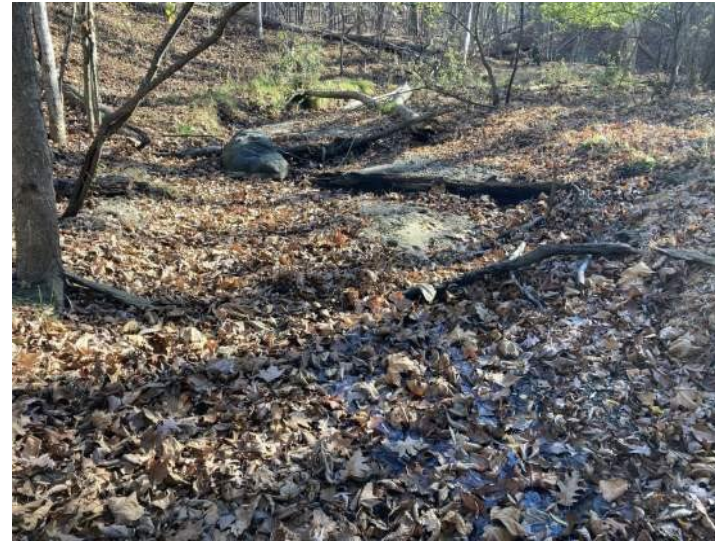
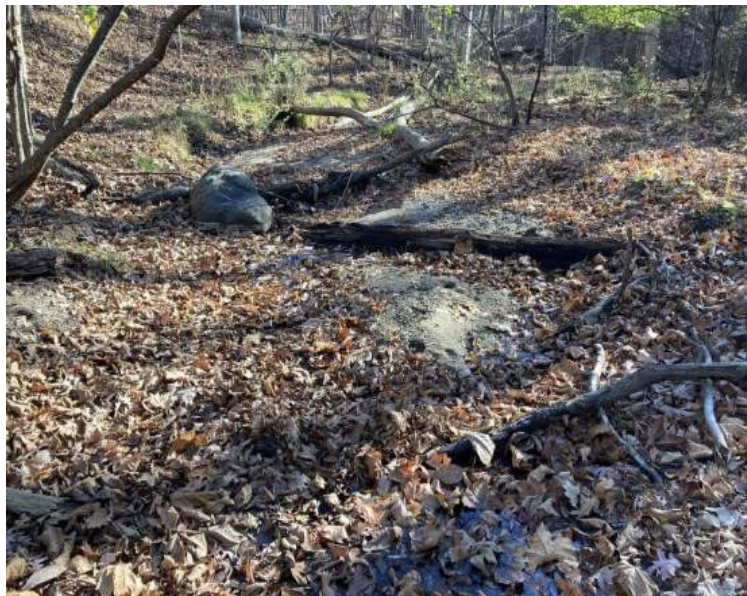
Blockage 1-22 Inspected November 2022

- Logs and large rocks obstructing stream route.
- *Blockage Length:* 10 ft located in the center of the creek.
- *Effects of Blockage:*
  - limit space available in the creek for larger rain events which may result in flooding
  - Cause excessive sand and debris build-up upstream of the blockage as the log slows down the speed at which water flows.

**Recommendations:** Remove log jam

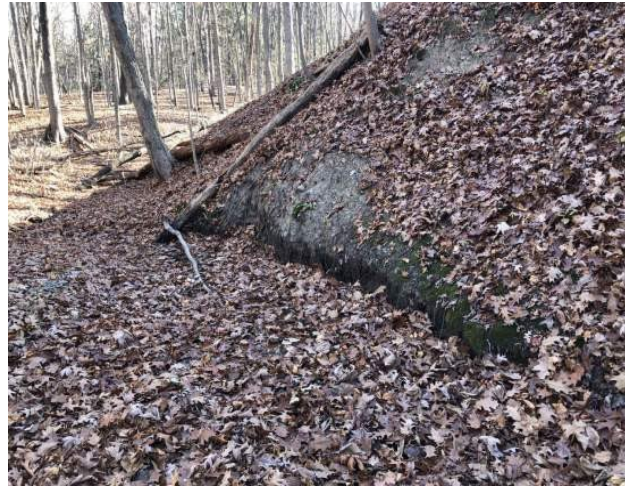
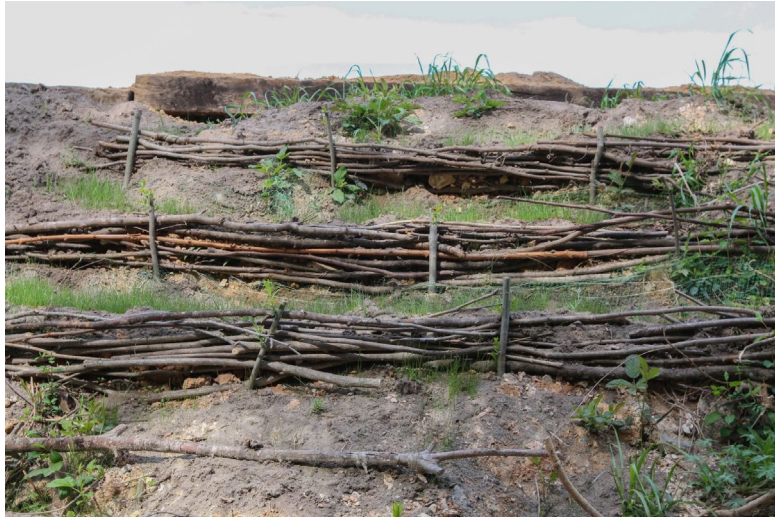
Bank Erosion 1-26 Inspected November 2022

The above photos show erosion in the creek.

- Length: 60ft on the right side.

- Stabilize slope and banks of creek utilizing vegetation and soft armor techniques such as dogwood wattles.

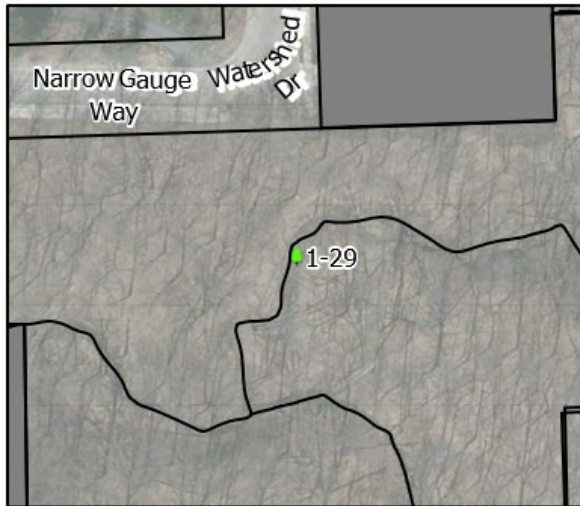
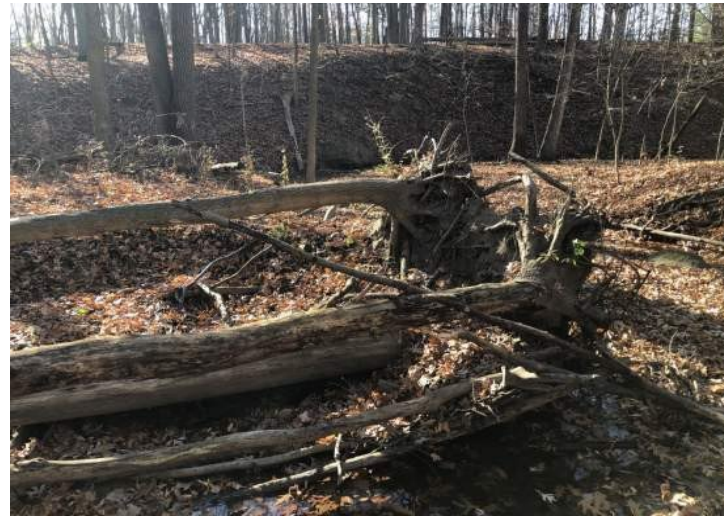
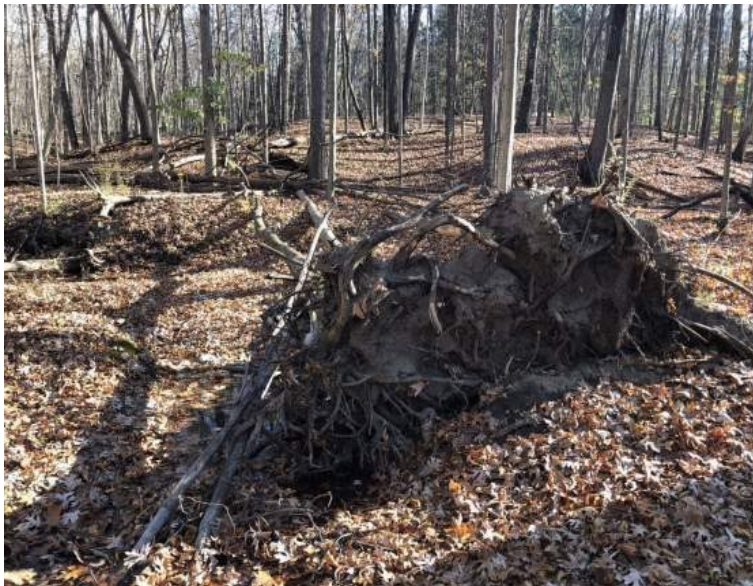
Blockage 1-29 Inspected November 2022

- *Blockage Length:* 50 ft
- *Effects of Blockage:*
  - Water flow – May obstruct water flow and may alter flow patterns, resulting in less space available in the basin to hold stormwater.
  - Water Quality – Trees introduce organic matter from leaves and branches which affects the water quality.
    - Decomposing trees may also release nutrients which affects the oxygen levels in the water.
  - Maintenance Challenges – Needs to be removed to prevent clogs in outlet pipes

**Recommendation:** Remove dead wood

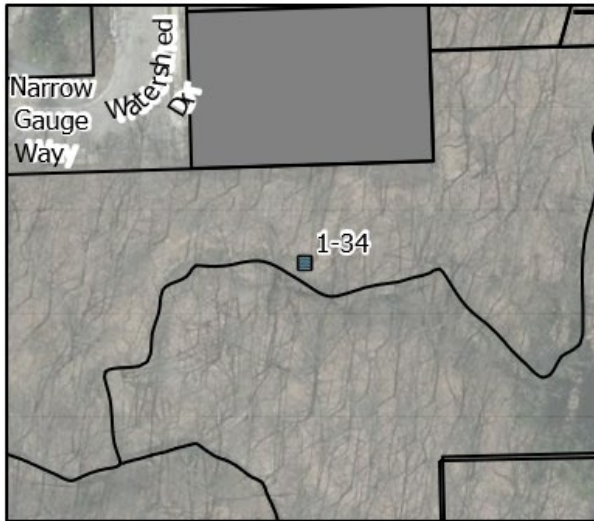
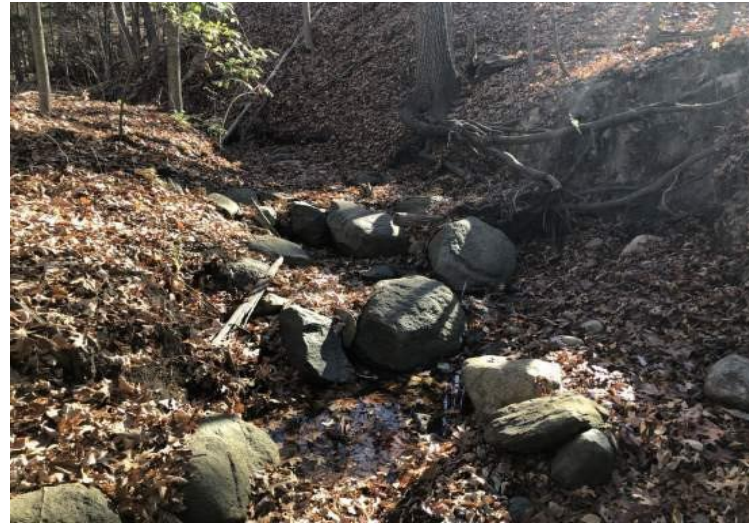
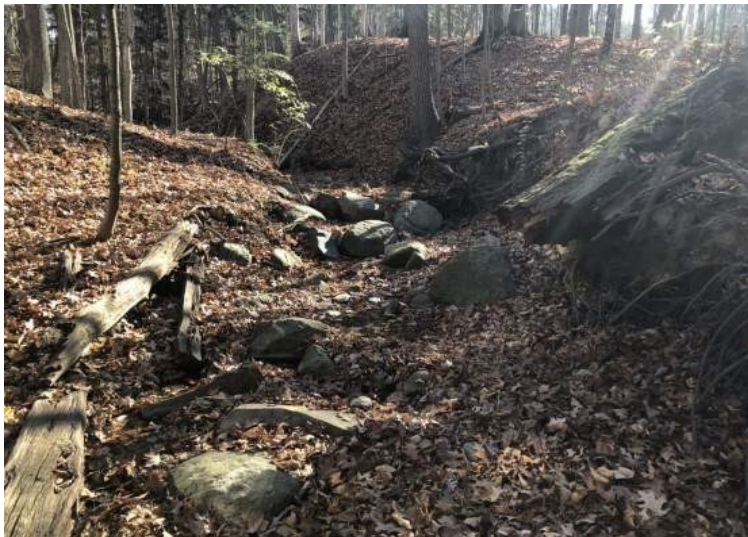
Riffle 1-34 Inspected November 2022

- *Effects of Blockage:*
  - Water flow – May obstruct water flow and may alter flow patterns, resulting in less space available in the creek to hold stormwater.
  - Water Quality – Despite rocks being a good natural filtration process, large rocks spaced further apart provide no benefits to filtering out pollutants and sedimentation.

- Leave area in current state as rock slow more intense storm water events.

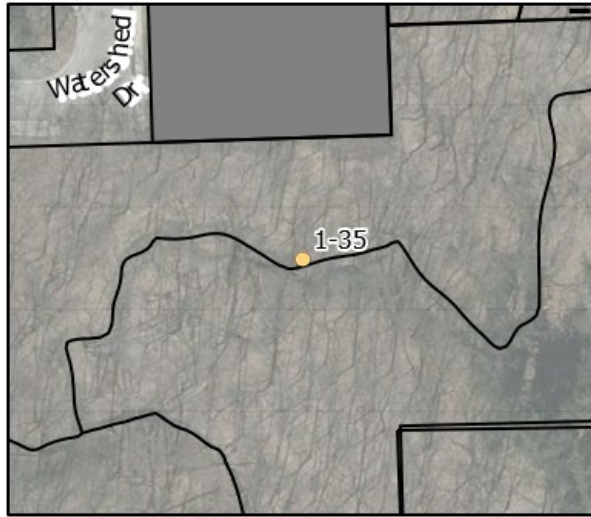
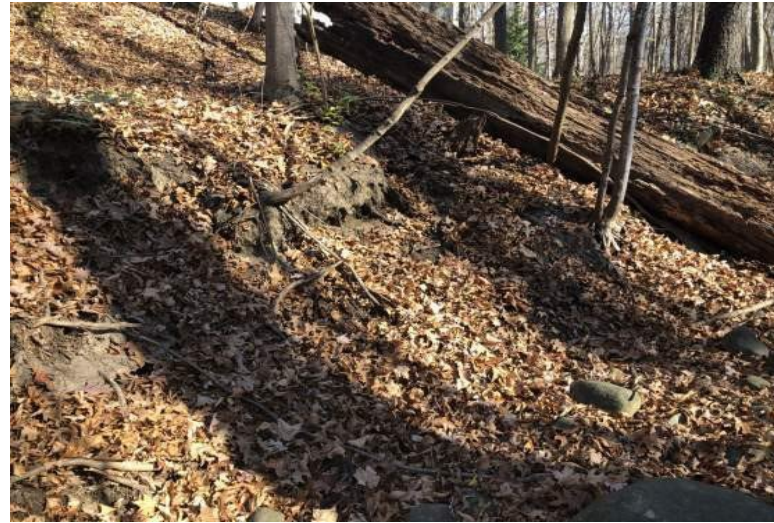
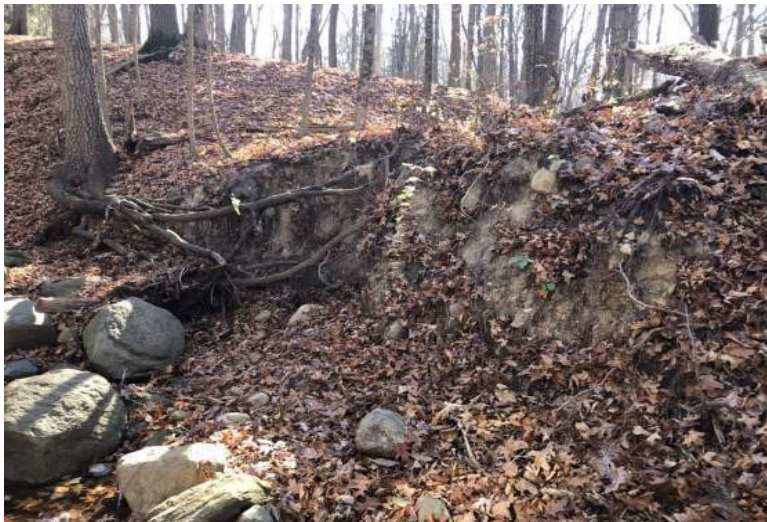
Bank Erosion 1-35 Inspected November 2022

The above photos show approx. 150 ft of bank erosion located on both sides of the creek.

- The right side (photo 1) contains more severe erosion

- Stabilize slope and banks of creek utilizing vegetation and soft armor techniques such as stakes dogwood wattles

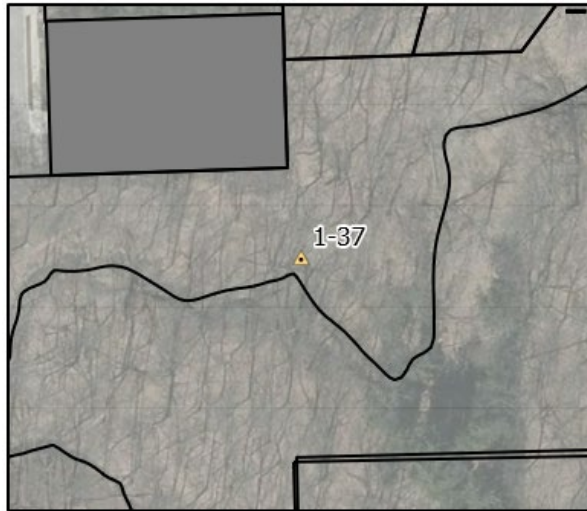
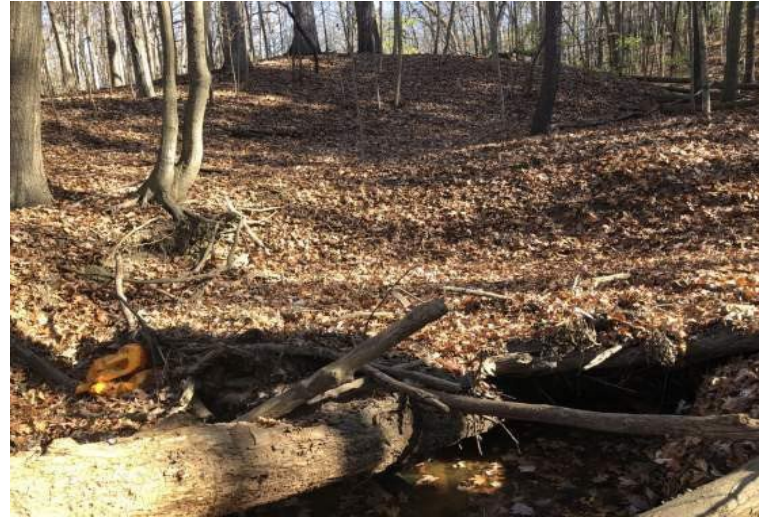
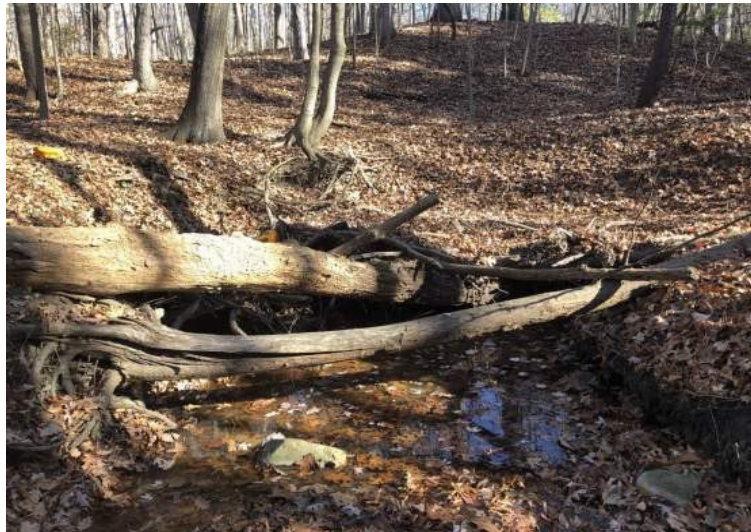
Blockage 1-37 Inspected November 2022

- Logs and large rocks obstructing stream route.
- *Blockage Length:* 10 ft located in the center of the creek.
- *Effects of Blockage:*
  - Approx. 10 ft long log jam causing heavy sediment buildup.

- Remove log jam.

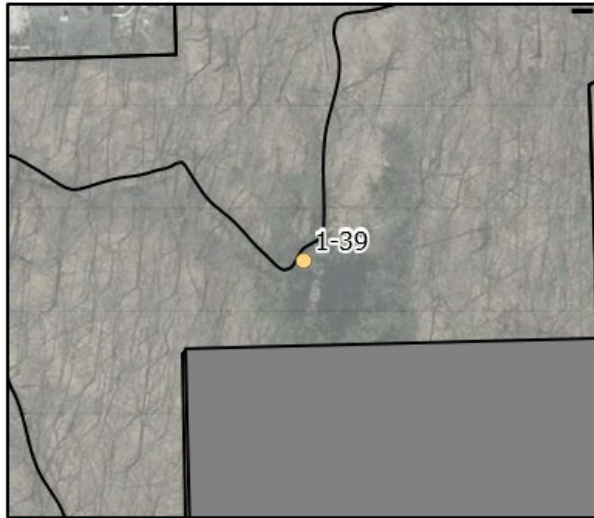
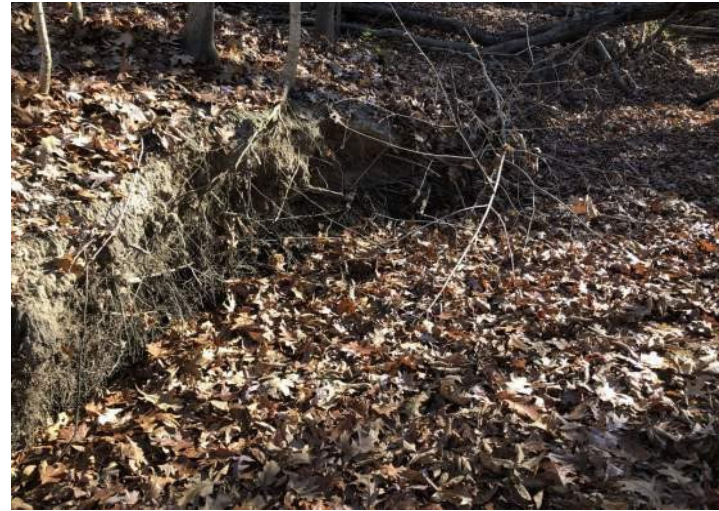
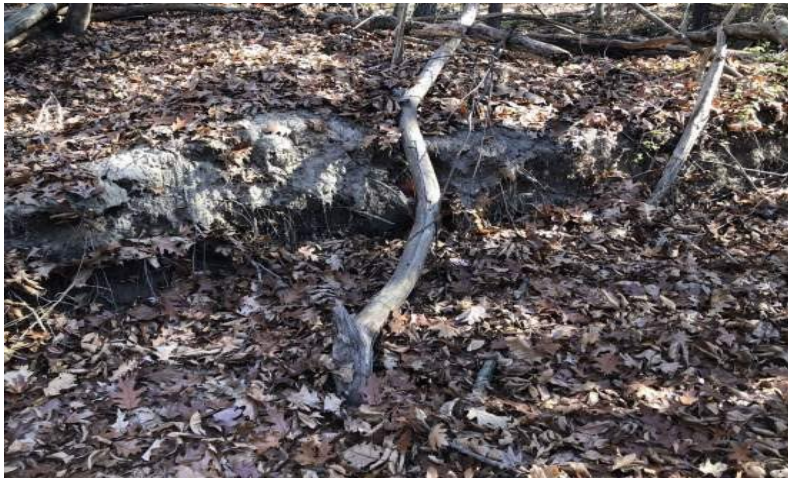
Bank Erosion 1-39 Inspected November 2022

The above photos show approx. 200 ft of bank erosion on both sides of the creek.

- Stabilize slope and banks of creek utilizing vegetation and soft armor techniques such as dogwood wattles.

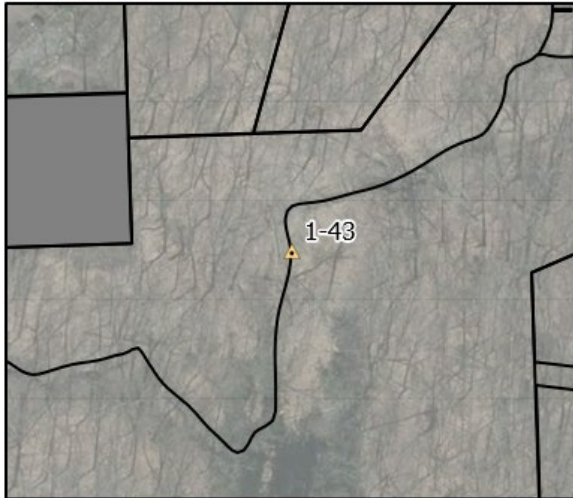
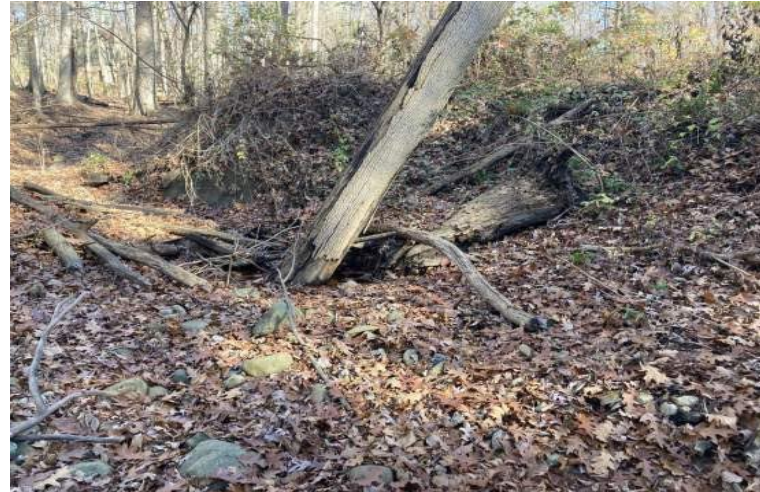
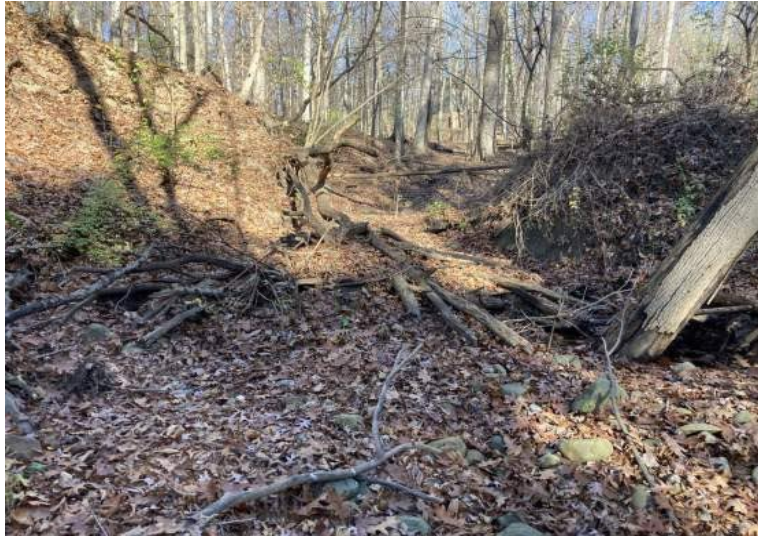
Blockage 1-43 Inspected November 2022

- Large log jam across the whole stream channel
- *Blockage Length:* 15 ft located in the center of the creek.
- *Debris Length:* 20 ft
- *Effects of Blockage:*
  - Limits space available in the creek for larger rain events which may result in flooding
  - Cause excessive sand and debris build up upstream of the blockage as the log slows down the speed at which water flows.

- Remove log jam

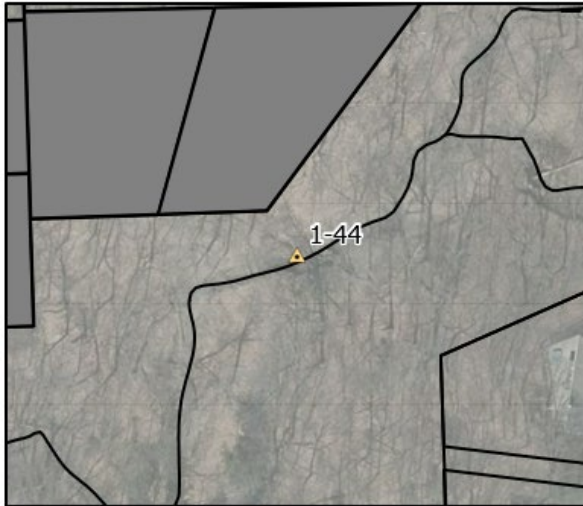
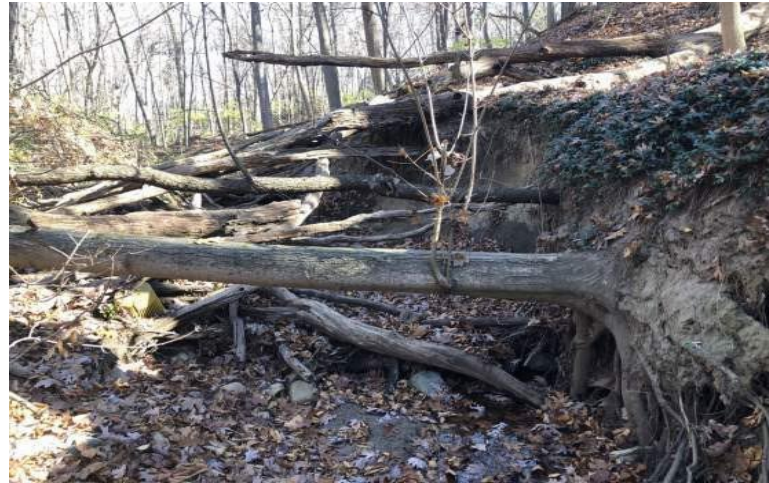
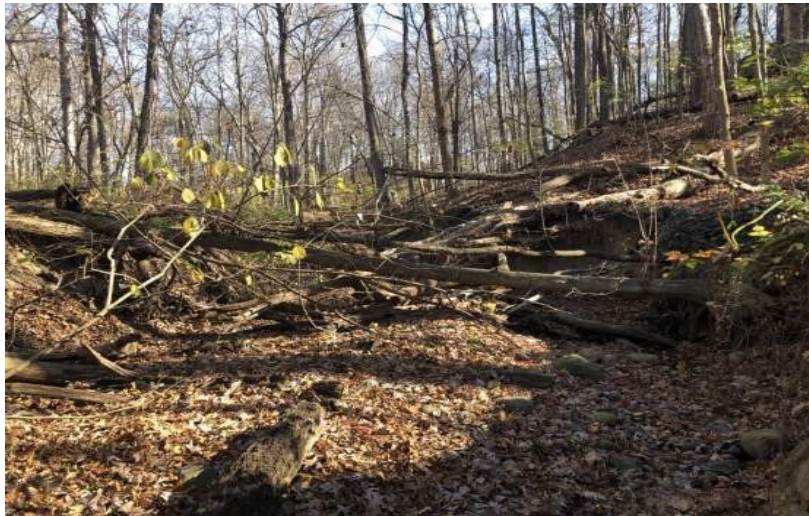
Blockage 1-44 Inspected November 2022

- *Blockage Length:* 15 ft located on both sides of the creek.
- *Effects of Blockage:*
  - limit space available in creek for larger rain events which may result in flooding
  - Cause excessive sand and debris build up upstream of the blockage as the log slows down the speed at which water flows.

- Remove log jam

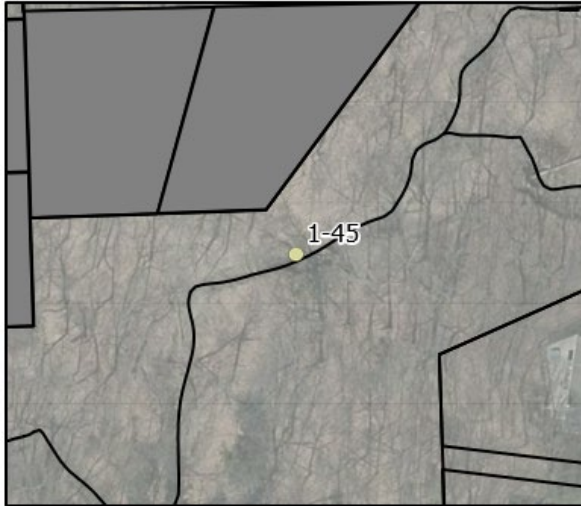
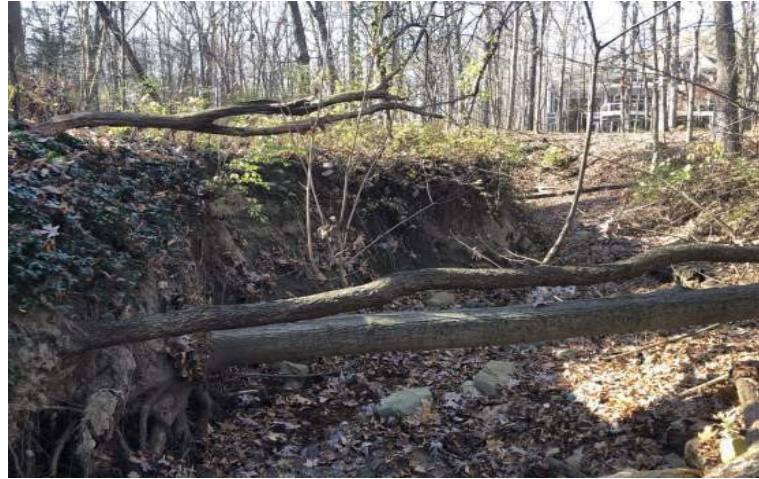
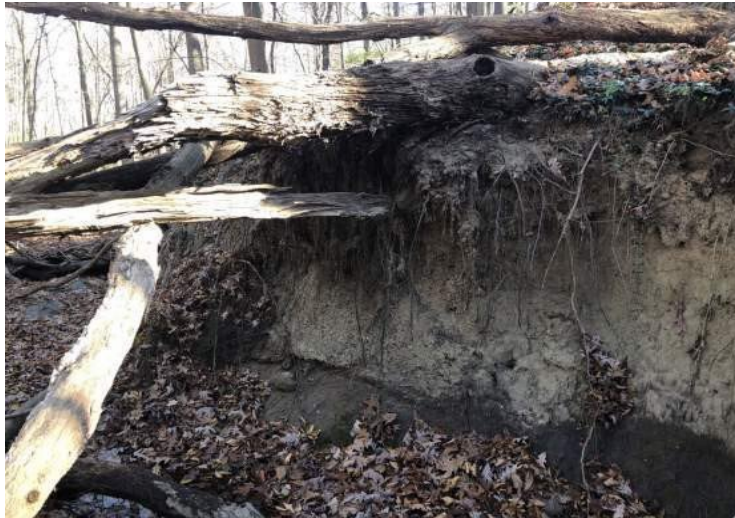
Bank Erosion 1-45 Inspected November 2022

The above photos show severe bank erosion on both sides of the creek downstream to Wye.

- Provide bank stabilization. Potentially install a cross vane to direct flow away from the bank.

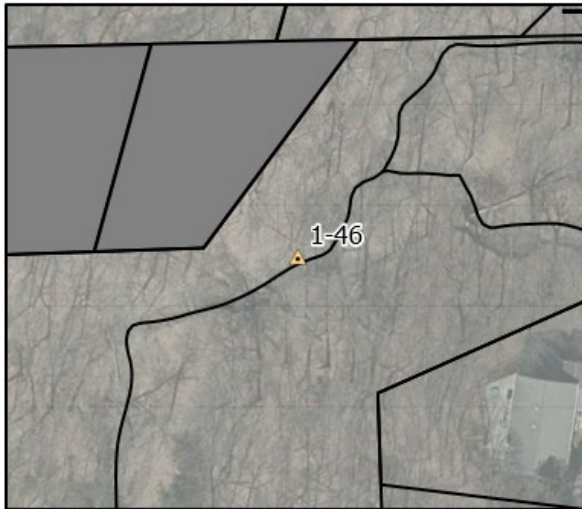
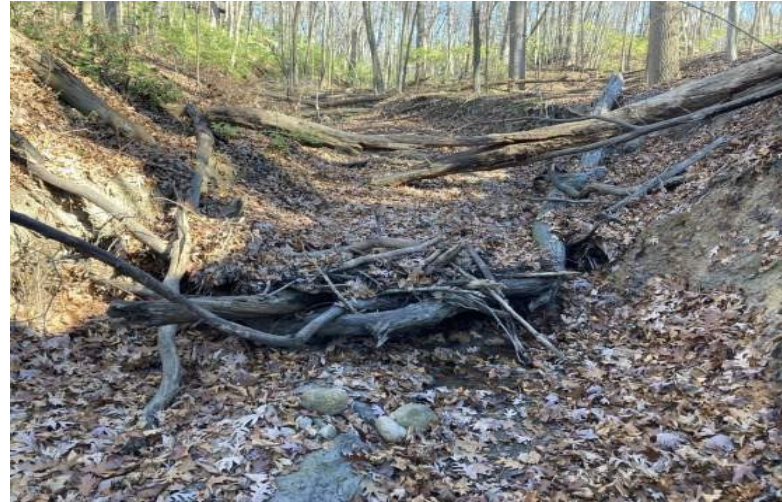
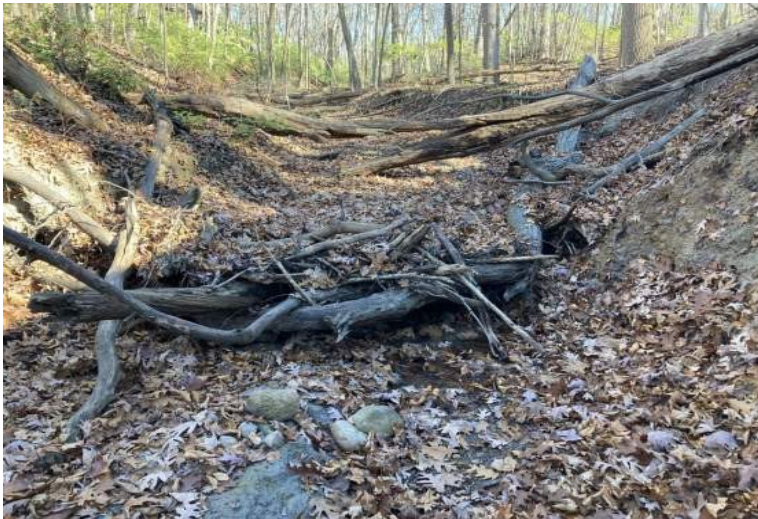
Blockage 1-46 Inspected November 2022

- *Blockage Length:* 5 ft located in the center of the creek.
- *Effects of Blockage:*
  - Sediment build-up directly behind logs

- Remove log jam

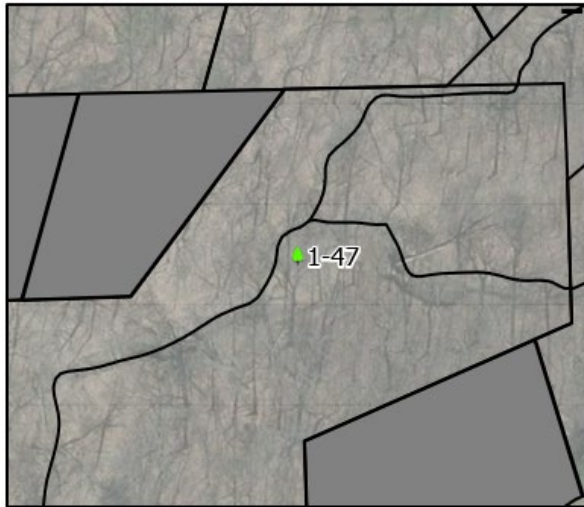
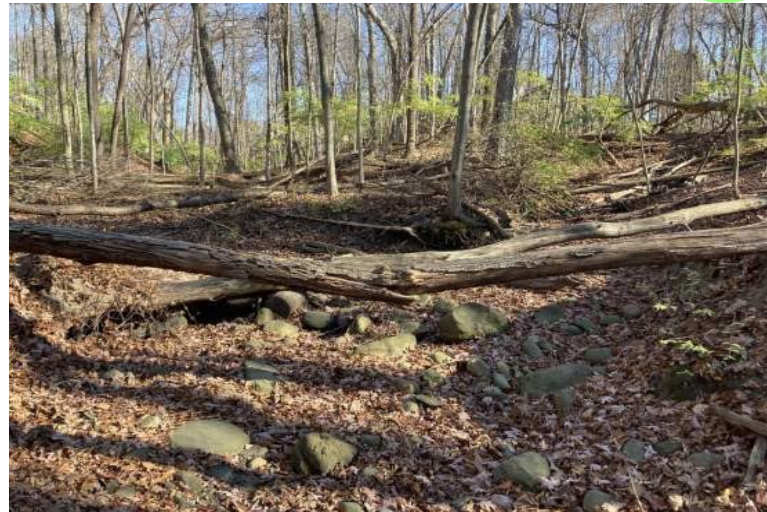
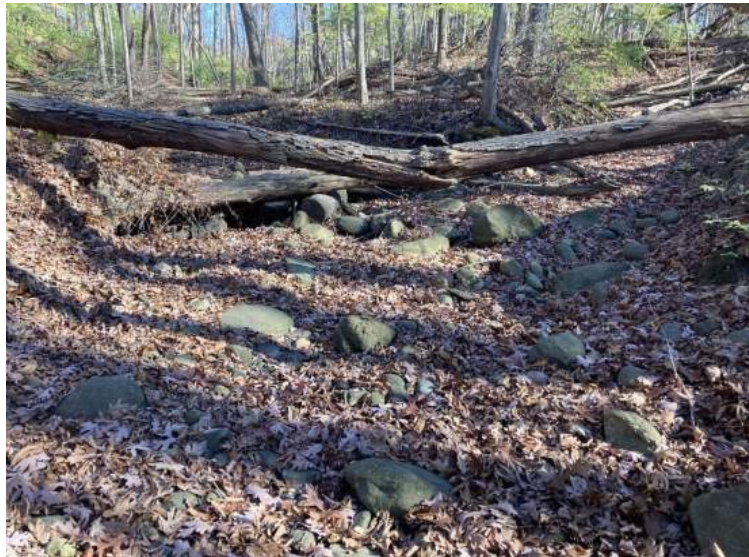
Blockage 1-47 Inspected November 2022

- *Location:* Center of Creek, across converging streams

- Leave area in current state as fallen trees and rocks are reducing/slowing erosion

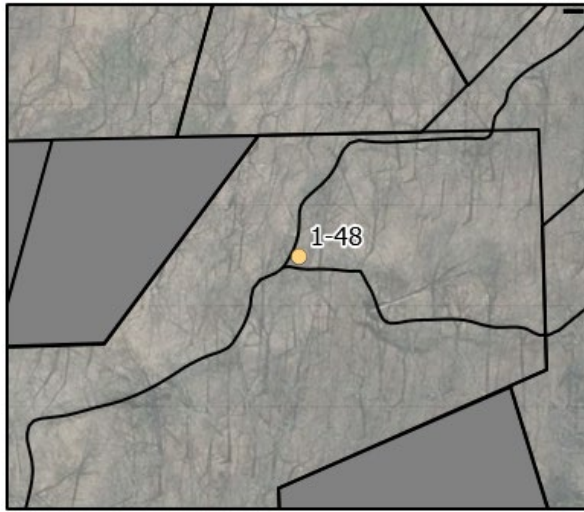
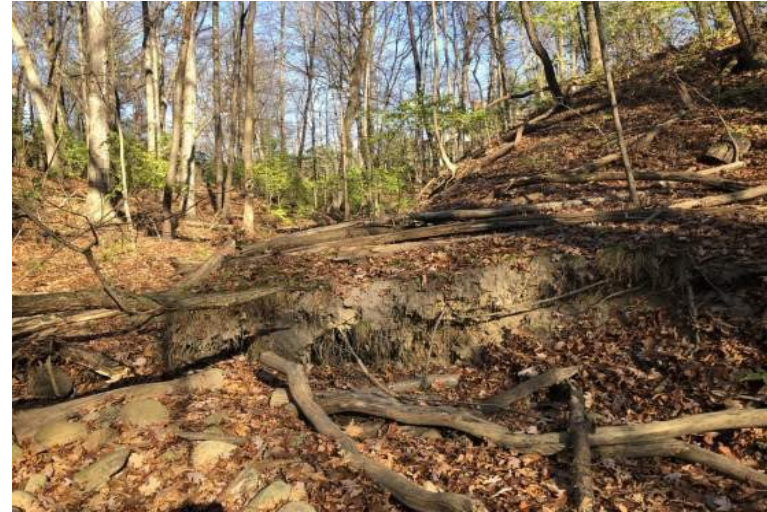
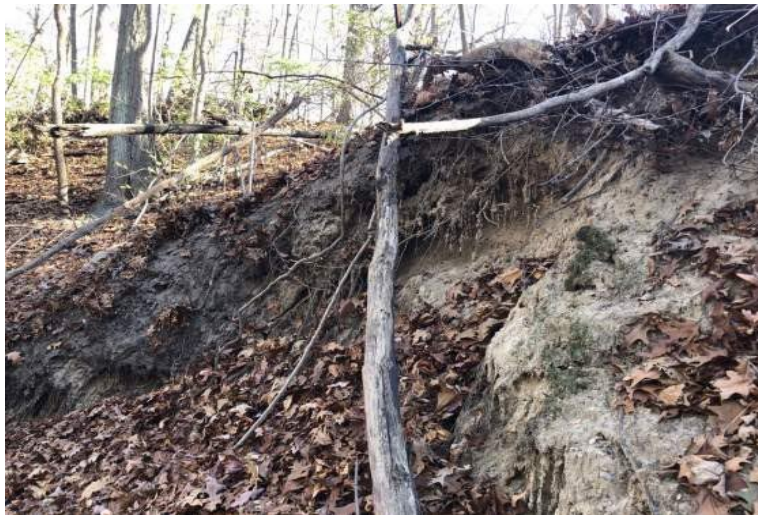
Bank Erosion 1-48 Inspected November 2022

The above photos shows severe bank erosion on both sides of the creek.

- Stabilize slope and banks of creek utilizing vegetation and soft armor techniques.

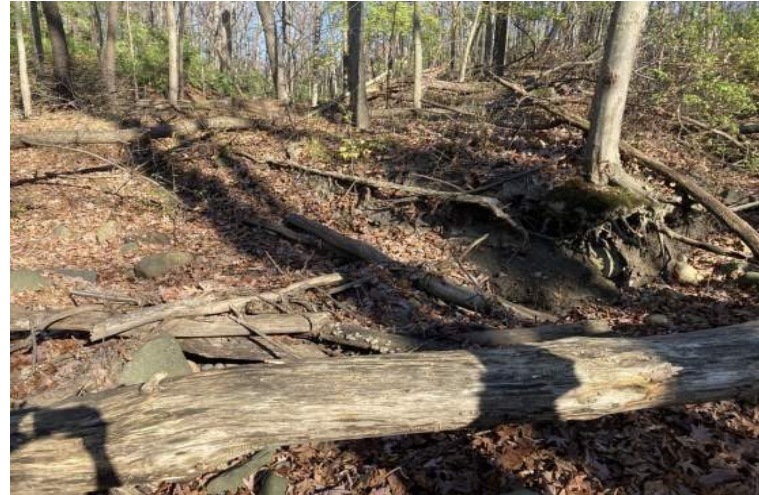
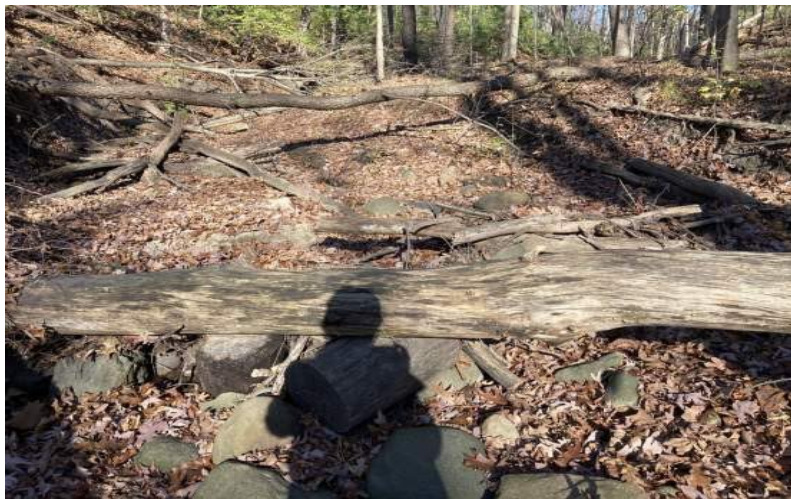
Blockage 1-40 Inspected November 2022

- Logs and large rocks obstructing stream route.
- *Blockage Length:* 50 ft located in the center of the creek.
- *Effects of Blockage:*
  - Log jam across the creek with large rocks and sediment build up.
  - Sediment build-up located behind logs and rocks

- Remove log jam

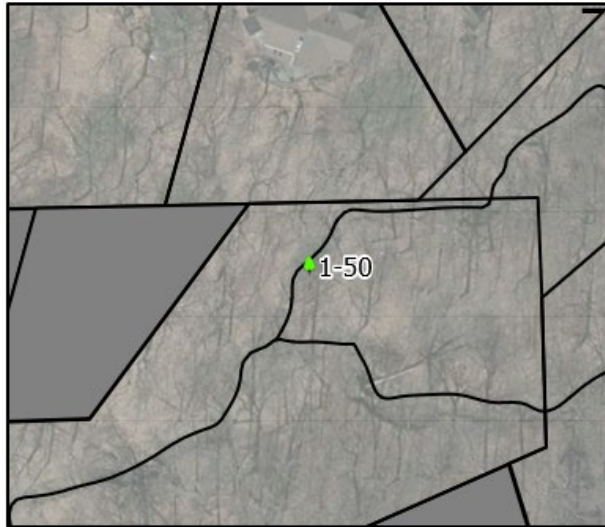
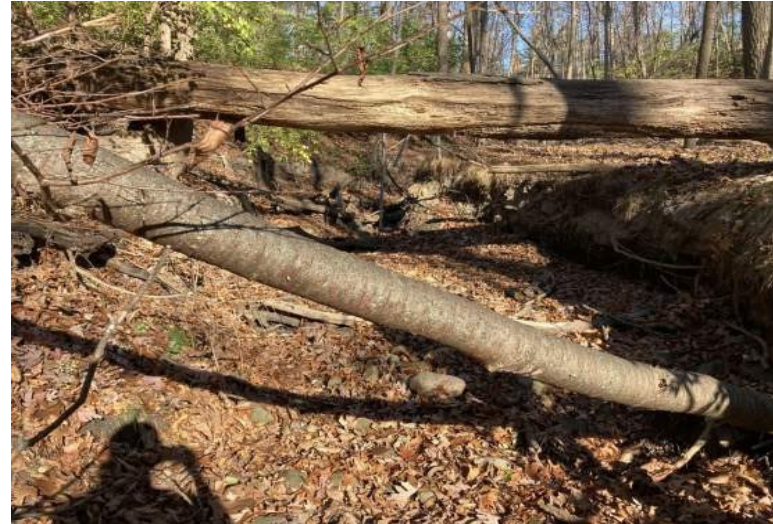
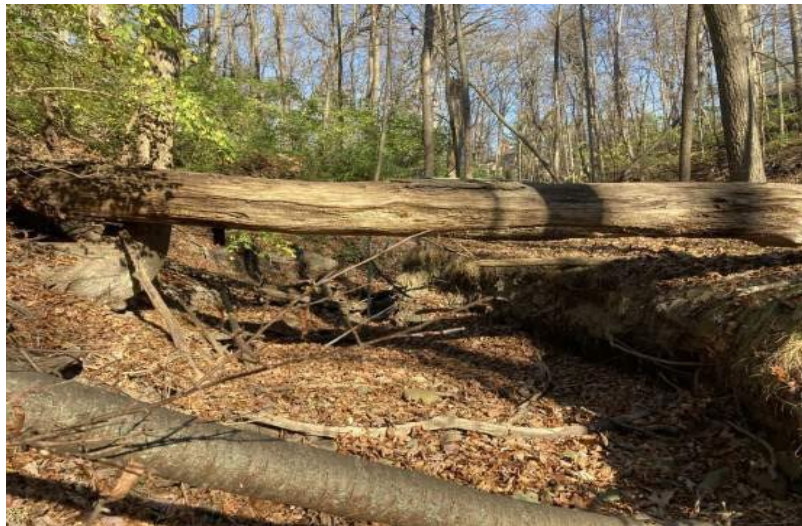
Blockage 1-50 Inspected November 2022

- Across creek and drain
- *Debris Length: 5 ft on both sides of creek*

- Removal dead wood

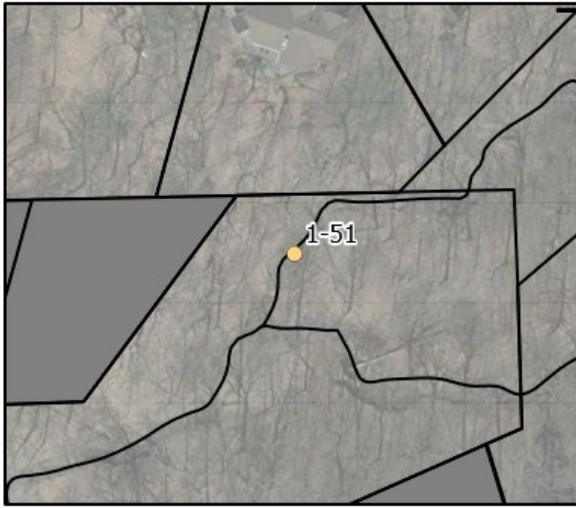
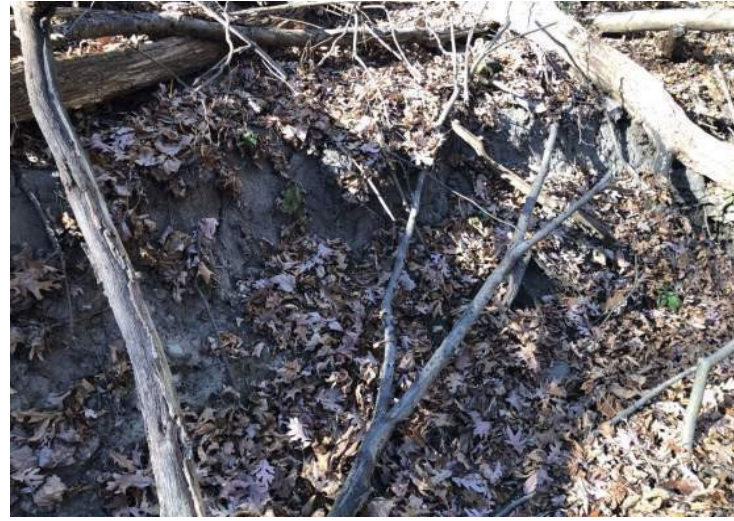
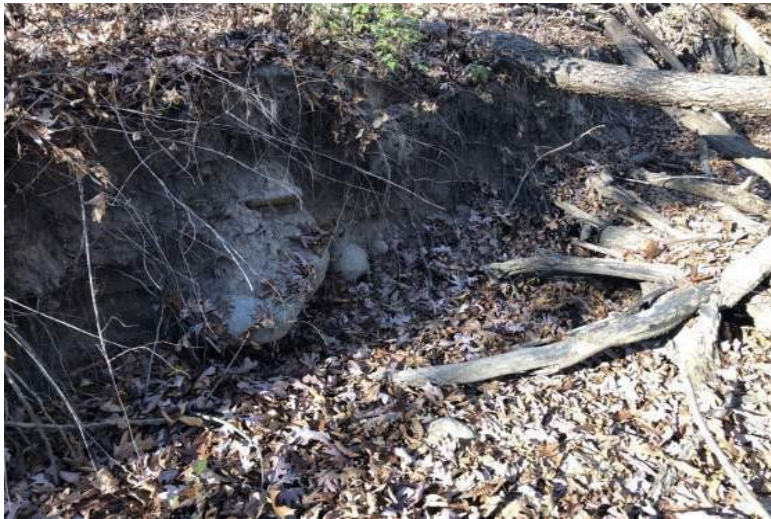
Bank Erosion 1-51 Inspected November 2022

The above photos show erosion in the creek.

- Length: 150ft on both sides

- Stabilize slope and banks of creek utilizing vegetation and soft armor techniques such as dogwood wattles.

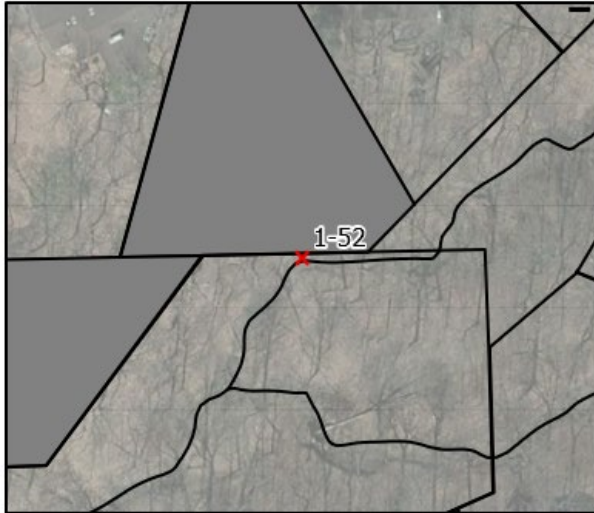
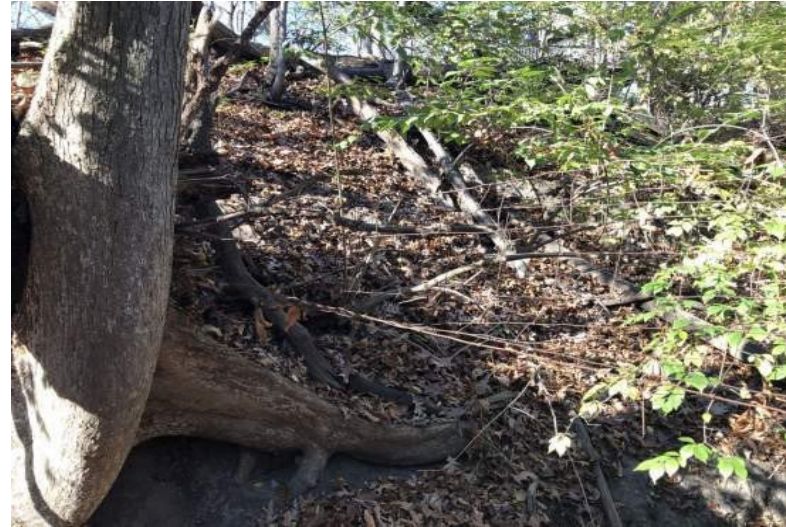
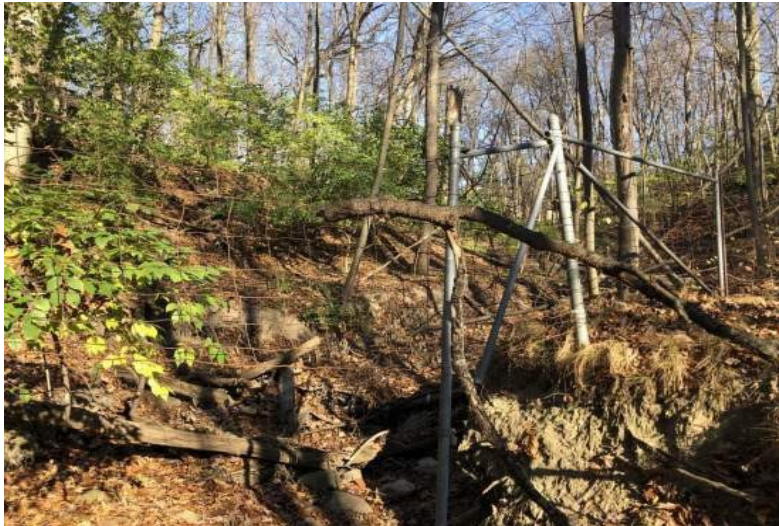
Utility 1-52 Inspected November 2022

The following images show a fence that is approx. 5 ft above the bottom of the creek.

- Remove existing fencing and install natural barrier.
