# NARROW GAUGE CREEK INSPECTION

Prepared By: Hubbell, Roth & Clark  
September 2024

ANN ARBOR  
**WATER**

# NARROW GAUGE CREEK INSPECTIONS

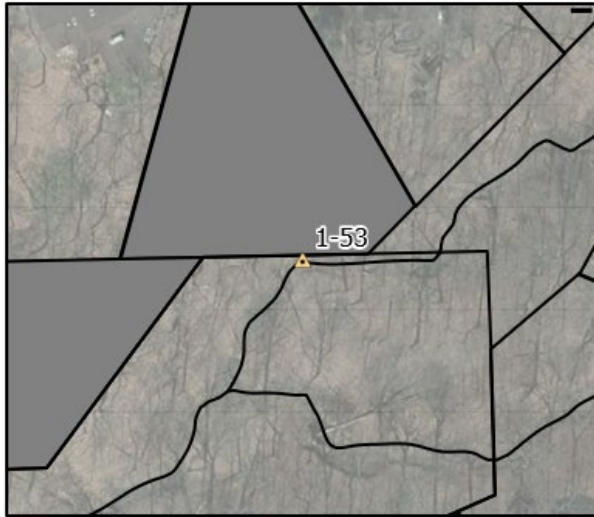
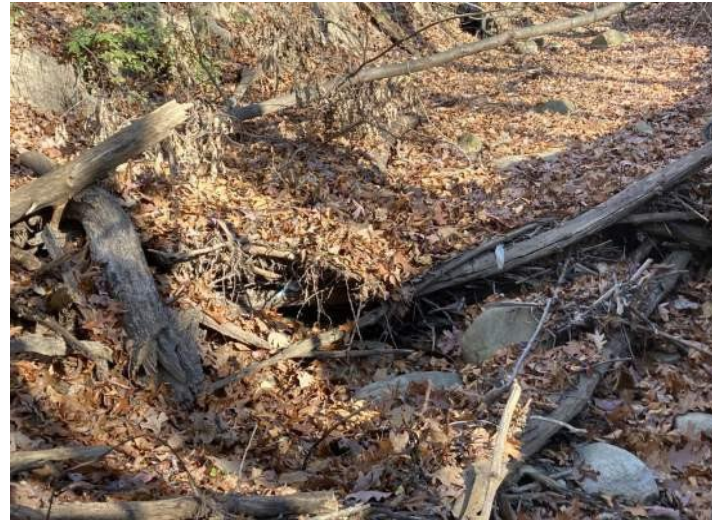
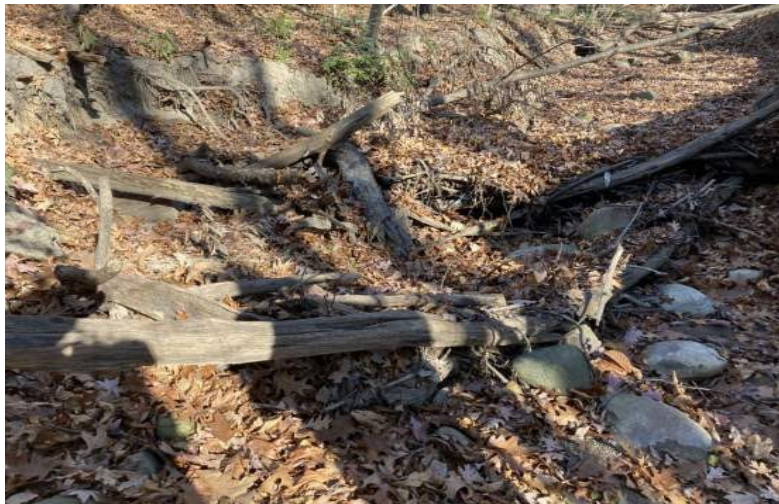
Blockage 1-53 Inspected November 2022

- Logs obstructing stream route across creek
- *Blockage Length:* 10 ft located in the center of the creek.
- *Debris Length:* 10 ft
- *Effects of Blockage:*
  - limit space available in the creek for larger rain events which may result in flooding
  - Cause excessive sand and debris build-up upstream of the blockage as the log slows down the speed at which water flows.

- Remove log jam

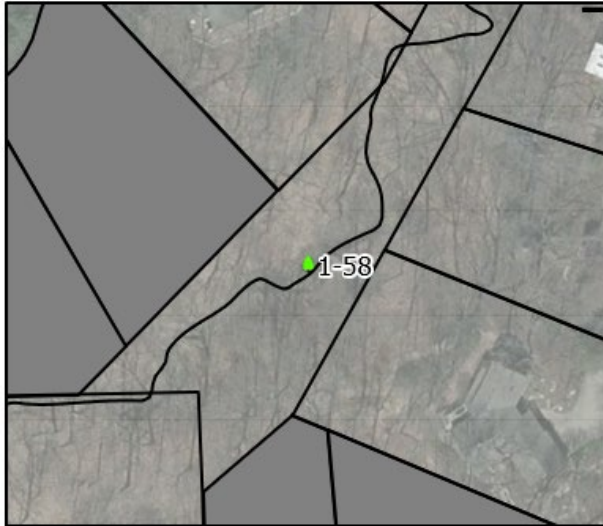
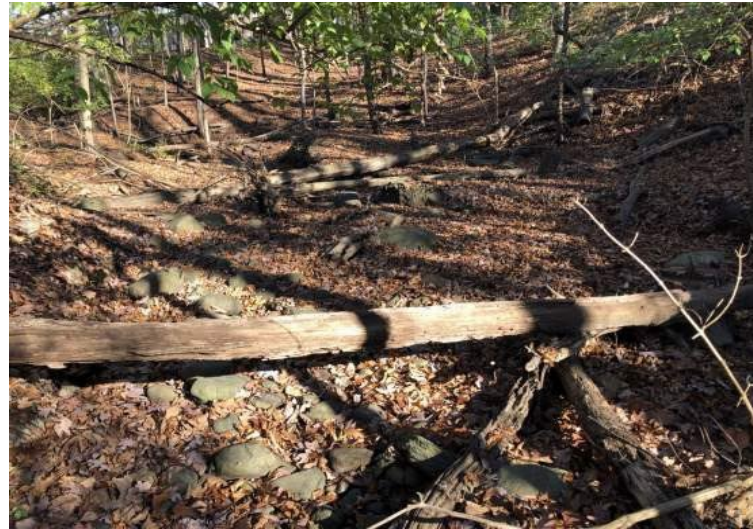
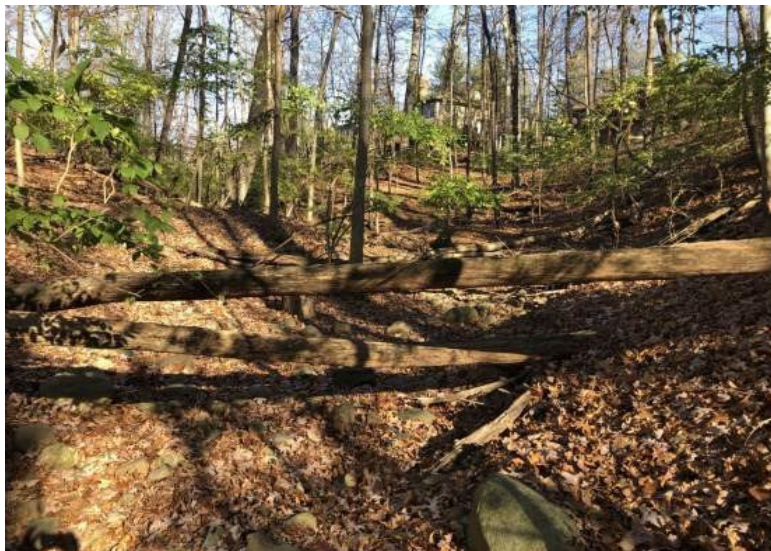
Blockage 1-58 Inspected November 2022

- *Blockage Length: 50 ft*
- *Effects of Blockage:*
  - Water flow
  - Water Quality
  - Maintenance Challenges

- Remove dead wood

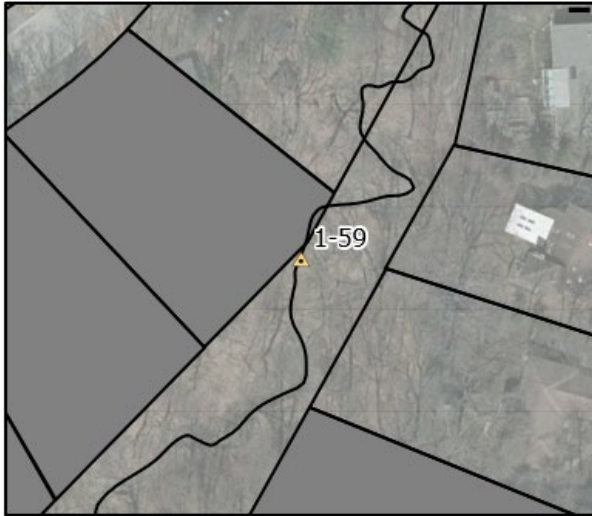
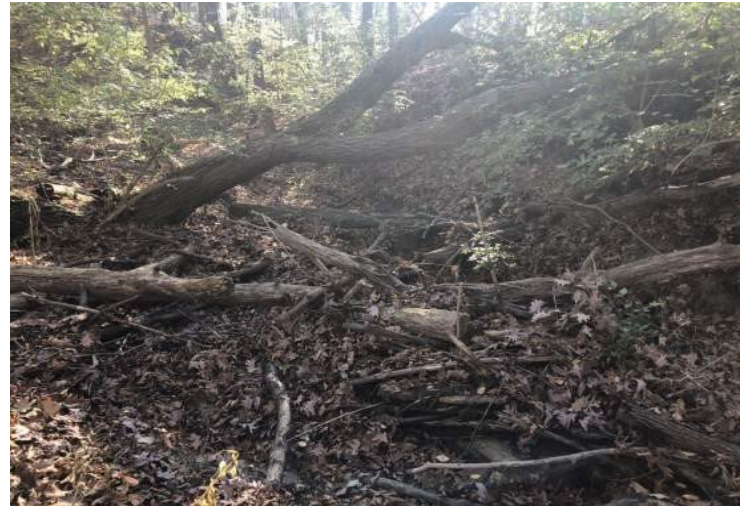
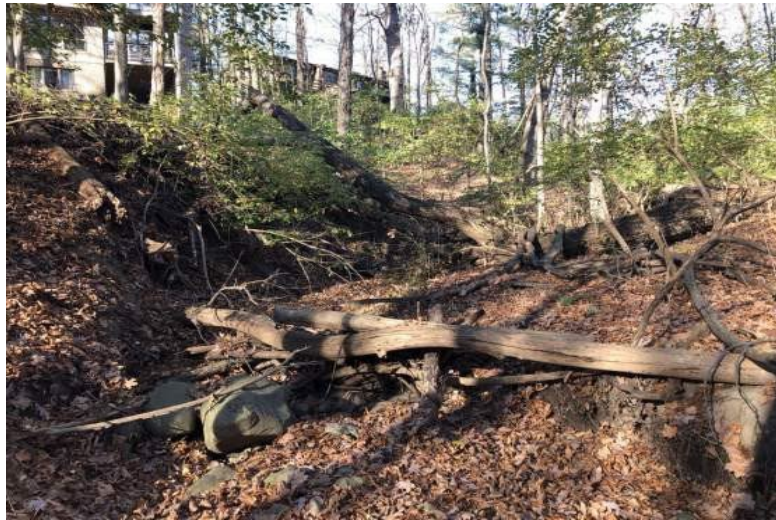
Blockage 1-59 Inspected November 2022

- Logs obstructing stream route.
- *Blockage Length:* 30 ft located on both sides of the creek.
- Effects of Blockage:
  - limit space available in the creek for larger rain events which may result in flooding
  - Cause excessive sand and debris build-up upstream of the blockage as the log slows down the speed at which water flows.

- Remove log jam

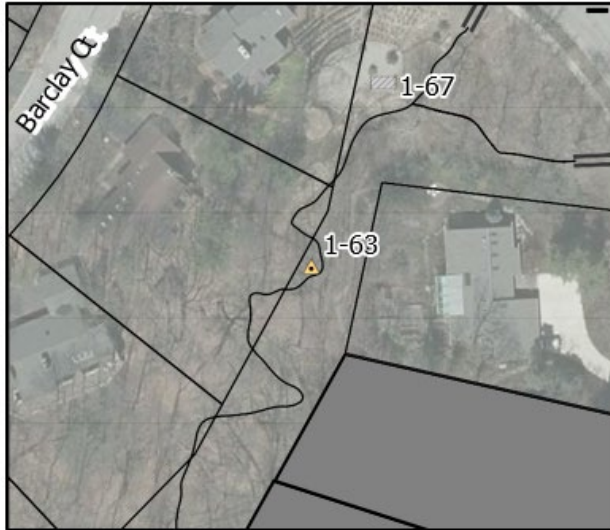
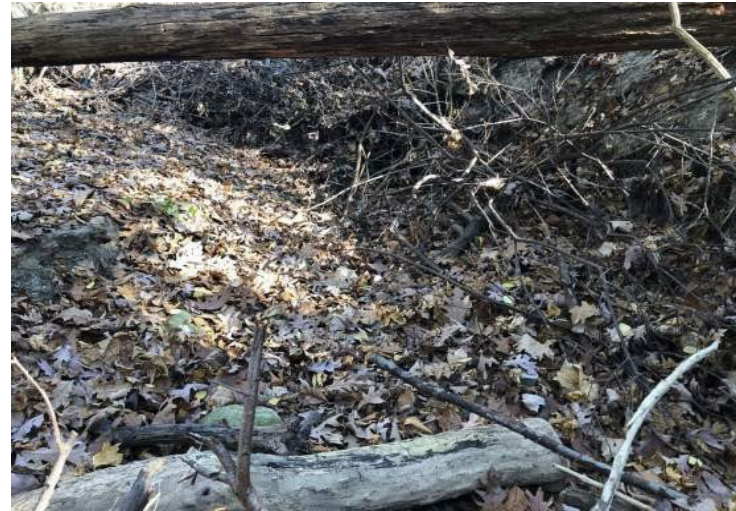
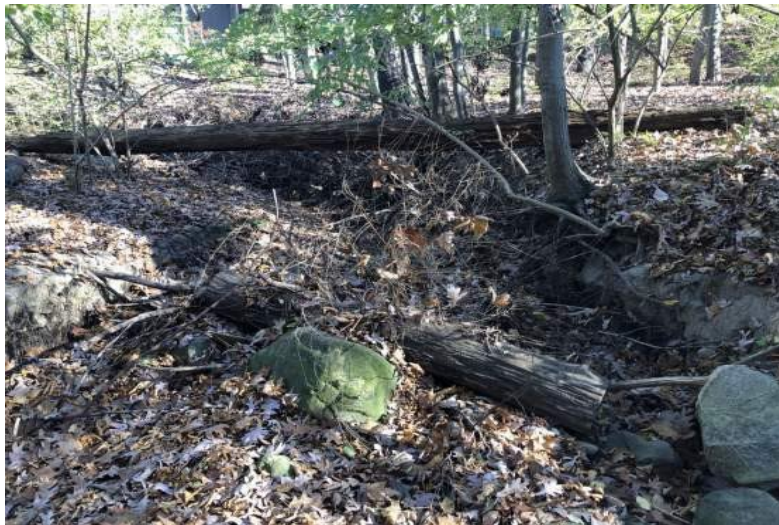
Blockage 1-63 Inspected November 2022

- Logs obstructing stream route and collecting dead vegetation
- *Blockage Length:* 50 ft located on the right side of the creek.
- *Effects of Blockage:*
  - limit space available in the creek for larger rain events which may result in flooding
  - Cause excessive sand and debris build-up upstream of the blockage as the log slows down the speed at which water flows.

- Remove log jam
