Appendix I
Phase I ESA Photographs
721 North Main Street
Ann Arbor, MI

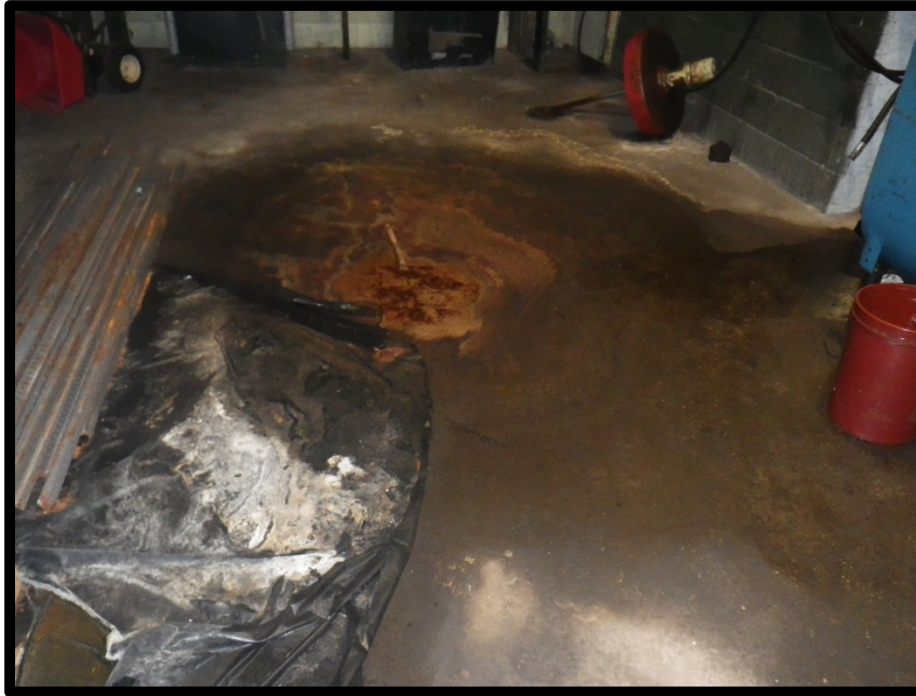
Staining on concrete in paint booth of maintenance garage

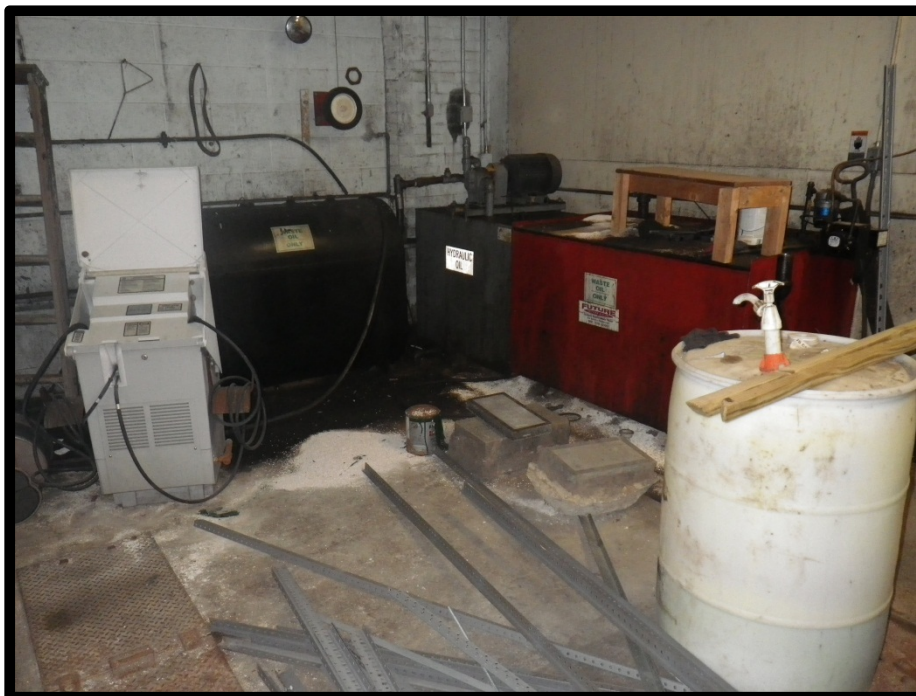
Waste oil, hydraulic oil, and waste anti-freeze tanks located in the maintenance garage

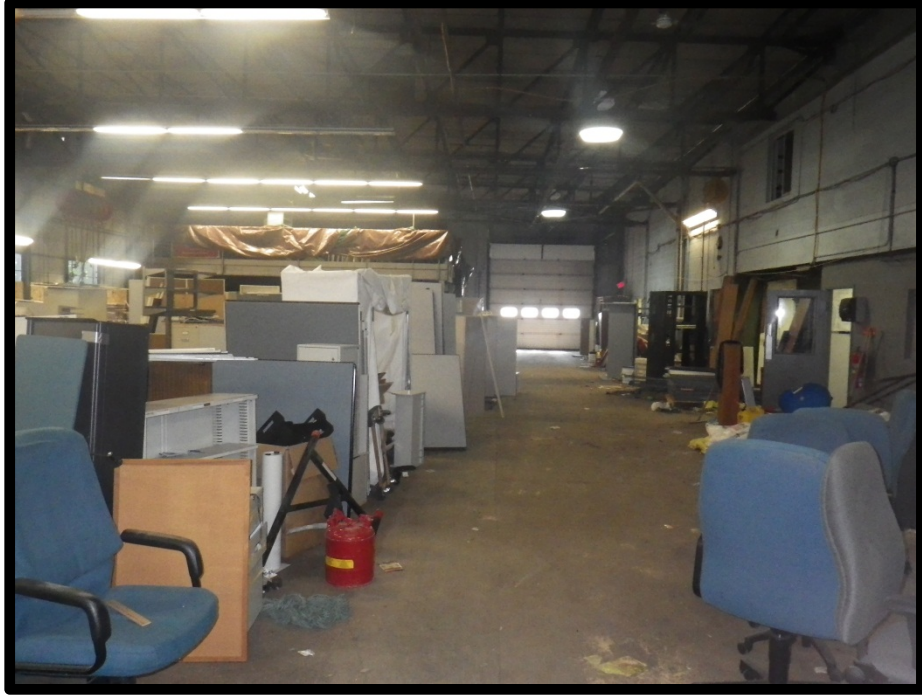
Looking east through the northern portion of the maintenance garage

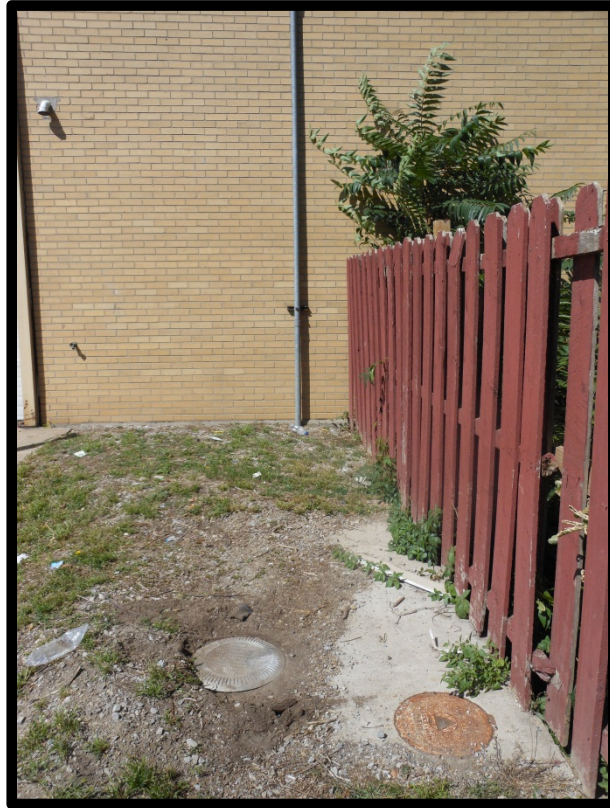
Location of waste oil UST and monitoring well east of maintenance garage

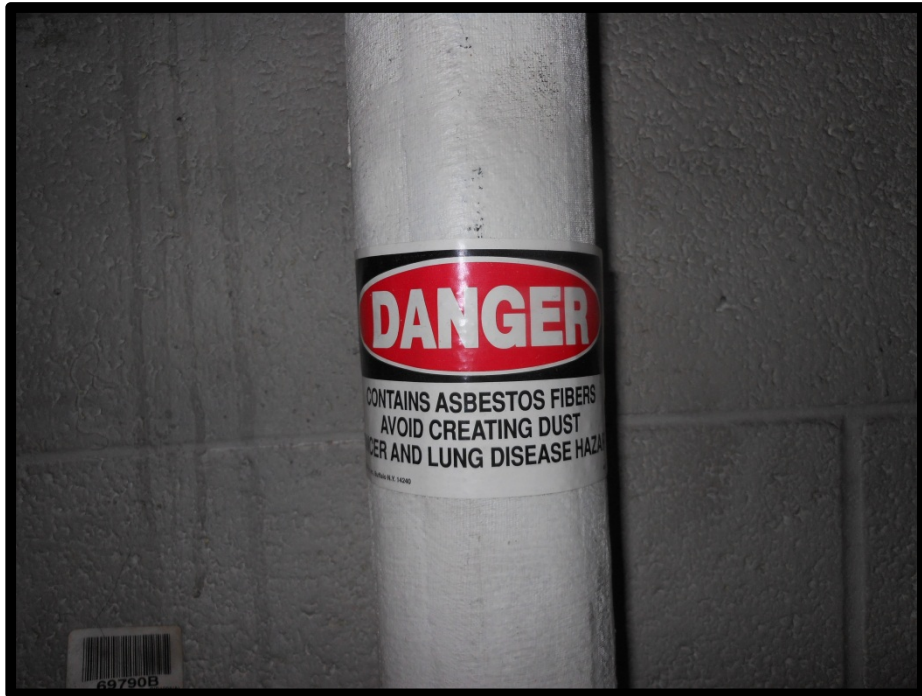
Asbestos wrap on piping in maintenance garage

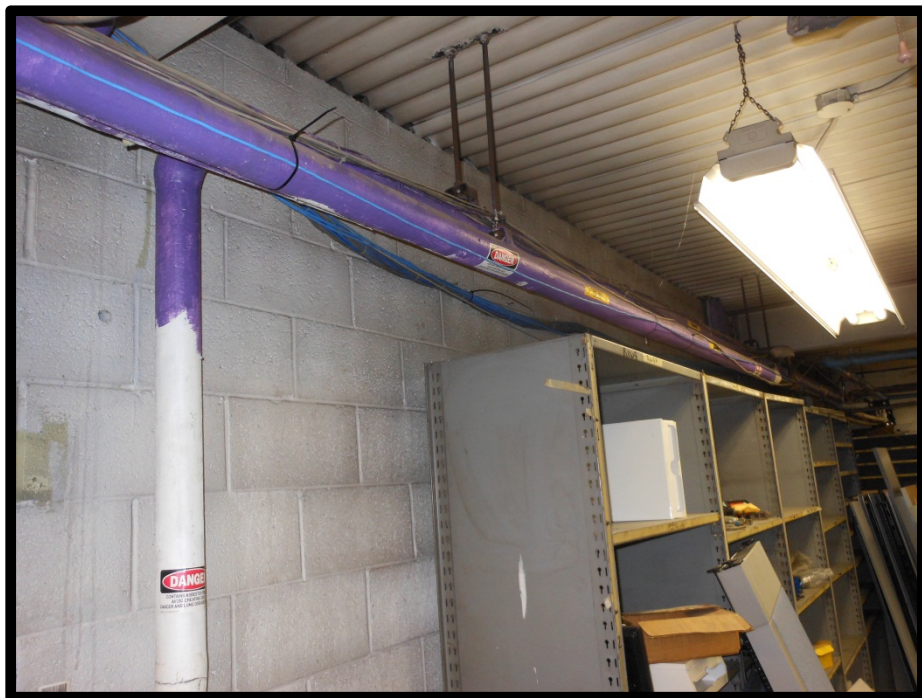
Asbestos wrap on piping in maintenance garage

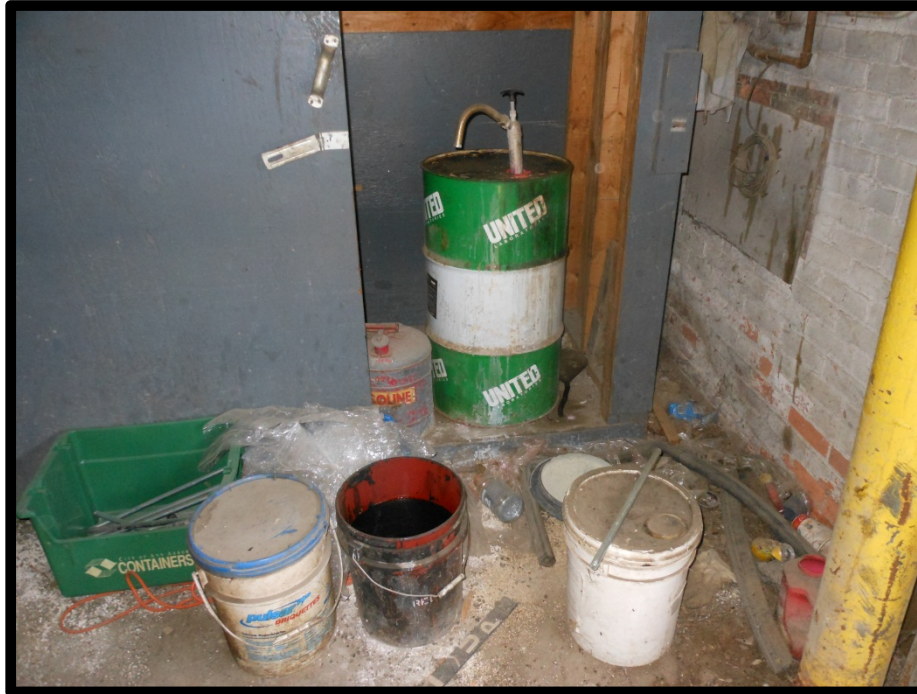
Miscellaneous buckets and drums in the south end of the maintenance garage

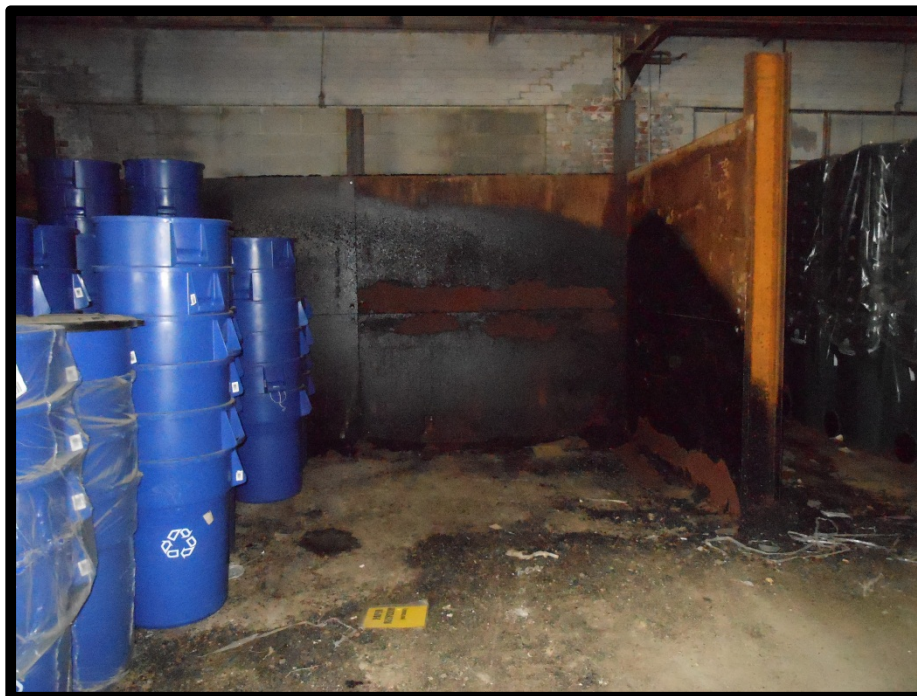
Asphalt storage area in the south end of the maintenance garage
