Rental Assistance Demonstration (RAD): **PART 1: PHYSICAL CONDITION ASSESSMENT**

1020 – 1042 Pennsylvania Avenue, Ann Arbor, Michigan 48103

PROJECT # 8359e-1-96

DATE October 11, 2013
Revised September 15, 2014
Revised November 20, 2014

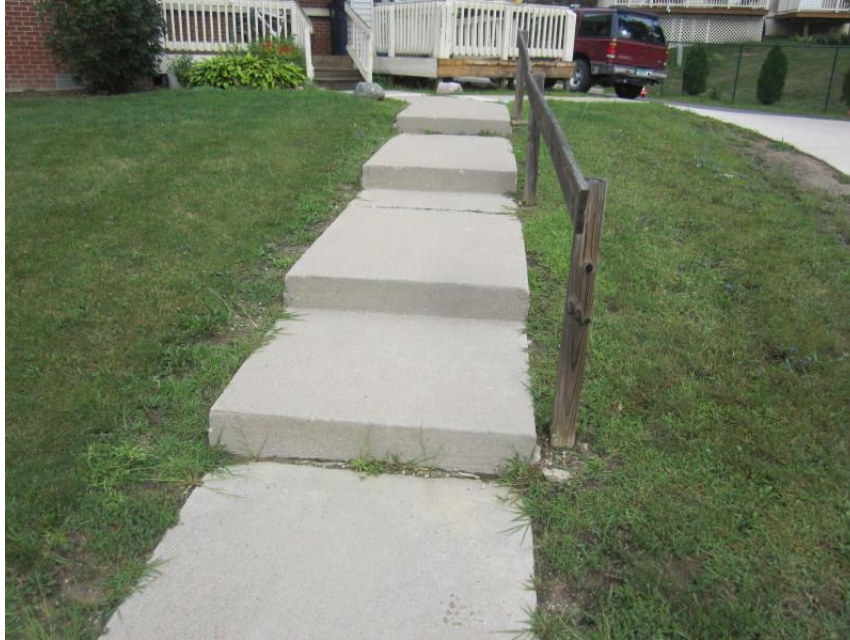
The flat work surrounding the building was observed to be in fair condition. Handrails appear to need repair or replacement.

PHOTOGRAPH NO. 3: TYPICAL VIEW OF LANDSCAPING AND FLATWORK THROUGHOUT SUBJECT PROPERTY

Approximately 20% of the existing flatwork is recommended for patching and repair. Replace handrails along sidewalk approach. Repair and maintain broken concrete walkways around the subject property to avoid continued degradation and possible trip hazards.

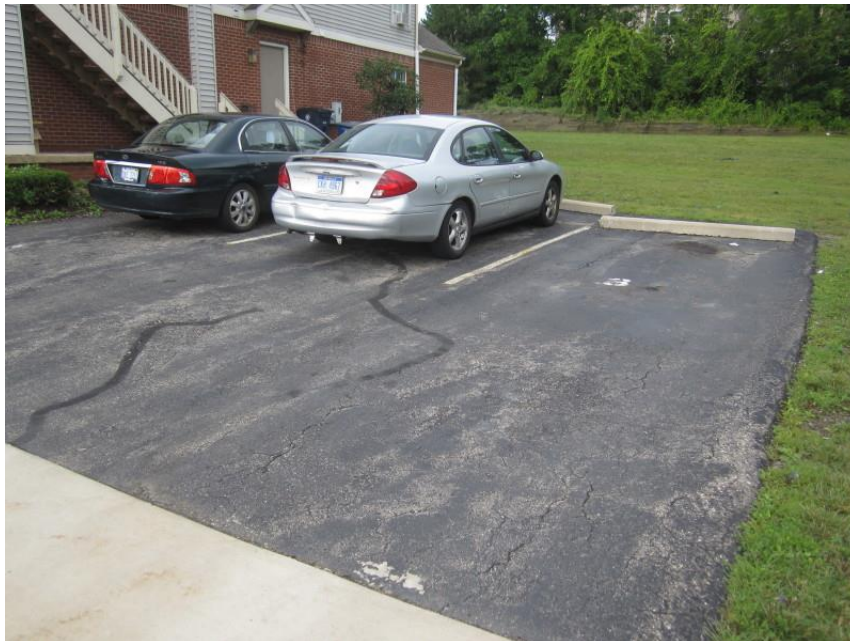
Overall, the concrete drive areas appear to be in fair condition. However, the asphalt parking pads are deteriorated and are in poor condition. It was also noted that the accessible path of travel requires maintenance and repair.

PHOTOGRAPH NO. 4: TYPICAL VIEW OF SUBJECT PROPERTY PARKING LOT

Approximately 1/3 of the asphalt parking area is in need of patching and repair. Seal coating and re-striping of the entire asphalt pavement area is recommended as a rehab item. Repairing and rebuilding accessibility ramp to ensure proper transitions and barrier free travel is recommended as a rehab item. Continued maintenance of paved areas is recommended. In addition, capital reserves should be considered for future expansion, maintenance, and/or replacement and repair of paved areas. Please refer to the attached Capital Needs Input, 20 Year Detail, 20 Year Schedule and Rehab Specifications for additional information on condition, rehab costs and capital reserves.

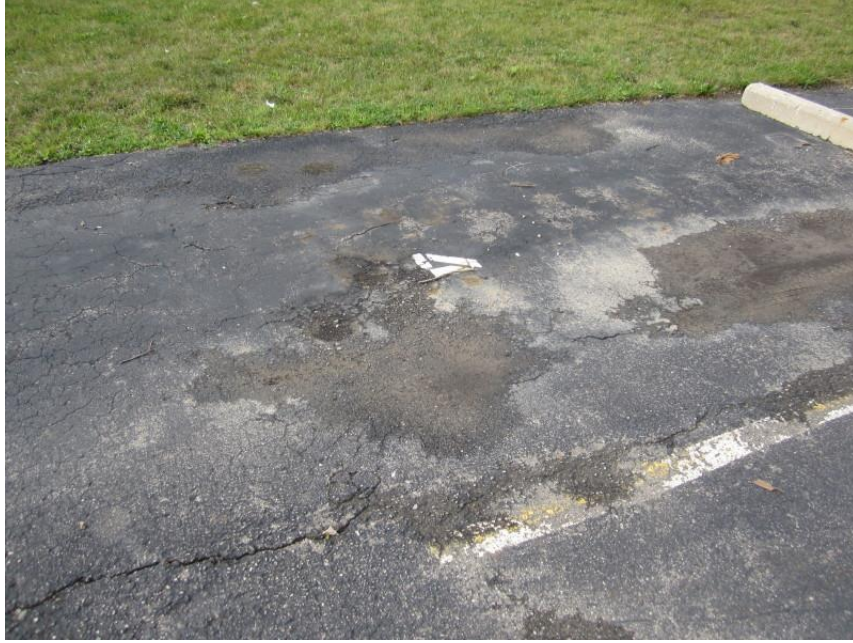
PHOTOGRAPH NO. 5: CLOSE UP OF DETERIORATED AREA IN PARKING LOT

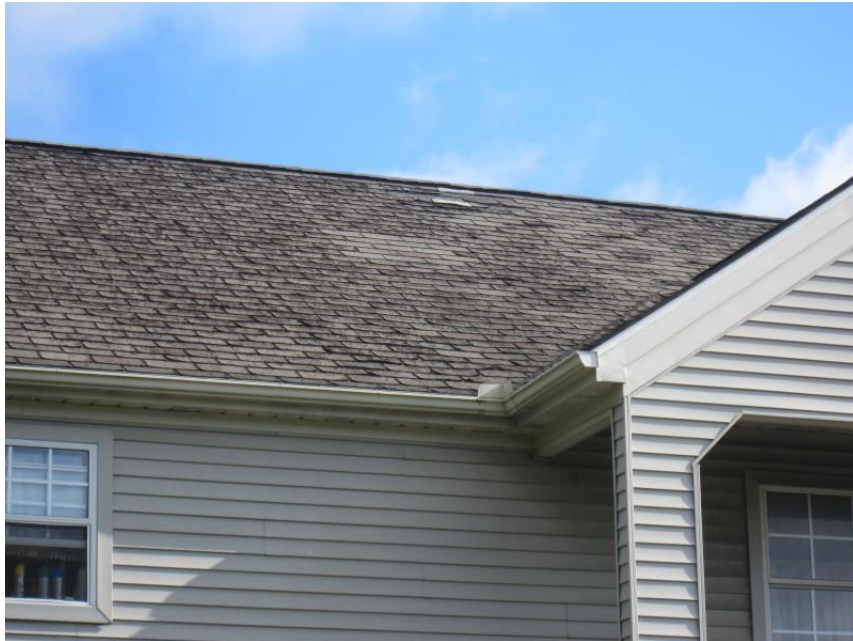
The roofs are gabled type, with one main gable and two small gables on the back of each building. The roofing system is asphalt shingles, and these appear to be original. The roofing system has surpassed its expected useful service life and the existing shingles show signs of deterioration; including cupping and breakdown of granular coating. This deterioration is more pronounced on the south side of the building, where it is exposed to more direct UV and heat radiation from the sun.

PHOTOGRAPH NO. 6: TYPICAL VIEW OF ROOFS (SOUTH FACING)

Re-roof existing roofing system. Please refer to Section 3.5 regarding environmental concerns. Please refer to the attached Capital Needs Input, 20 Year Detail, 20 Year Schedule and Rehab Specifications for additional information on condition, rehab costs and capital reserves.

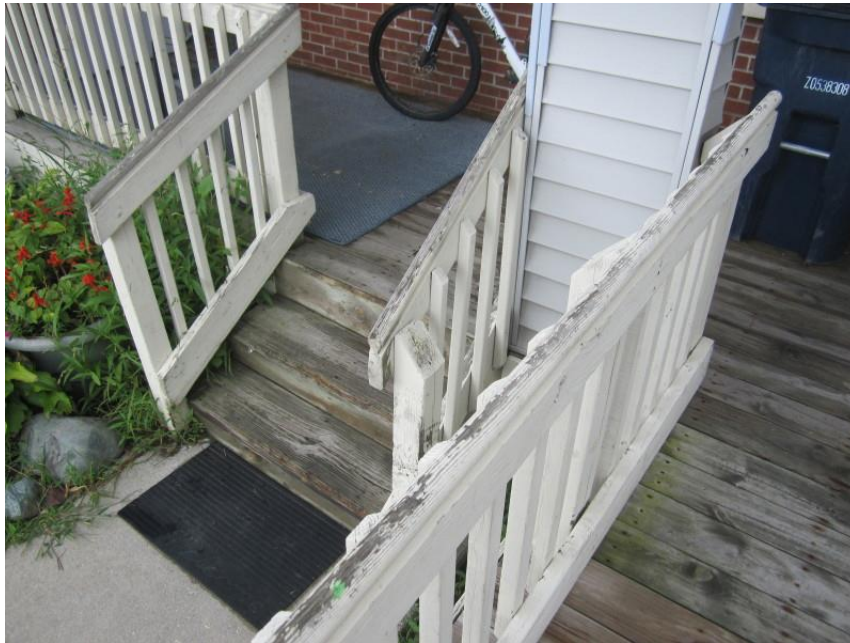
The concrete patio areas are in fair condition. The pressure treated wood decks are in fair to poor condition. The railings and balusters are painted, and the paint has deteriorated, the hand rail surfaces are weathered and rough to the touch. Railings show lateral play (looseness) in some areas. There is evidence of mold on the underside of the pressure treated deck structure and flooring. Many of the joist hangers are heavily corroded.

PHOTOGRAPH NO. 7: TYPICAL VIEW OF DECK COMPONENTS

Repair or replace any hardware components contributing to lose railings with excessive lateral play, and brace as required. Prepare, sand, and paint all railing and baluster components. Wash pressure treated deck components with solution designed to stop mold growth in all areas with existing mold. Replace any joist hangers that are severely corroded with new exterior hangers of material compatible with existing pressure treated material. Please refer to the attached Capital Needs Input, 20 Year Detail, 20 Year Schedule and Rehab Specifications for additional information on condition, rehab costs and capital reserves.

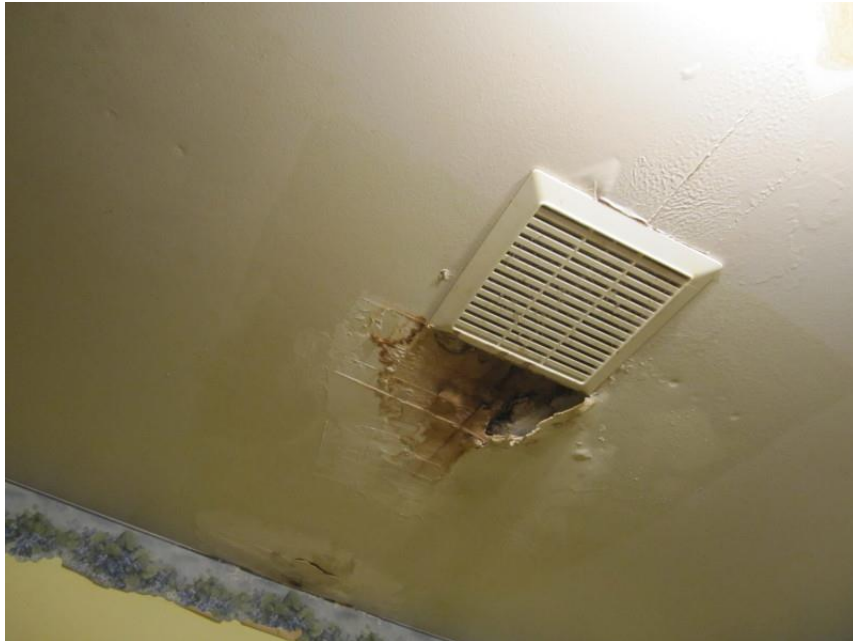
PHOTOGRAPH NO. 12: CEILING MOISTURE PROBLEM (UNIT 1020)

- Repair / replace bathroom ceiling in unit #1020 and resolve moisture issue.

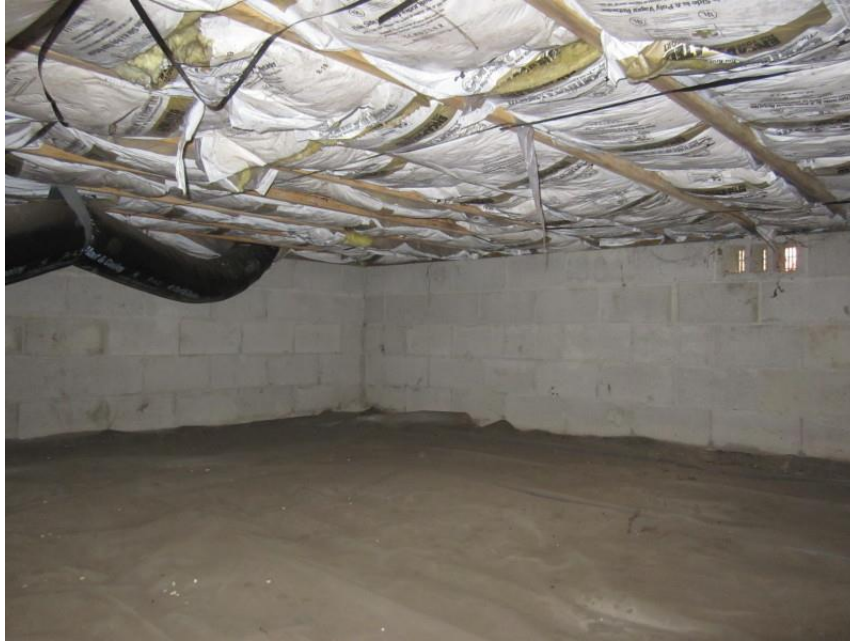
Observations of the subject property indicate the foundations of the subject buildings consists of a trench footing with cement masonry unit (CMU) foundation walls. There are also CMU piers on spread footings that support a beam in the middle of the building. The piers were noted to not be grouted solid.

PHOTOGRAPH NO. 13: TYPICAL VIEW OF CRAWL SPACE

The CMU piers should be grouted solid as specified in the original construction documents. The building foundations should be observed as routine building operations.

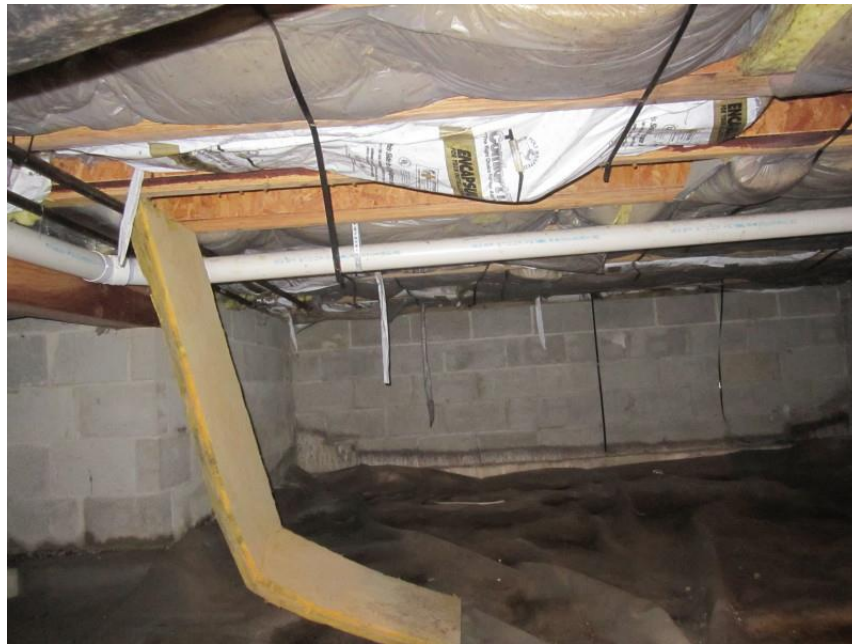
PHOTOGRAPH NO. 16: VIEW OF OPEN RETURN AIR CHASE (TYPICAL)
