Rental Assistance Demonstration (RAD): **PHYSICAL CONDITION ASSESSMENT**

106 Packard Street, Ann Arbor, Michigan 48104

PROJECT # 8212E

DATE February 21, 2014

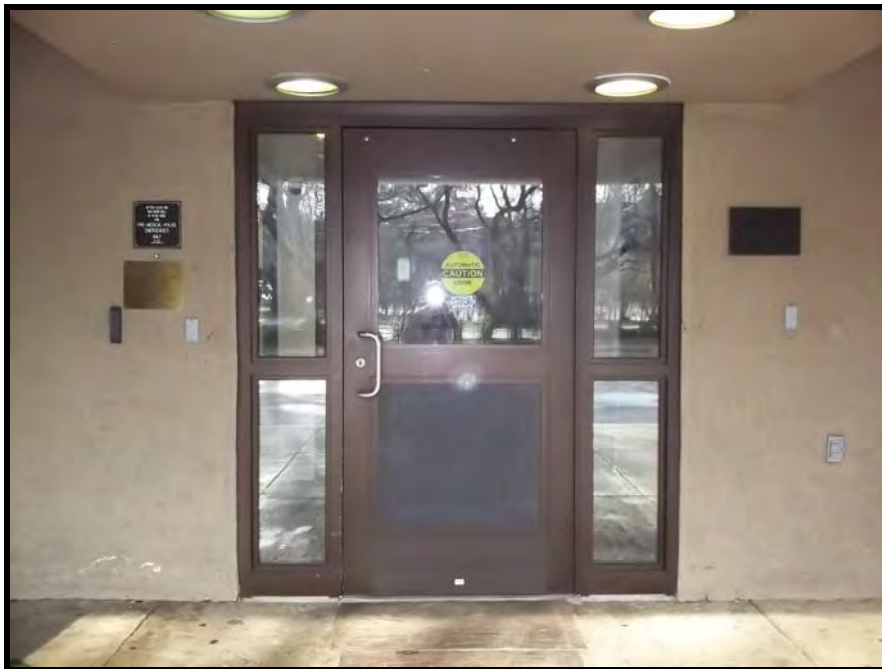
Tuck pointing of the masonry veneer was recently completed. The existing entrance door is in fair condition, but it was stated that additional security entry doors are needed for this facility.

PHOTOGRAPH NO. 2: MAIN ENTRANCE TO BUILDING ON EAST SIDE

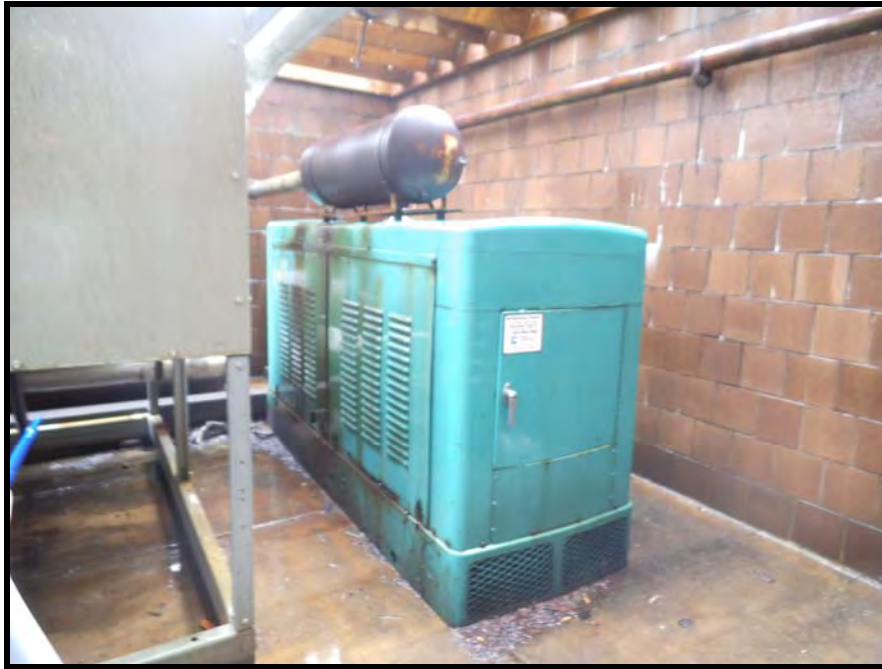
PHOTOGRAPH NO. 9: SUBJECT BUILDING: TYPICAL VIEW OF OLD DIESEL GENERATOR

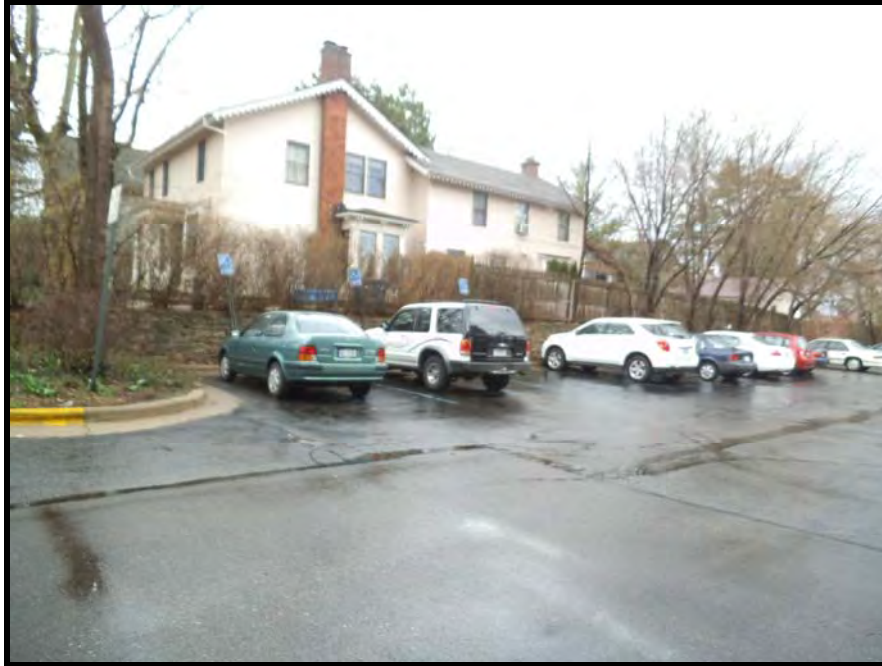
Overall, the asphalt and concrete paved areas appear to be in fair condition. However, longitudinal cracking and localized delamination was observed on the asphalt pavement drives and parking areas. Longitudinal cracking and movement along engineered seams was also observed on the concrete paved sidewalk. The concrete approach was observed to be in good condition.

PHOTOGRAPH NO. 21: SUBJECT BUILDING: VIEW OF PARKING LOT

Replacement of address and site signage (accessibility, entry, and/or directional) is recommended as a rehab item. Continued maintenance of paved areas is recommended. In addition, capital reserves should be considered for future maintenance and/or replacement and repair of paved areas. Please refer to the attached Capital Needs Input, 20 Year Detail, 20 Year Schedule and Rehab Specifications for additional information on condition, rehab costs and capital reserves.
