ADDENDUM No. 1

RFP No. 24-35

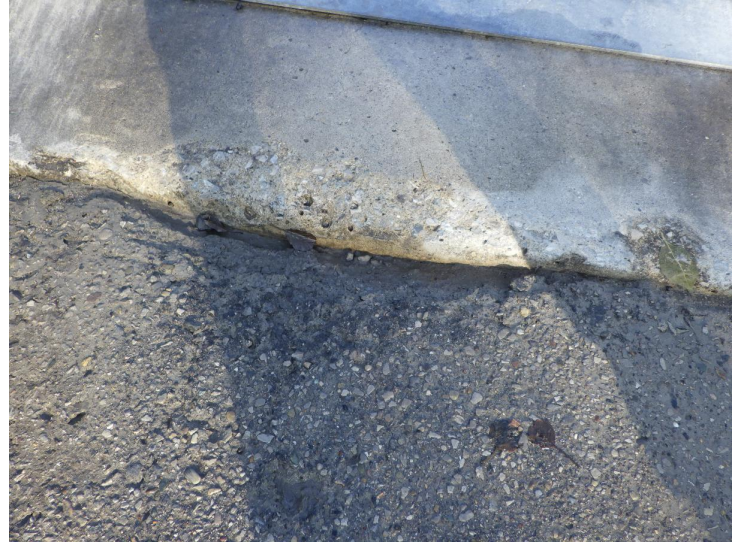
Document Name: R0011732.JPG
 Category: Approach
 Span Number: 1
 Comments: HMA spall at south reference line

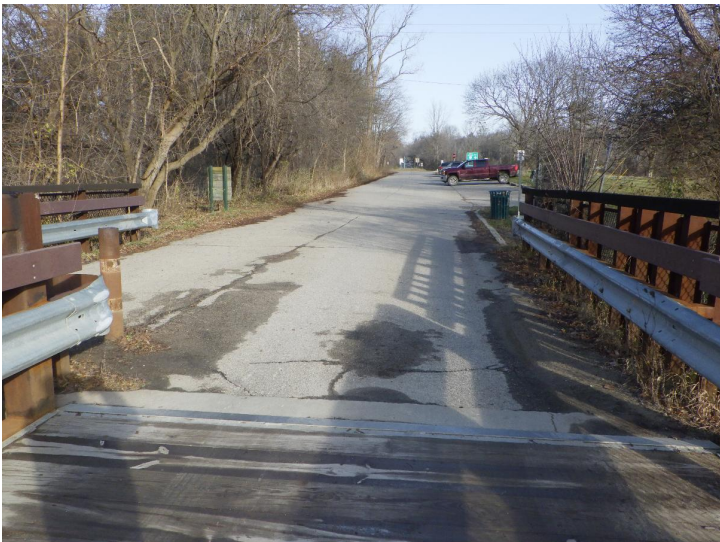
Document Name: R0012527.JPG
 Category: Approach
 Span Number:
 Comments: North approach

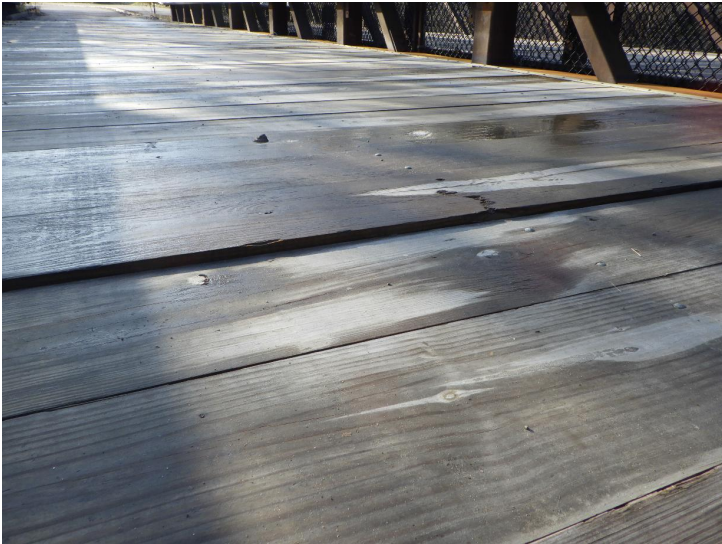
Document Name: R0011727.JPG
 Category: Deck
 Span Number: 1
 Comments: Deck member with broken connection near midspan

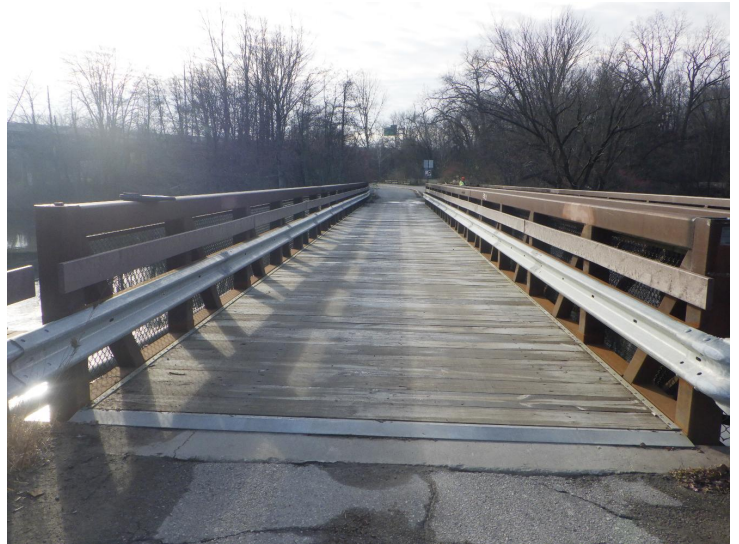
Document Name: R0012526.JPG
 Category: Deck
 Span Number: 1
 Comments: Bridge deck looking south

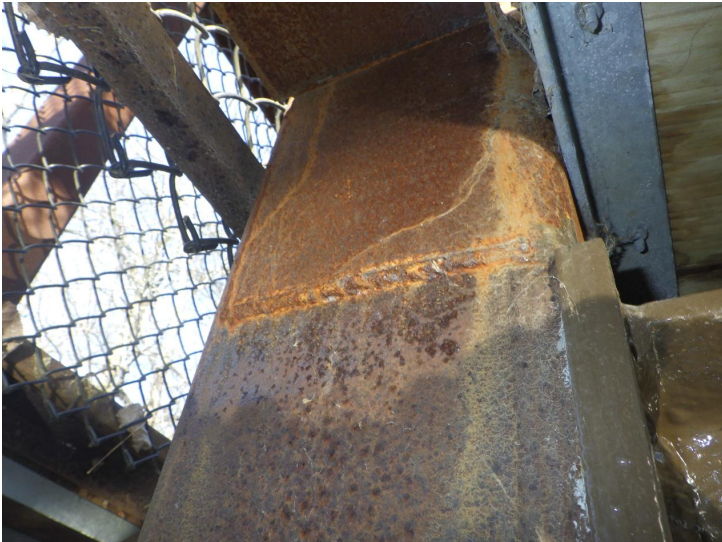
Document Name: R0012532.JPG
 Category: Superstructure
 Span Number: 1
 Comments: Typical vertical truss member repair, located above floorbeam connections

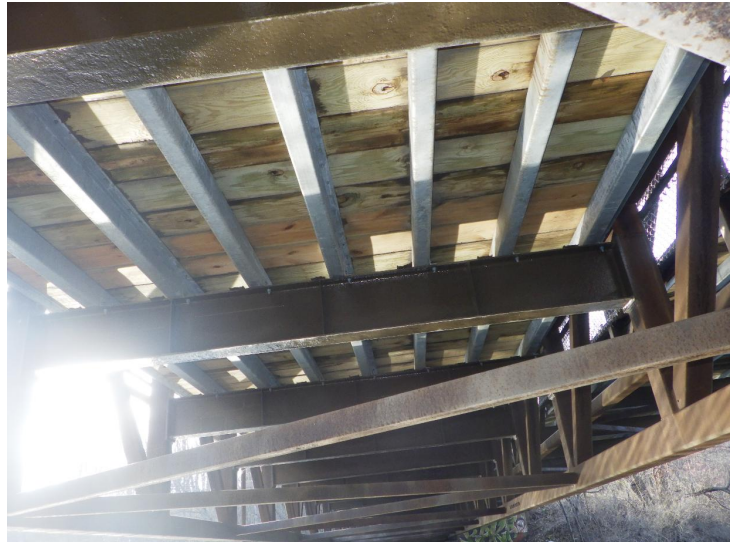
Document Name: R0012534.JPG
 Category: Superstructure
 Span Number: 1
 Comments: Typical galvanized stringers and bottom of deck

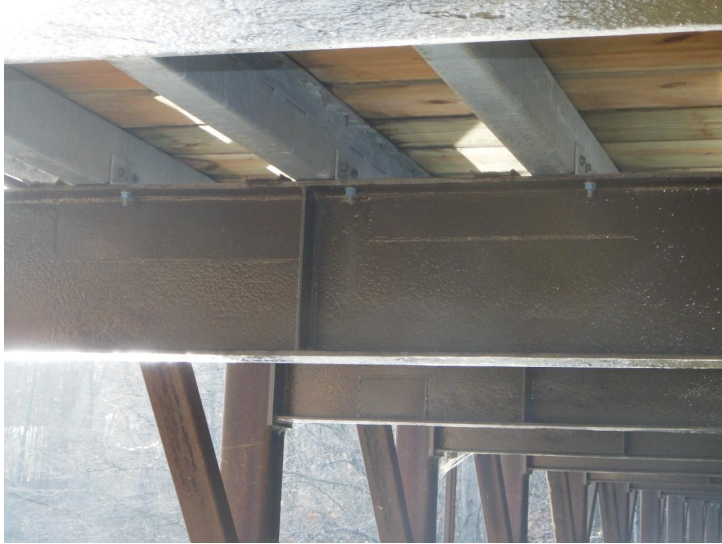
Document Name: R0012536.JPG
 Category: Superstructure
 Span Number: 1
 Comments: Typical floorbeam web repair and paint condition

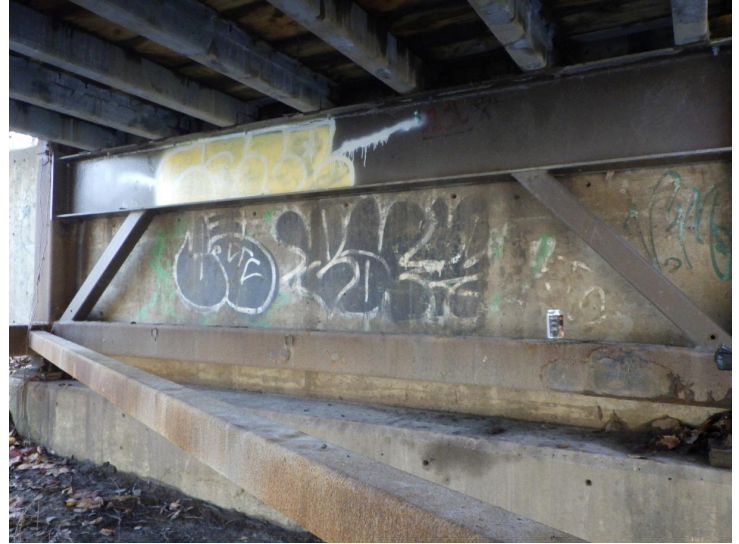
Document Name: R0011742.JPG
 Category: Substructure
 Span Number: 1
 Comments: Typical abutment, south shown

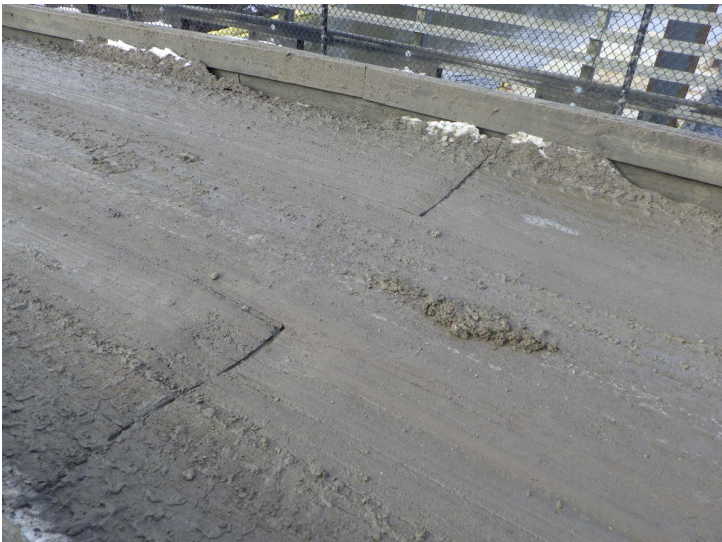
Document Name: R0011776.JPG
 Category: Deck
 Span Number:
 Comments: Worn wheel lines in decking, worse at edges of decking members

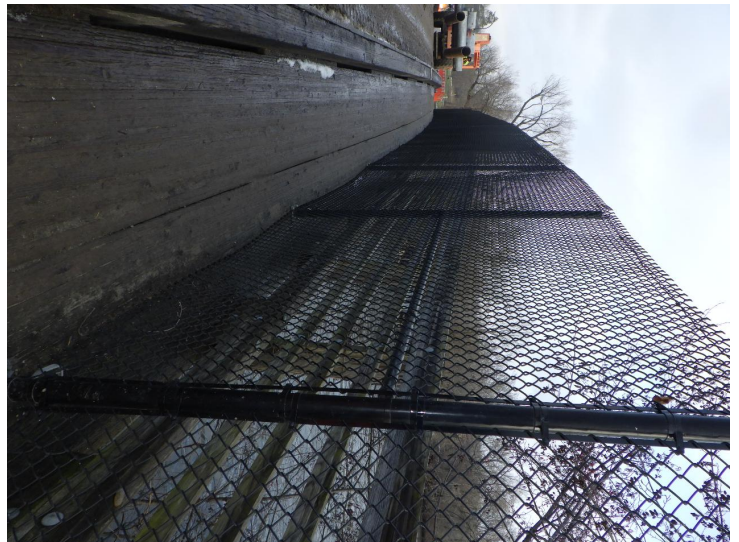
Document Name: R0011780.JPG
 Category: Deck
 Span Number:
 Comments: Typical sidewalk with chain link fence

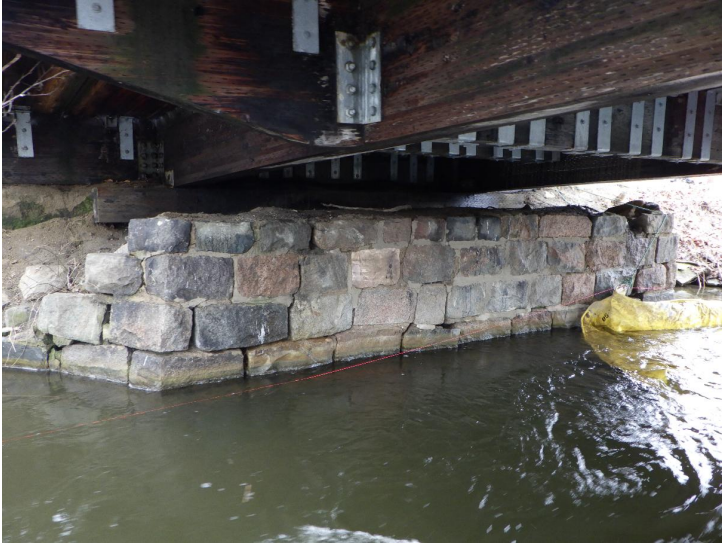
Document Name: R0011808.JPG
 Category: Substructure
 Span Number: 1
 Comments: South abutment missing grout between stones. Timber abutments behind previous bridge abutment

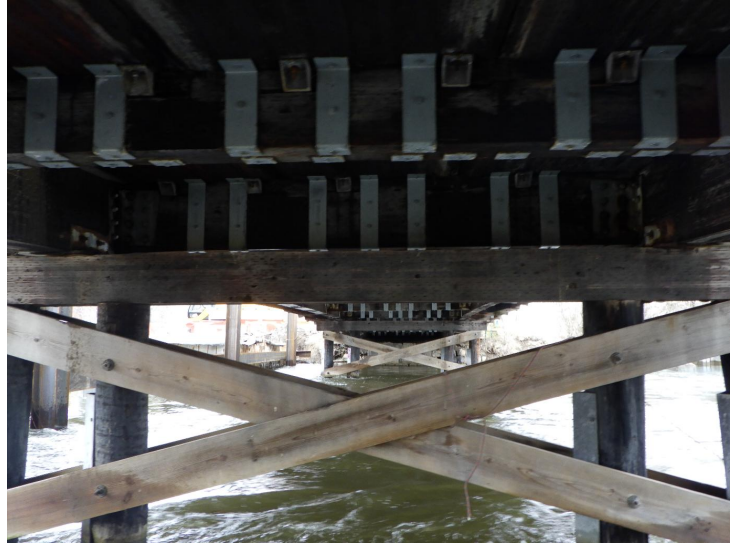
Document Name: R0011809.JPG
 Category: Substructure
 Span Number:
 Comments: Typical pier

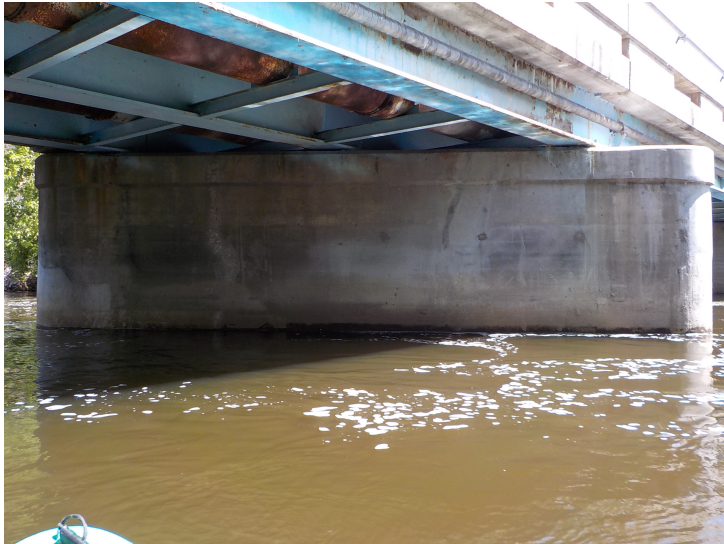
Document Name: DSCN3009.JPG
 Category: Substructure
 Span Number:
 Comments: West elevation of Pier 1w

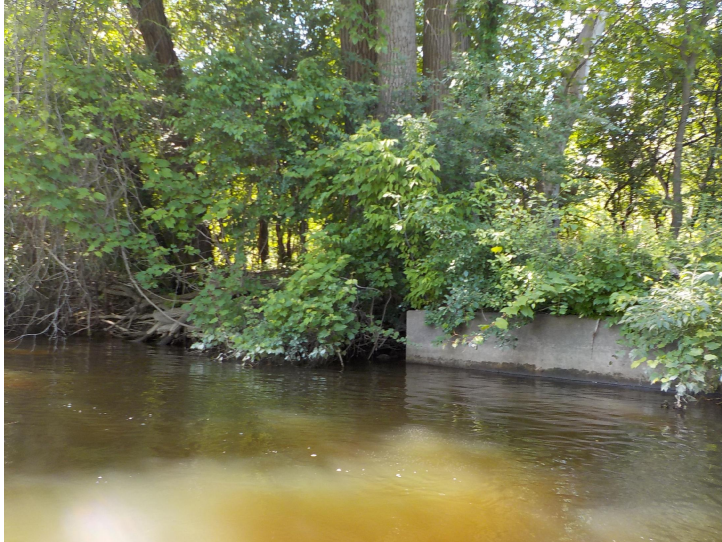
Document Name: DSCN3011.JPG
 Category: Channel
 Span Number:
 Comments: SW quadrant

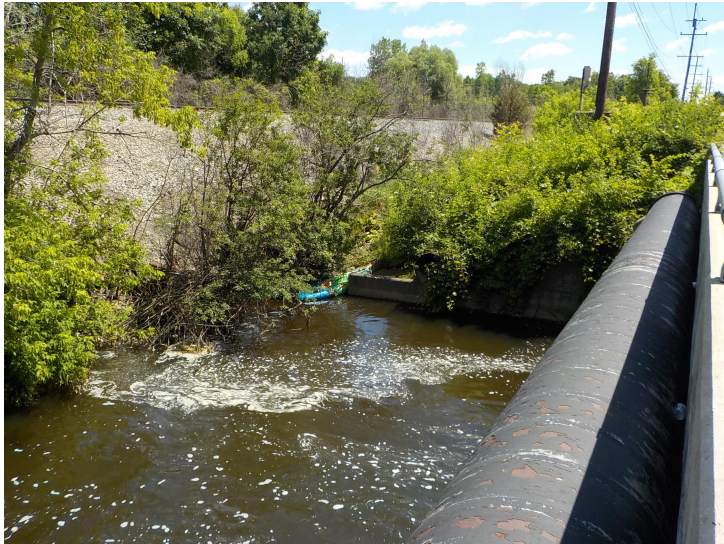
Document Name: DSCN3017.JPG
 Category: Channel
 Span Number:
 Comments: NE quadrant
