**City of Ann Arbor
Lower Town Mobility Study
Road Safety Audit**

FINAL REPORT

July 2020

Road Safety Audit

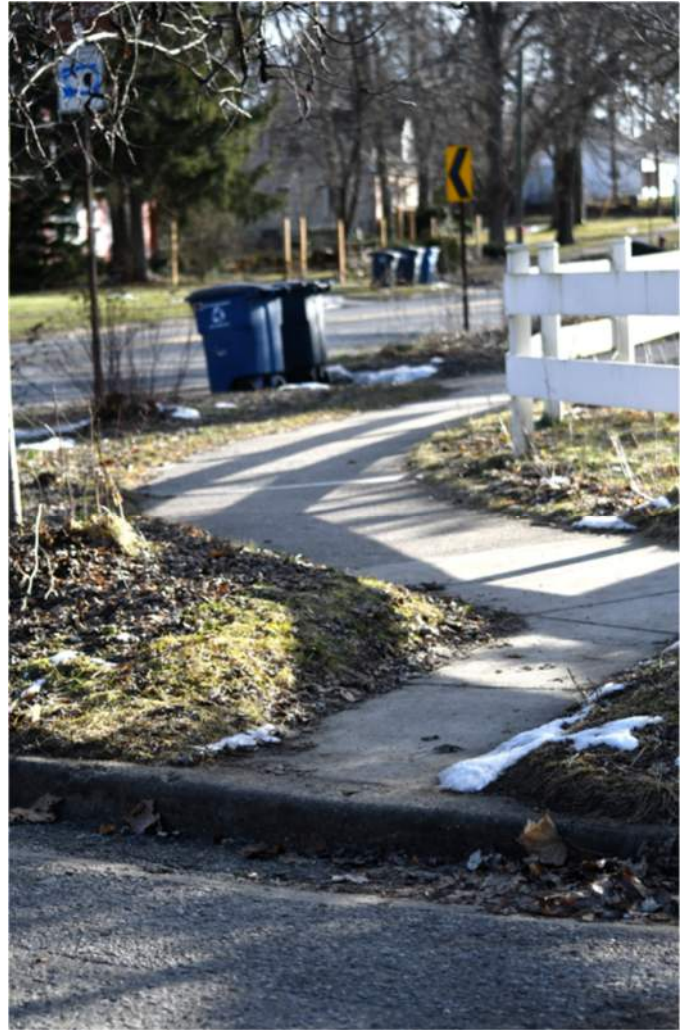
Figure 23: Sidewalk Crossing Without Accessible Ramp and Detectable Warning

- Upgrade all non-ADA compliant ramps to meet ADA requirements.
- Some items that need to be improved include:
 - Grades
 - Crossing Push-Button Locations with appropriate level landings
 - Adding Truncated Domes
 - Providing Landing Areas
 - Providing Curb Drops

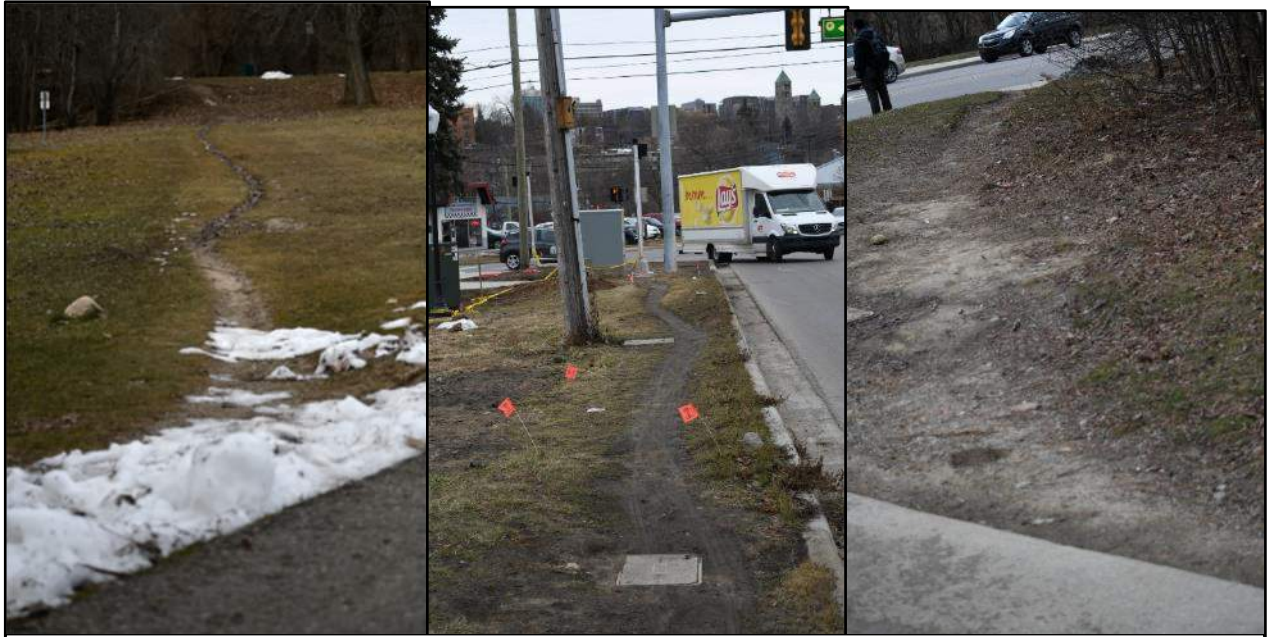
The RSA Team noticed locations where “goat trails”, or more formally desire lines, were present and represent where pedestrians and bicyclists actually travel.

Figure 25: Examples of “Goat Trails” Created by Pedestrians Which Show the True Desire Lines of Travel

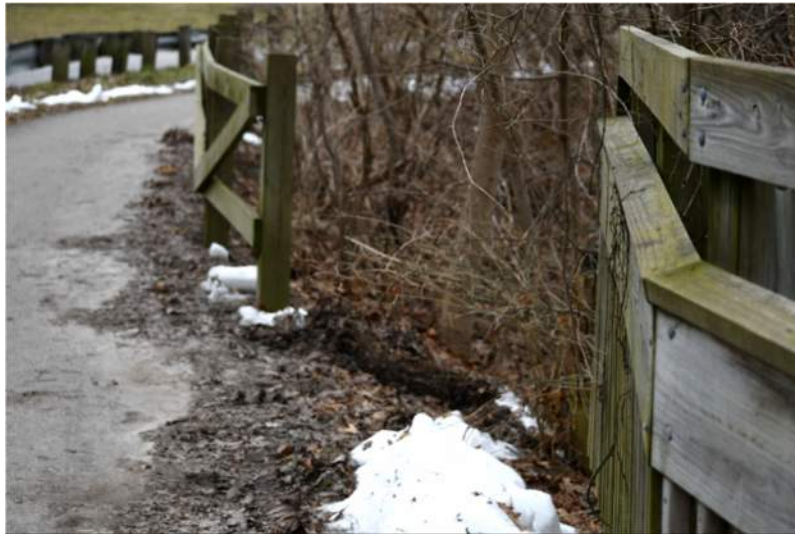
- A number of locations contained gaps in fences and railings that exist along sidewalks and could be a hazard for those walking alongside.
- Some appear to be forced by pedestrians looking for a shortcut down a steep slope

Figure 28: Gap in Fence, Coinciding with Pedestrian Desire Line to go from Barton Dr to Pathways Along Huron River

- Fill gaps in railings to keep pedestrians from falling
- Replace fencing in areas as needed

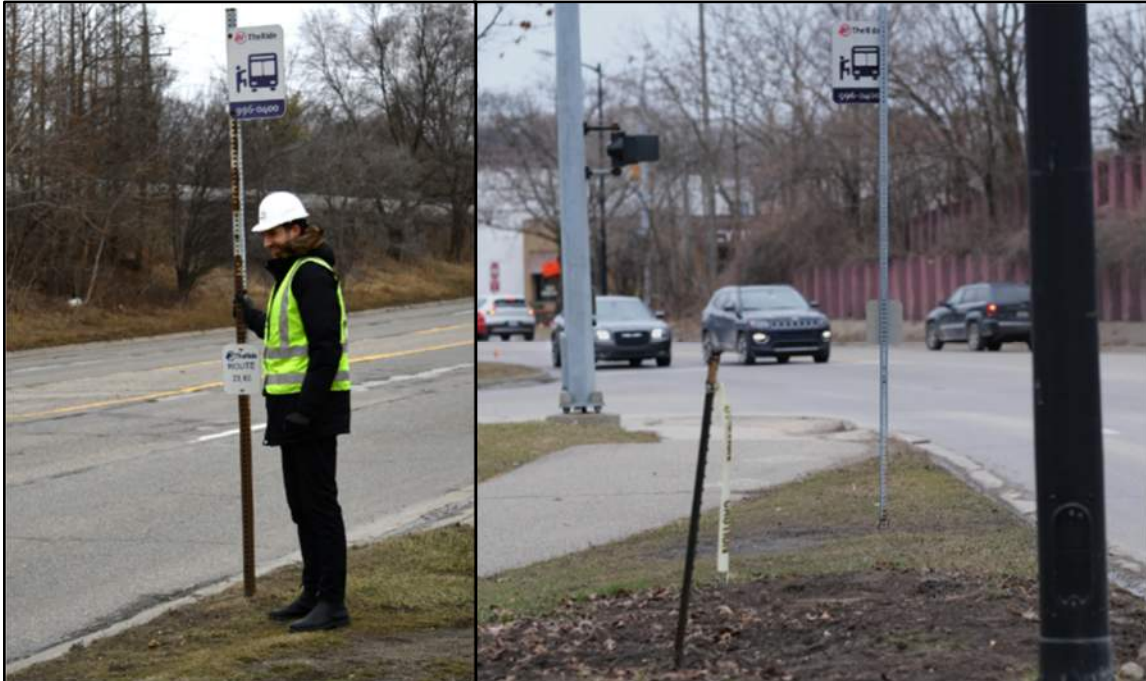
- Several bus stops do not have of pedestrian landing pads connecting the sidewalk to the curb. These bus pads are essential for the bus stop to be ADA accessible.

Figure 32: Example of Bus Stop Without a Landing Pad or Connection to Sidewalk/Pathway

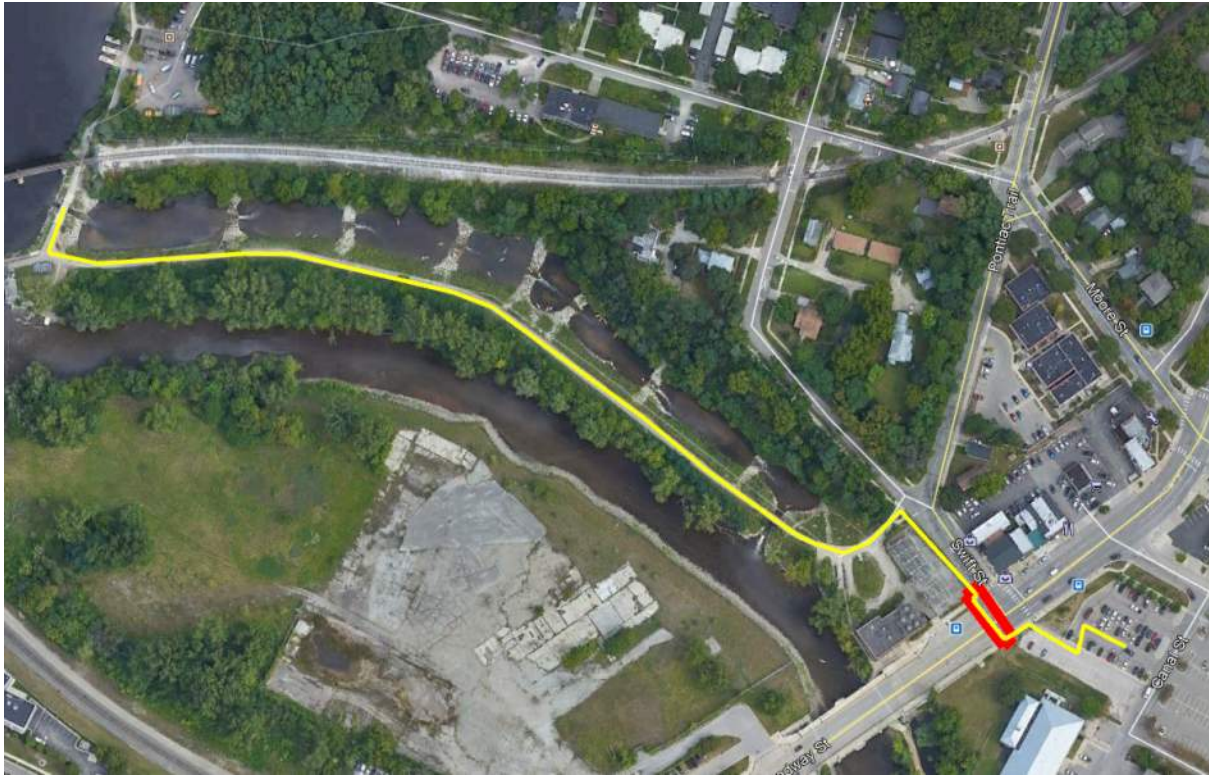
- The Cascades are a very popular City Park asset that draws large crowds in the summer. Many using the Cascades park in the lots at Broadway Street and Wall Street and must cross Broadway – along with kayaks or innertubes – to access the Cascades. Large numbers of park-goers cross at the Swift Street intersection, some without waiting for the light to change.

Figure 33: A Pedestrian Route Used from Overflow Parking East of Broadway St to Headwater of the Cascade Park

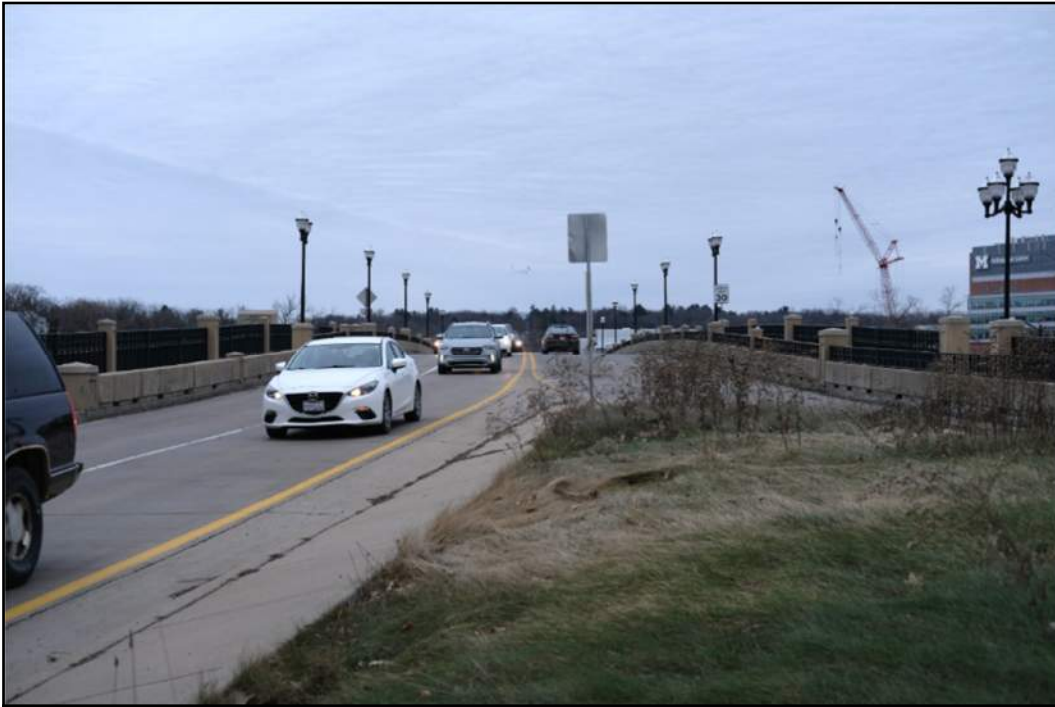
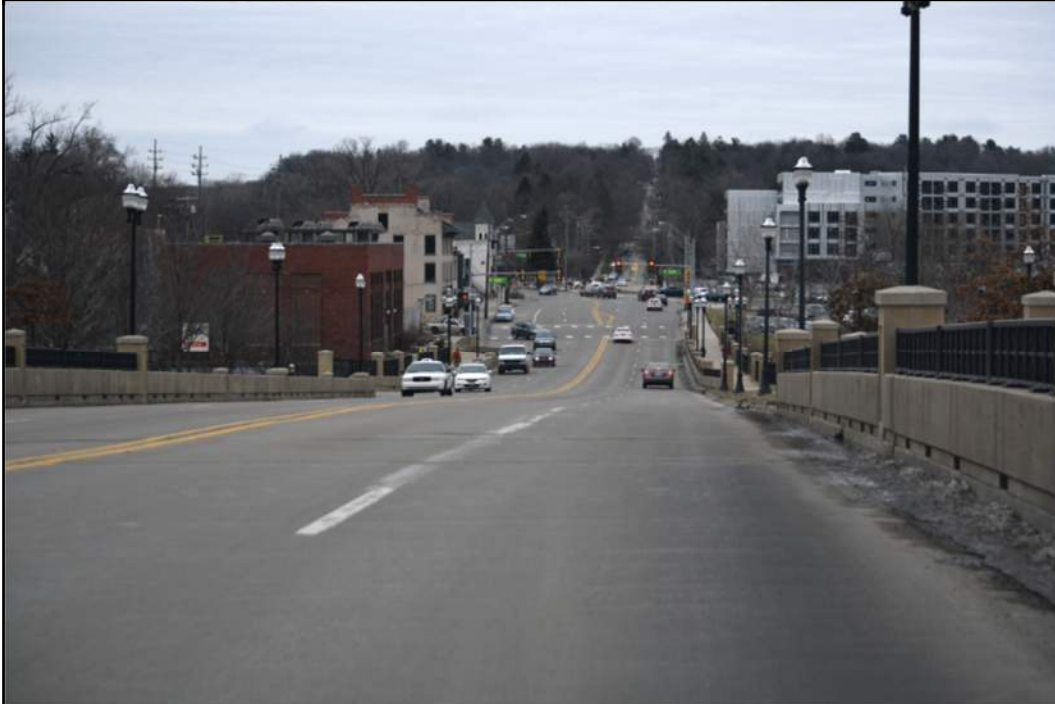
- High vehicle travel speeds coming down both ends of the Broadway Bridge. The speed limit on the Bridge is 30 mph, but vehicles were observed traveling faster than the posted speed limit.

Figure 40: The continuous down-grade for NB Broadway exacerbates the poor observance of the posted speed limit.

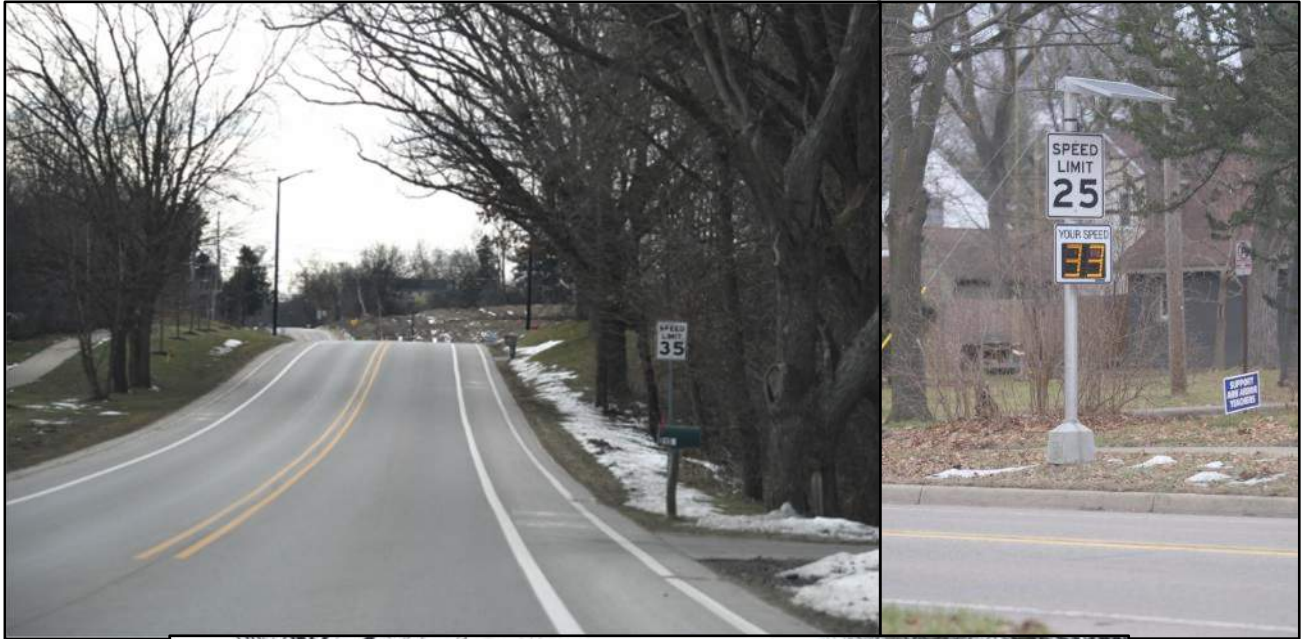
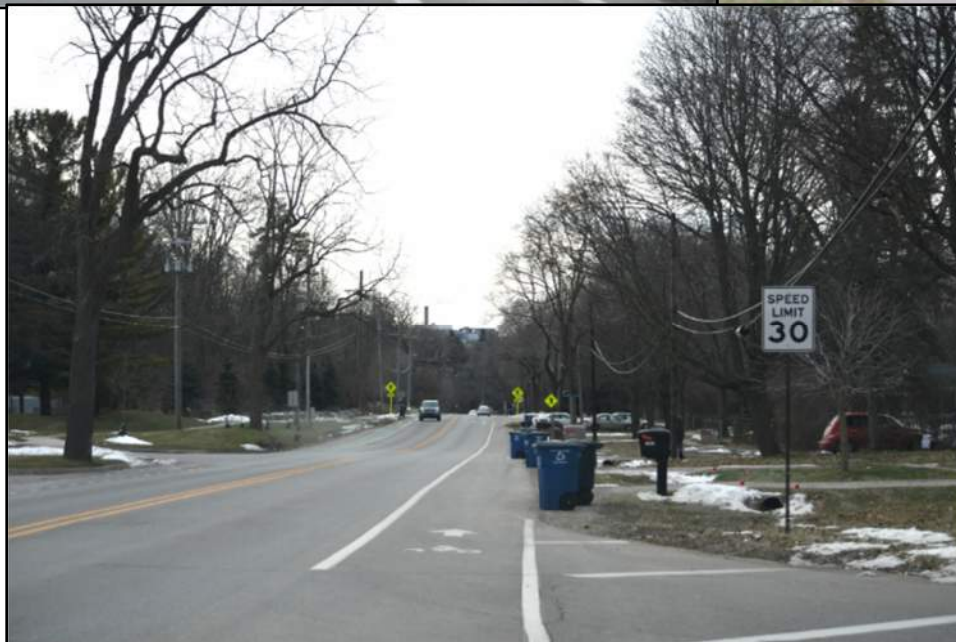
Figure 42: A variety of speed limits are posted along the Pontiac Trail / Pontiac St. The different postings are not commiserate with the roadside environment.

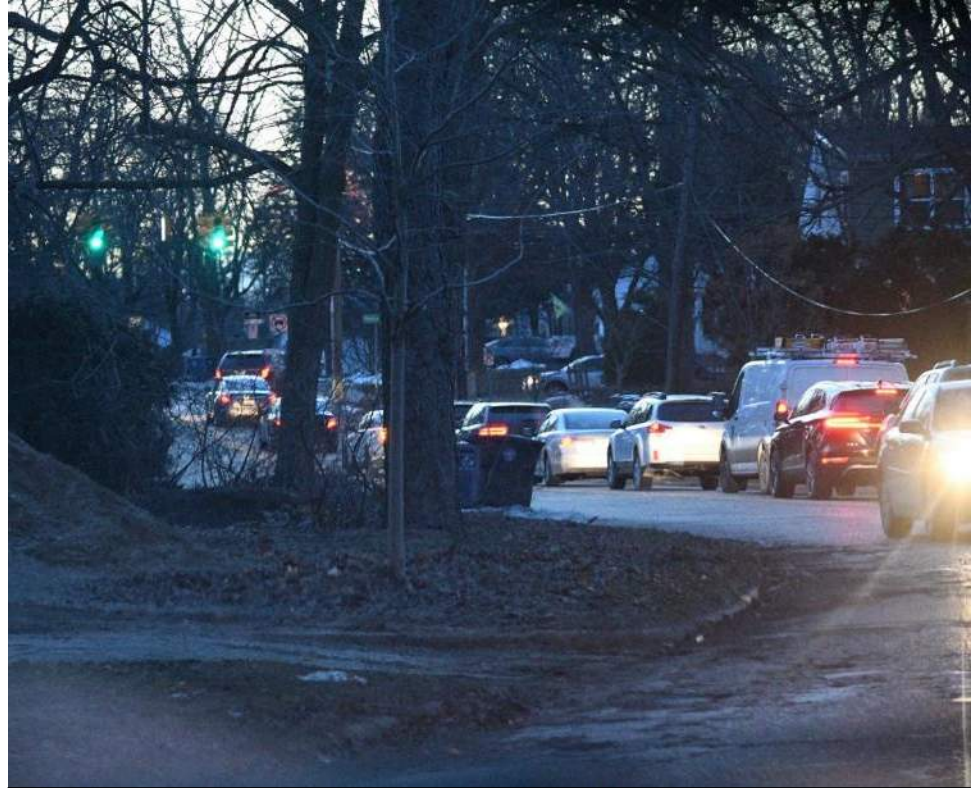
Figure 45: Traffic queues on Barton Dr from signal at Pontiac Trail.

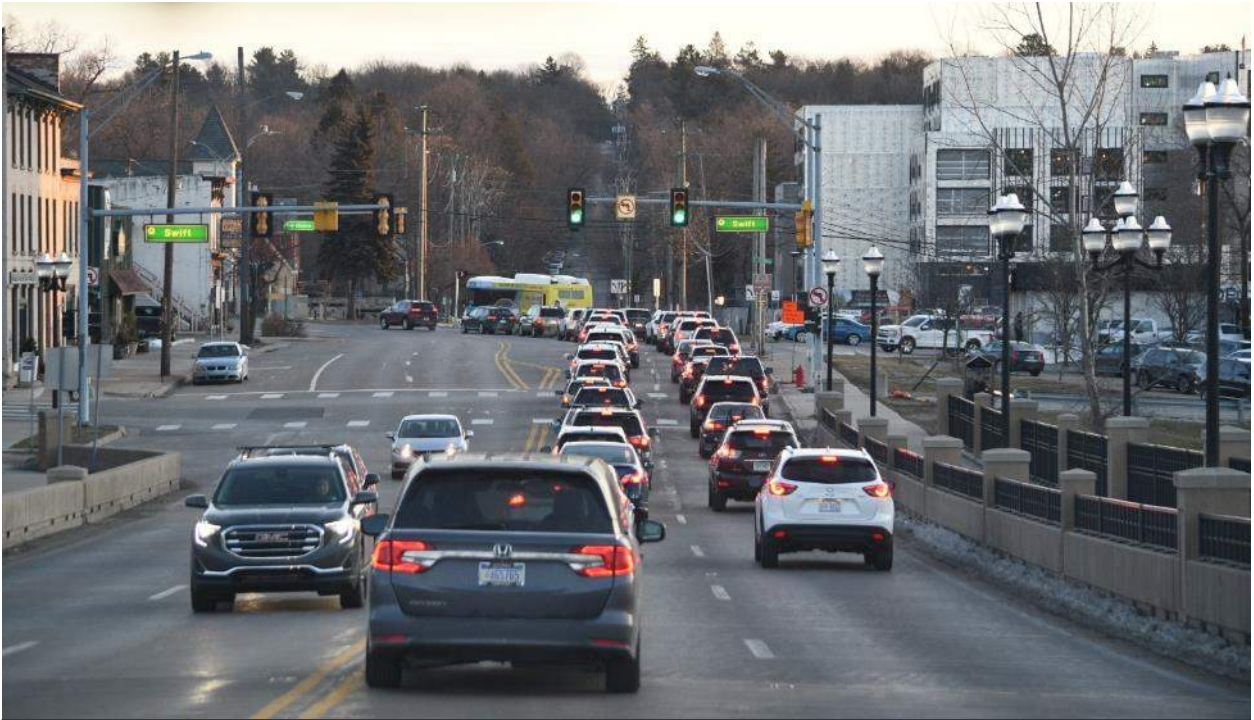
Figure 48: Traffic backups for NB Broadway from the traffic signal at Maiden Lane / Moore St extend through the signal at Swift St.

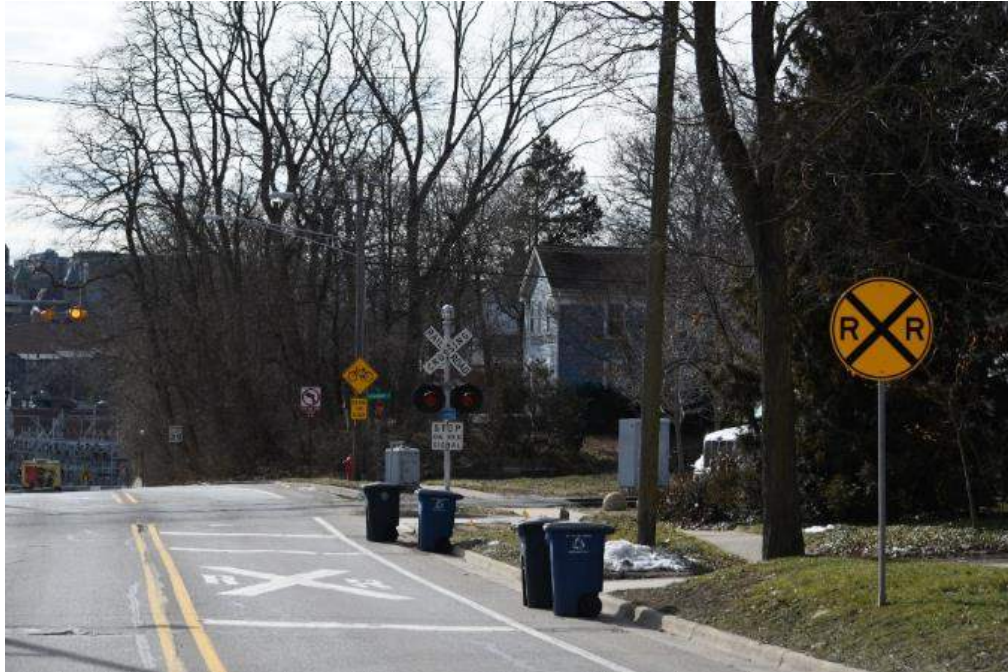
Figure 53: On-street bike lanes lose their utility when blocked by rubbish receptacles or other types of obstructions.

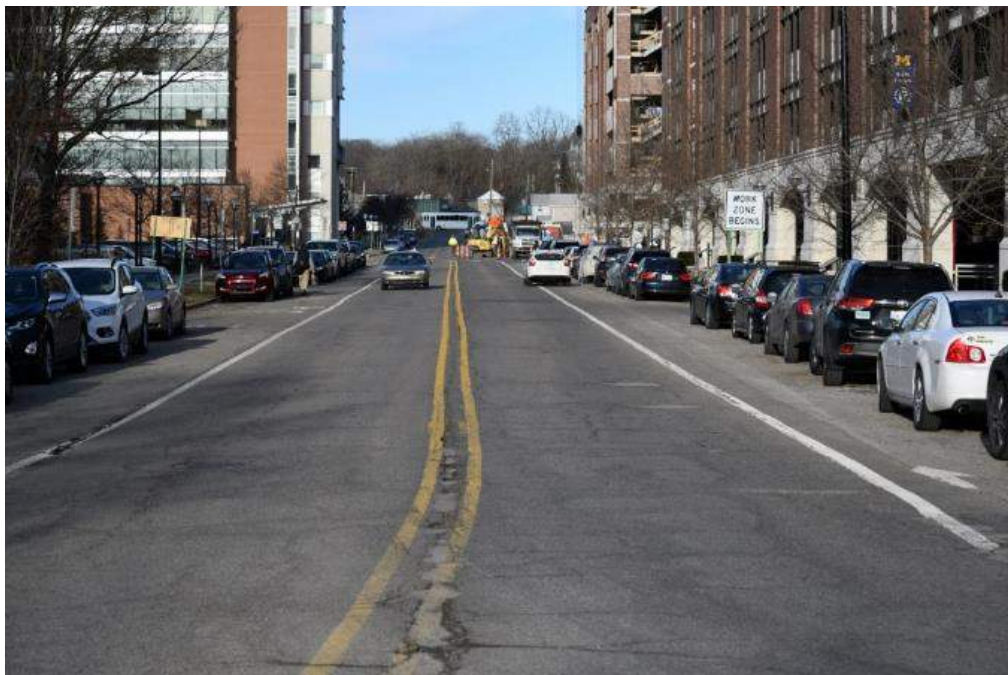
Figure 54: On-street bike lanes adjacent to parked vehicles should generally be wider (~6') to reduce likelihood of bicyclists running into opening car doors. Construction work zones must include warnings for cyclists that their exclusive lanes are blocked and there is a need to share the road. At least one instance of a car double-parked resulted in the bike lane being blocked.

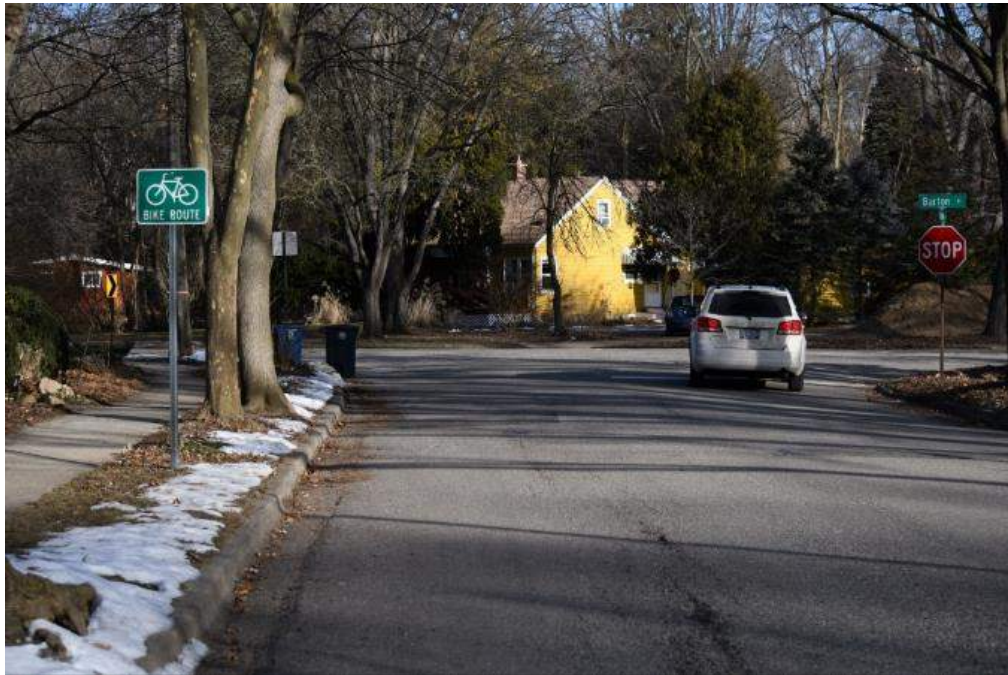
Figure 61: The bike route on Chandler Road does not lead to a bicycle facility and only designates Chandler Road as a safe bicycle street. There are few other signs and the signs are lacking arrows pointing where the bike route continues.

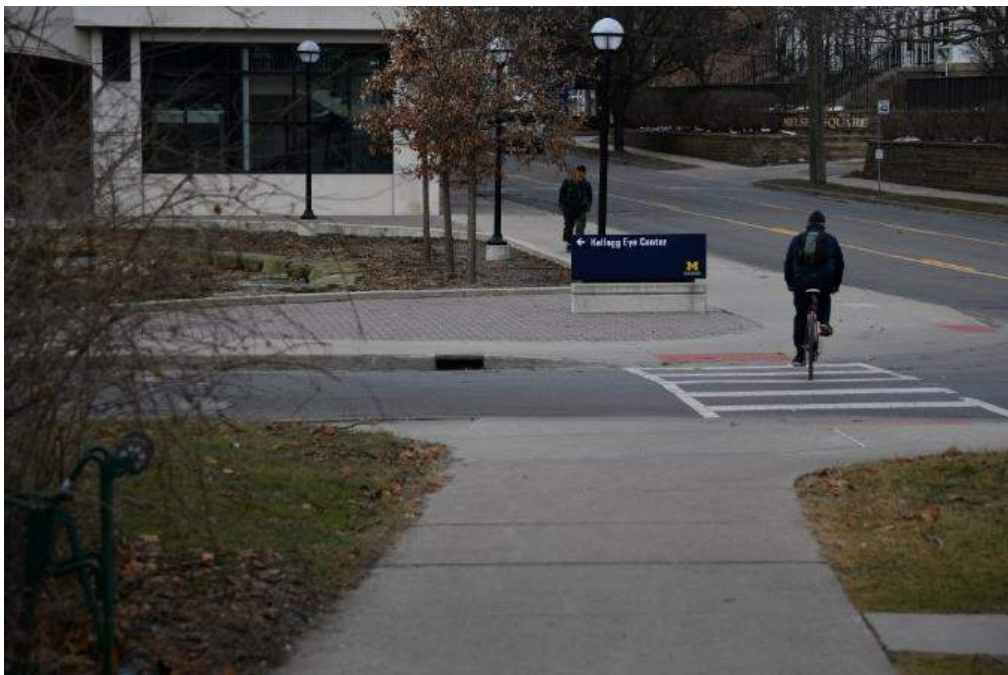
Figure 62: There are no bike lanes on Maiden Lane, which is a high traffic bicycle route for students and employees looking to access the hospital.

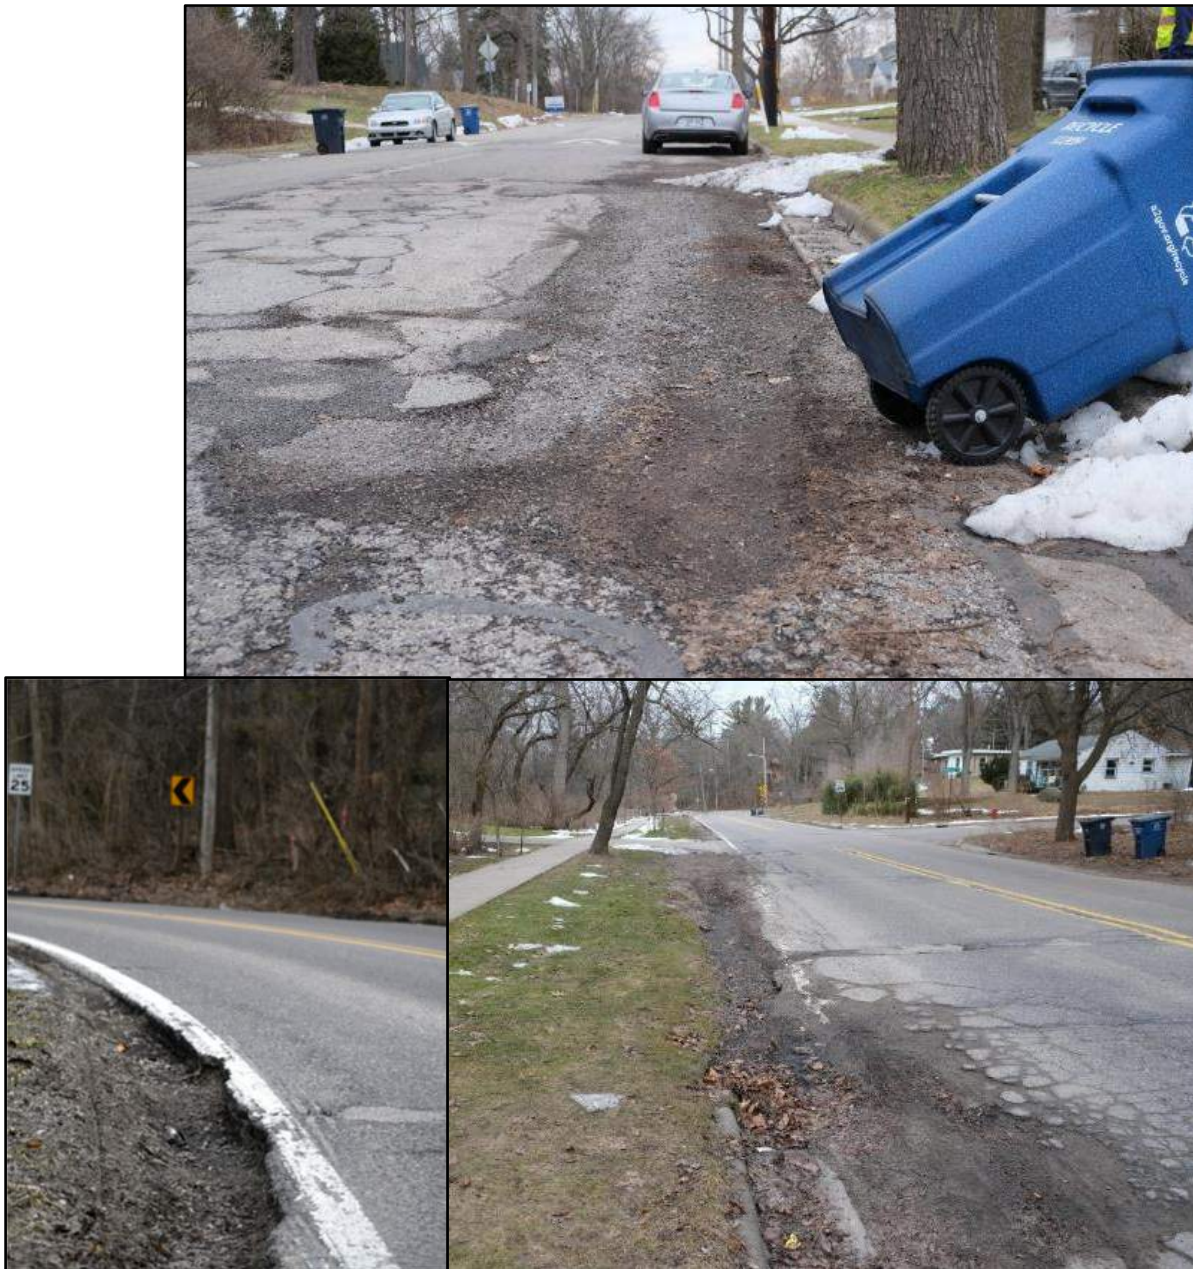
Figure 65: Poor pavement conditions, including severe edge rutting, exist on several roads within the project study area, including Broadway Street, Barton Drive, and Traver Road.

Figure 66: Rehabilitate or reconstruct pavement in areas with damaged roadway surfaces.

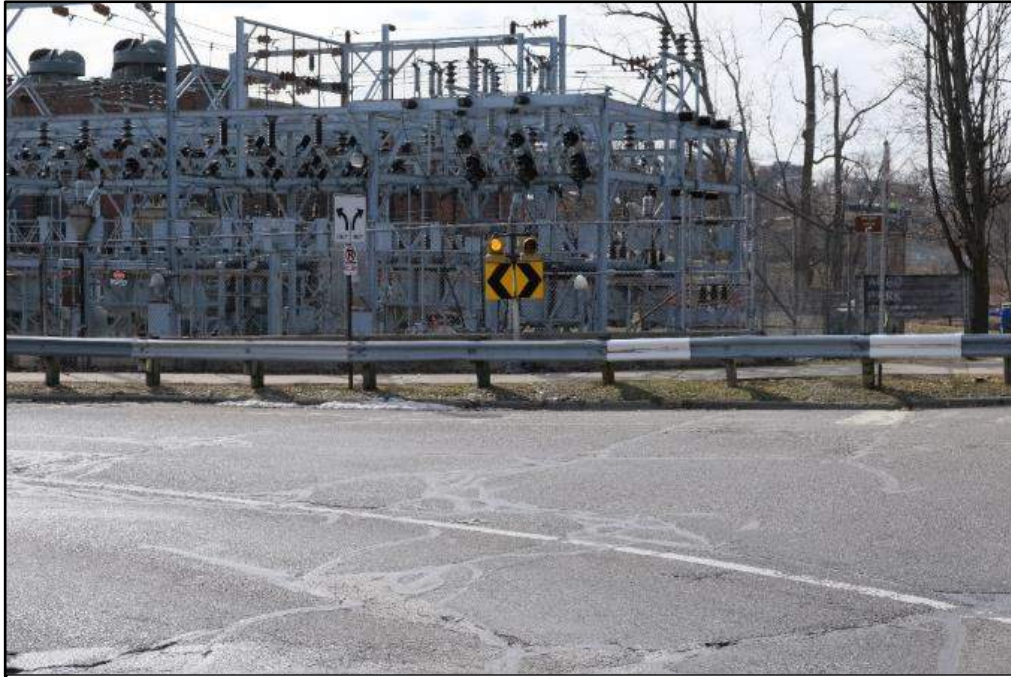
Figure 67: Chevron signs at Swift Street and Pontiac Street are improper. Should be a Two-direction Large Arrow (W1-7).

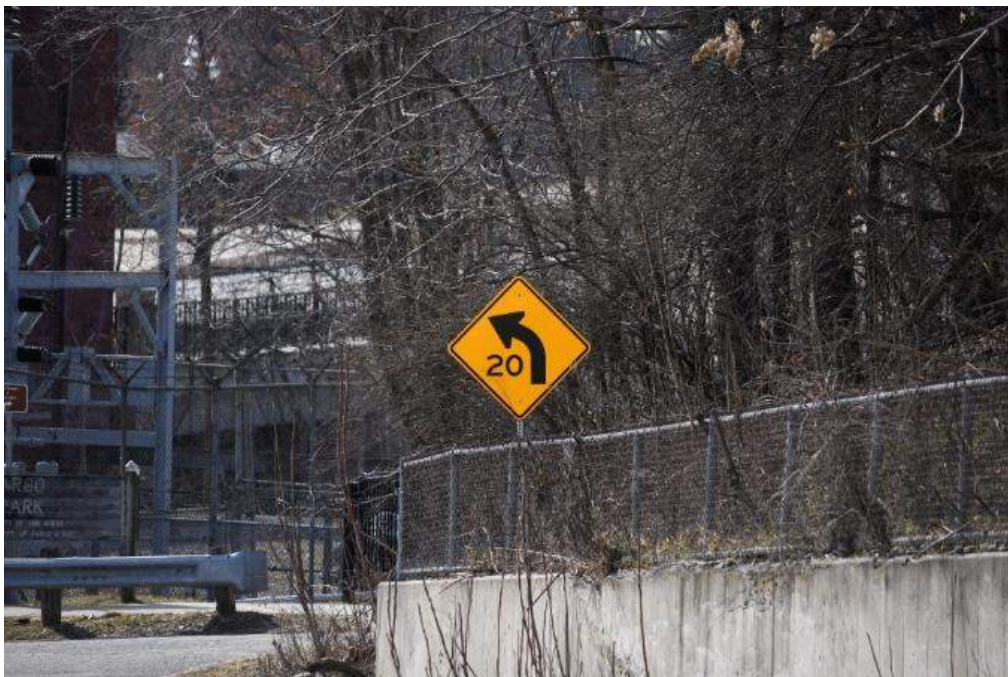
Figure 68: Per MMUTCD, Curve with advisory speed sign (W1-2a) is only to supplement a standard alignment sign with an additional advisory speed plaque (W13-1). In any case, sign is wrong because it combines a curve message with an advisory speed associated with a turn. Curve signs are for speeds 35 mph and above.

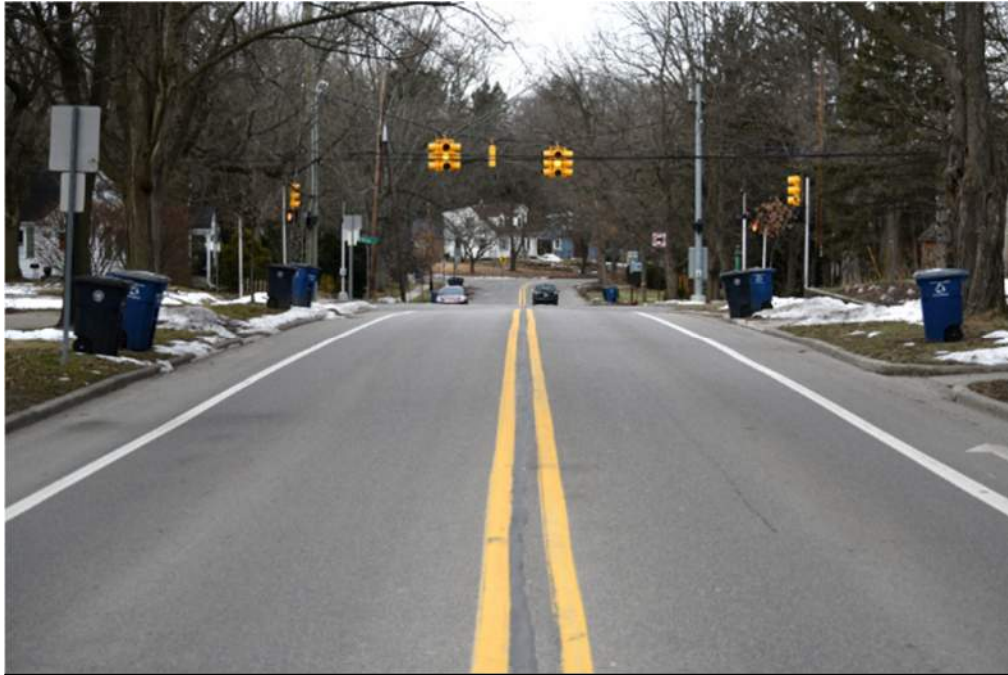
Figure 69: No horizontal alignment warning sign for westbound Barton Drive west of Pontiac Trail.

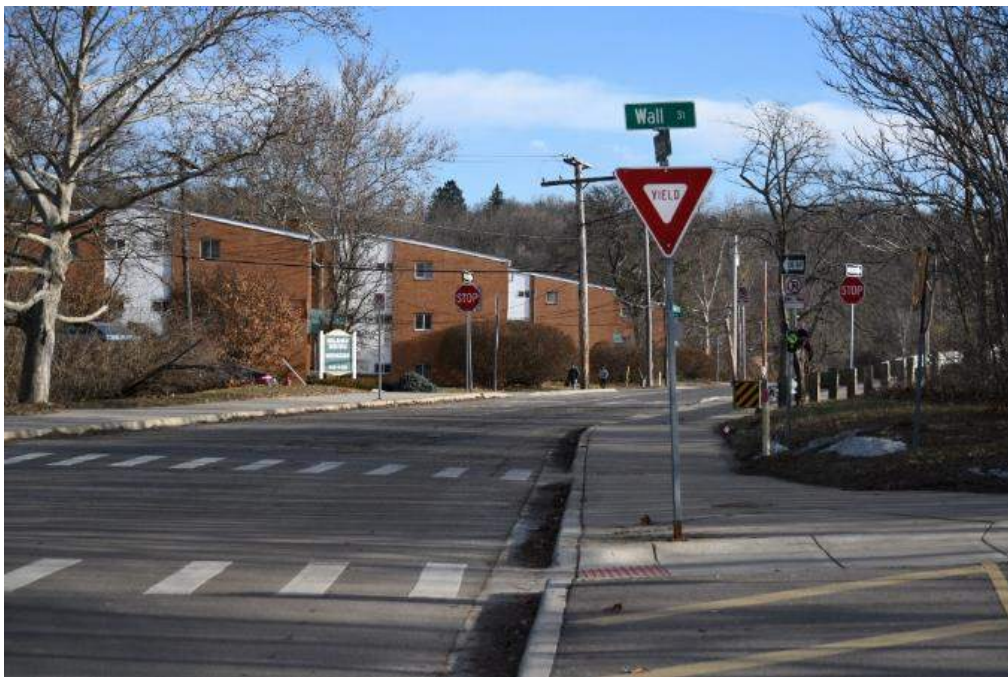
Figure 70: Yield sign on Wall Street at Canal Street is placed beyond the crosswalk.

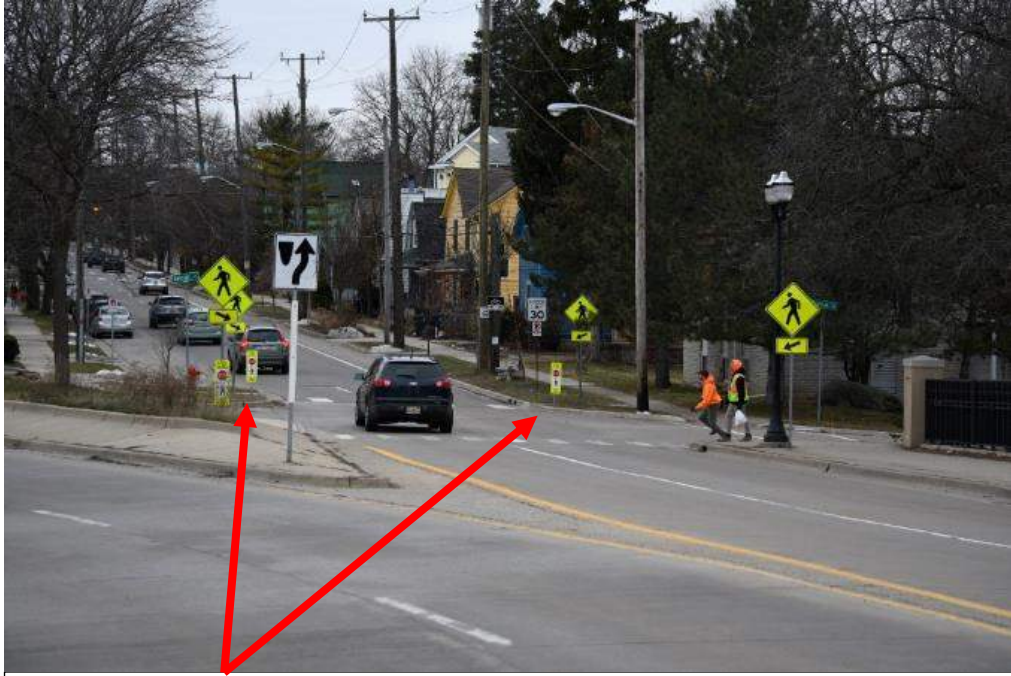
Figure 71: R1-6 signs need to be placed in the road on the lane line or in a pedestrian island per the MMUTCD.

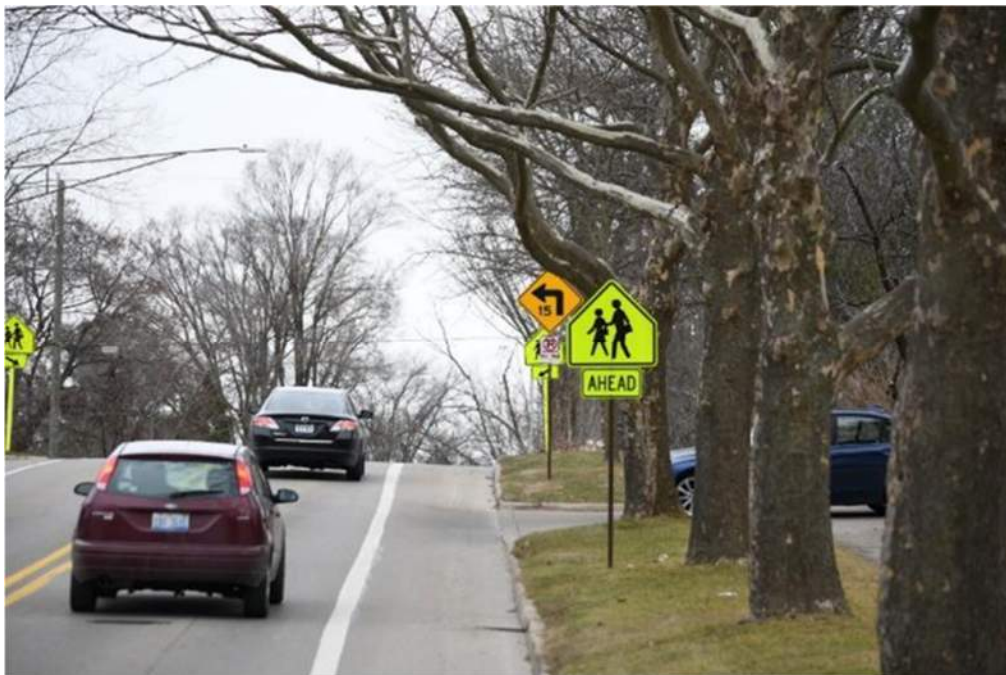
Figure 72: Turn warning sign with advisory speed on Barton Drive, in front of the Northside STEAM school, is poorly located. Should be located just beyond the school pedestrian crossing to not detract from the crossing itself.

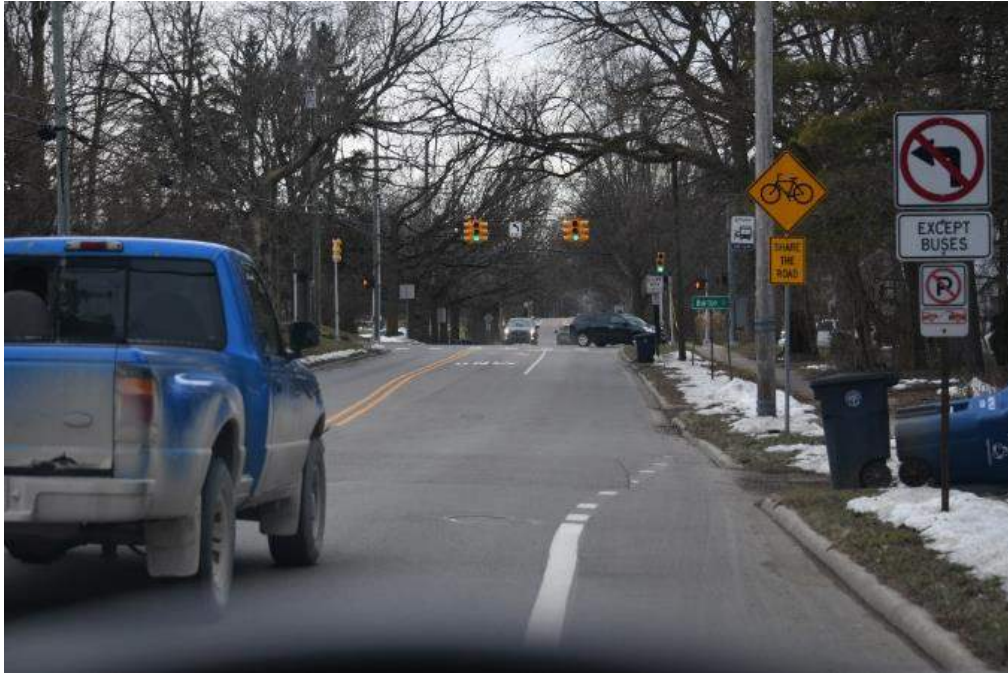
Figure 77: Inconsistent sharrow pavement markings throughout the Study Area in areas where bike lanes end.

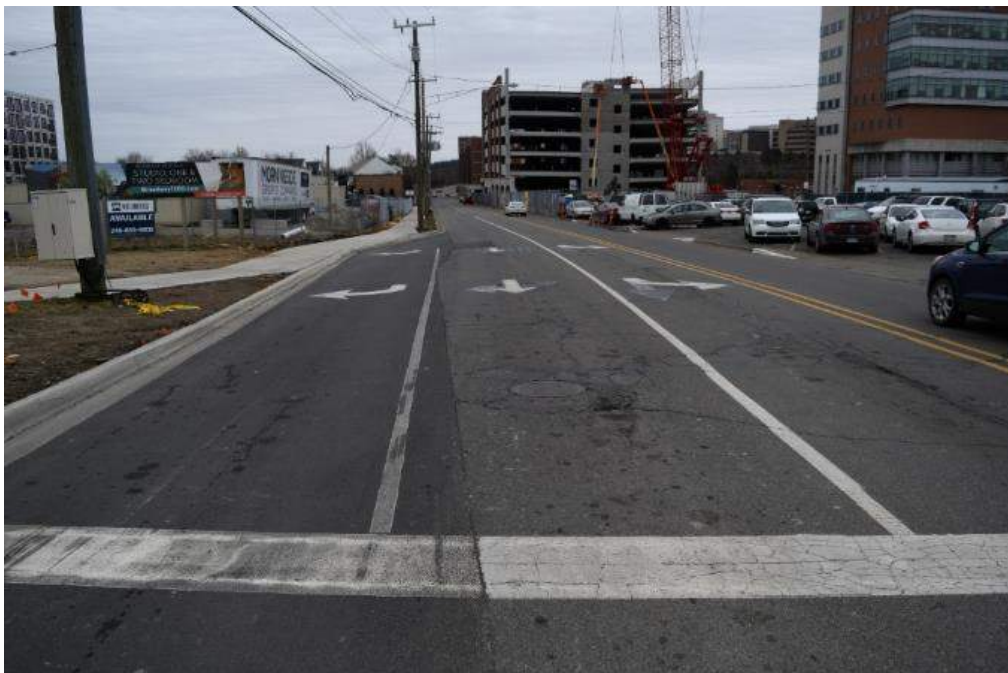
Figure 78: Old pavement markings have not been fully removed in areas where changes have been made, which sends mixed messages to road users.

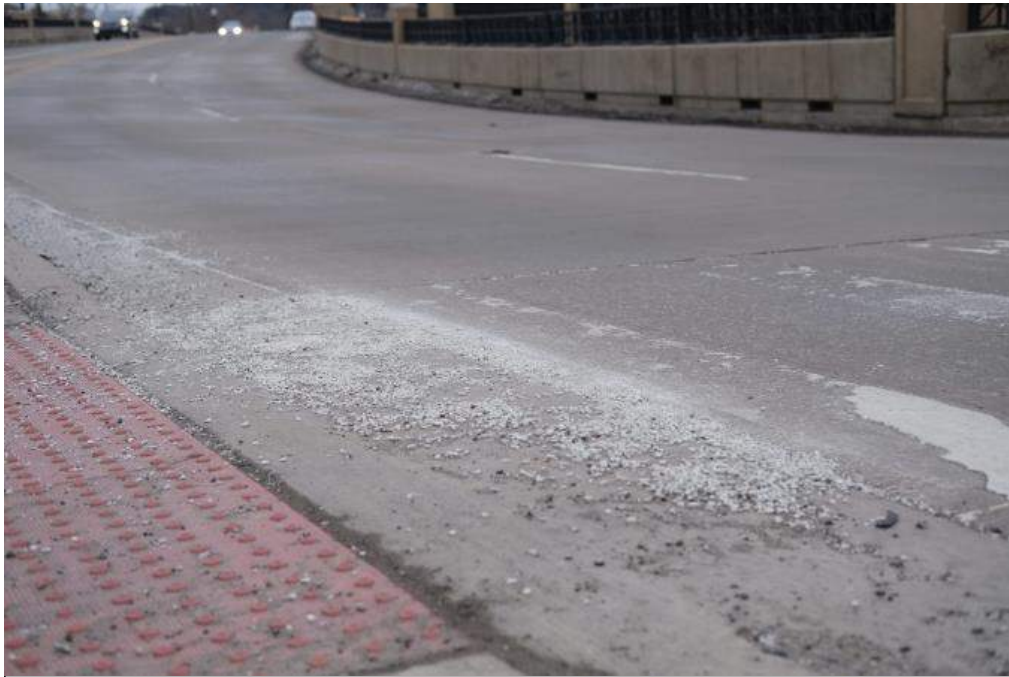
Figure 79: Multiple crosswalks throughout the Study Area have degraded markings, making it hard to distinguish where the crosswalk is.

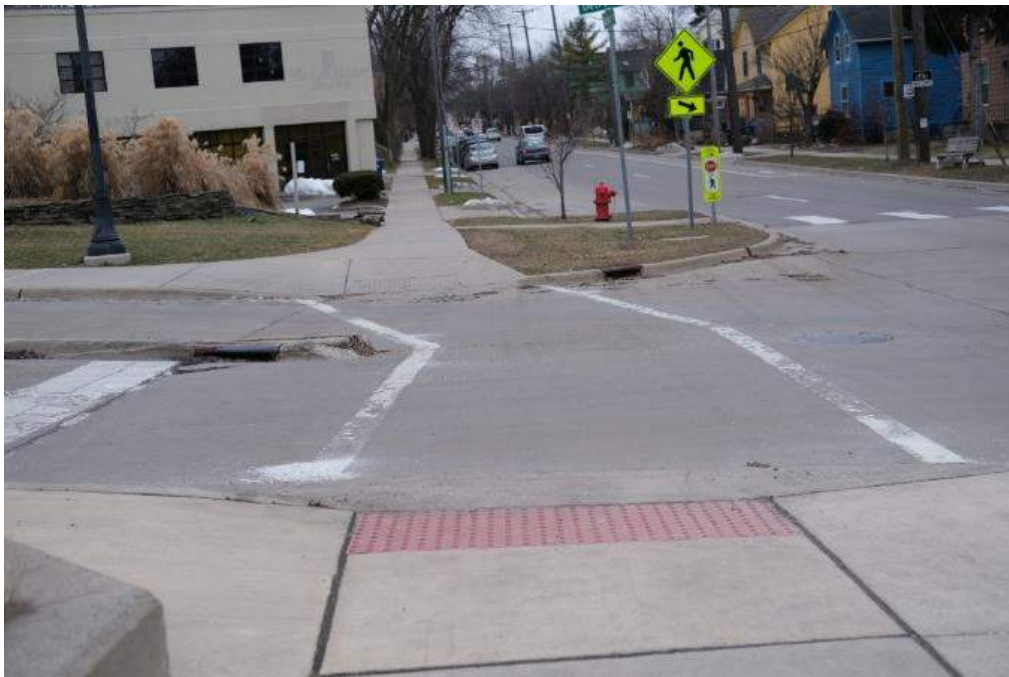
Figure 80: The crosswalk at Detroit Street and Broadway Street/Beakes Street has a deflection mid-crossing, making it non-ADA compliant.

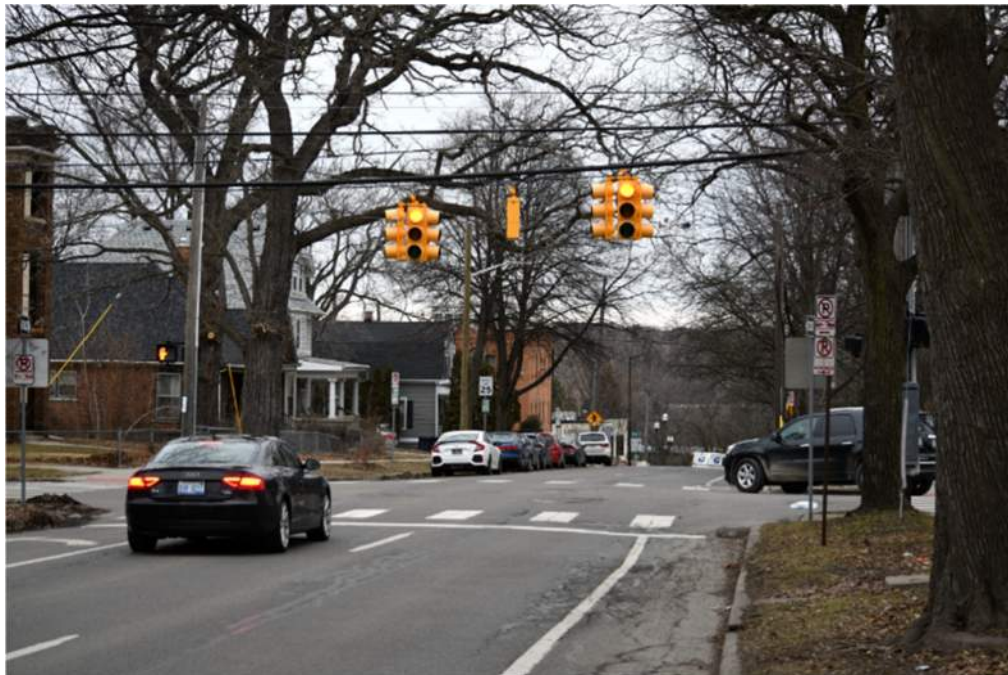
Figure 83: Outdated diagonal span-wire mounted traffic signals should be considered for modernization.

Figure 86: Install box span-wire mounted or mast arm mounted signals to improve visibility and safety.

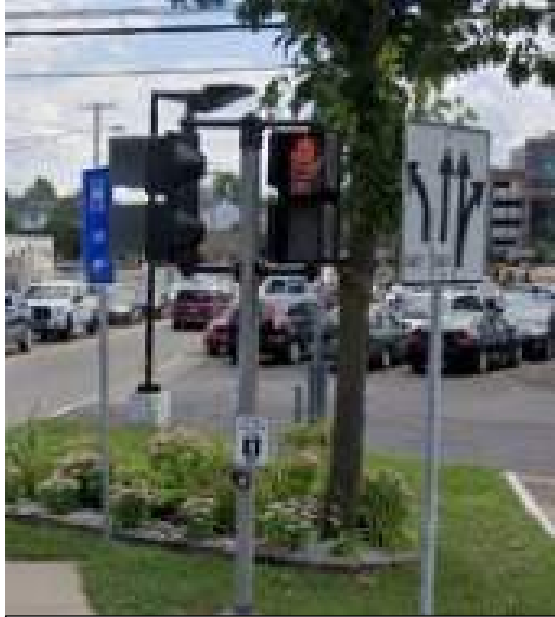
Figure 84: Pedestrian signal heads were noted that lack countdown feature.

Figure 87: Accelerate the replacements of obsolete pedestrian signal heads. [Notes: MMUTCD Section 4E.07 – All pedestrian signal heads used at crosswalks where the pedestrian change interval is more than 7 seconds shall include a pedestrian change interval countdown display in order to inform pedestrians of the number of seconds remaining in the pedestrian change interval. There was an August 2015 compliance date for the replacement of all pedestrian signal heads at such locations to incorporate the countdown feature. This may imperil agencies receiving Act 51 funding.]

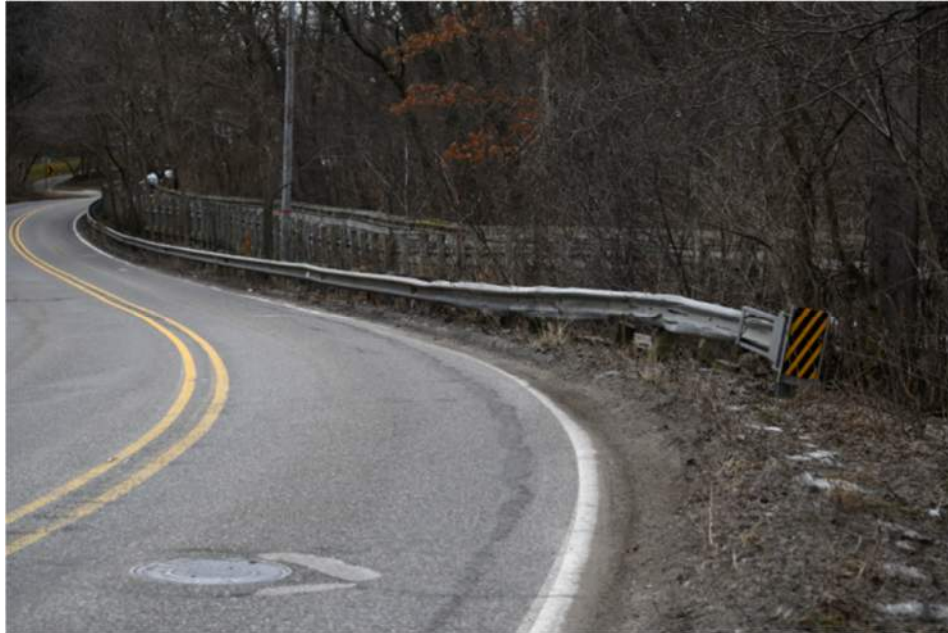
Figure 88: Guardrail is damaged at Barton Drive and M-14.

- Repair guardrail on Barton Drive
- Relocate any and all fixed objects behind the guardrail or extend guardrail to encompass the fixed objects.
