**City of Ann Arbor
Lower Town Mobility Study
Road Safety Audit**

FINAL REPORT

July 2020

Road Safety Audit

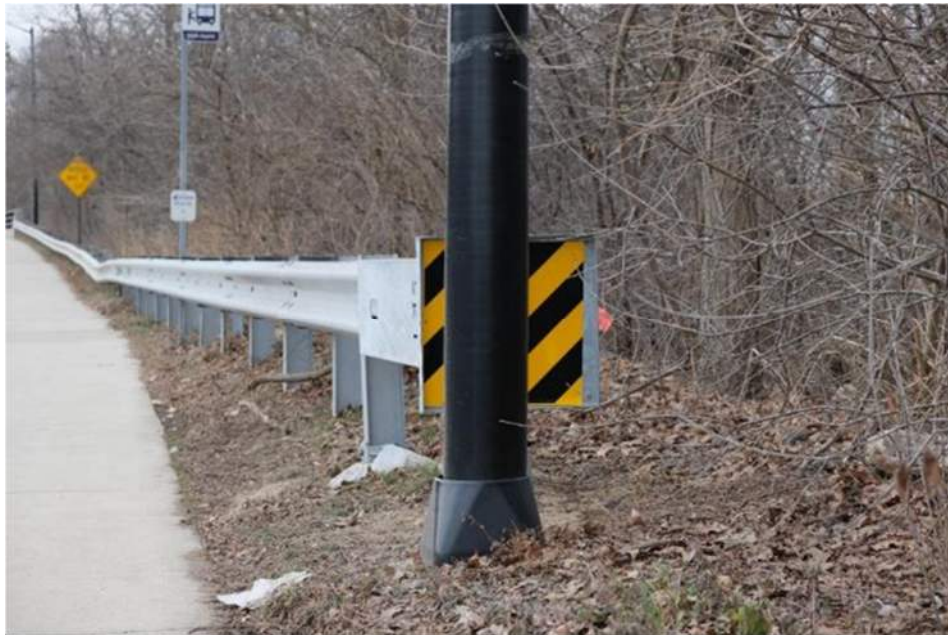
Figure 89: A light pole is located in front of the attenuator at Fuller Road and Maiden Lane intersection.

- Repair guardrail on Barton Drive
- Relocate any and all fixed objects behind the guardrail or extend guardrail to encompass the fixed objects.

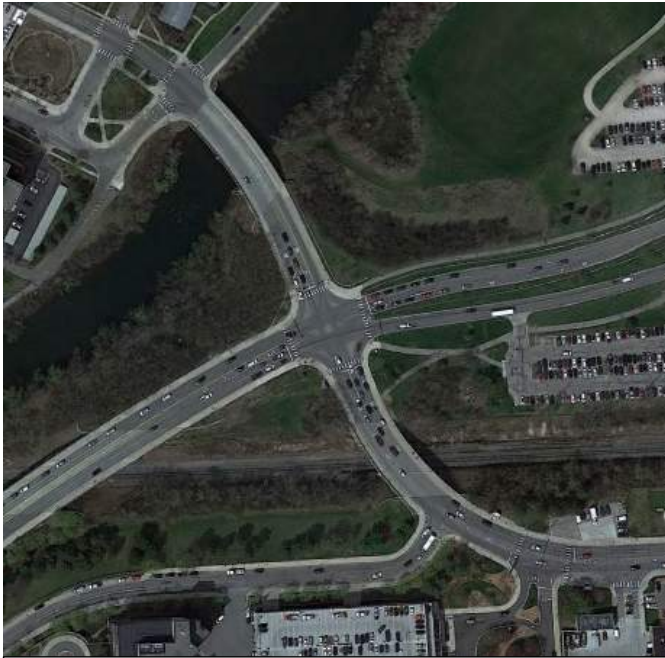
Figure 107: Fuller Rd at Maiden Ln/E Medical Ctr is highly congested with vehicles especially during the peak hours. Left turns from Maiden Lane onto Fuller Road cause backups during peaks.

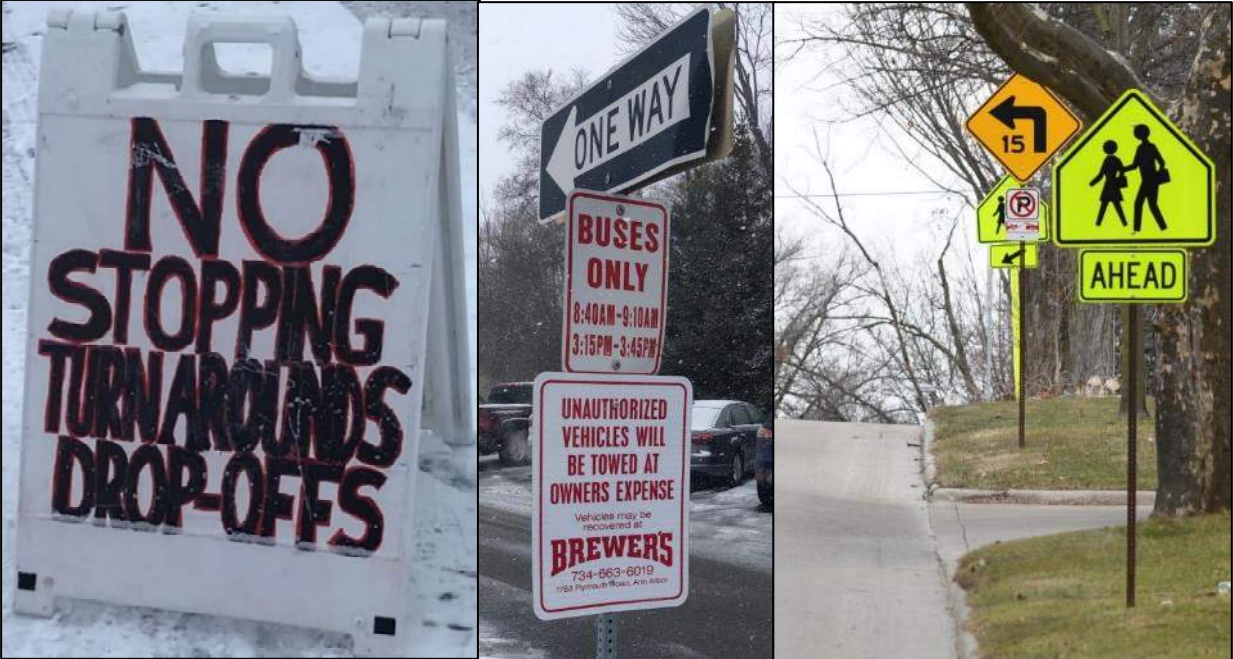
Figure 116: Signing practices around the school are confusing and not to roadway standards. Some signs are handmade, others are typical standard street signs but poorly located, and others are related to towing practices.

Figure 119: Update all signage around the school to be consistent

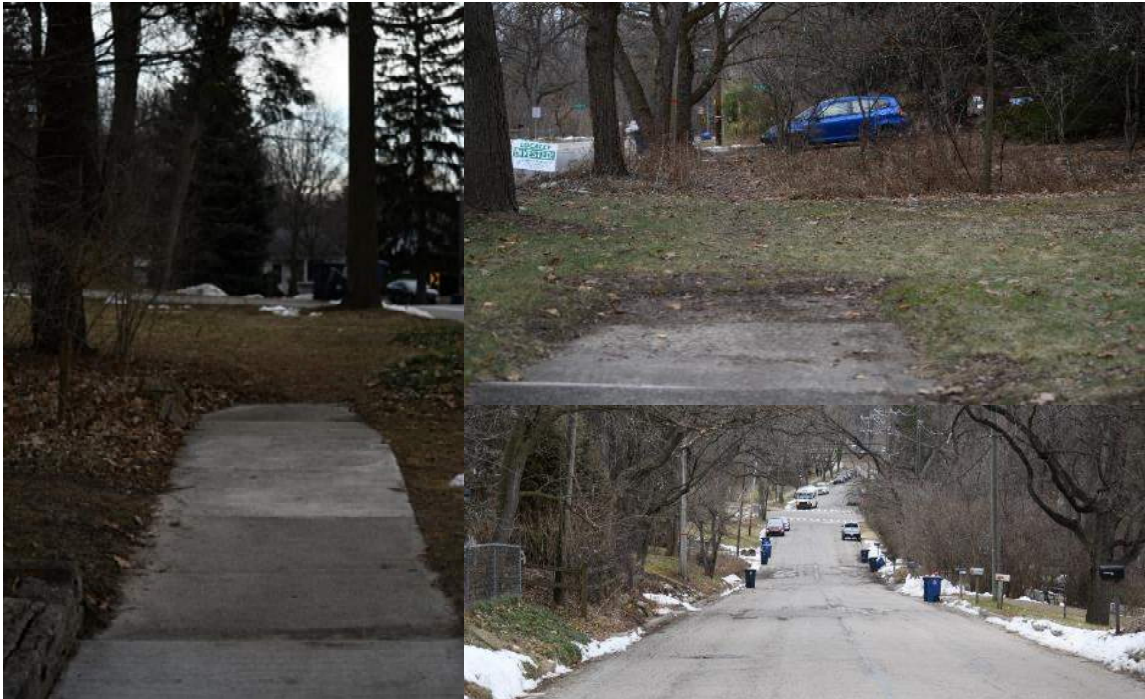
Figure 117: The neighborhood around the school features many sidewalk gaps, short ones on Barton Dr and especially long gaps on Traver Rd.

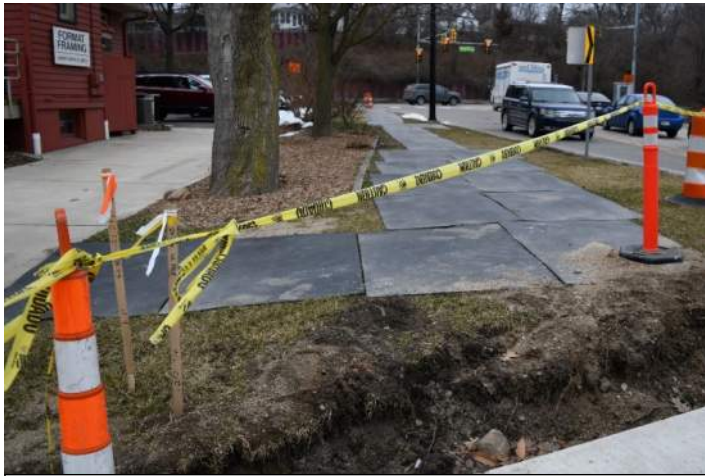
Figure 120: On Broadway, in front of the Format Framing building, a temporary sidewalk was constructed using thick rubber mats. These were not placed close enough together to eliminate gaps and the mat itself was not sturdy enough to be stable for someone in a wheelchair or walker. Caution tape was used to prevent pedestrian from falling off the end of the mat pathway at the drop off.

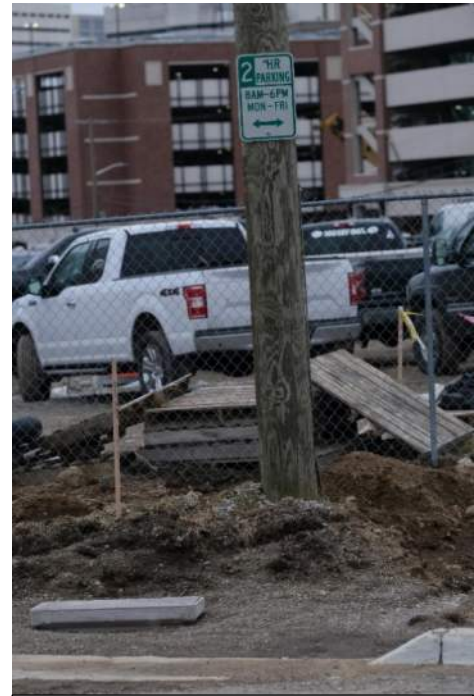
Figure 121: Other construction site issues including missing sidewalks, holes in the concrete, and exposed electrical boxes.

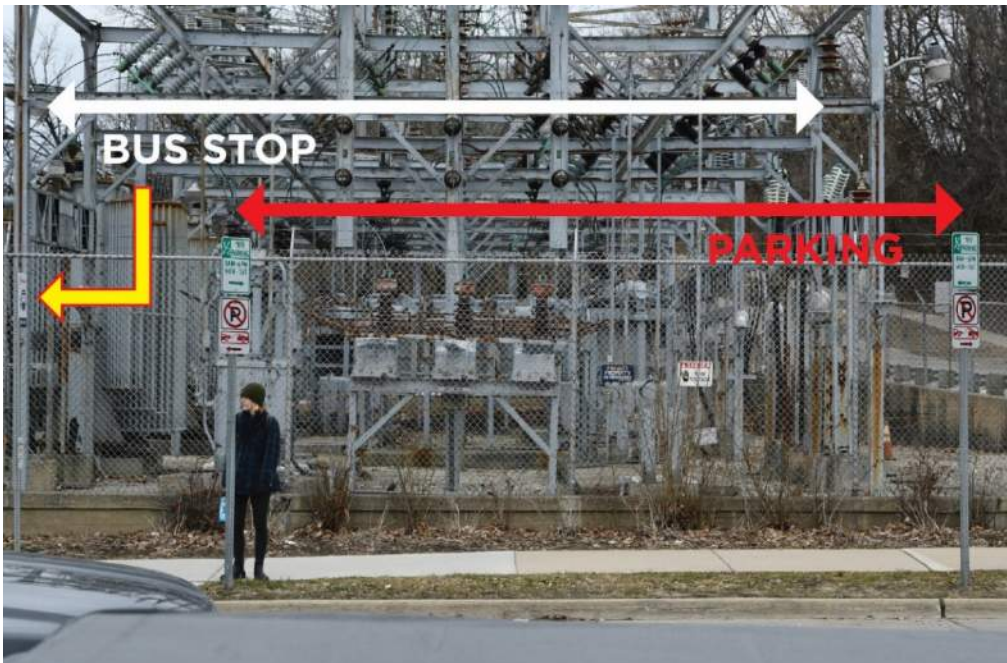
Figure 123: In front of the electrical substation on Broadway Street at Swift Street a 30-minute parking sign shares the same places as an AAATA bus stop. If a vehicle is parked in the spot, bus riders will be forced to enter the street in order to board. There is no ramp down from the sidewalk to the street level for a person in a wheelchair to travel down to the street.

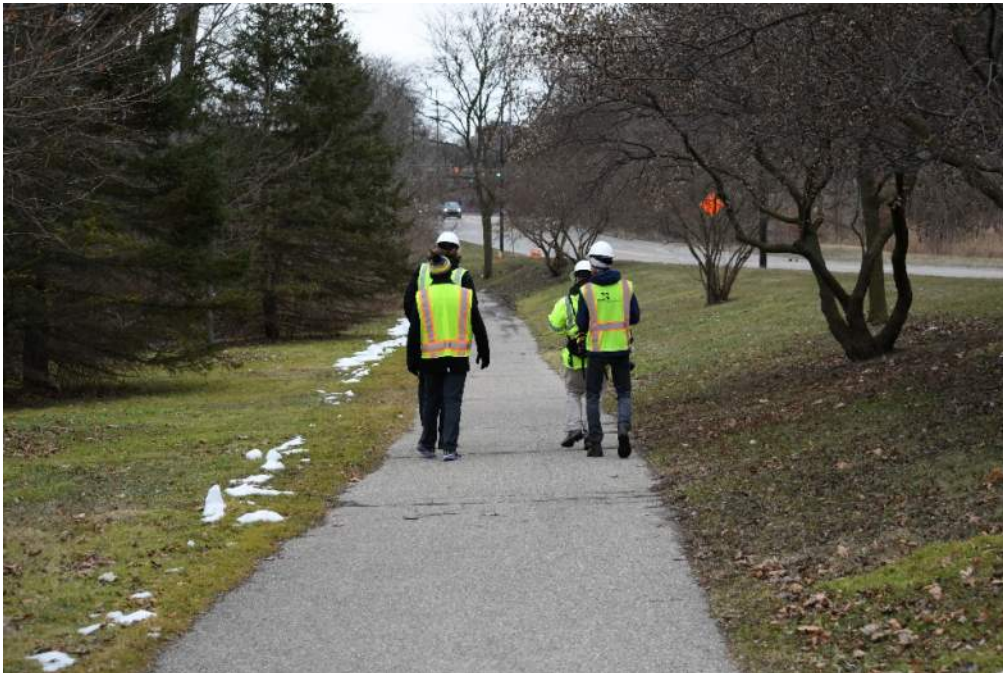
Figure 124: Side path in the depressed section along Plymouth Road does not get much light from streetlights and could use path level lighting.

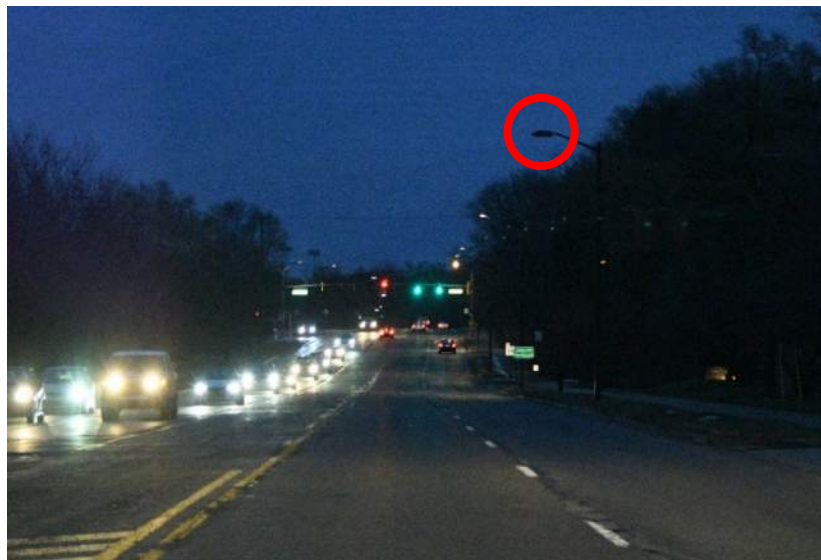
Figure 125: There is a light burned out on Plymouth Road, between Broadway Street and Barton Drive

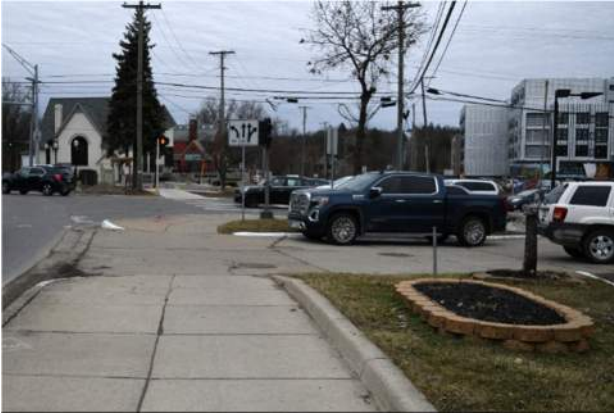
Figure 126: The auto repair shop with access to Broadway Street, Maiden Lane and Wall Street has at least six different curb cuts allowing vehicles to pull in and out of traffic in many places. Some of these driveways are blocked by parked cars throughout the day and should be considered for closure.

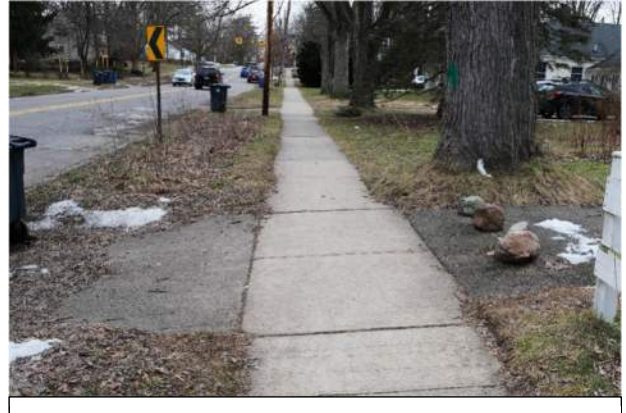
Figure 127: It is our understanding that local ordinance calls for driveway not in use to be closed. If correct, this driveway on Barton Drive is a candidate for removal.
