Appendix I
Phase I ESA Photographs
721 North Main Street
Ann Arbor, MI

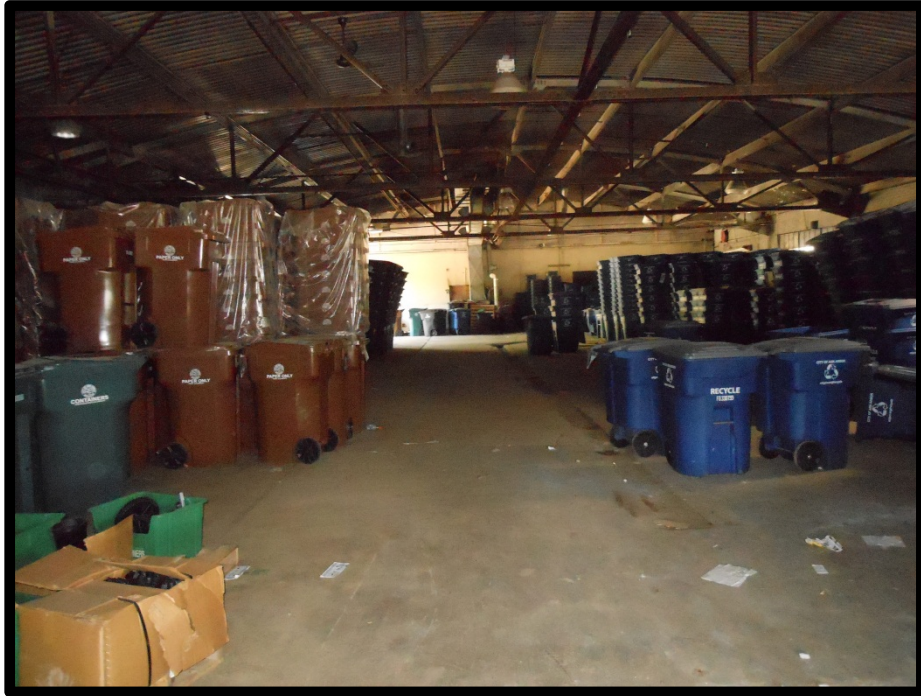
Looking north through the southern portion of the maintenance garage

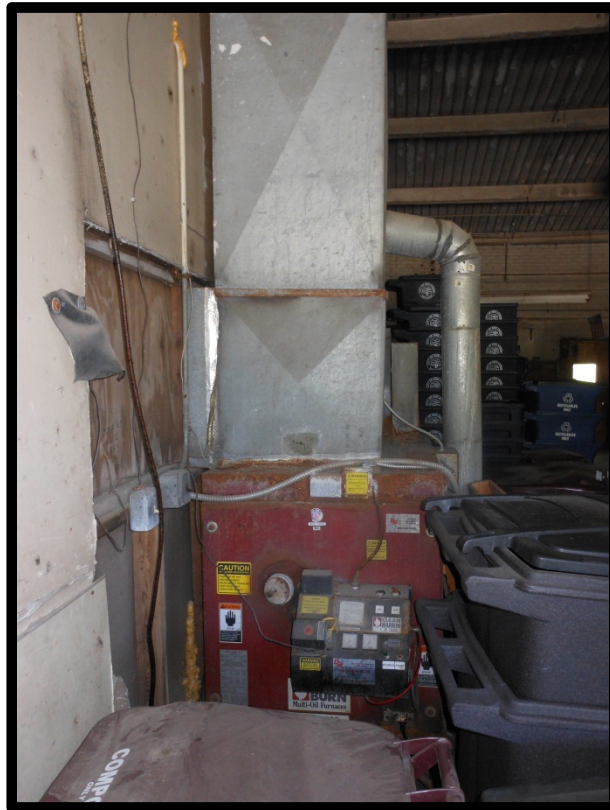
Oil burning furnace on the north wall of the southern portion of the maintenance garage

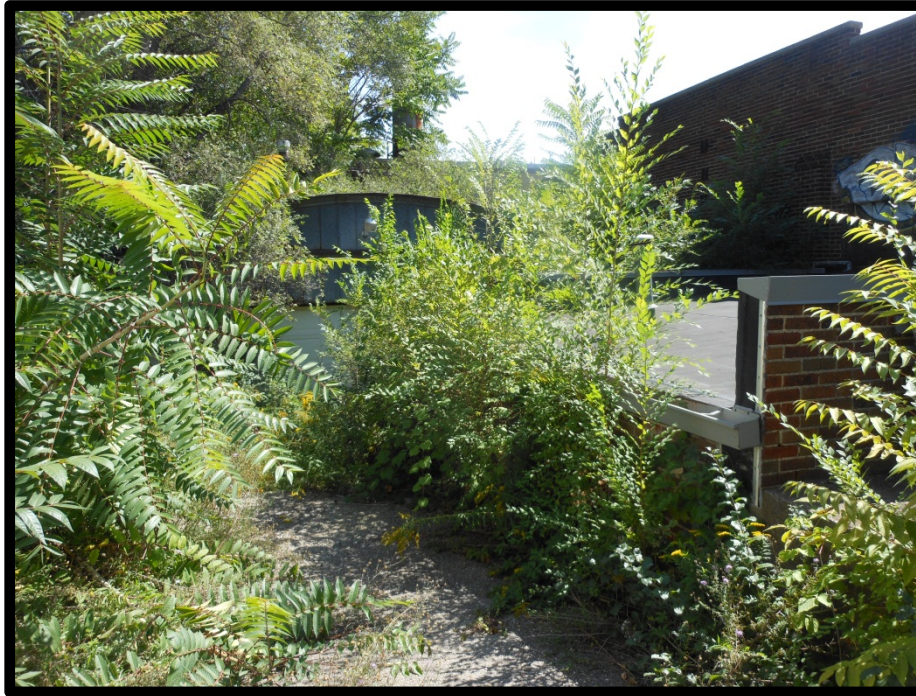
Looking east at the street maintenance garage (straight) and boiler/sump room (right).

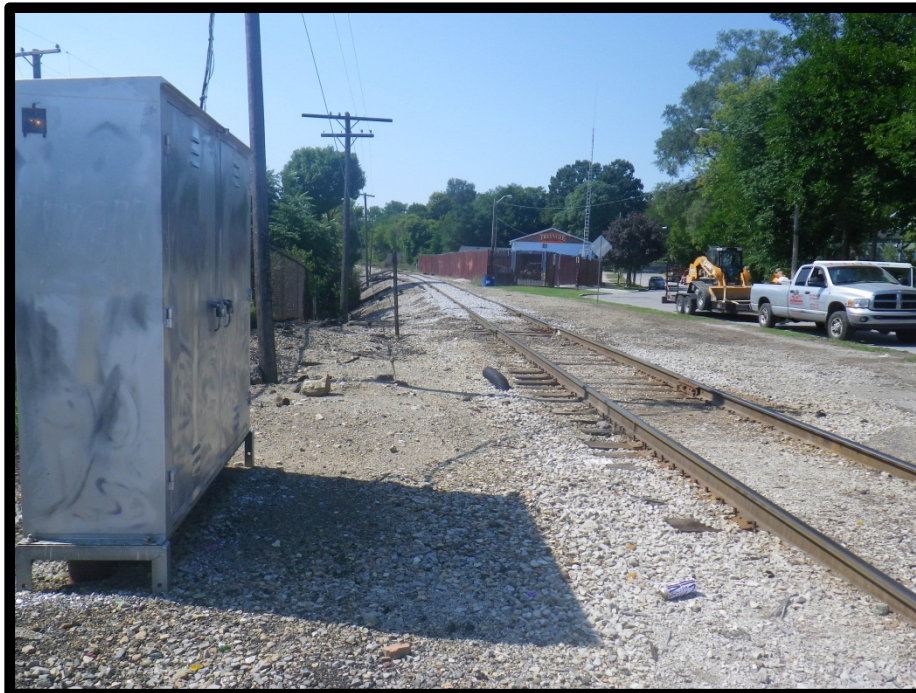
Looking south along the AARR

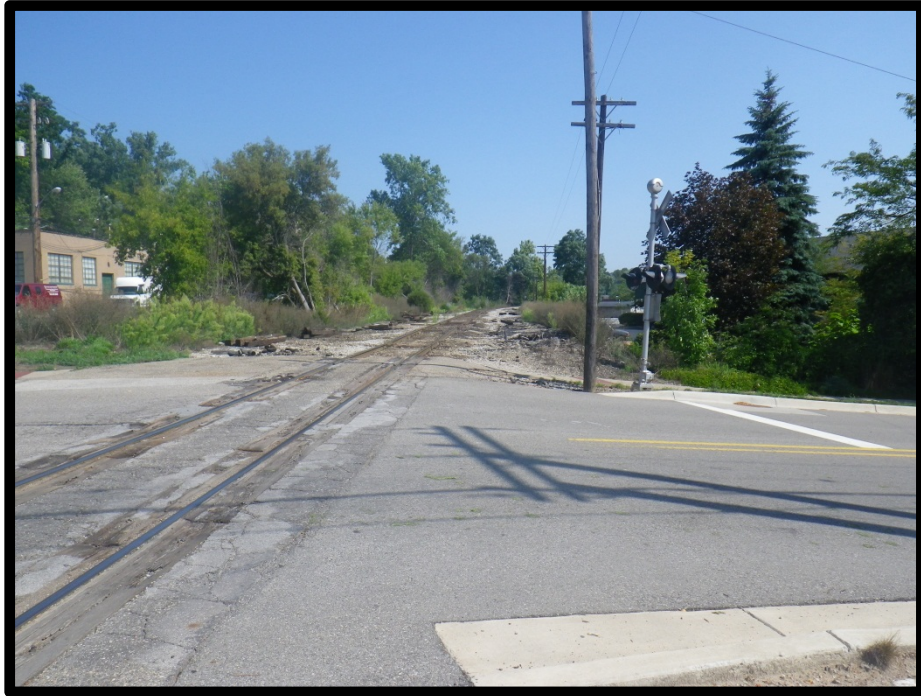
Looking north along the AARR at Summit St.

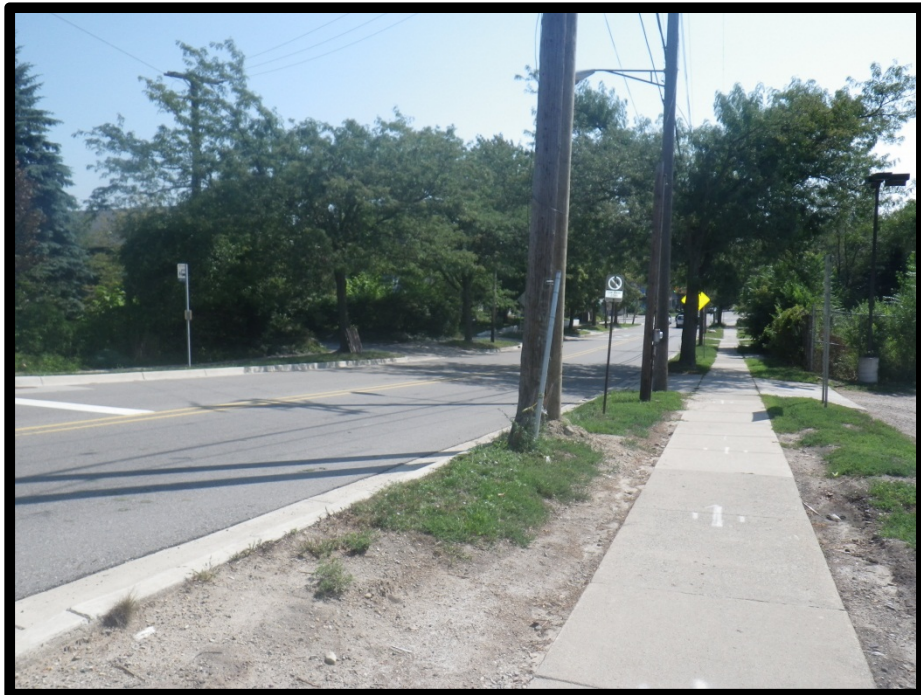
Looking east down Summit St.
