# Rental Assistance Demonstration (RAD): **PHYSICAL CONDITION ASSESSMENT**

800-890 S. Maple Avenue, Ann Arbor, Michigan 48103

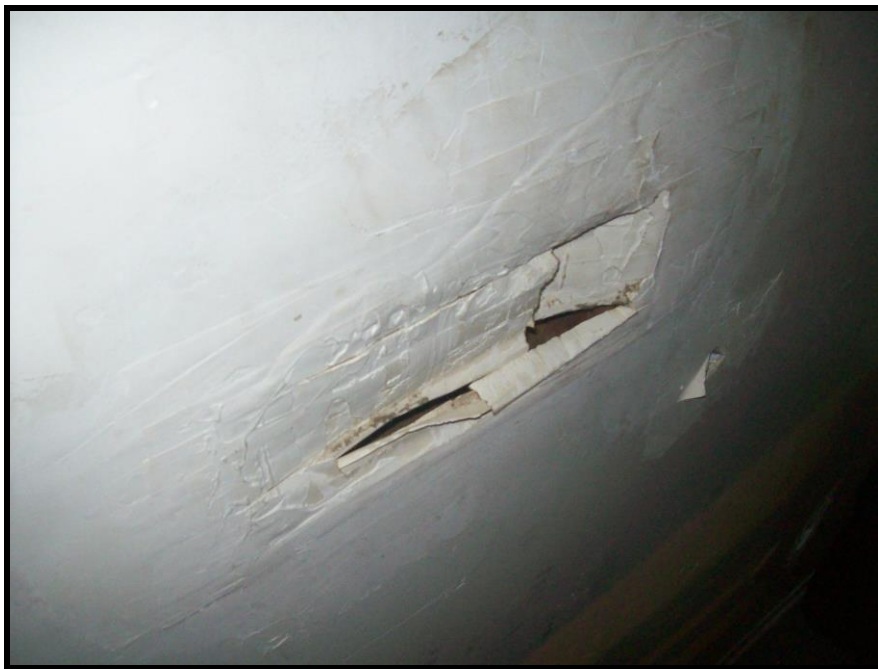
*PHOTOGRAPH NO. 18: DAMAGED DRYWALL IN TENANT UNIT*

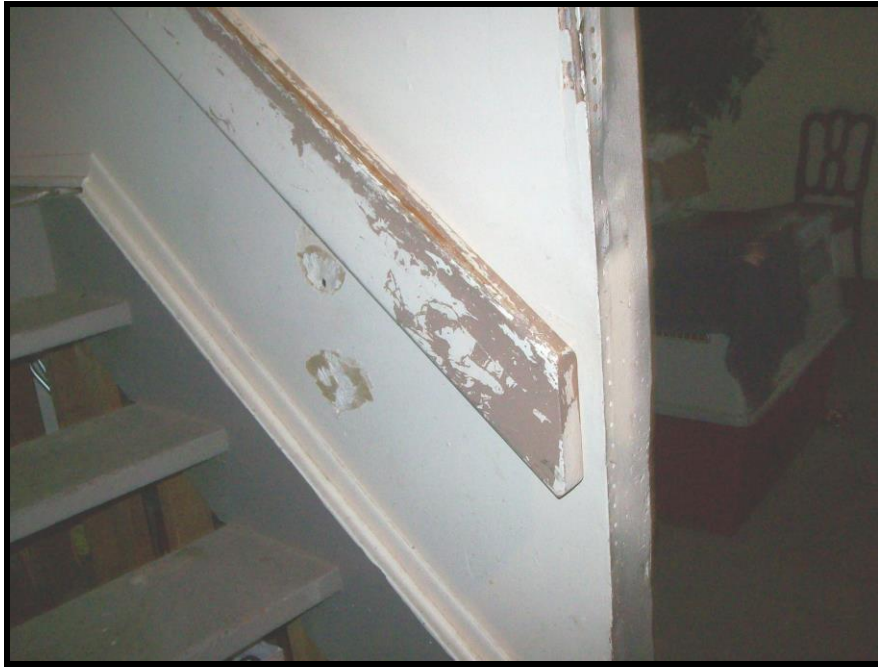
*PHOTOGRAPH NO. 19: VIEW OF DAMAGED DRYWALL AND PAINT IN TENANT UNIT*

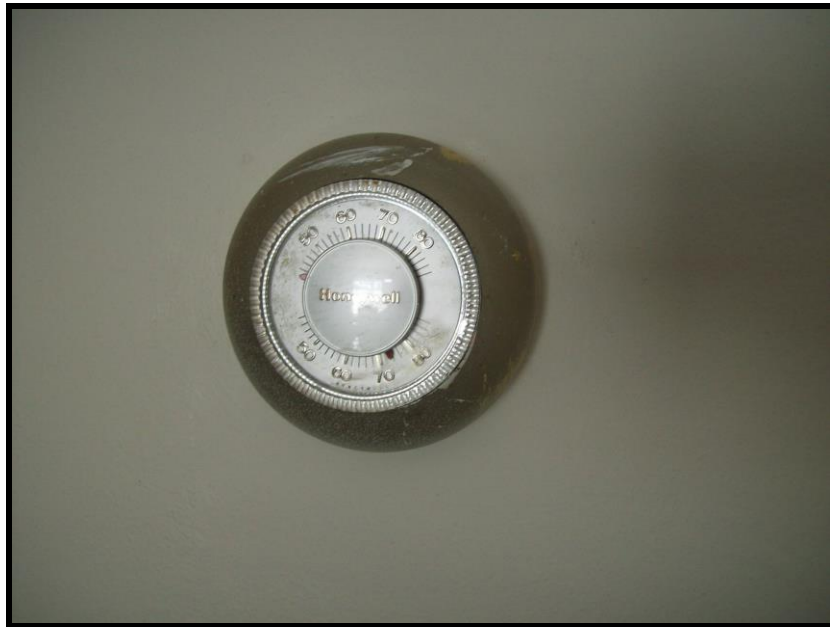
*PHOTOGRAPH NO. 20: TYPICAL VIEW OF TENANT UNIT THERMOSTAT*

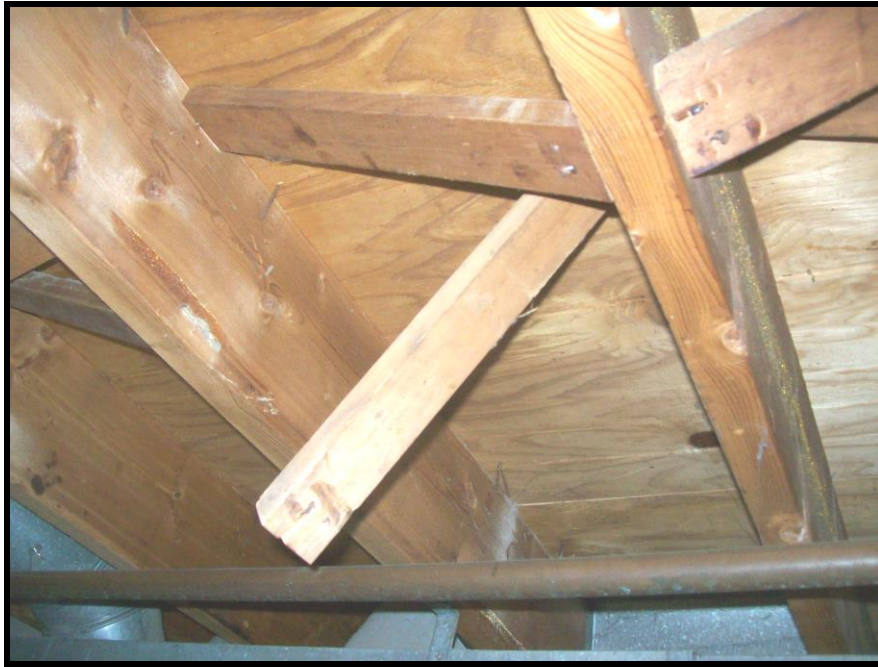
*PHOTOGRAPH NO. 21: VIEW OF DAMAGED JOIST BRACING IN TENANT UNIT*

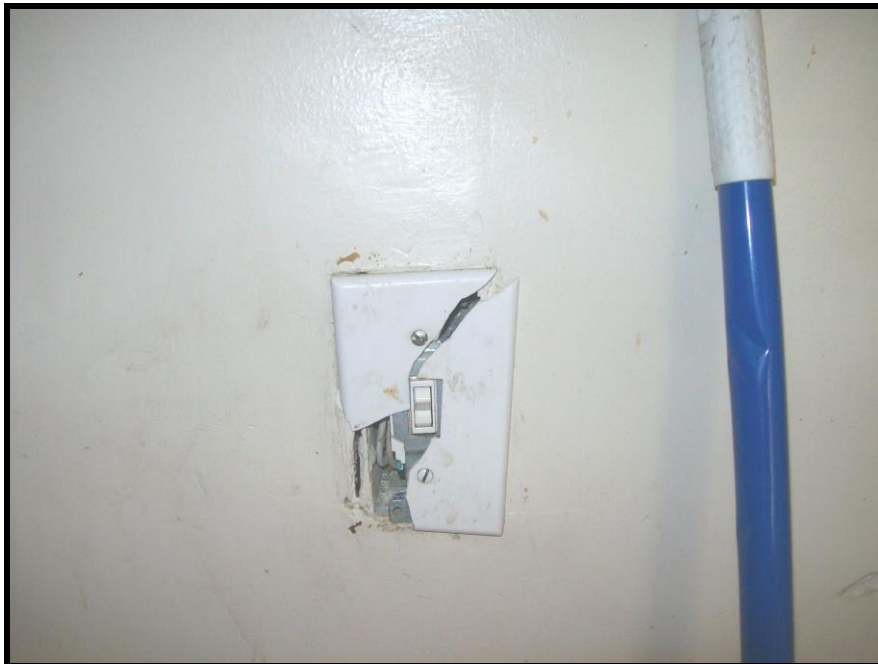
*PHOTOGRAPH NO. 22: VIEW OF DAMAGED ELECTRICAL SWITCH COVER IN TENANT UNIT*
