Appendix C

Ann Arbor

Lower Town Mobility Study

Corridor Crash Analysis

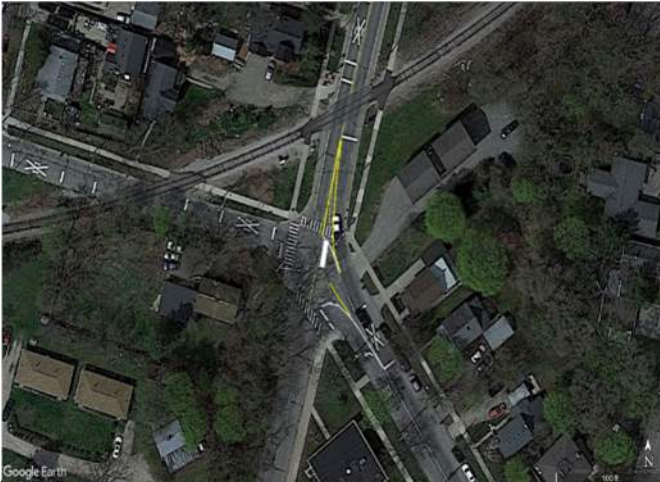
Short Term - Add pavement markings to better delineate vehicle paths through intersection.

Potential crash mitigations involve improvements to the various intersections along the corridor. Pontiac Trail at Dhu Varren is a good candidate location for a single-lane roundabout. Utilizing Crash Modification Factors (CMF) from the Highway Safety Manual, it is anticipated that a roundabout at this intersection would reduce total crashes from an average of 2.3 per year to 1.3 per year, a 44% reduction. Pontiac Trail at Barton is currently operating under signal control. This traffic signal should be evaluated for updating its clearance intervals. Signal clearance intervals encompass yellow and all red intervals. When properly timed for the approach speed of vehicles and the width of the intersections, they help minimize the incidents of rear end and angle collisions. The intersection of Pontiac St / Moore St / Longshore Dr involved a special review during the Road Safety Audit (RSA), including the review of various reconfigurations of the intersection with the goal of reducing the complexity and in turn the number of conflict points for this area. These are shown here.

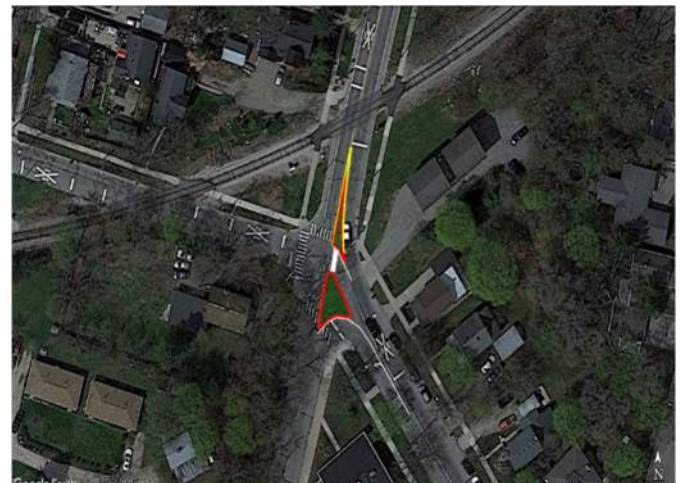
Mid-Term Option A – Add new islands to intersection. Stop sign would be added for Moore Street to Longshore Drive movement. Traffic flashers would be removed.

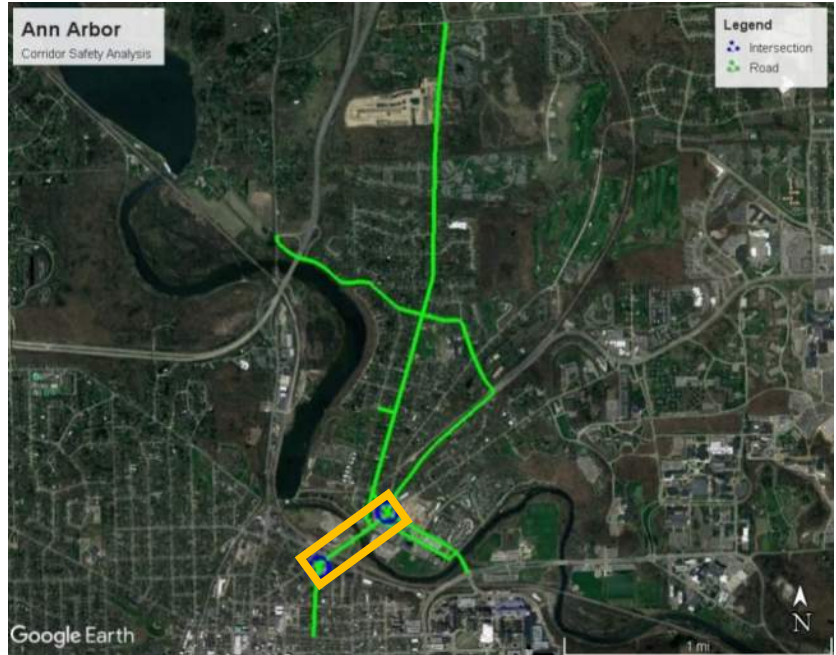
Figure 7 – Broadway St

The Broadway Street corridor segment is approximately 0.4 mile and runs from Division Street to Maiden Lane. The table does not include crashes at the intersections with Division Street and Maiden Lane, as those crashes have been pulled out and are discussed in the intersection crash data section.

The majority of crashes here were rear end and side swipe crashes that occurred during the day and dry conditions. This route includes a parking lot for the train station in the area. Furthermore, there is a signalized intersection where Broadway Street meets Swift Street. A large number of crashes that occurred were near where the roadway intersects with Swift Street. There were no fatalities or type A injuries in this segment. However, there was one type C and one Type B injury that took place on this segment. No accidents involved pedestrians or bicyclists. Both injury crashes occurred in rear end crashes.

Potential crash countermeasures for the signalized intersection of Swift St would be to evaluate it for proper clearance intervals, i.e. yellow and all-red periods.

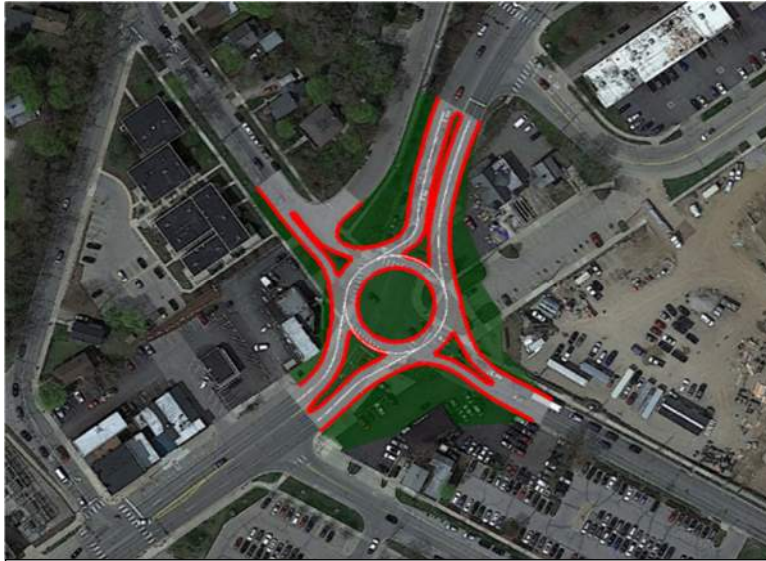
Convert intersection of Broadway St, Maiden Lane and Moore St to 2-lane roundabout. Moore St could change to 2-way traffic. Depicted is one with about 150' diameter.

Potential crash countermeasures for this signalized intersection would be to evaluate it for proper clearance intervals, i.e. yellow and all-red periods. This is also a good candidate for a roundabout. Utilizing Crash Modification Factors (CMF) from the Highway Safety Manual, it is anticipated that a roundabout at this intersection would reduce total crashes from an average of 11.2 per year to 9.1 per year, a 19% reduction. Given the volumes here, it would likely be two lanes for the Broadway and Plymouth approaches, but just one lane for Maiden Ln and Moore St. This roundabout option is illustrated here:

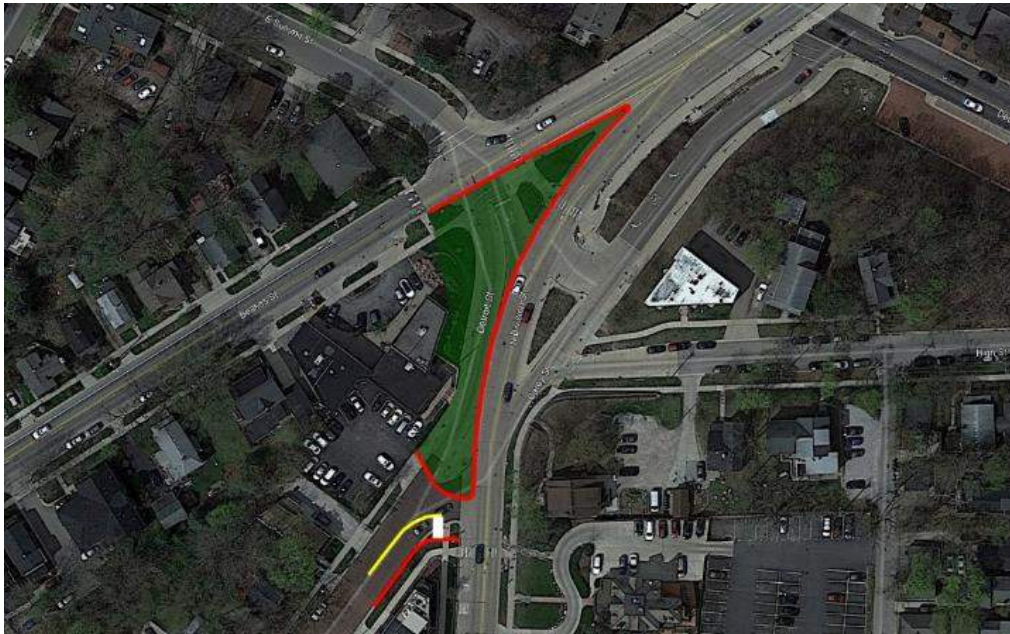
Option A – Close access between Detroit / Division and Broadway / Summit. This would eliminate conflicts with pedestrians crossing Beakes St and Broadway St. Crosswalk would be moved south along Division to improve visibility around the retaining wall.

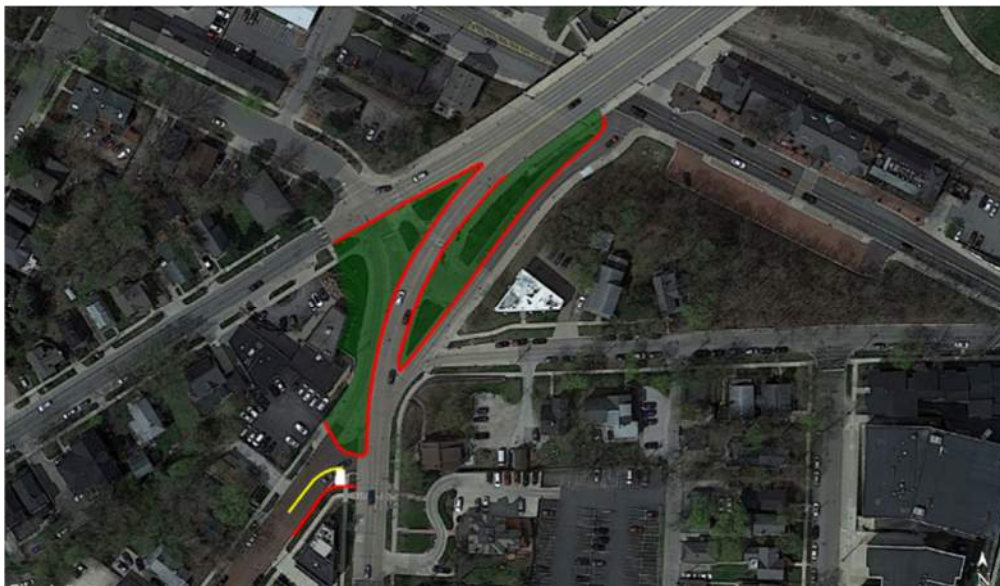
Option B – Variation on Option A. Would eliminate conflicts related to pedestrian crossings at Beakes St and Broadway St. Maintains access from Division St down to Depot St and to High St, but Depot St up to Broadway St. will be detoured.

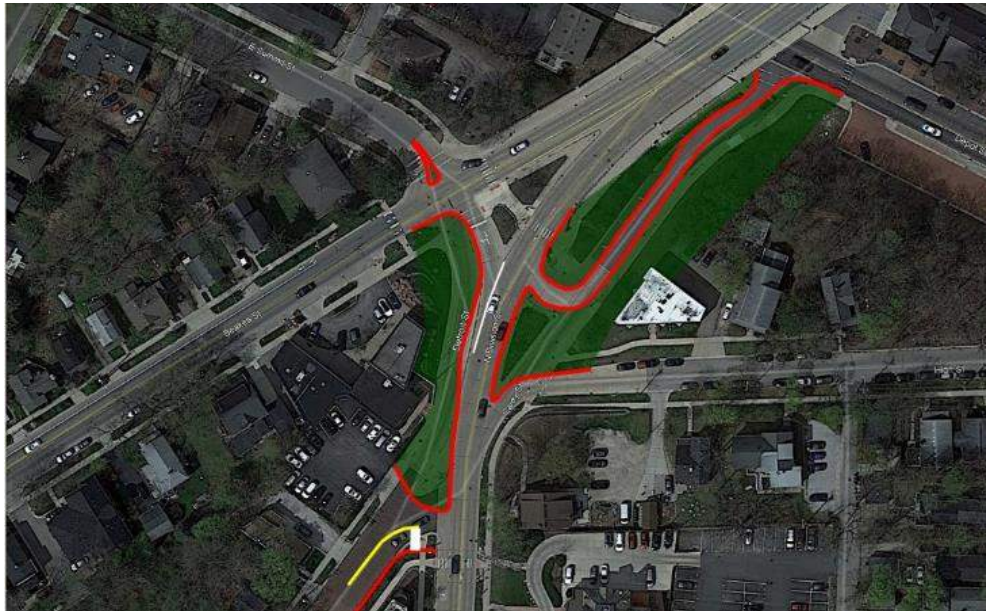
Option C – Close northbound entrance to Carey St from Division St and southbound access to Detroit St from Broadway St/Summit St. Maintains access from Division to Summit. Left turns and thru movements would be channelized. Would maintain access to the Broadway Street bridge from Depot Street and to High Street from Division.
