Rental Assistance Demonstration (RAD): **PART 2: ENERGY AUDIT**

1701-1747 Green Road, Ann Arbor, Michigan 48105
GREEN BAXTER

PROJECT # 8213E-2-96

DATE February 21, 2014

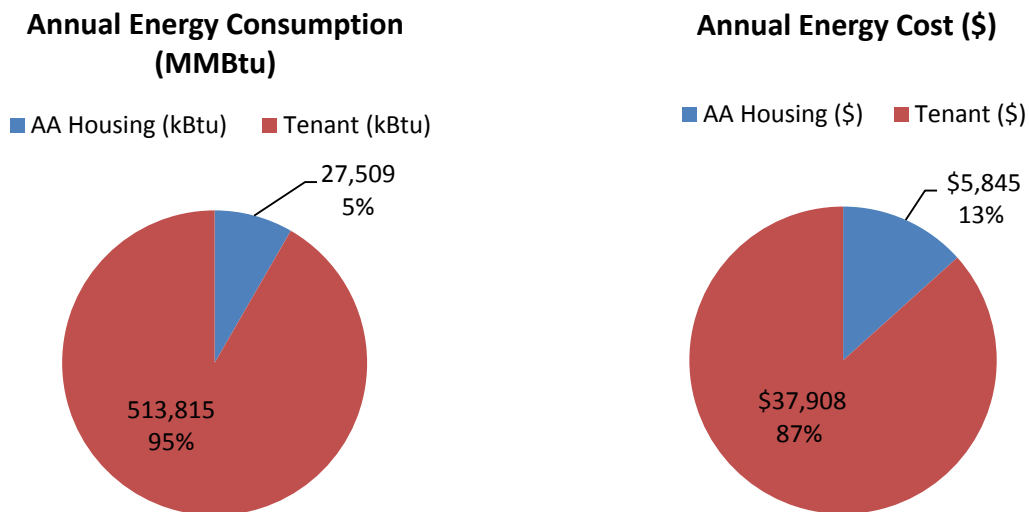
Figure 1. Historical Annual Energy Consumption and Cost

A preliminary energy use assessment was conducted prior to the cost reduction measure analysis. The figure below describes the historical annual energy consumption and cost for the subject property.

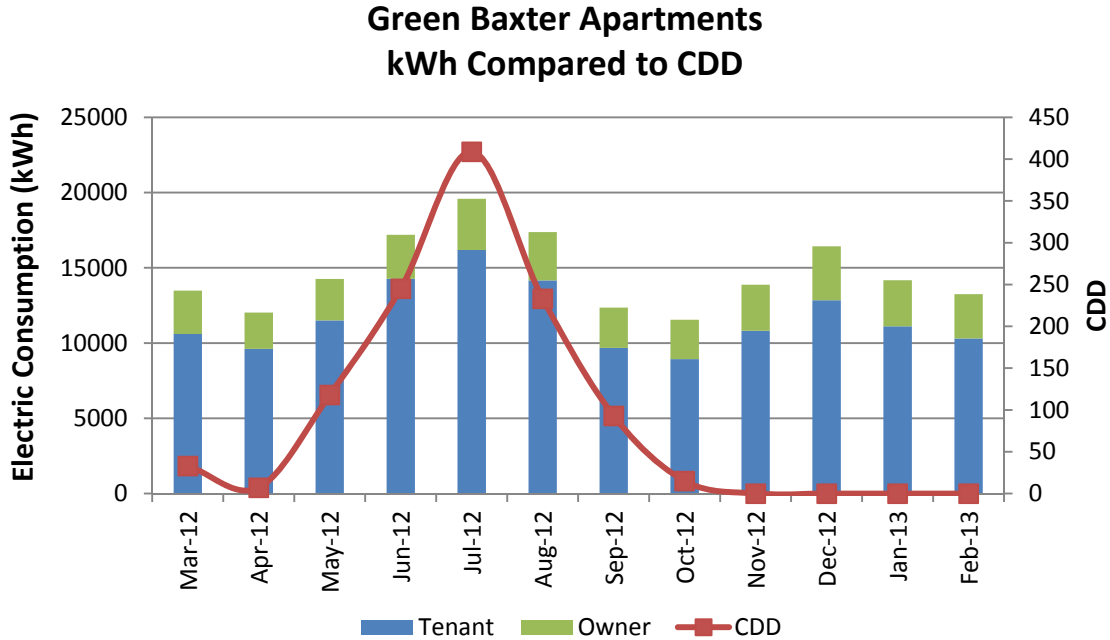
Figure 4. Electricity Consumption Graph

Electricity is supplied and delivered to the subject property by DTE Energy. Historic common area electrical use and tenant use compared to cooling degree days is summarized in the following figure:

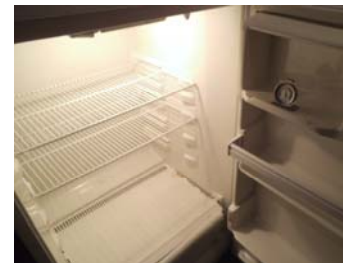
The audit team identified a refrigerator in the community center basement that was plugged in with no perishables in the freezer or cold storage compartments (nothing in it).

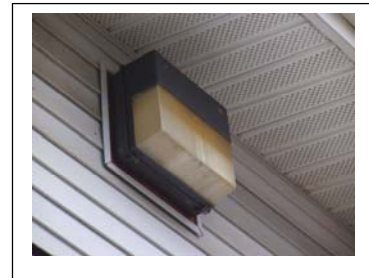
The outside grounds of the Green Baxter Court Apartments property are lighting throughout the evening hours for safety and security. There are exterior lighting (wall pack) fixtures located near the front and rear entrance doors of each home. These wall packs are of the high intensity discharge (HID) type with high pressure sodium (HPS) lamps that appeared to be 35 watts each. There are also larger flood lights installed on the gable ends (mostly) to light the grounds. These flood lights are of the high intensity discharge (HID) type with high pressure sodium (HPS) lamps that appeared to be 250 watts each. The site visit light count total was 50 of the smaller wall packs and 30 of the larger flood lights.

Please note that the exterior lighting on two of the buildings was operating during daytime hours (at time of site visit). This is most likely due to a faulty photocell control. This should be repaired (wasted energy cost of \$1,285 annually), but is not factored into this ECM analysis.

The existing HID exterior lighting is outdated, and significantly more efficient lighting options are readily available. For this application, it is recommended that exterior lighting be retrofitted with more efficient light emitting diode (LED) lighting.

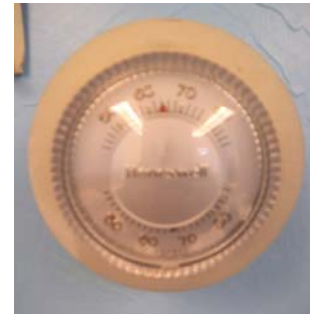
Currently, control of the furnace heat in each home is by a manual thermostat located in the living room. Please note that although the thermostat observed during the site visit (and possibly others) is electronic with a digital display, it is not programmable.

It is recommended that a programmable thermostat is installed to control the heat. The programmable thermostats would allow a nighttime setback to be employed, thereby saving energy on heating during overnight hours.

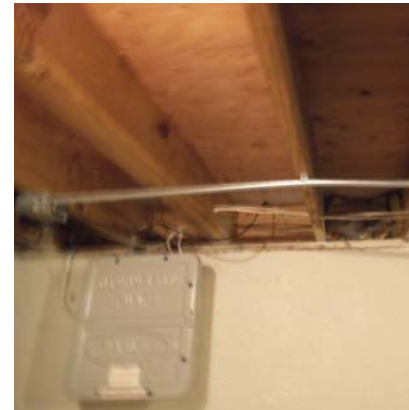
In order to improve the comfort, efficiency, durability and healthfulness of buildings, it's necessary to control the movement of heat, air and moisture within and through a building envelope. Attention to insulation and air-sealing details throughout a house is critical. One area that is commonly overlooked or undervalued is the rim or band joist, located in the basement and between floors.

The typical residential unit at Green Baxter Court Apartments was observed to have Kraft-faced, R-11 insulation tucked into rim cavities in the basement. Almost all areas were poorly installed and many areas were missing insulation completely. Stuffing fiberglass batts between floor joists is a common method of insulating the rim joist in many homes, but it's a flawed technique. Fiberglass works best in an enclosed space where it can trap air (between drywall and the exterior sheathing of a stud wall, for example). In a typical (poorly) insulated fiberglass installation, as observed tenant units, air moves freely around the batts, as well as through the fiberglass itself.

As an alternative, relatively new to the market, two-component spray-foam kits offer a quick, effective solution to tricky insulating problems. The kit consists of two liquid chemicals that mix together in the tip of a gun, and then expand once they hit the surface. The foam is highly adhesive, so it sticks and stays in place as it expands to fill gaps. Once cured, the foam provides an effective air seal as well as insulation.

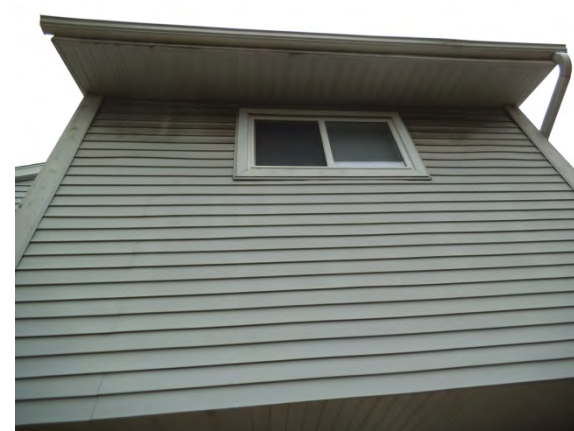
The typical windows appear to be vinyl clad sliders/glidors, with double pane tempered insulating glass. The windows may have been replaced since 2009, as aluminum framed windows were identified in previous reports. Though they may be new, the windows are standard efficiency units and in some cases the team found the assemblies to be loose and dirty. Proper tenant maintenance will allow the windows to seat and close properly, increasing their effectiveness.

Photo 4: Typical vinyl window

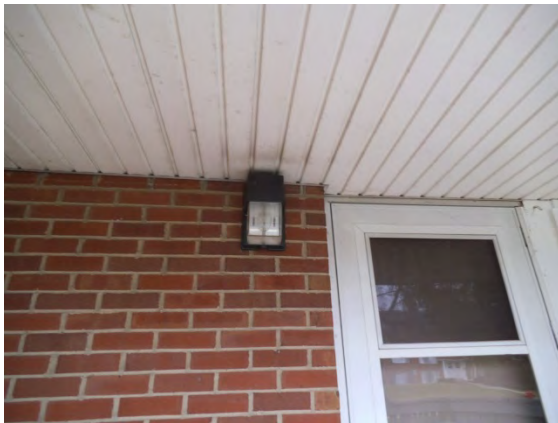
Photo 5: Exterior wall-pack near each entrance

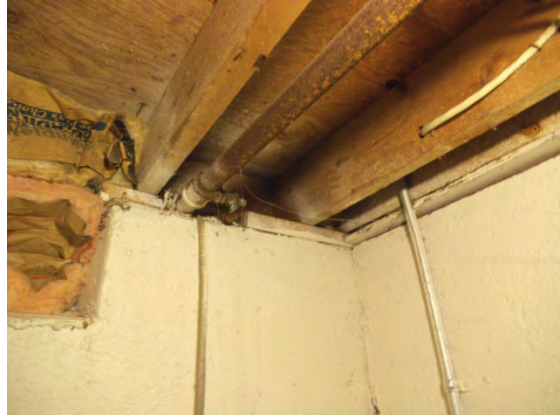
The basement walls appear to be 8" cast-in-place concrete with a poured slab floor. The walls and floor slab appear to be uninsulated. The rim band, or band joist, appears to be insulated with loose fitting fiberglass insulation stuffed in between floor joists at the perimeter. Insulation was visibly missing in

Photo 8: Insulation between basement walls

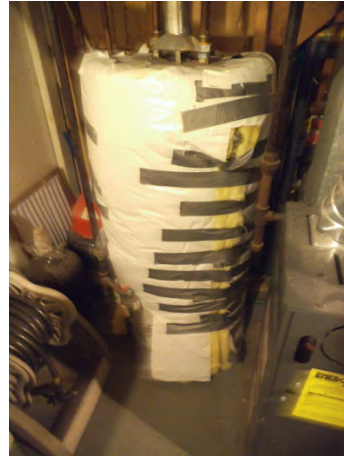
Photo 14: Insulated DHW storage tank

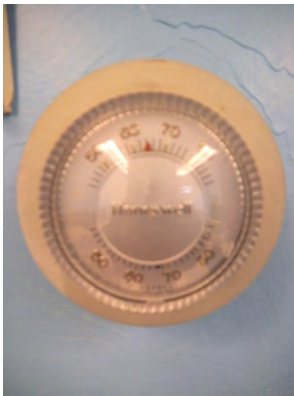
Photo 15: Manual thermostat in community center

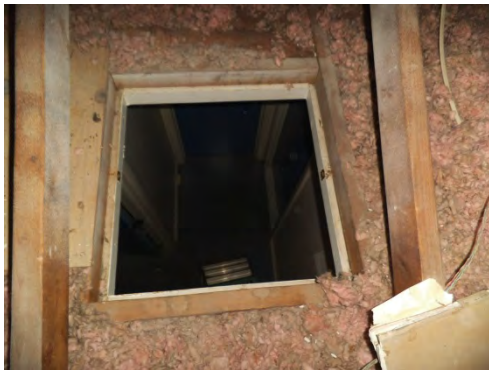
Photo 17: Insulation surrounding attic hatch

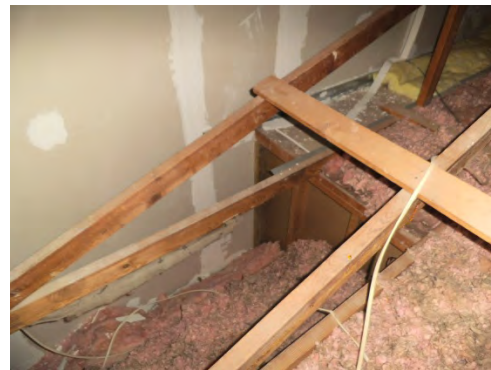
The typical attic appears to have 3.5” (nominal) batts of R-11 insulation laid on the ceiling with approximately 3” of blown fiberglass insulation on top of the batts. The estimated R-value of this insulation type and level is R-19 (loose fill fiberglass, 0.6 lb/ft³, horizontal application, open blow, R-value 2.8 per inch. The insulation observed onsite appeared to be poorly placed with the blown insulation often unevenly distributed. It was also noted that areas around the stairwell were missing insulation. This uneven distribution of insulation results in a lower effective insulation value in the attic. Overall, this insulation would be considered standard efficiency at best, or in some cases substandard efficiency (<R-21).

Photo 18: Minimal insulation in some areas

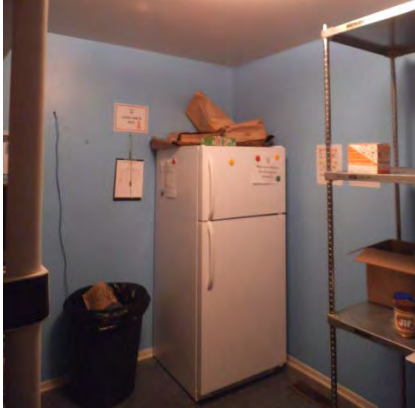
The community center space utilized three (3) refrigerators throughout. One located in the kitchen area and two additional refrigerators were located in the basement and found upstairs in the office/storage area. More efficient models are available for these units. One of the units, located in the basement, did not contain any perishables in the freezer or cold storage area. A horizontal freezer unit was also identified and located in the basement.

Photo 19: Additional refrigerator in storage area
