Rental Assistance Demonstration (RAD): **PART 2: ENERGY AUDIT**

2702-2760 Hikone Drive, Ann Arbor, Michigan 48108
HIKONE

PROJECT # 8214E-2-96

DATE February 10, 2014

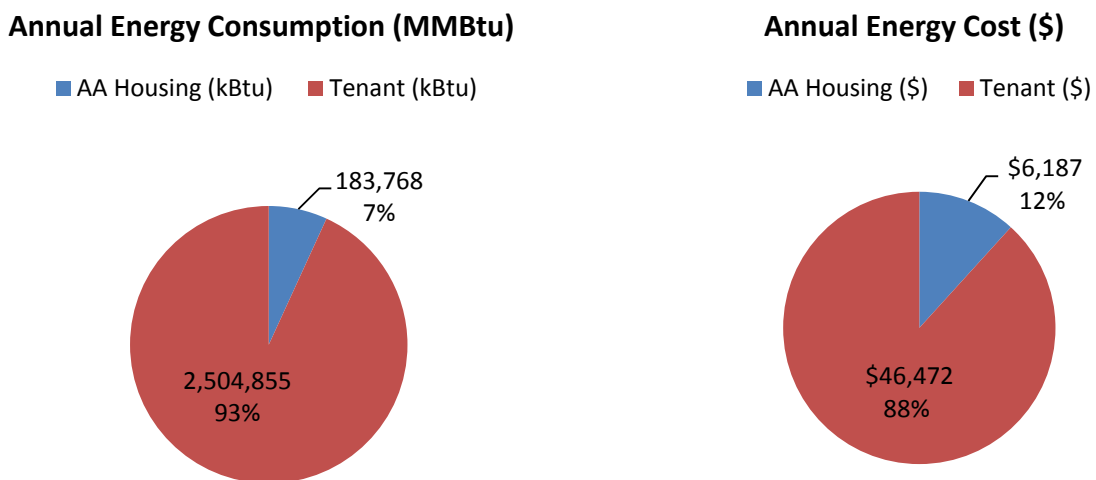
Figure 1. Historical Annual Energy Consumption and Cost

A preliminary energy use assessment was conducted prior to the cost reduction measure analysis. The figure below describes the historical annual energy consumption and cost for the subject property.

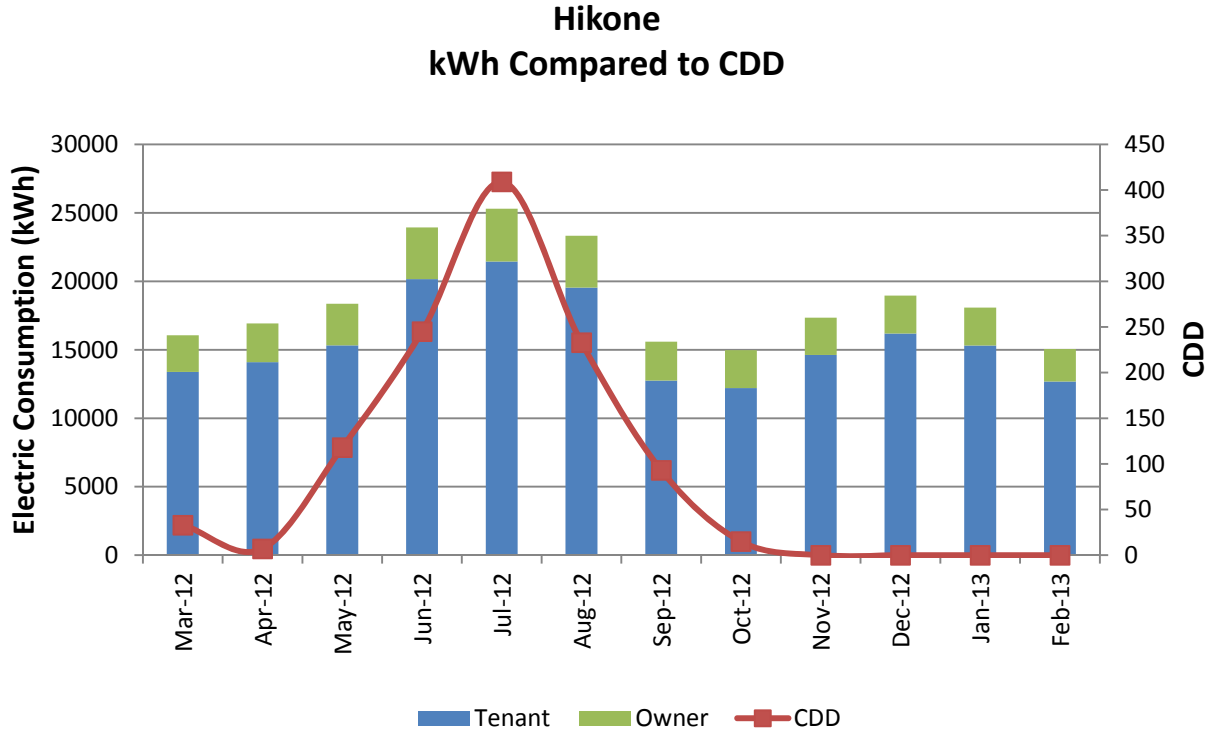
Figure 4. Electricity Consumption Graph

Electricity is supplied and delivered to the subject property by DTE Energy. Historic common area electrical use and estimated tenant use is compared to cooling degree days is summarized in the following figure:

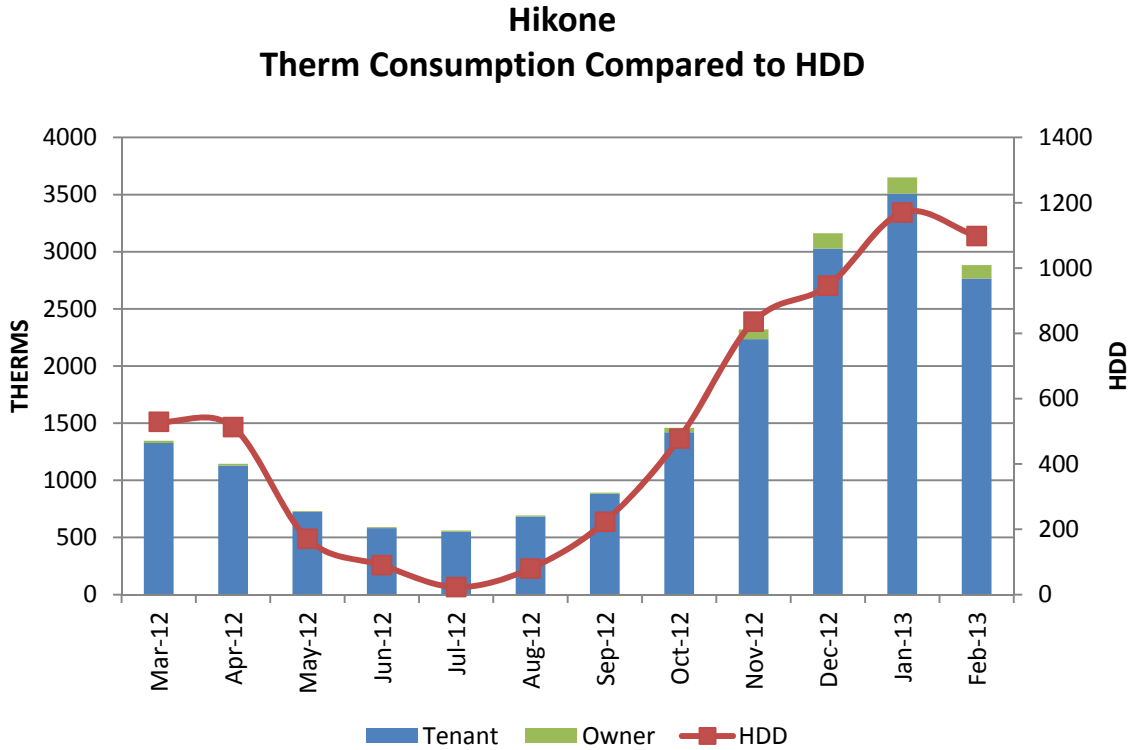
Figure 5. Natural Gas Consumption Graph

Natural gas is supplied and delivered to the subject property by DTE Energy. Historic natural gas use is summarized in the following figures:

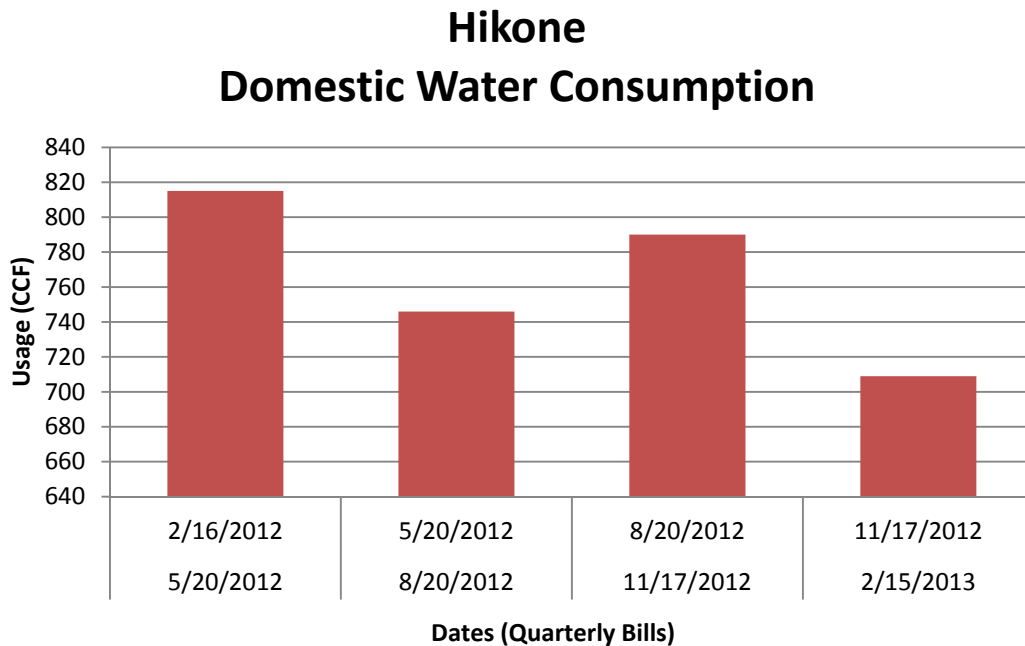
Figure 6. Domestic Water Consumption Graph (Owner)

For the time period covered by client provided records, historic domestic water use is summarized in the following figures.

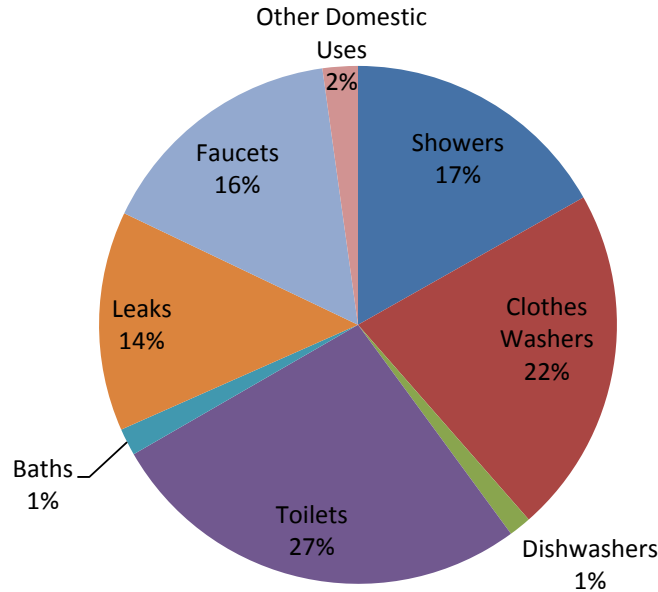
Figure 7. Domestic Water Typical End Use

Figure 8 below shows the REUWS typical domestic water consumption breakdown by end use.

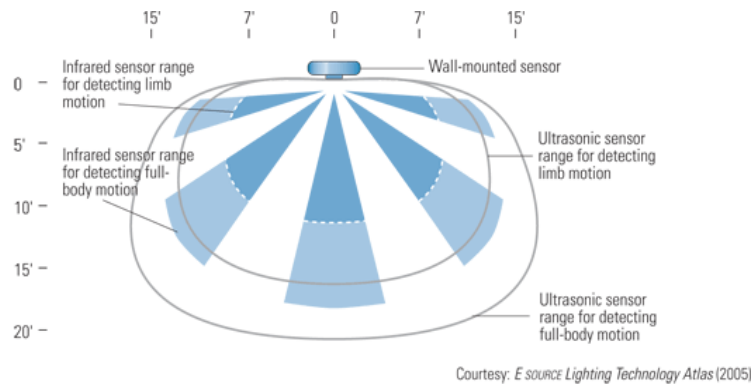
Figure 1. Occupancy Sensor Coverage Patterns

The three most common types of occupancy sensors are passive infrared (PIR), ultrasonic, and those that combine the two technologies. PIR devices are the least expensive and most commonly used type of occupancy sensor. They detect the heat emitted by occupants and are triggered by changes in infrared signals when, for example, a person moves in or out of the sensor's field of view. PIR sensors are quite resistant to false triggering and are best used within a 15-foot radius. Ultrasonic sensors can detect motion at any point within the contour lines. Infrared sensors "see" only in the wedge-shaped zones, and they do not generally see as far as ultrasonic units. Some sensors see farther straight ahead than to the side. The ranges shown here are representative; some sensors may be more or less sensitive.

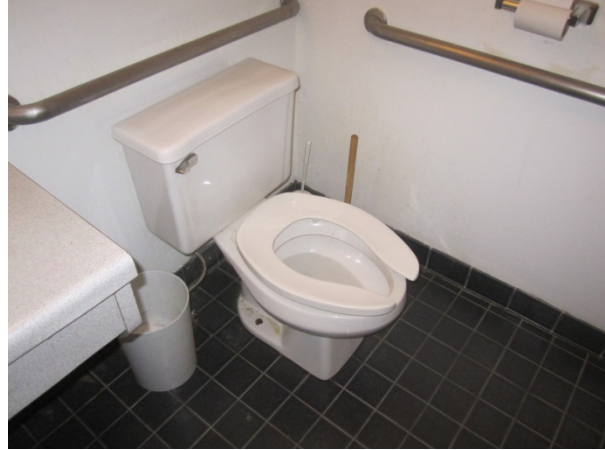
Photo 8: Typical Bathroom Toilet

It is recommended that the toilet (1) be replaced with a new toilet meeting the 1.6 GPF criteria. Even better would be to replace with a toilet certified with the WaterSense label. Such toilets use 20 percent less water than the current federal standard, while still providing equal or superior performance. WaterSense, a program sponsored by the U.S. Environmental Protection Agency (EPA), is helping consumers identify high performance water-efficient toilets that can reduce water use in the home and help preserve the nation's water resources.

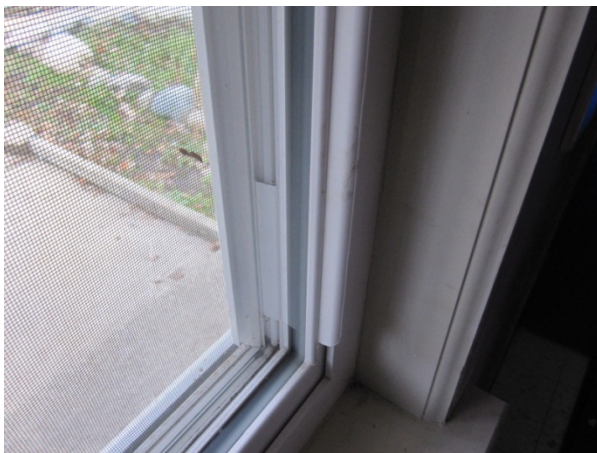
Photo 11: Vinyl windows in Community Center

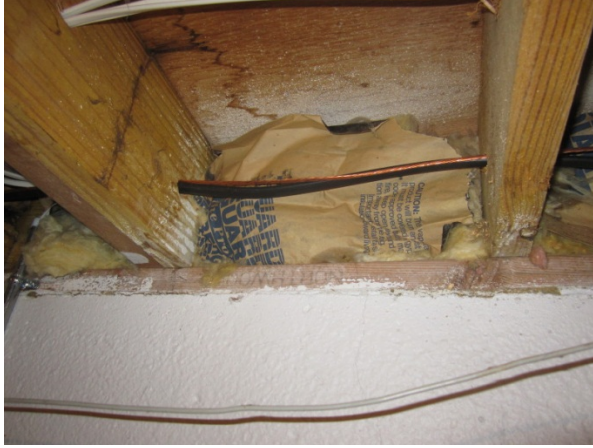
The basement walls appear to be 8" cast-in-place concrete with a poured slab floor. The walls and floor slab appear to be uninsulated. The rim band, or band joist, appears to be insulated with loose fitting fiberglass insulation stuffed in between floor joists at the perimeter. Insulation was visibly missing in

Photo 13: Insulation in between floor joists in basement

The typical residential unit at Hikone Apartments was observed to have Kraft-faced, R-11 insulation tucked into rim cavities in the basement. Almost all areas were poorly installed and many areas were missing insulation completely. Stuffing fiberglass batts between floor joists is a common method of insulating the rim joist in many homes, but it’s a flawed technique. Fiberglass works best in an enclosed space where it can trap air (between drywall and the exterior sheathing of a stud wall, for example). In a typical (poorly) insulated fiberglass installation, as observed tenant units, air moves freely around the batts, as well as through the fiberglass itself.

As an alternative, relatively new to the market, two-component spray-foam kits offer a quick, effective solution to tricky insulating problems. The kit consists of two liquid chemicals that mix together in the tip of a gun, then expand once they hit the surface. The foam is highly adhesive, so it sticks and stays in place as it expands to fill gaps. Once cured, the foam provides an effective air seal as well as insulation.

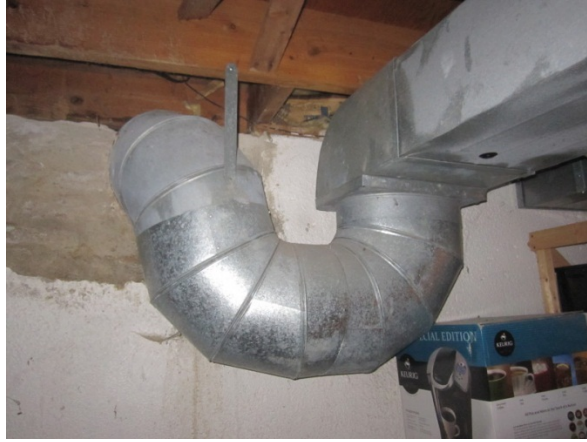
Heat to the apartment is supplied through sheet metal ducts, with no visible mastic for duct sealing. Return air is ducted to the furnace. Fresh air appears to be supplied by operable windows and natural infiltration. Mechanical exhaust is limited to the bathrooms, with overhead exhaust fans ducted to the outside.

Photo 14: Ducting from the furnace

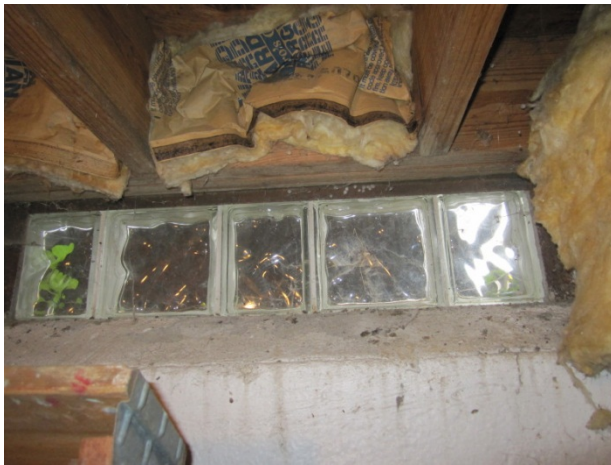
The basement of each apartment has 1-3 glass block windows located above grade and 36"x8". The frame around several of these windows was in fair to poor condition.

Photo 15: Basement glass block windows

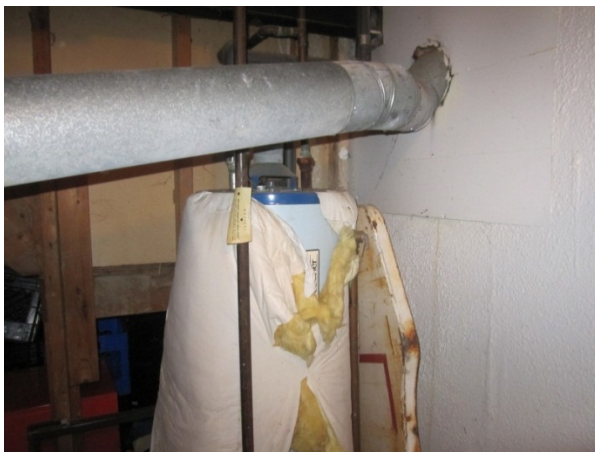
Photo 17: Slightly insulated hot water heater

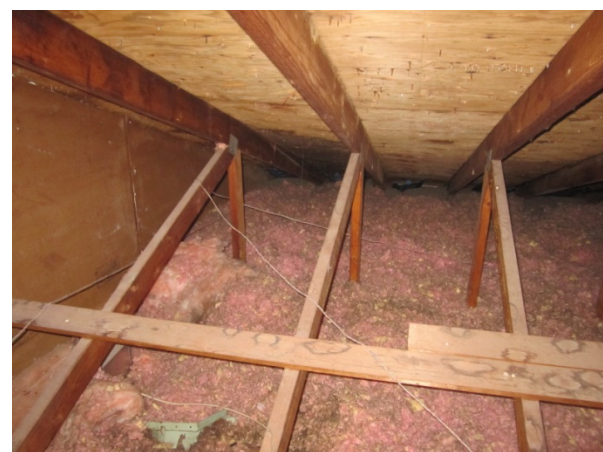
The typical roof design on the five apartment buildings is a gabled, passively vented roof. Approximately 16" overhangs with continuous soffits run parallel to the ridge and balance a continuous ridge vent. The roof assembly is asphalt shingled roof (grey) over felted wood substrate mechanically fastened to prefabricated or site built 2x wood trusses. The typical attic appears to have 3.5" batts of R-11 insulation laid on the ceiling with approximately 3" of blown fiberglass insulation on top of the batts. The insulation observed onsite appeared to be poorly placed with the blown insulation often unevenly distributed. It was also noted that areas around the stairwell were missing insulation. This uneven distribution of insulation results in a lower effective insulation value in the attic. Overall, this insulation would be considered standard efficiency at best, or in some cases substandard efficiency (<R-21).

Photo 18: Insulation in attic space

The typical attic appears to have 3.5” (nominal) batts of R-11 insulation laid on the ceiling with approximately 3” of blown fiberglass insulation on top of the batts. The estimated R-value of this insulation type and level is R-19 (loose fill fiberglass, 0.6 lb/ft³, horizontal application, open blow, R-value 2.8 per inch. The insulation observed onsite appeared to be poorly placed with the blown insulation often unevenly distributed. It was also noted that areas around the stairwell were missing insulation. This uneven distribution of insulation results in a lower effective insulation value in the attic. Overall, this insulation would be considered standard efficiency at best, or in some cases substandard efficiency (<R-21).

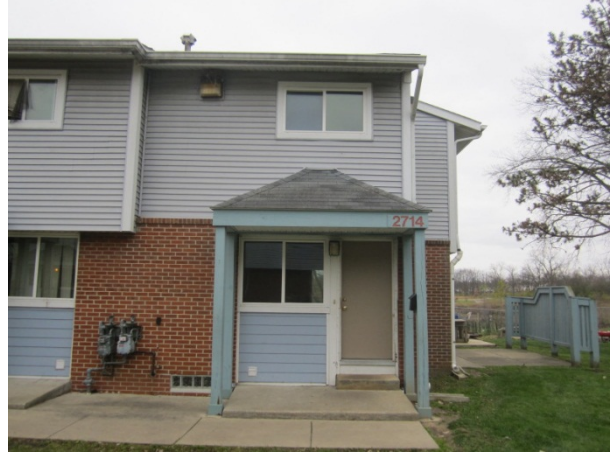
The audit team conducted a calibrated “blower door” test on a sample 3-bdr unit to determine the apartment’s airtightness. This test, utilizing several gauges for quantifying the analysis, pulls air out of the residential unit, lowering air pressure inside. This allows the (higher) outside air pressure to flow into the apartment through all unsealed cracks and openings.

The test recorded an infiltration rate of 1950 cubic feet per minute (cfm) at 50 Pascals of pressure. Given the unit conditioned volume (approximately 10,720 cubic feet) this equates to 10.9 air changes per hour at 50 Pascals (ACH50), or approximately 0.545 natural air changes per hour (NaCH). Most standards recommend a target natural air change rate of 0.35 NaCH or less (if mechanically ventilated). This represents an infiltration rate of 35% more than the target.

Photo 20: Sample unit used for blower-door test

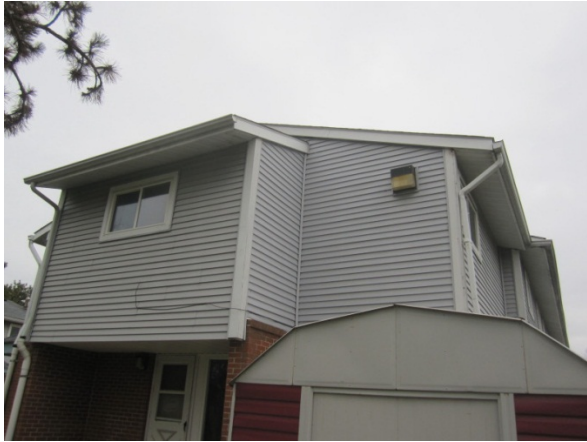
Photo 21: Exterior wall-mounted lighting

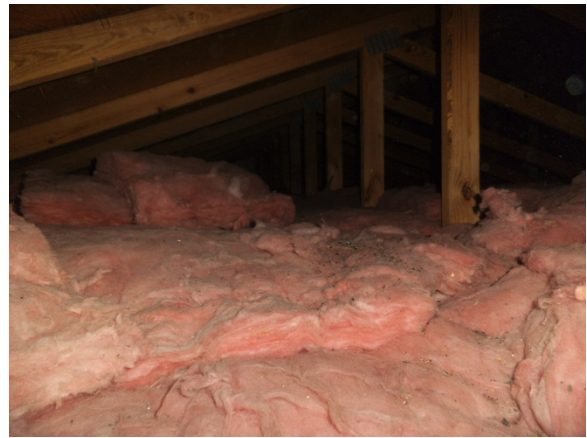
Photo 22: Batt insulation in attic space

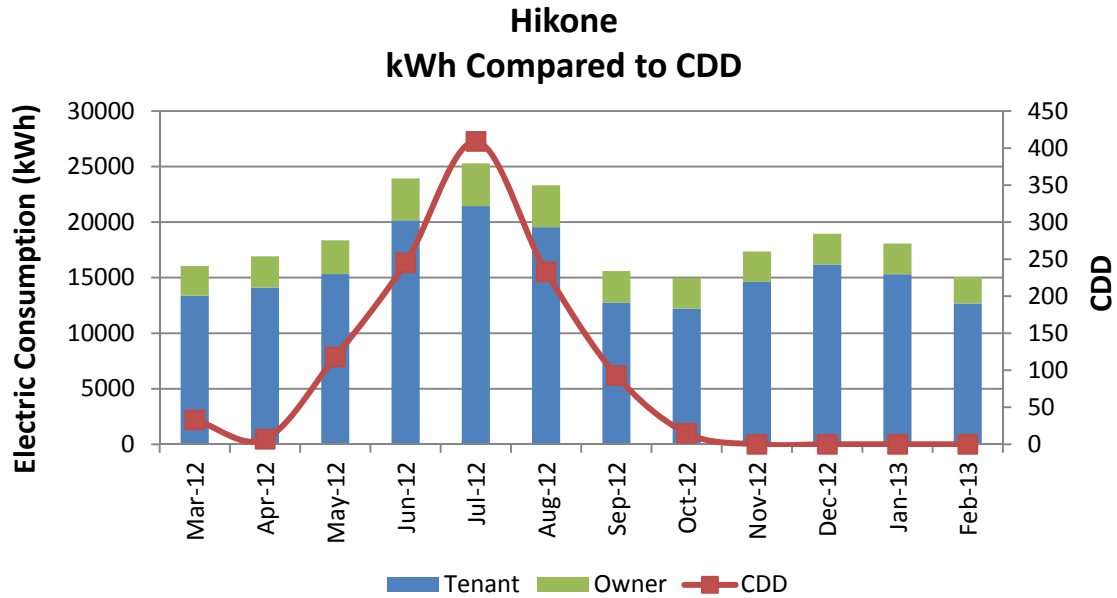
Figure 4.1 Electricity Consumption Graph

The following figure (Figure 4.1) identifies monthly electrical consumption (kWh) in comparison to cooling degree days (CDD). Cooling Degree Days (CDD) are roughly proportional to the energy used for cooling a building, while Heating Degree Days, (HDD) are roughly proportional to the energy used for heating a building. In general, daily degree days are the difference between a base point temperature (65 degrees) and the average outside temperature.

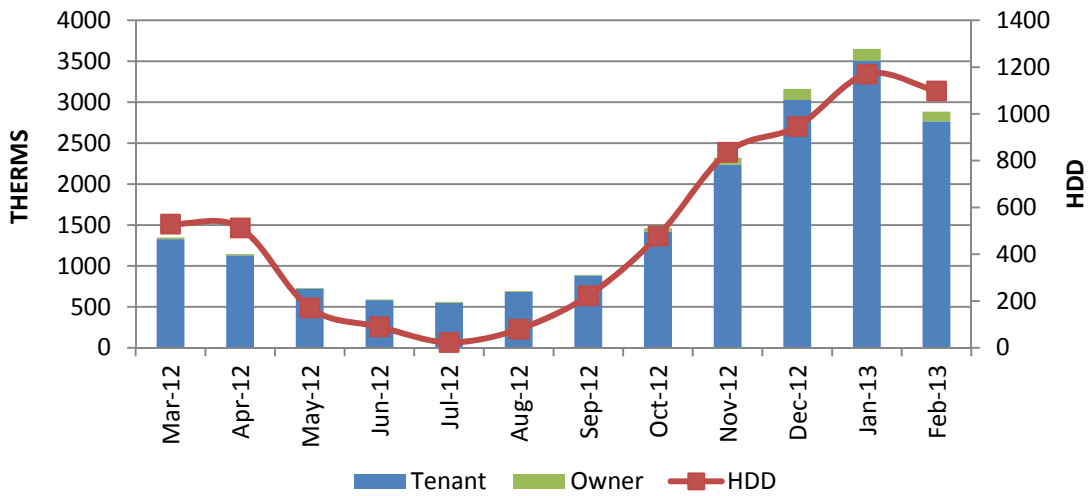
Figure 4.2 Natural Gas Consumption Graph

Hikone Therm Consumption Compared to HDD
