3.0 Part 2: Energy Audit

Rental Assistance Demonstration (RAD): **PART 2: ENERGY AUDIT**

800-890 South Maple Street, Ann Arbor, Michigan 48103
MAPLE MEADOWS

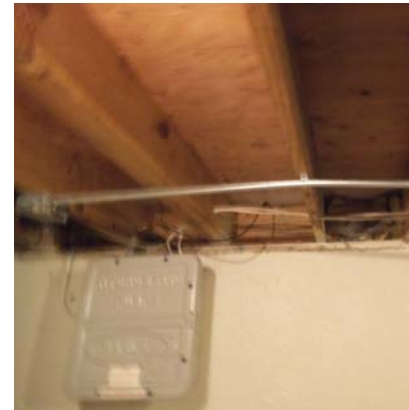
The basement walls appear to be 8” cast-in-place concrete with a poured slab floor. The walls and floor slab appear to be uninsulated. The rim band, or band joist, appears to be insulated with loose fitting fiberglass insulation stuffed in between floor joists at the perimeter. Insulation was visibly missing in some cavities, and the effective R-value of the band joist insulation is limited due to the installation technique. This is generally considered substandard efficiency.

The typical residential unit at Maple Meadows was observed to have Kraft-faced, R-11 insulation tucked into rim cavities in the basement. Almost all areas were poorly installed and many areas were missing insulation completely. Stuffing fiberglass batts between floor joists is a common method of insulating the rim joist in many homes, but it's a flawed technique. Fiberglass works best in an enclosed space where it can trap air (between drywall and the exterior sheathing of a stud wall, for example). In a typical (poorly) insulated fiberglass installation, as observed tenant units, air moves freely around the batts, as well as through the fiberglass itself.

As an alternative, relatively new to the market, two-component spray-foam kits offer a quick, effective solution to tricky insulating problems. The kit consists of two liquid chemicals that mix together in the tip of a gun, and then expand once they hit the surface. The foam is highly adhesive, so it sticks and stays in place as it expands to fill gaps. Once cured, the foam provides an effective air seal as well as insulation.

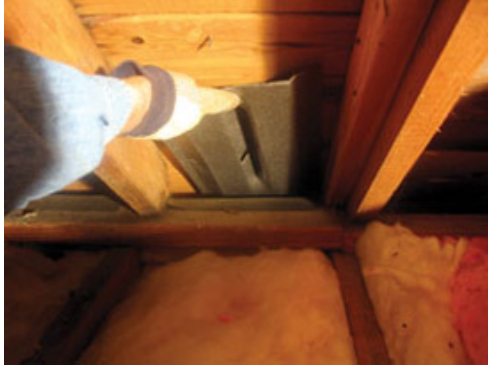
To completely cover your attic floor with insulation out to the eaves you need to install rafter vents (also called insulation baffles). Complete coverage of the attic floor along with sealing air leaks will ensure you get the best performance from your insulation. Rafter vents ensure the soffit vents are clear and there is a channel for outside air to move into the attic at the soffits and out through the gable or ridge vent. To install the rafter vents, staple them directly to the roof decking. Rafter vents come in 4-foot lengths and 14-1/2 and 22-1/2 inch widths for different rafter spacings. Rafter vents should be placed in your attic ceiling in between the rafters at the point where your attic ceiling meets your attic floor.

Once they are in place, you can then place the batts or blankets, or blow insulation, right out to the very edge of the attic floor. Note: Blown insulation may require an additional block to prevent insulation from being blown into the soffit. A piece of rigid foam board placed on the outer edge of the top plate works very well for this.

If the attic insulation is increased, be sure to do any required air sealing first. Also, rafter vents (insulation baffles) will likely be required to achieve the desired insulation depth near the eaves. The following is from the Energy Star website regarding rafter vents:

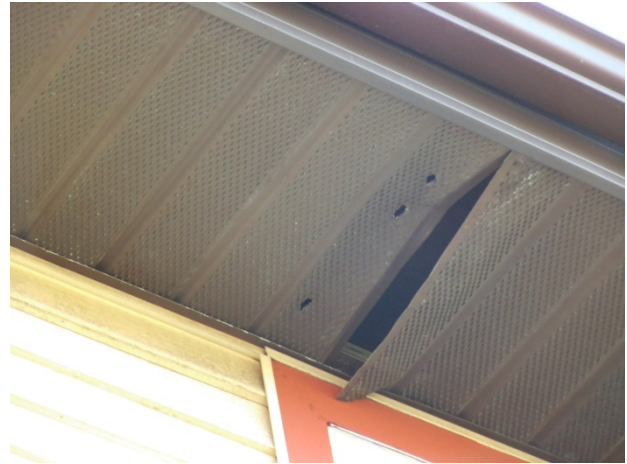
Photo 4: Broken soffit vents at complex

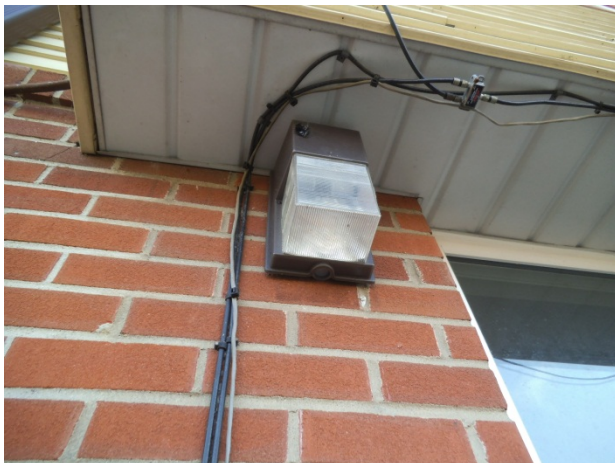
Photo 5: Typical exterior wall-mounted lights

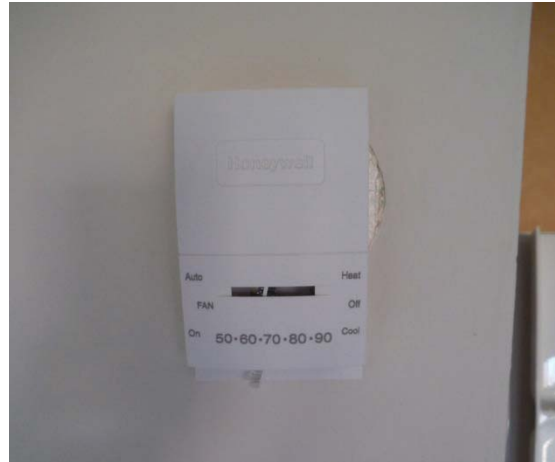
Each apartment is equipped with a natural gas-fired up-flow furnace, located in the basement. None of the units have central air conditioning. The furnaces are typically Carrier brand units, Model #88PAV090 with an input rating of 88,000 Btu/h and an output capacity of 71,000 Btu/h for an overall efficiency of 80%. These units appear to have been installed in 2001 and are considered standard efficiency units. Each furnace appears to be controlled by one non-programmable thermostat.

Photo 8: Typical manual thermostat

It is recommended that a programmable thermostat is installed to control the heat. The programmable thermostats would allow a nighttime setback to be employed, thereby saving energy on heating during overnight hours.
