BUILDING DEMOLITION PROJECT

2150 JACKSON, 315 DETROIT, 415 W. WASHINGTON & 721 N. MAIN

CITY OF ANN ARBOR

WASHTENAW COUNTY, MICHIGAN
HRC JOB Nos. 20220118, 20230292, & 20240292

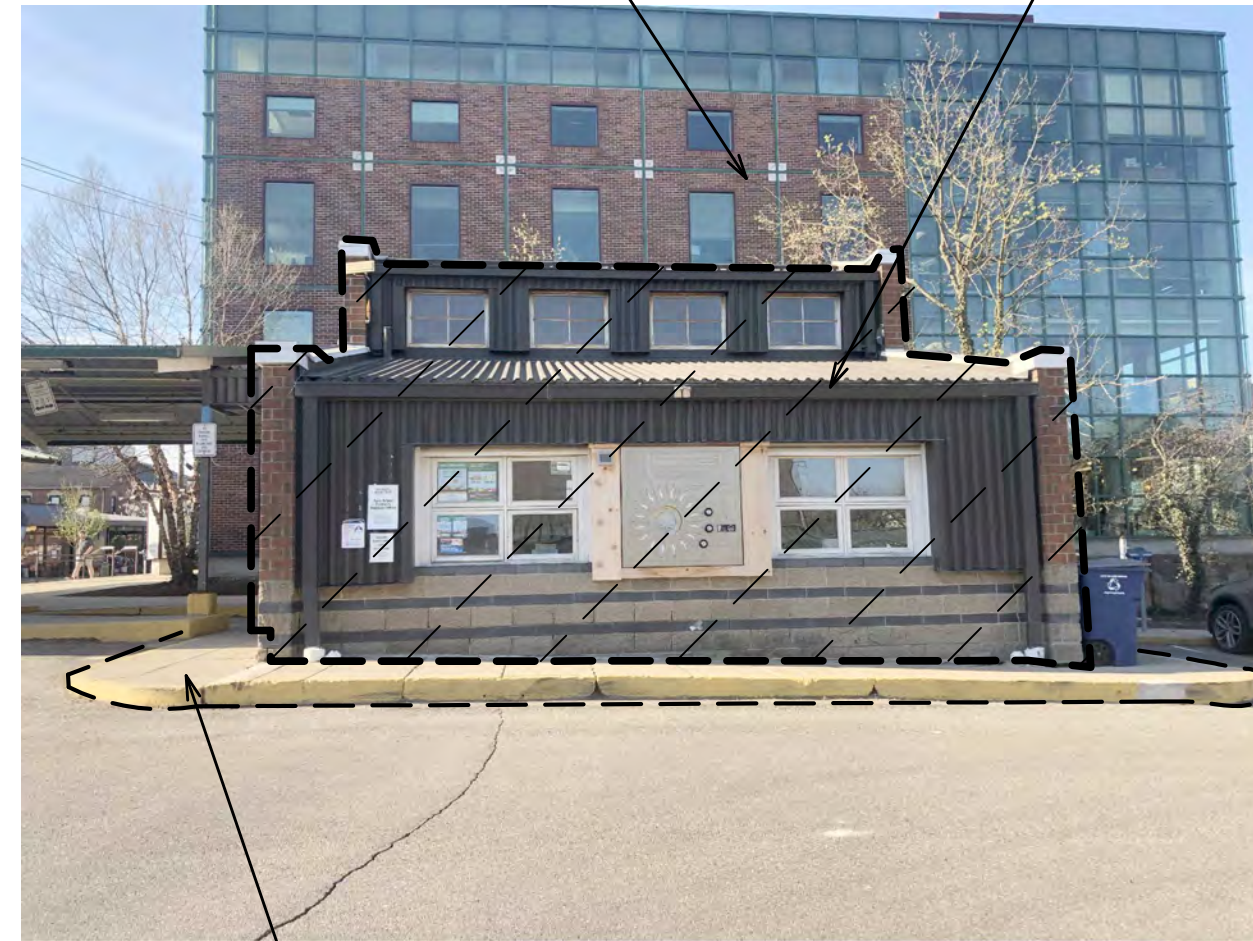
PHOTO NO. 01

EXISTING ADJACENT BUILDING TO REMAIN AND BE PROTECTED DURING CONSTRUCTION (TYP.)

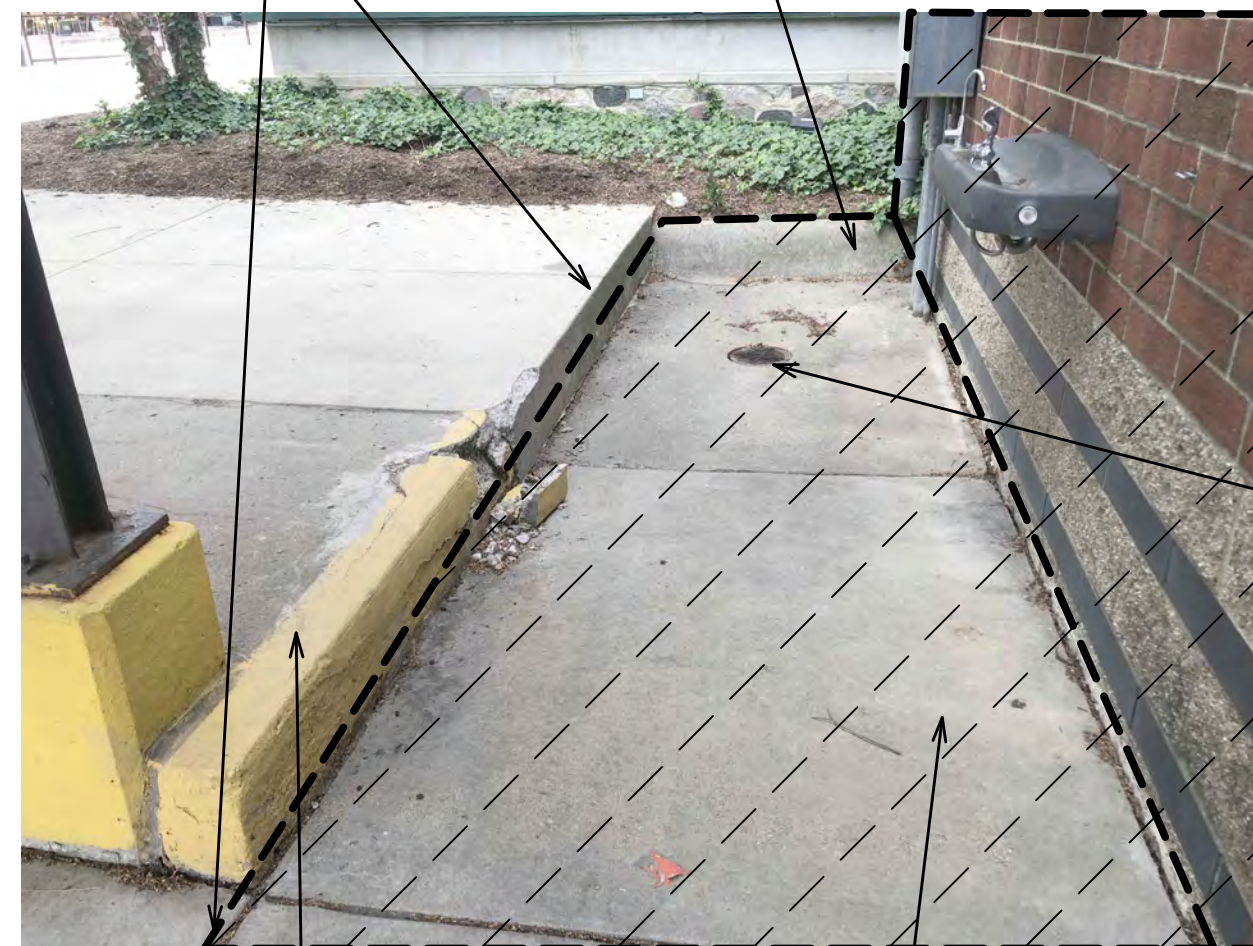
PHOTO NO. 05

EXISTING SIDEWALK AROUND STRUCTURE TO BE REMOVED (TYP.)

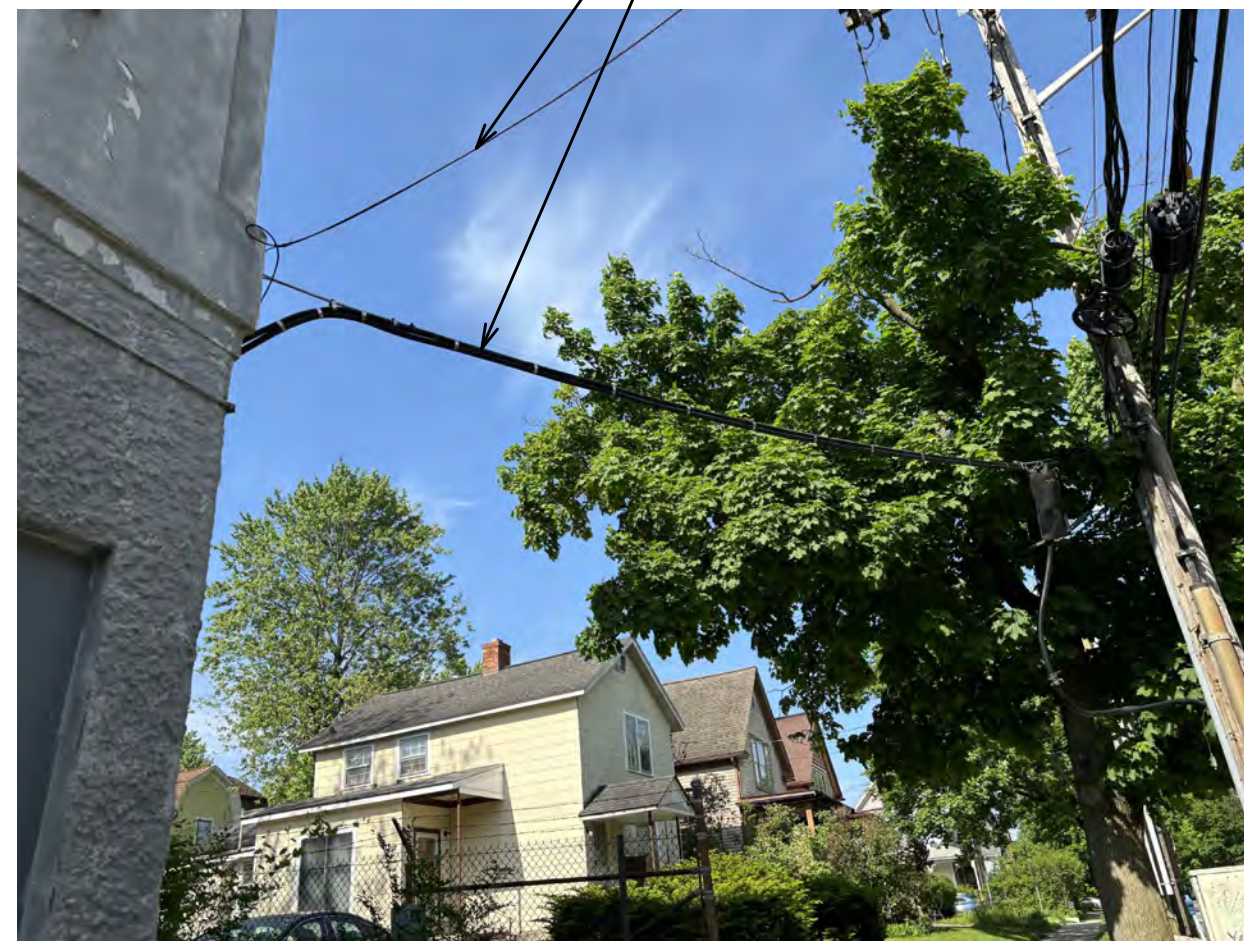
PHOTO NO. 11

EXISTING ABOVE GRADE EXPOSED POWER AND FIBER LINES TO BE REMOVED BACK TO SOURCE (TYP. U.N.O.)

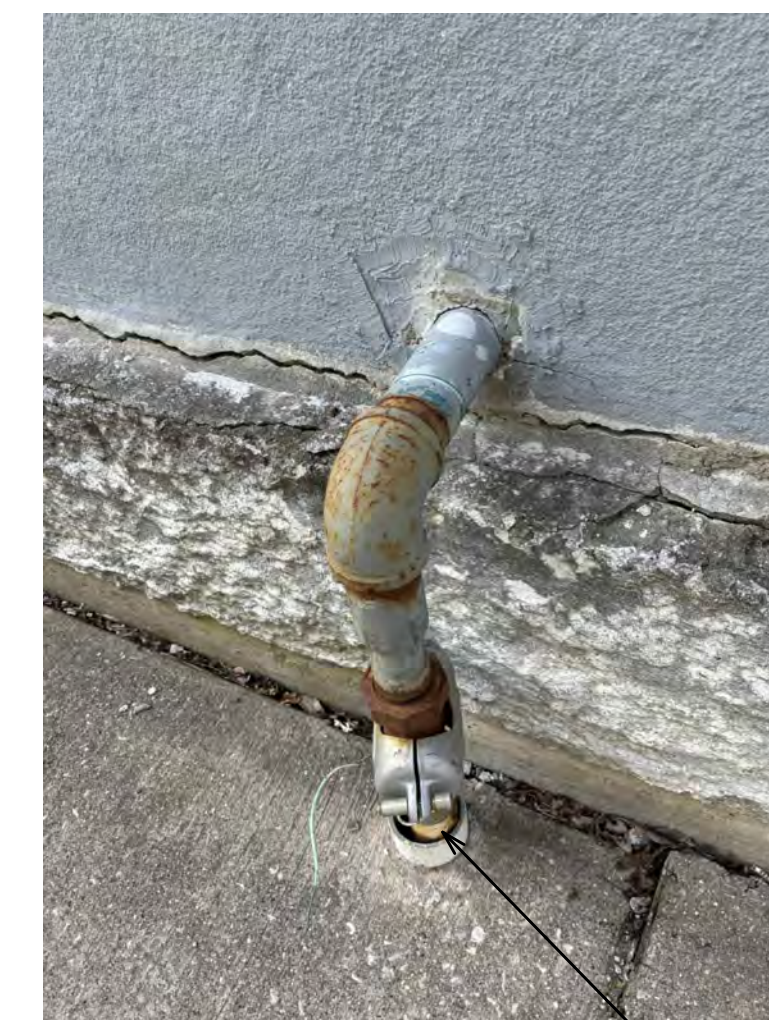
PHOTO NO. 12

EXISTING PIPING PENETRATIONS TO BE REMOVED AND CAPPED FLUSH AT GRADE - SAWCUT AND REPLACE CONCRETE SIDEWALK WITH NEW TO MATCH EXISTING AS REQ'D

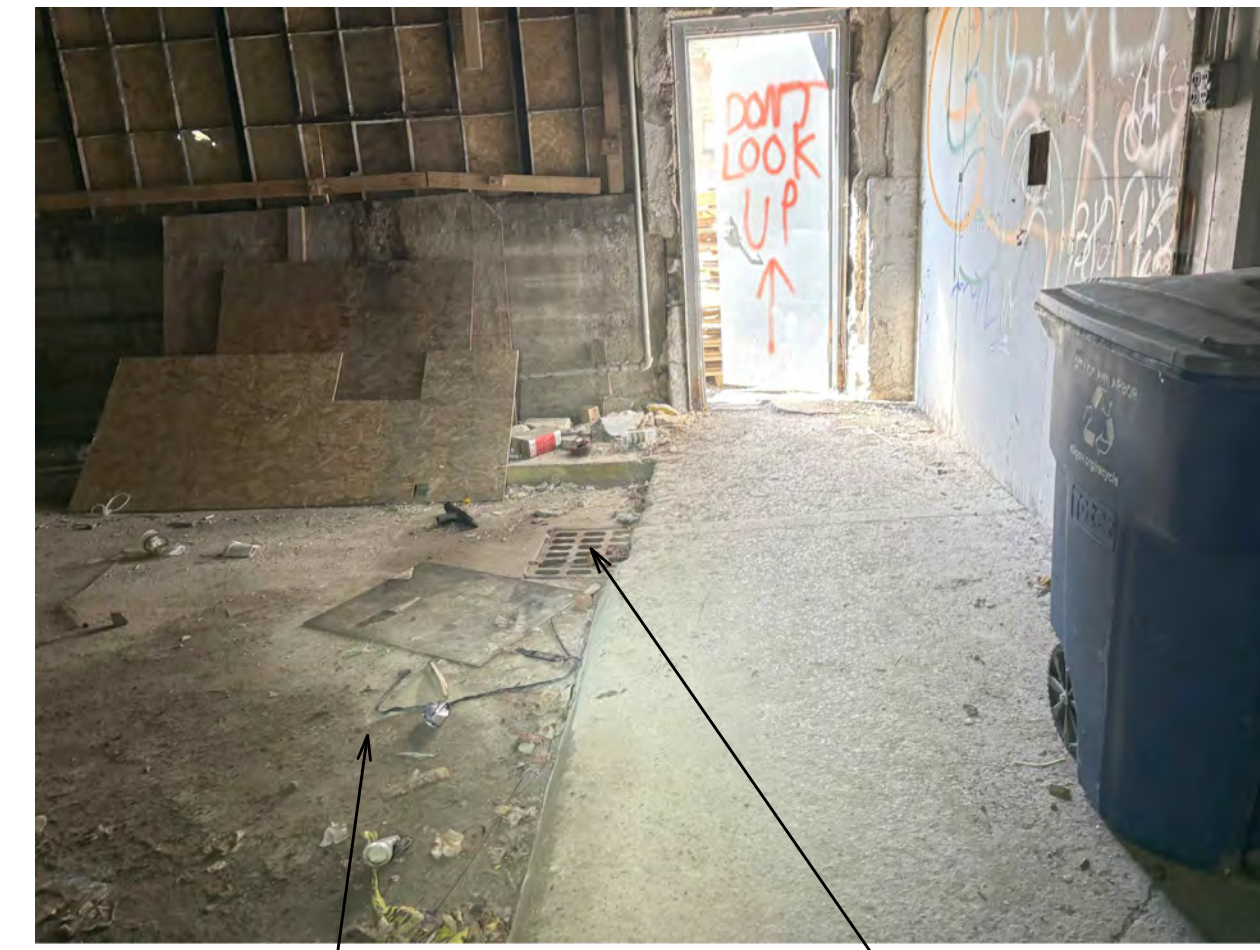
PHOTO NO. 16

REMAINING BELOW GRADE UTILITY STRUCTURES TO BE CRACKED AND FILLED WITH PEA GRAVEL AND CAPPED FLUSH WITH GRADE TO PREVENT PONDING (TYP.)

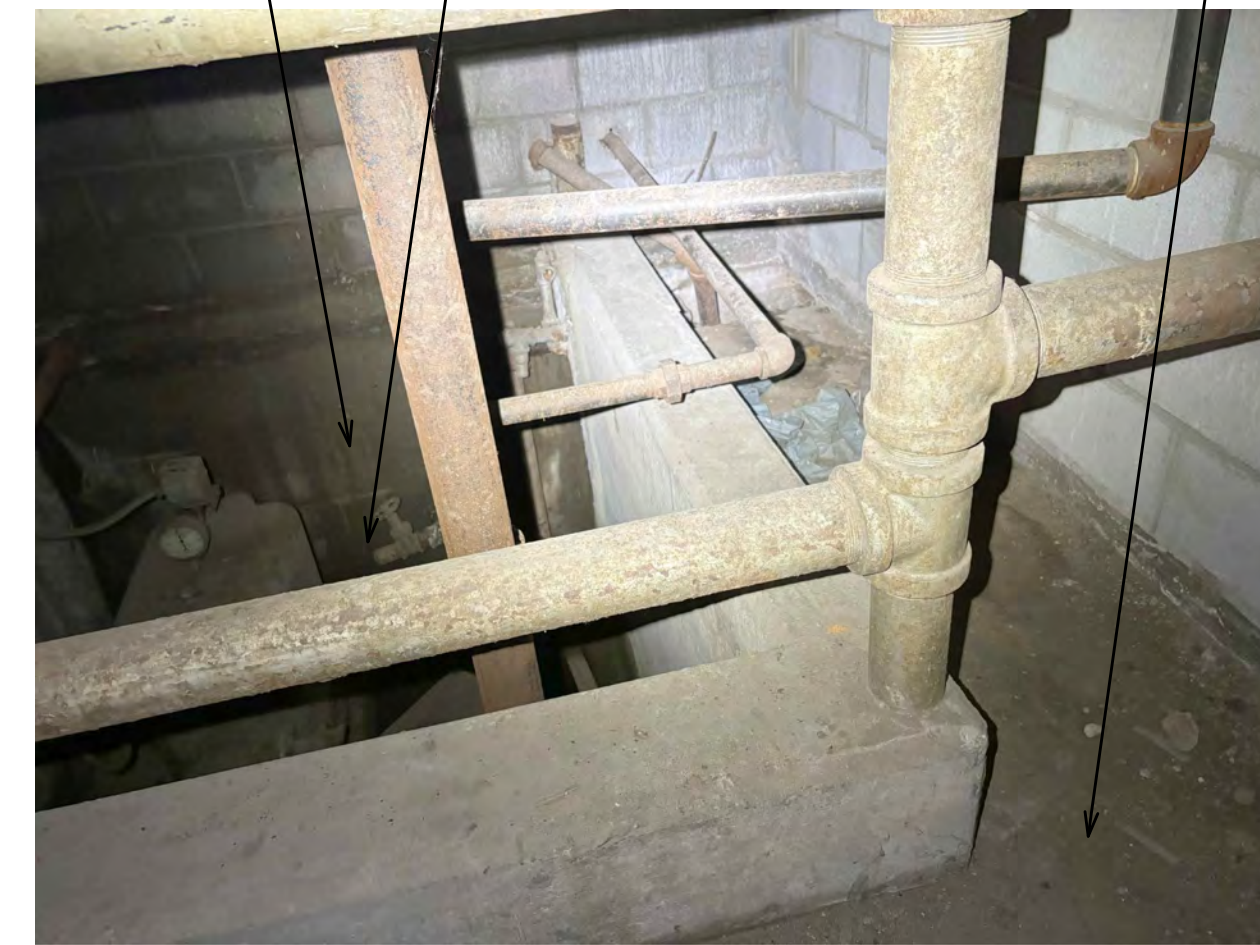
PHOTO NO. 24

EXISTING BELOW GRADE PITS TO REMAIN AND BE BACKFILLED TO GRADE - REMOVE EQUIPMENT, PIPING, AND LOOSE DEBRIS PRIOR TO BACKFILLING (TYP.)

INFILL ALL REMAINING BELOW GRADE PITS AND GRADE OUT ANY REMAINING FLOOR HEIGHT TRANSITIONS AT BUILDING FOOTPRINT WITH COMPACTED CLASS II SAND FOR A SMOOTH FINISHED SURFACE TO PREVENT PEDESTRIAN TRIP HAZARDS

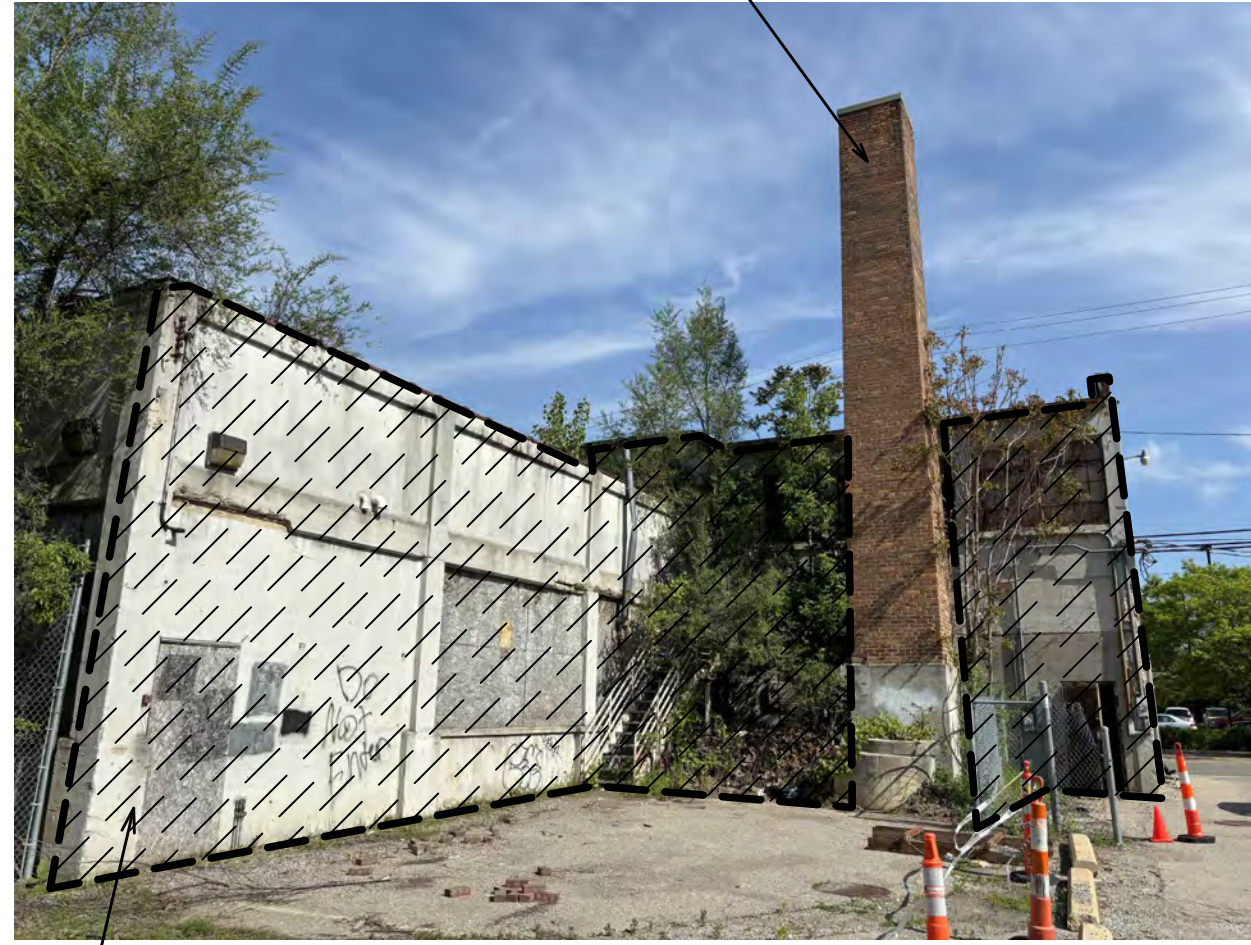
PHOTO NO. 01

EXISTING CHIMNEY TO REMAIN AND BE PROTECTED

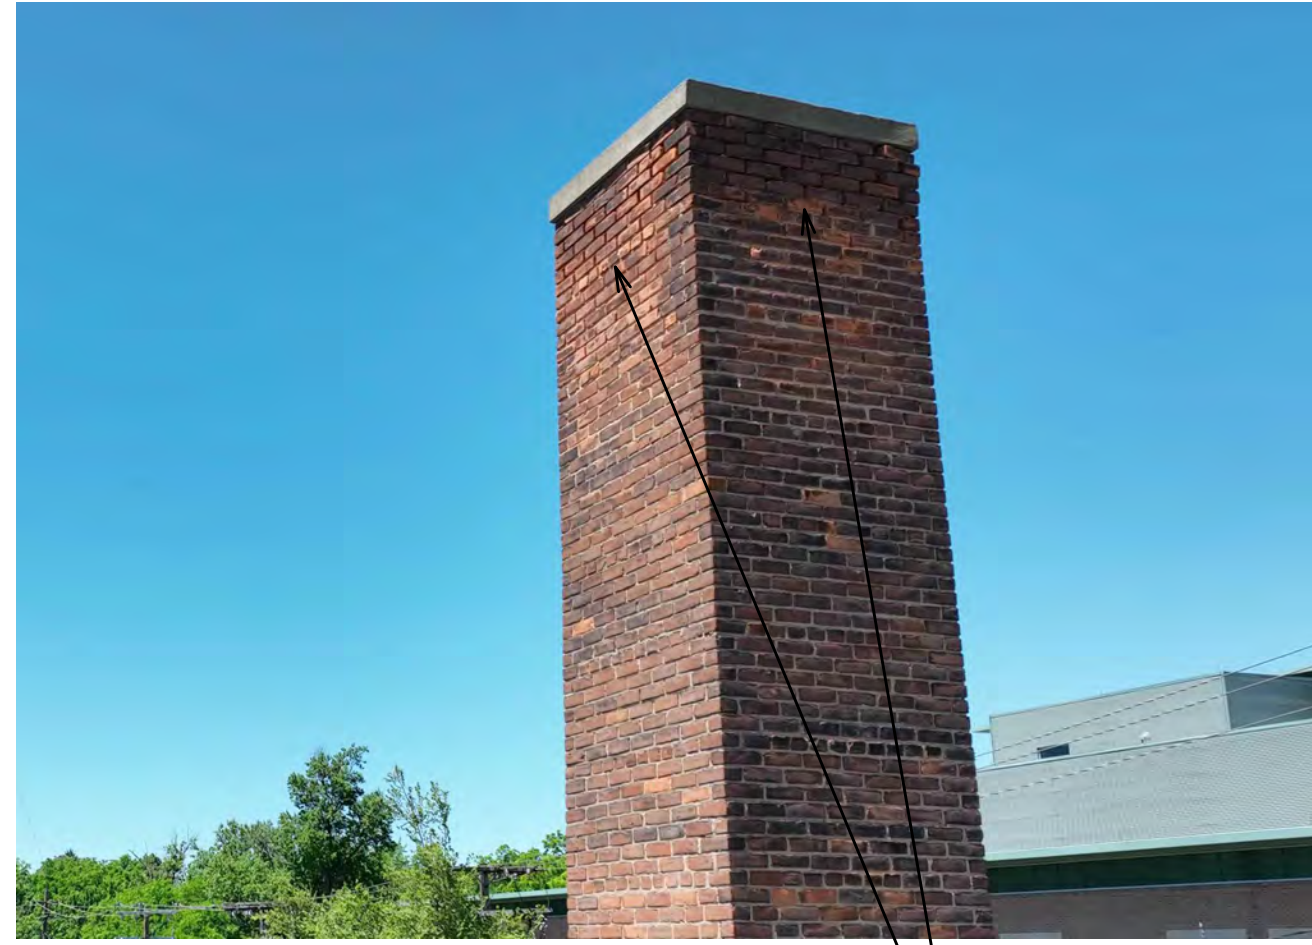
PHOTO NO. 02

SALVAGE 250 BRICK MASONRY UNITS FOR REUSE IN CHIMNEY

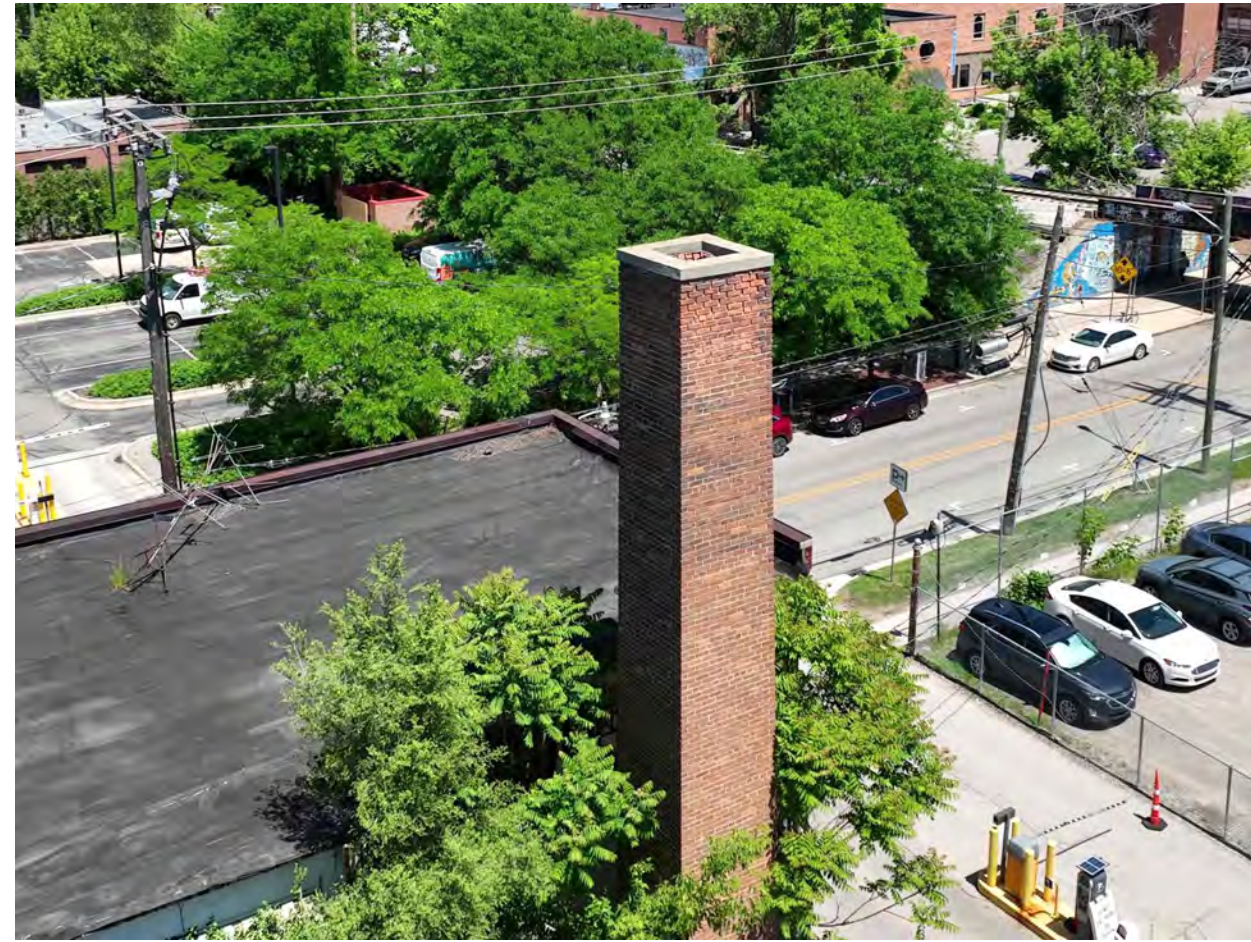
PHOTO NO. 03

RAKE- OUT LOOSE MORTAR AND REPOINT THE BED AND HEAD JOINTS IN THE TOP 4' OF COURSES ON THE EXTERIOR AND INSIDE THE SHAFT

- DETERIORATED MORTAR JOINTS IN EXISTING BUILDING MASONRY, AND OTHER AREAS THAT MAY BE SHOWN ON THE DRAWINGS, SHALL BE CLEANED OUT AND REFILLED WITH FRESH MORTAR.
- ALL NEW MORTAR INSTALLED AS PART OF THIS WORK SHALL MATCH THE COLOR OF THE ADJACENT MORTAR FOR THE AREA BEING WORKED ON.
- JOINTS SHALL BE CONSIDERED DETERIORATED IF THEY ARE ERODED BACK 1/4 INCH OR MORE FROM THE FACE OF THE MASONRY UNITS; MORTAR HAS FALLEN OUT OF THE JOINT; HAIRLINE CRACKS RUN THROUGH THE MORTAR; OR THE BOND BETWEEN MORTAR AND MASONRY UNIT IS BROKEN.

- MORTAR MAY BE REMOVED WITH A HAND-HELD GRINDER, A SMALL MASON'S CHISEL, OR A SPECIAL RAKING TOOL.
 - IF THE GRINDER IS USED TO RAKE VERTICAL JOINTS, CARE SHALL BE TAKEN NOT TO CUT THE BRICK IN THE NEXT COURSE ABOVE OR BELOW THE JOINT.
 - BEFORE TUCKPOINTING, BRUSH ALL LOOSE FRAGMENTS AND DUST FROM THE JOINT OR FLUSH THEM OUT WITH A STREAM OF WATER.

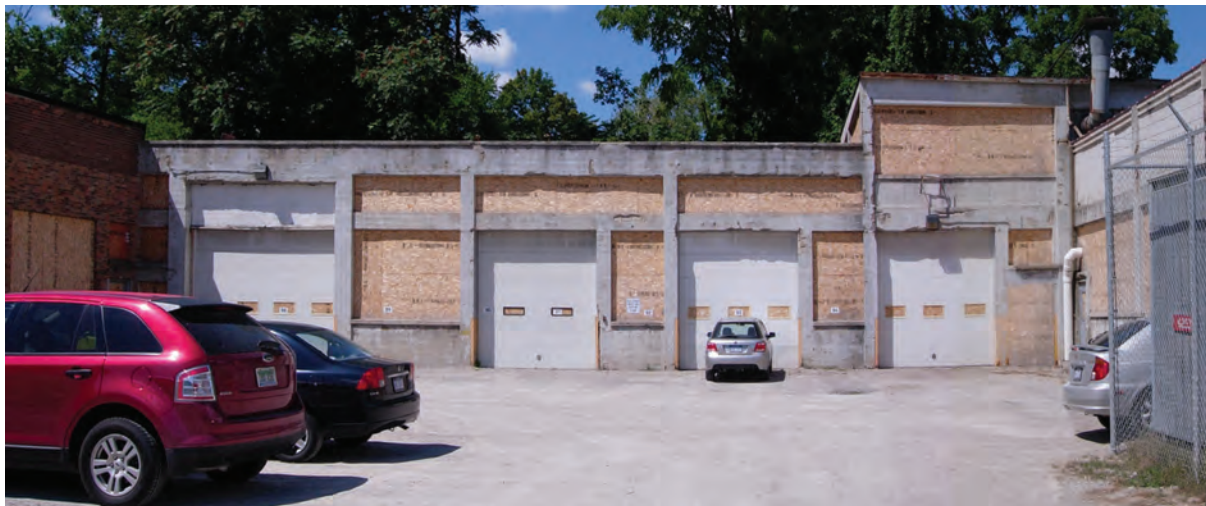
This reinforced concrete frame was a 1928 addition to the two-story building fronting on Washington Street. It extended southward for one two-story bay and then dropped down to a lower high bay repair shop. In the southern-most end was a forge and overhead chain-hoist rail stretching along the whole repair shop length. Most of the rail still remains. This later addition has a different floor and roof structural system. The steel-framed high bay roof has a modern steel deck whose replacement date has not been documented. The deck is supported by older Warren trusses similar to those on the Phase 1 high bay space.

2012 photo of the 1928 addition showing the steel sash covered with OSB board for security.

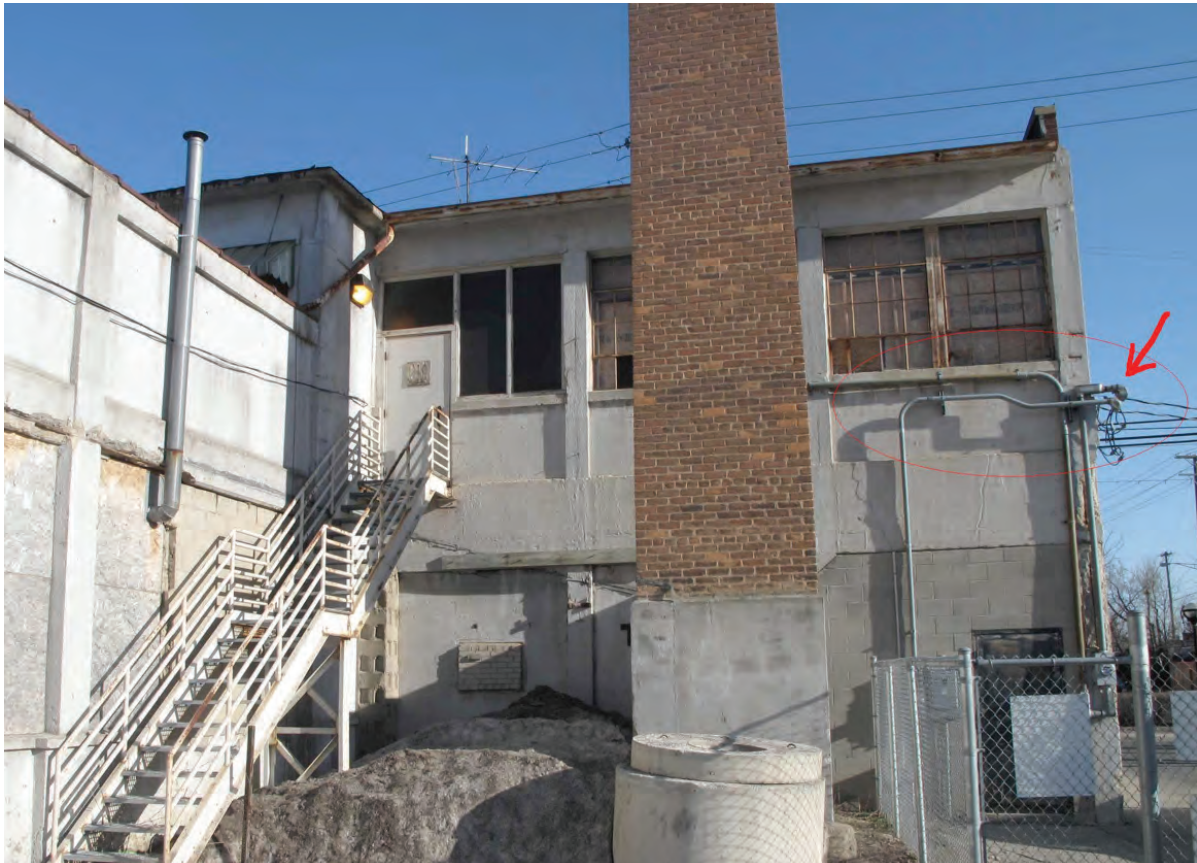
Picture E1: Existing electrical service at corner of buildings A & B

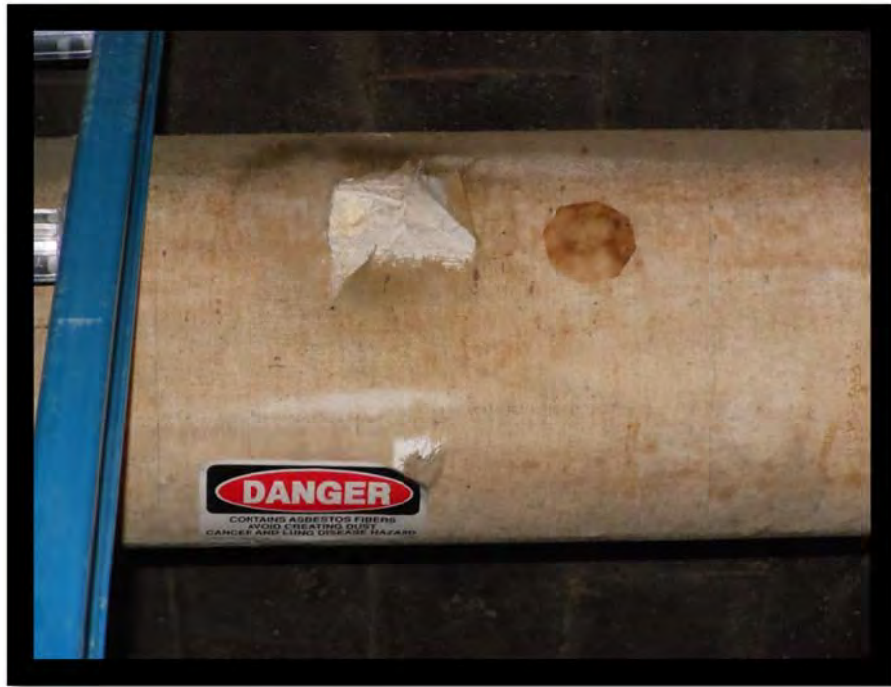
Potential asbestos covered pipes located inside the North Garage

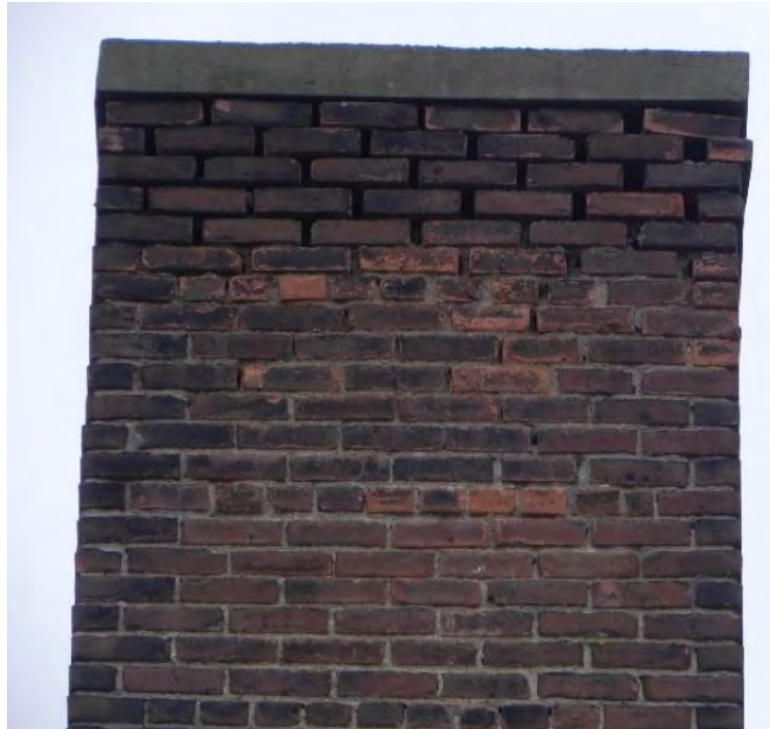
Photoset 1: Loose bricks and lack of mortar joints at top of chimney.

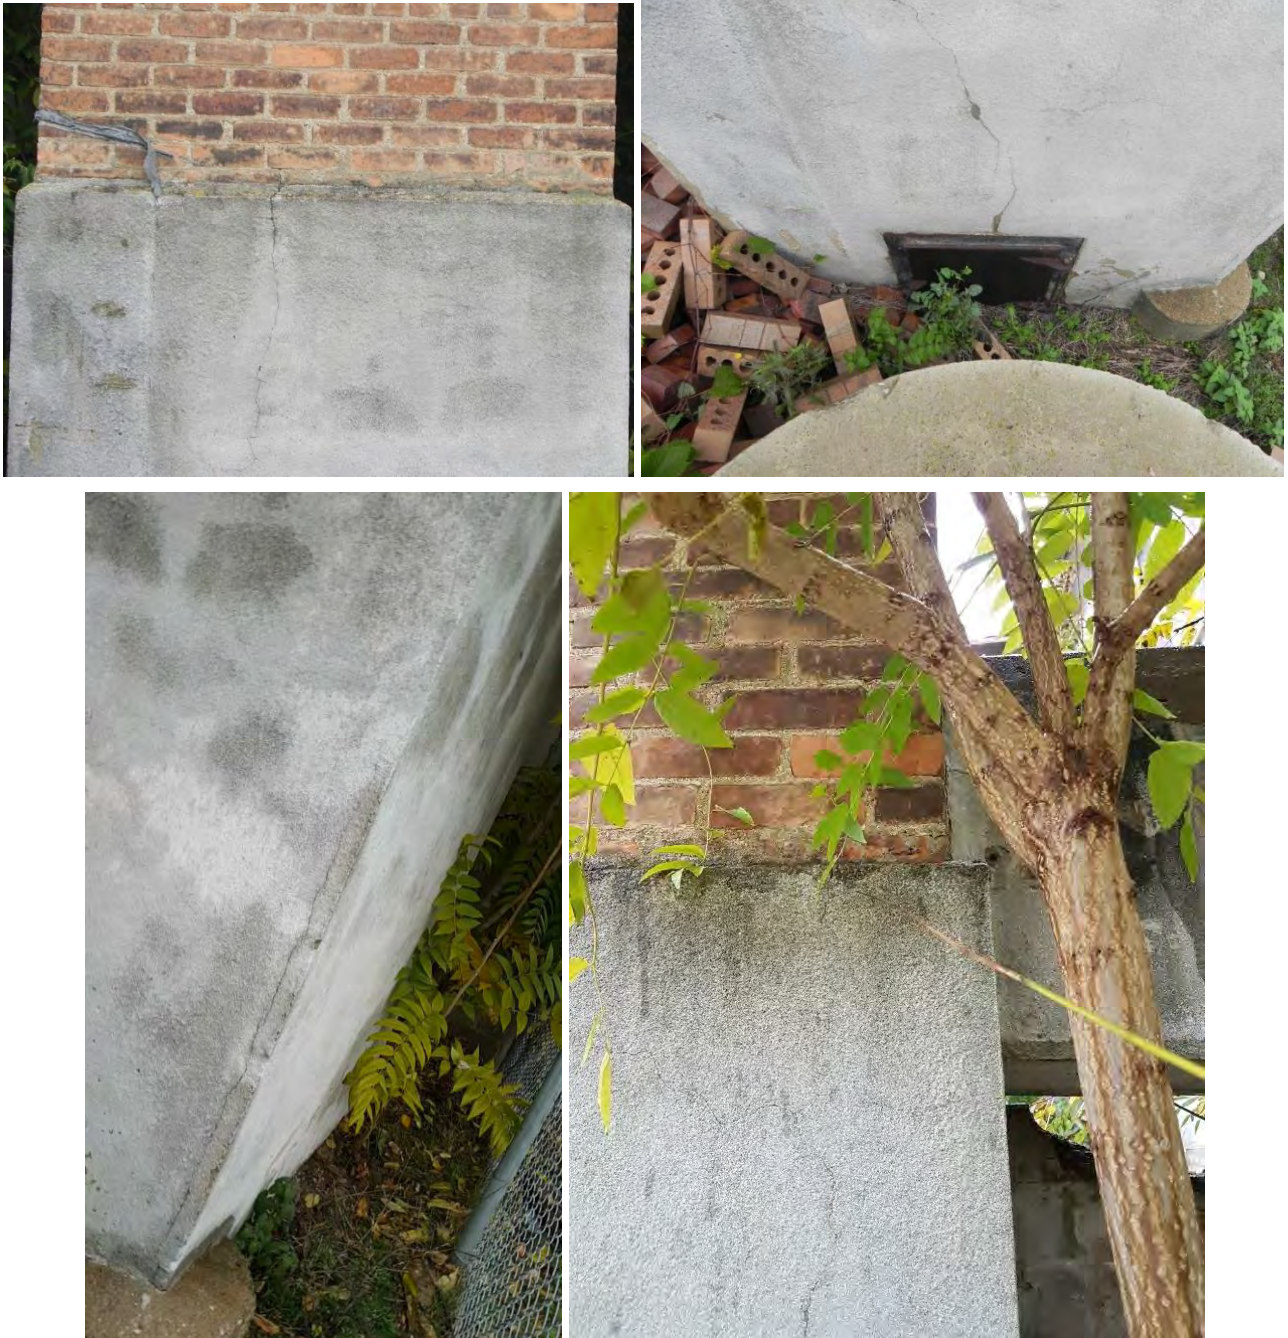
Photoset 2: Major vertical cracks along the south and east sides of the base.

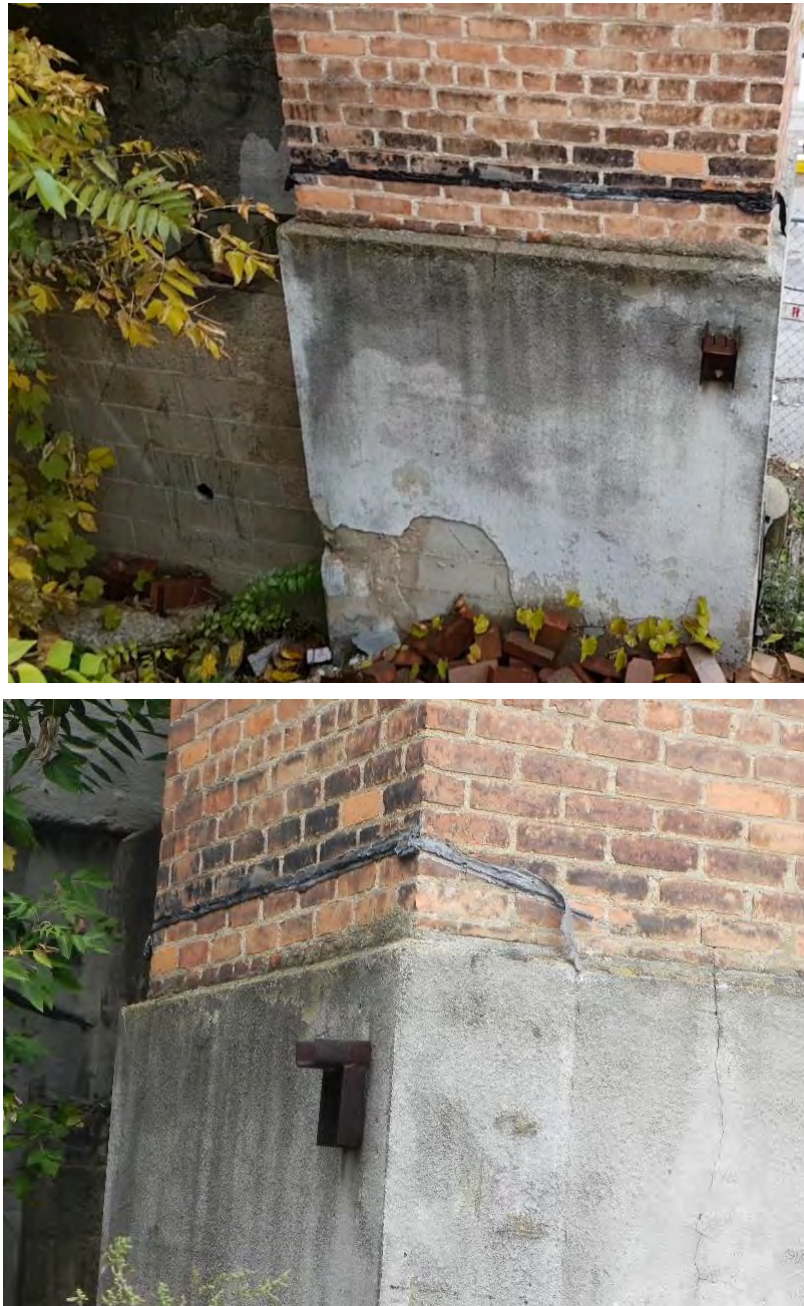
Photoset 3: Major horizontal cracks in brick above the concrete base along south and west sides.

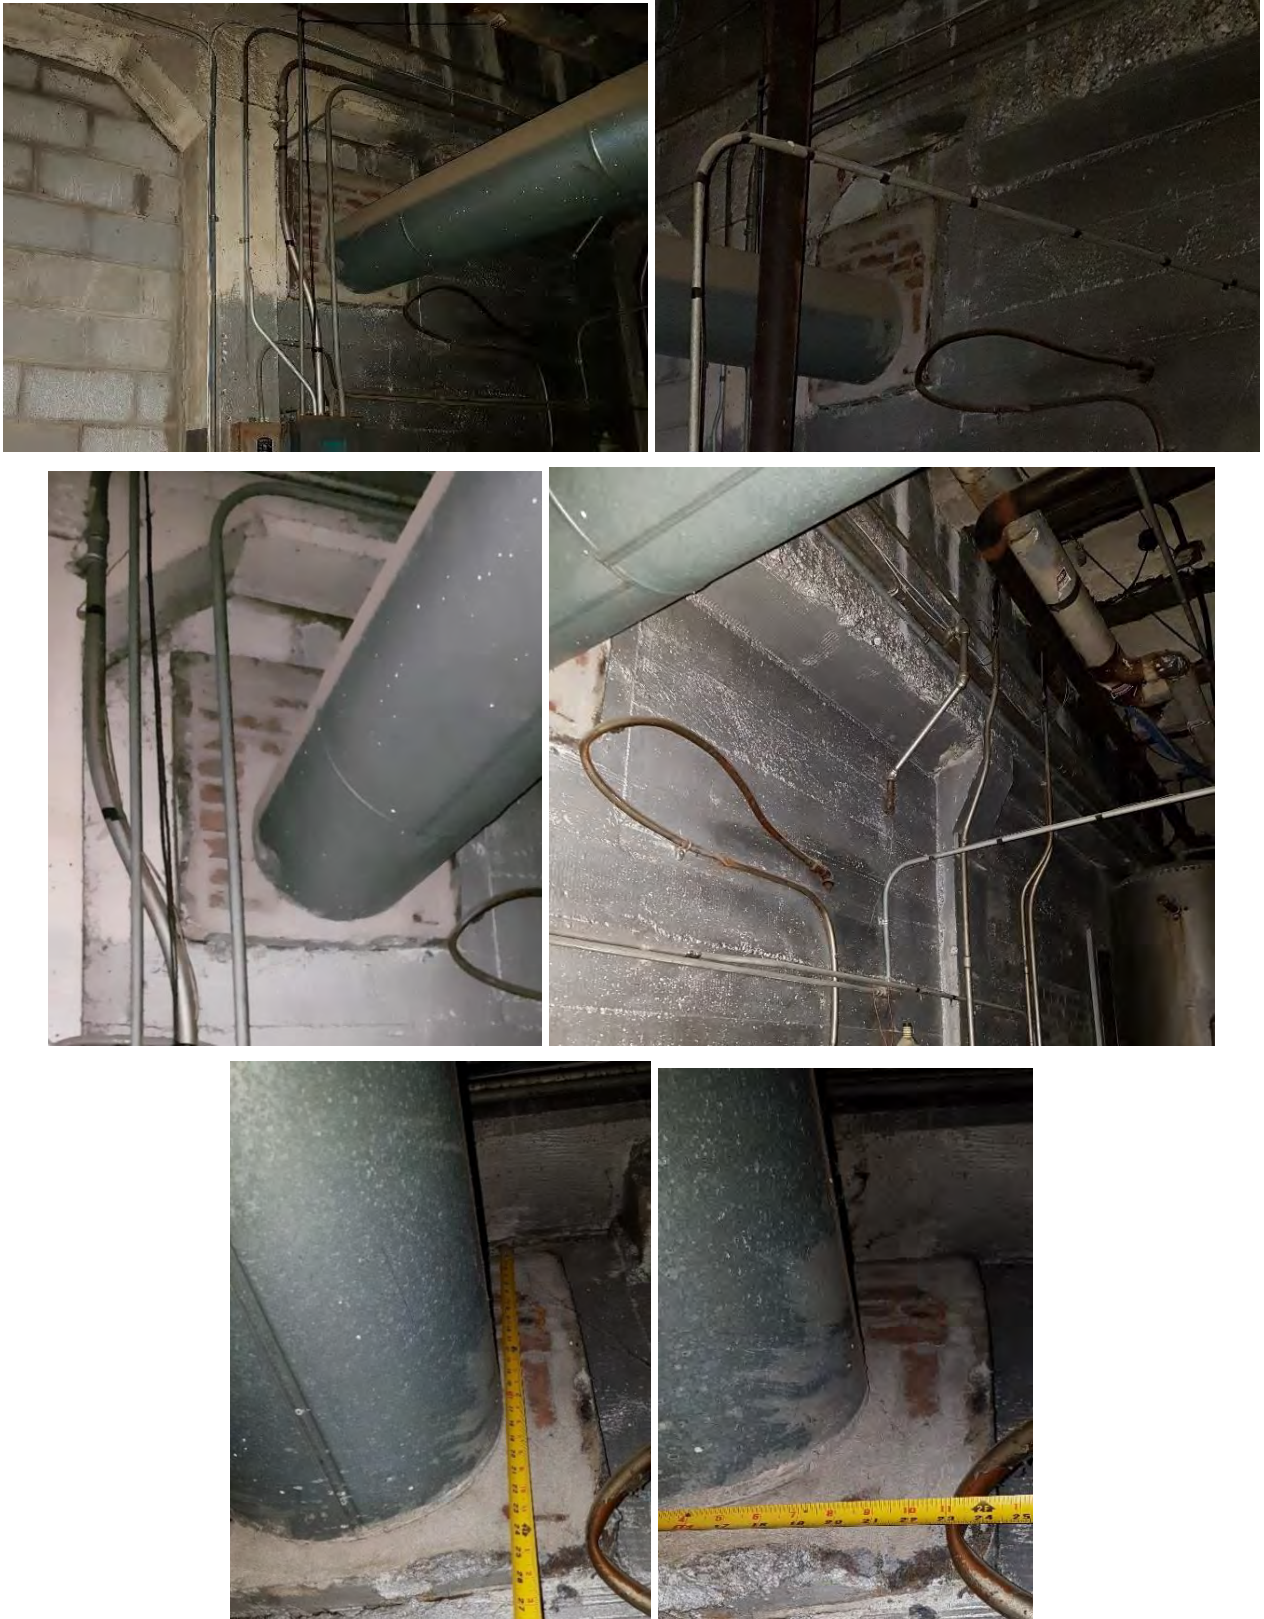
Photoset 5: Extension of the concrete beam end to the inside of the adjacent building.
