Management of Millers Creek Sediment Accumulation Study - Report

Prepared for: The City of Ann Arbor

December 2013

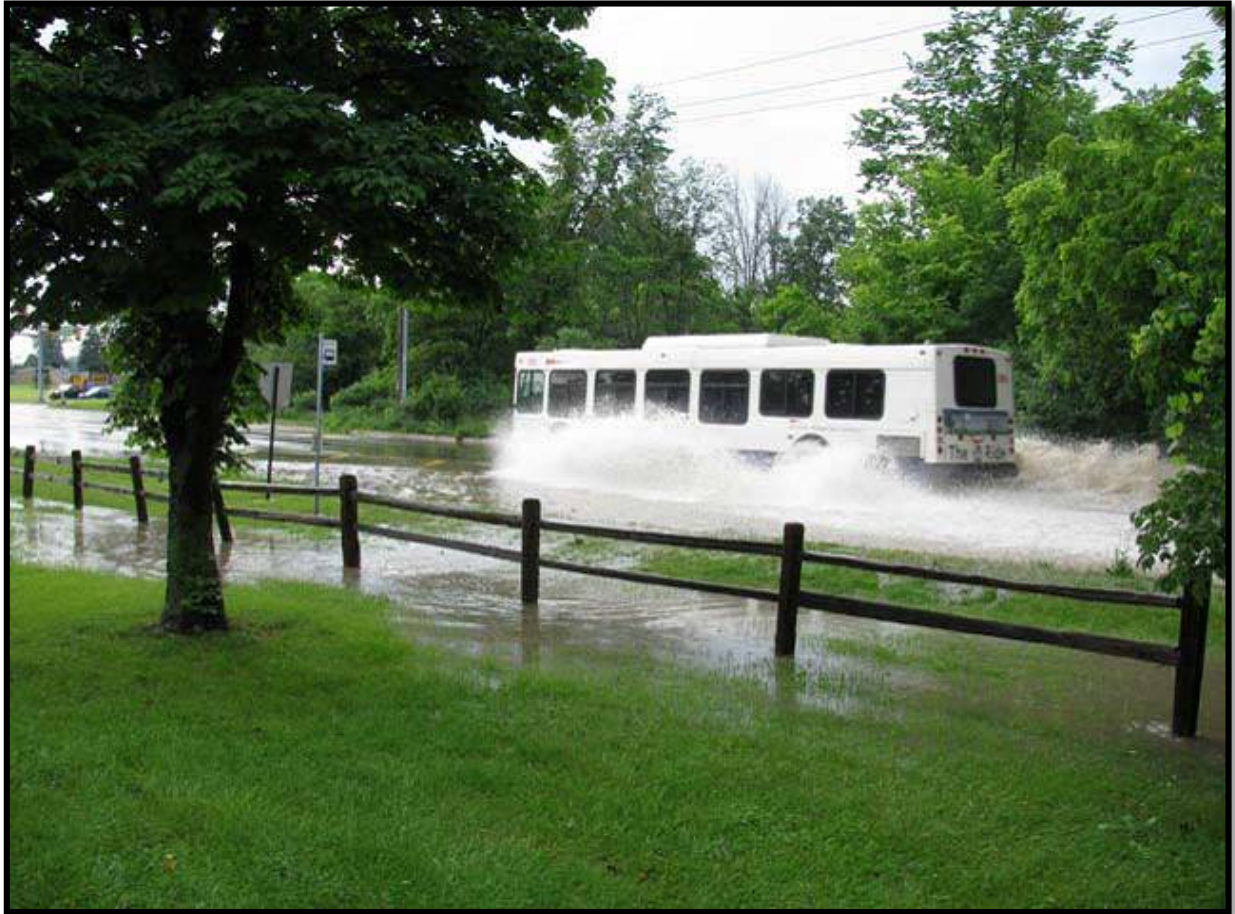
Figure 2. Geddes Road flooding near Gallup Park (foreground) caused by Millers Creek sediment accumulation.

Figure 3 shows the current location of Millers Creek in the Ruthven Nature Area. Normally Millers Creek flows under Geddes Road through a culvert located east of Gallup Park (1) that is designed for that purpose. During flood events, stormwater flows over the banks and along the east side of Huron Parkway (2A). This flow path is the result of sedimentation in the natural channel of Millers Creek (3). Sediment reduces the size of the natural channel and the amount of water that can flow through it. Then water flowing over the banks (2A) has formed a new channel (2B) along the east side of Huron Parkway. The over bank flow is conveyed through a culvert

located west of Gallup Park (4) that is not designed to convey the flow of Millers Creek, resulting in road flooding.

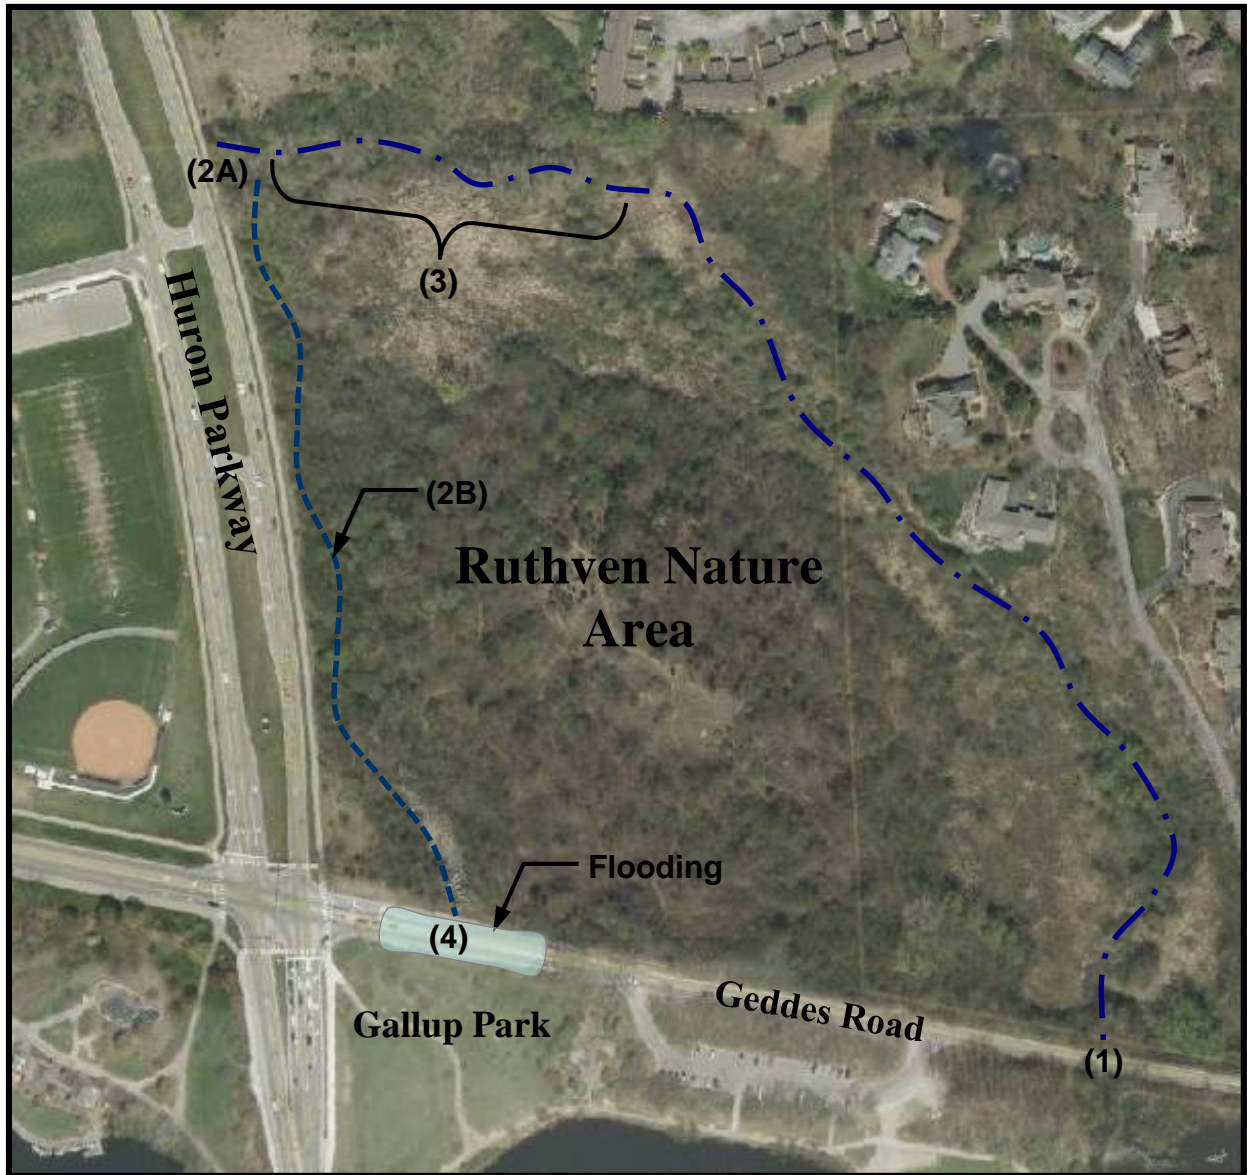
Figure 3. Location of Millers Creek in the Ruthven Nature Area (2010 aerial photography).

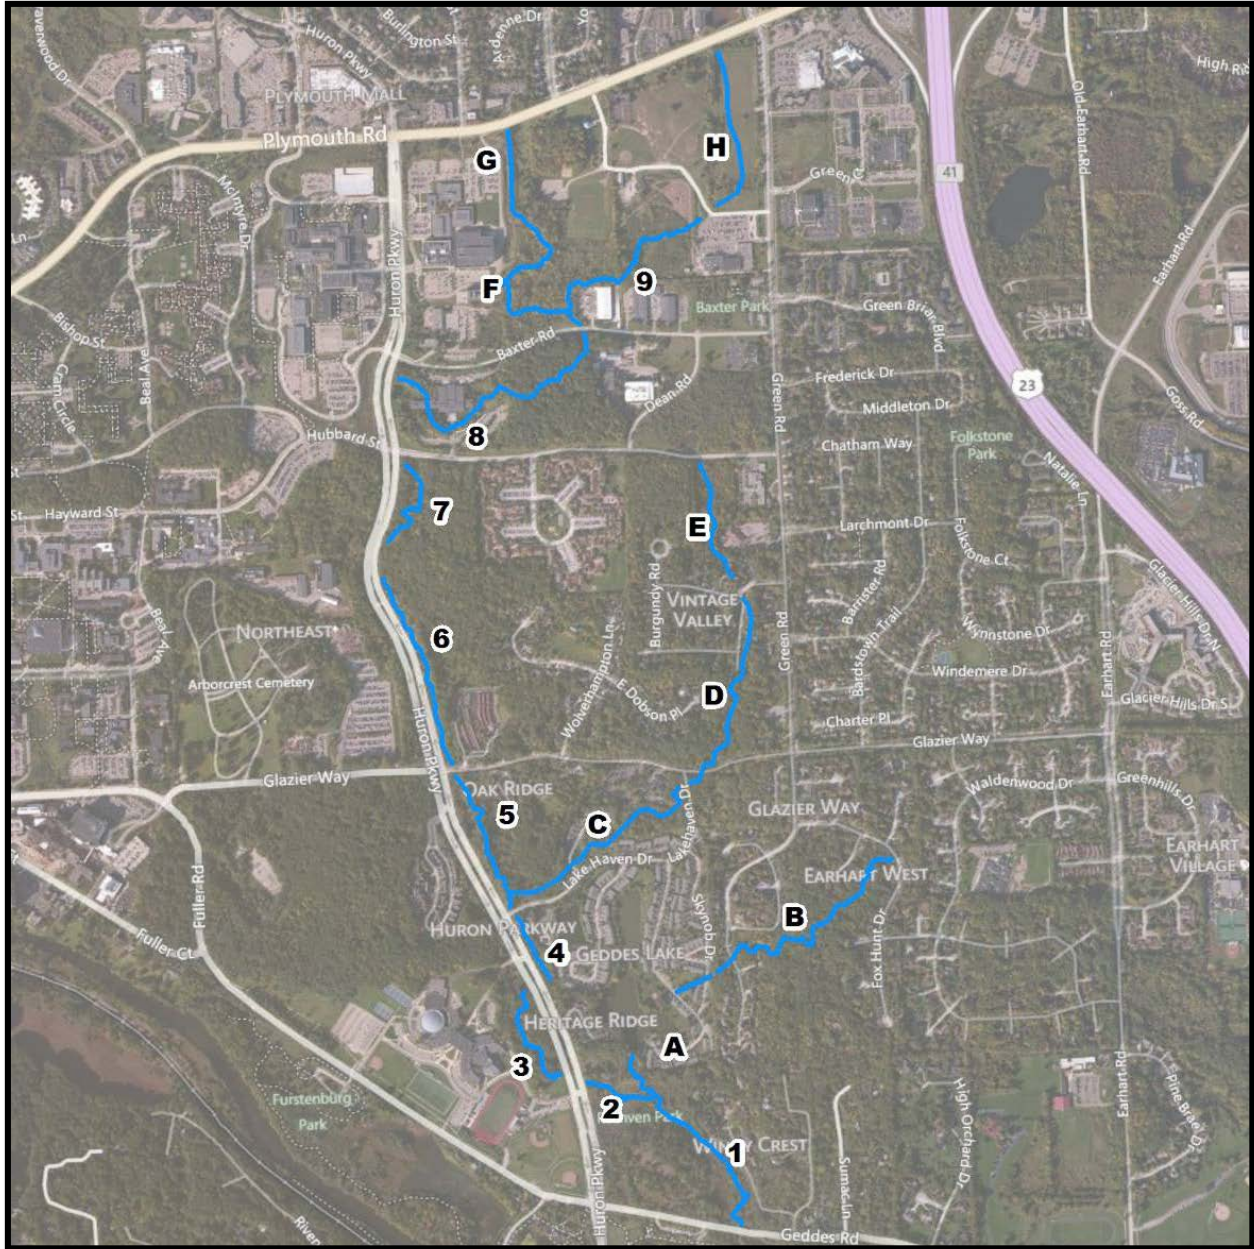
Figure 4. Millers Creek channel network, Washtenaw County, Michigan. Numbers and letters designate study reaches. Reaches 1 and 2 are located in the Ruthven Nature Area.

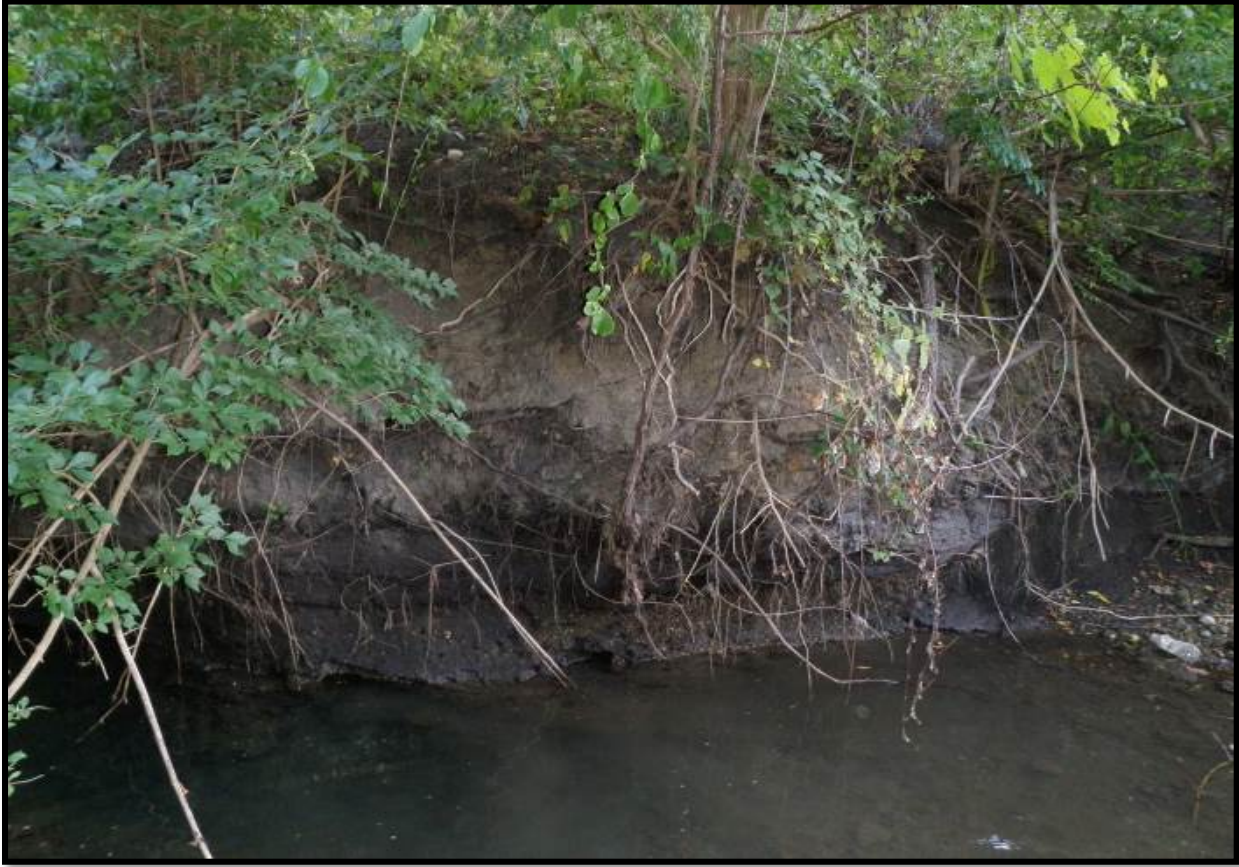
Figure 5. Severe bank erosion in Reach 6.

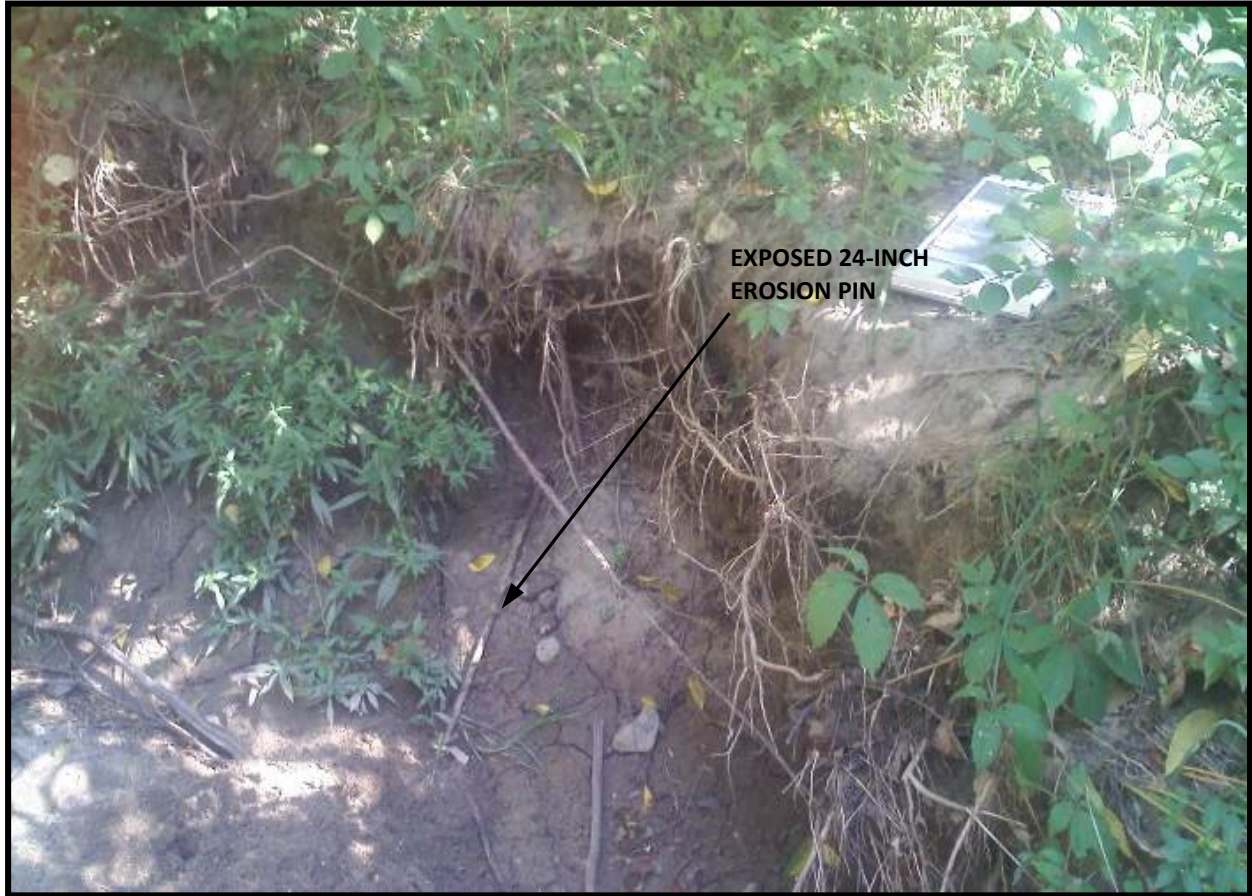
Figure 6. Completely exposed 24-inch erosion pin, Reach F

Six bank erosion pins (**Figure 6**) installed in 2006 by the Huron River Watershed Council (HRWC) and its project partners were measured during the field assessment – one in Reach 7, one in Reach G, and five in Reach F. Calculated annual erosion rates ranged from 0.04 ft/yr to 0.33 ft/yr, with a mean of 0.14 ft/yr. Two of the eroding banks in Reach F with erosion pins had moved more than two feet since installed in 2006. Although the bank erosion rate is not extreme except in isolated locations within any given reach, streambank erosion is extensive within several reaches, particularly Reaches 5, 6, 7, 8, D, and F. In these reaches more than 50% of the streambank length is experiencing accelerated erosion.

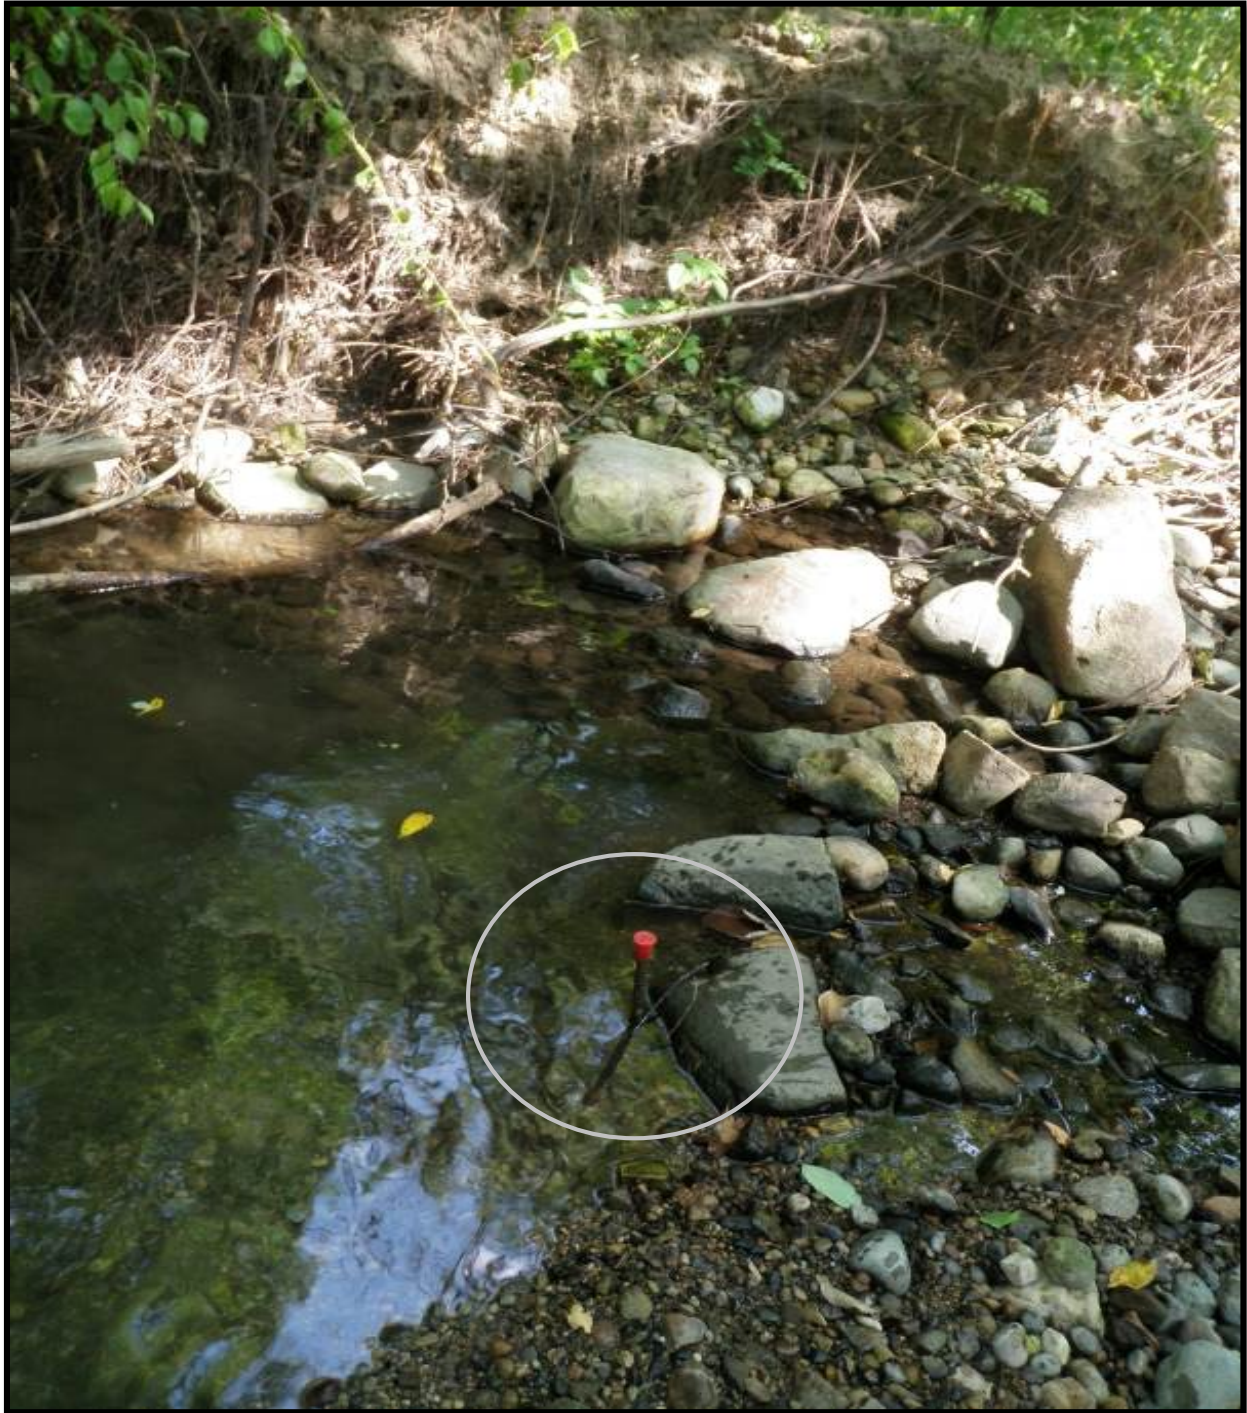
Figure 7. Bed erosion pin installed in Reach 7 in 2006

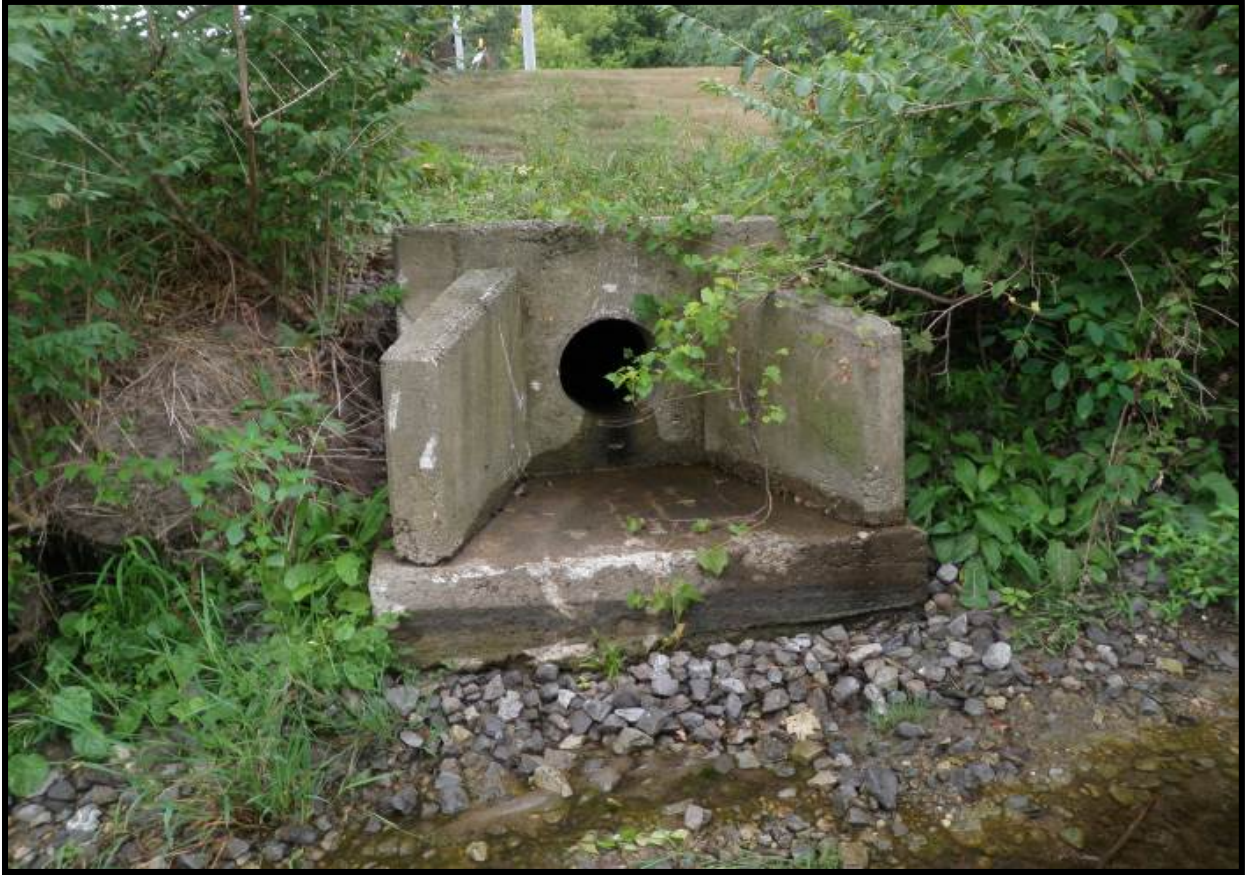
Figure 8. Storm sewer outfall in Reach 4 showing degree of bed lowering

Bed erosion rates were also estimated from four storm sewer outfalls and one road culvert that had been undermined by bed erosion. Three of the storm sewer outfalls are located in Reach 6 and one is located in Reach 4 (**Figure 8**). The road culvert is located in Reach D. Two of the Reach 6 storm sewer outfalls were repaired by the City in 2007-2009 as part of a streambank stabilization project between Hubbard Road and Glazier Way. However, ECT collected data on those two structures during design in 2007. It is assumed that the storm sewer outfalls were all installed by 1970 following completion of Huron Parkway construction in the mid to late ‘60s. The road culvert in Reach D was constructed in approximately 1965 based on review of historical aerial photographs. Using measured distances from the structures to the bed in 2007 and 2012 bed erosion rates were calculated. Rates ranged from 0.03 ft/yr to 0.14 ft/yr with a mean of 0.08 ft/yr. These rates are very similar to the bed erosion pin rates over a more recent period.

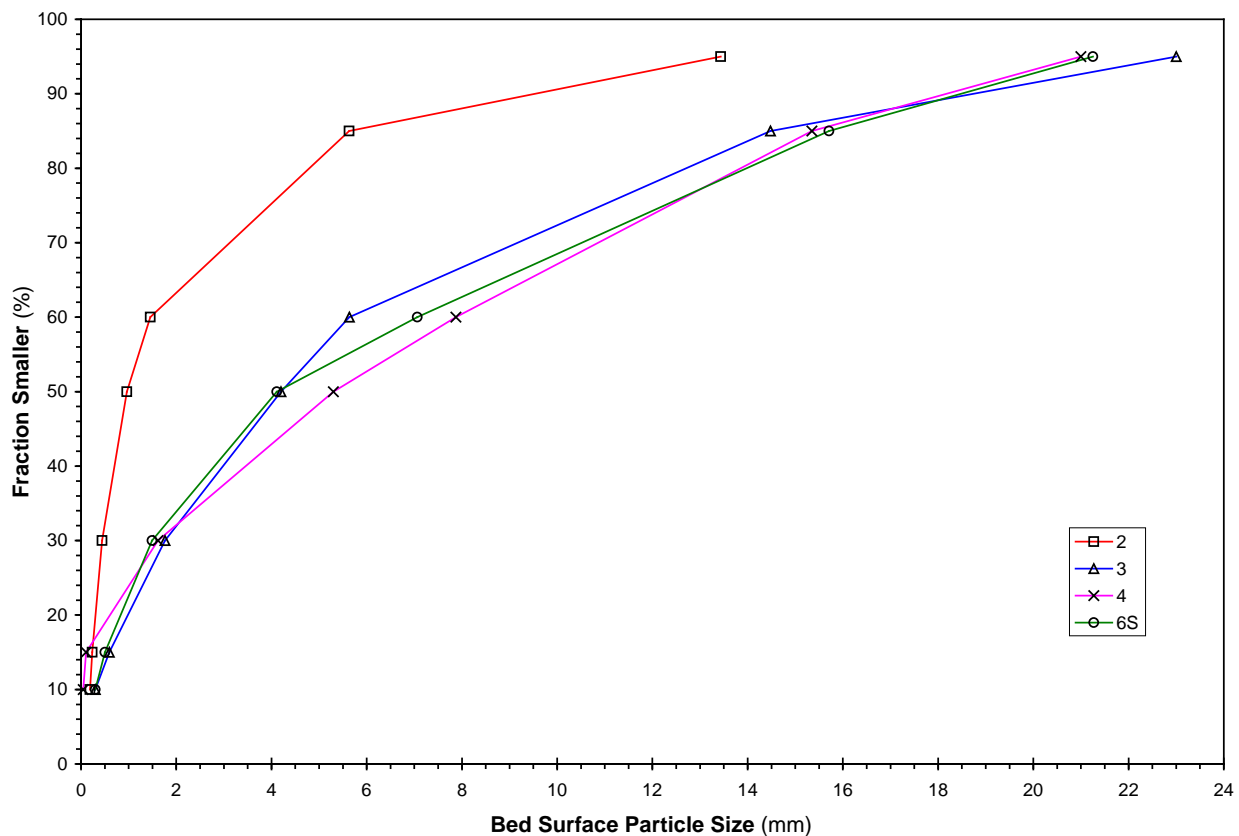
Figure 9. Bed sediment particle size gradation in Reaches 2, 3, and 4 compared to the gradation of sediment stored in the Reach 6 concrete baffle box (6S), Millers Creek, Washtenaw County, Michigan

Particle size gradations are necessary for sediment transport modeling, but the data also serve as a diagnostic tool providing qualitative information about morphological conditions and sediment transport characteristics. A sediment sample was collected from the baffle box and submitted to a lab for sieve analysis. The baffle box is located at the downstream end of a 60-inch culvert enclosure of Millers Creek under Huron Parkway. It stores a limited supply of sediment that is

transported from upstream reaches (7, 8, 9, D, and F). Therefore, the stored sediments are indicative of upstream sediment supply and transport characteristics. It is reasonable to conclude that the sediment is representative of the upstream sediment load from bank erosion. Because the material was transported from upstream, it is also reasonable to conclude that the stream has the capacity to transport the sediment sizes observed in the baffle box. The baffle box sieve data are compared to streambed pebble count data for Reaches 2, 3, and 4 in **Figure 9**. This comparison shows that the material transported from upstream of the baffle box is nearly identical to material on the bed of Reaches 3 and 4. Furthermore, as a source-assessment approach these data verify that the upper watershed can be contributing to sediment aggradation in Reaches 2 and 3 based on material character alone. That is, reaches upstream of the baffle box are producing and transporting sediments similar to the sand and gravel observed on the Ruthven Nature Area streambed.

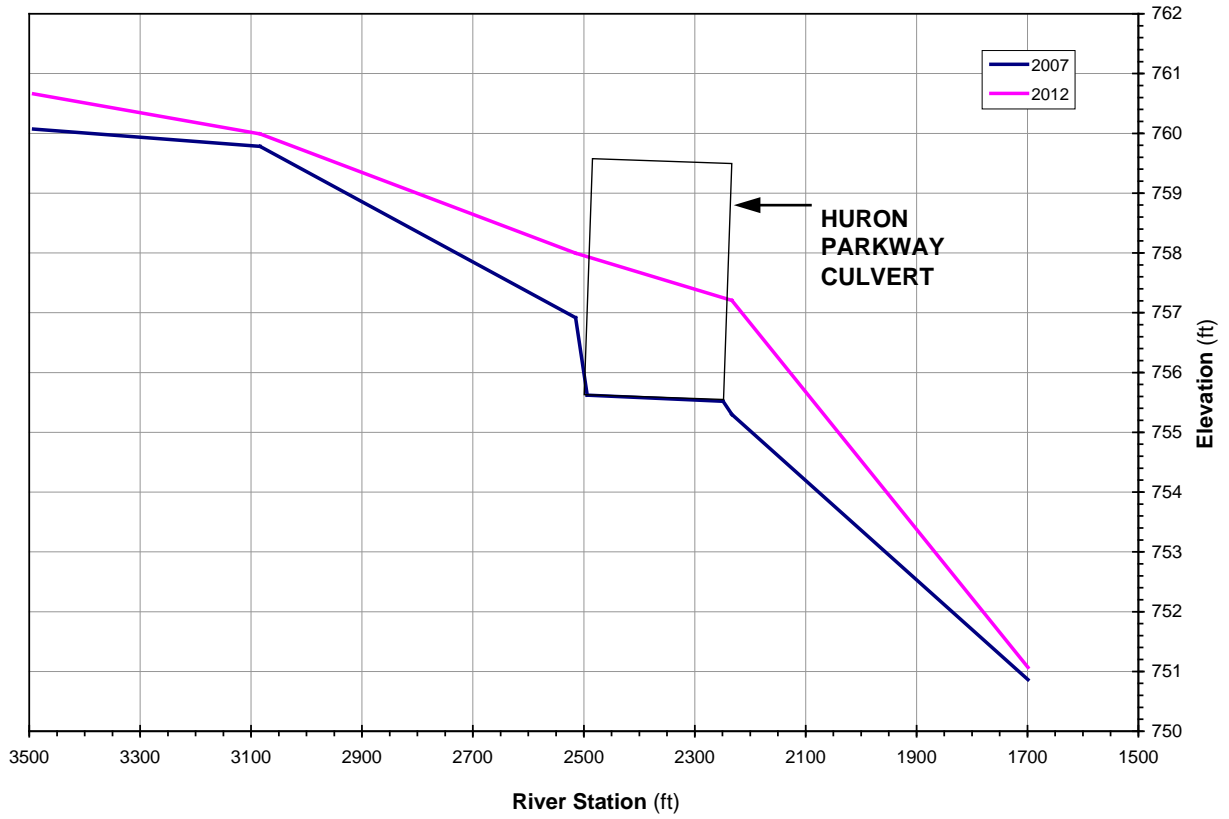
Figure 10. Reach 3 and 2 model predicted 2007 and 2012 bed profiles showing increase in bed elevation resulting from sediment deposition, Millers Creek, Washtenaw County, Michigan

Figure 10 shows the bed profile through Reaches 3 and 2 based on the average bed elevation of the 2007 and 2012 cross-sectional model output. **Figures 11 through 15** show the cross-sectional changes in bed elevation predicted by the sediment transport model through Reaches 3 and 2. The sediment transport model predicted 234 tons of sediment deposition through Reaches 3 and 2 between 2007 and 2012 or 47 tons per year, resulting in an average increase in the bed elevation of 0.84 feet. The maximum predicted bed elevation increase was 2.5 feet, which occurred downstream of the Huron Parkway culvert.

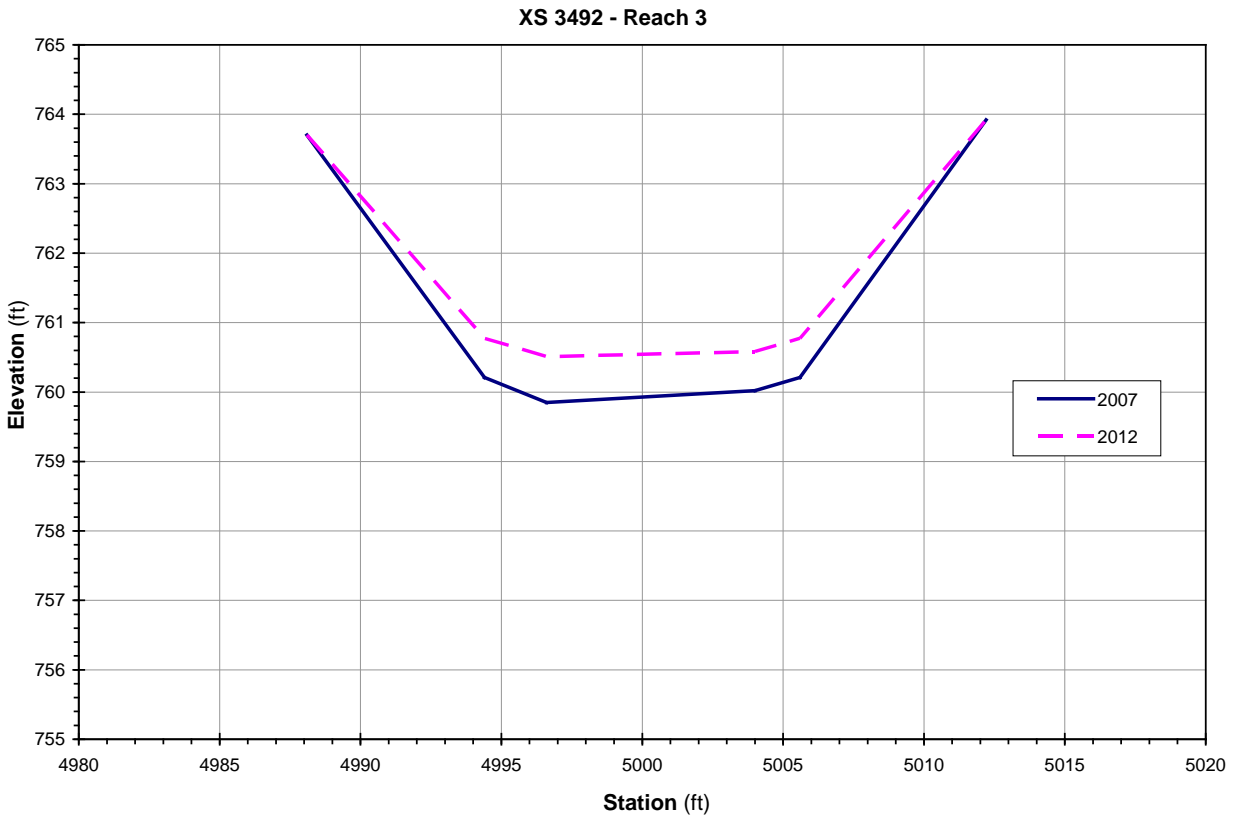
Figure 11. Model cross-section 3492, Reach 3, bed elevation change between 2007 and 2012 due to sediment deposition, Millers Creek, Washtenaw County, Michigan

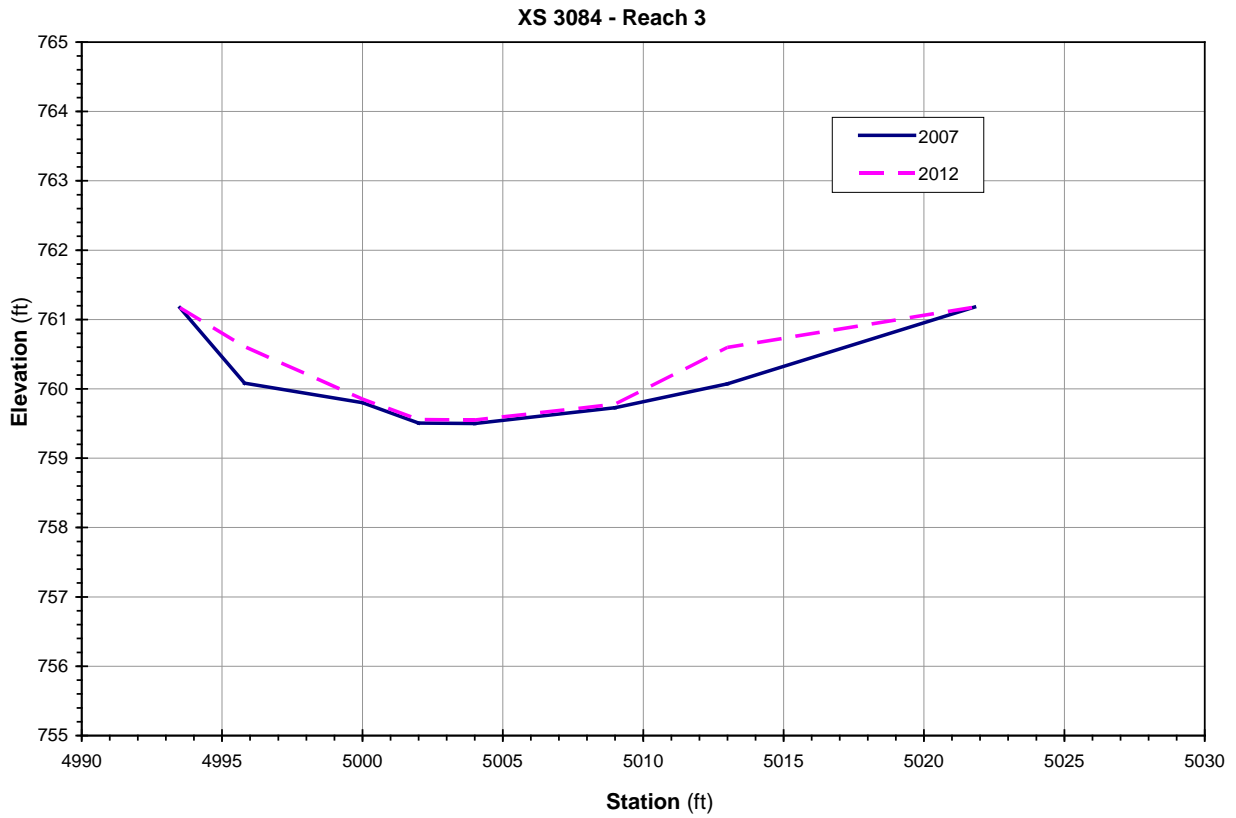
Figure 12. Model cross-section 3084, Reach 3, bed elevation change between 2007 and 2012 due to sediment deposition, Millers Creek, Washtenaw County, Michigan

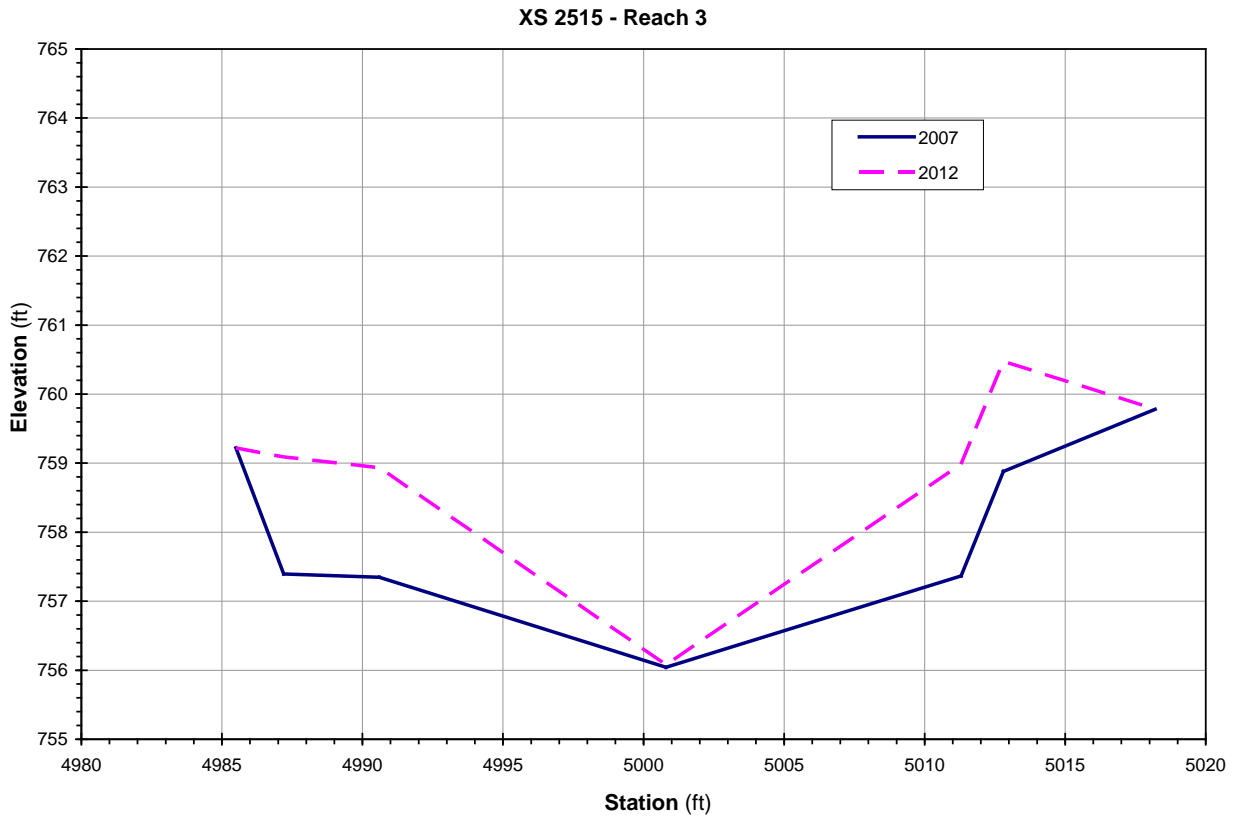
Figure 13. Model cross-section 2515, Reach 3, bed elevation change between 2007 and 2012 due to sediment deposition, Millers Creek, Washtenaw County, Michigan

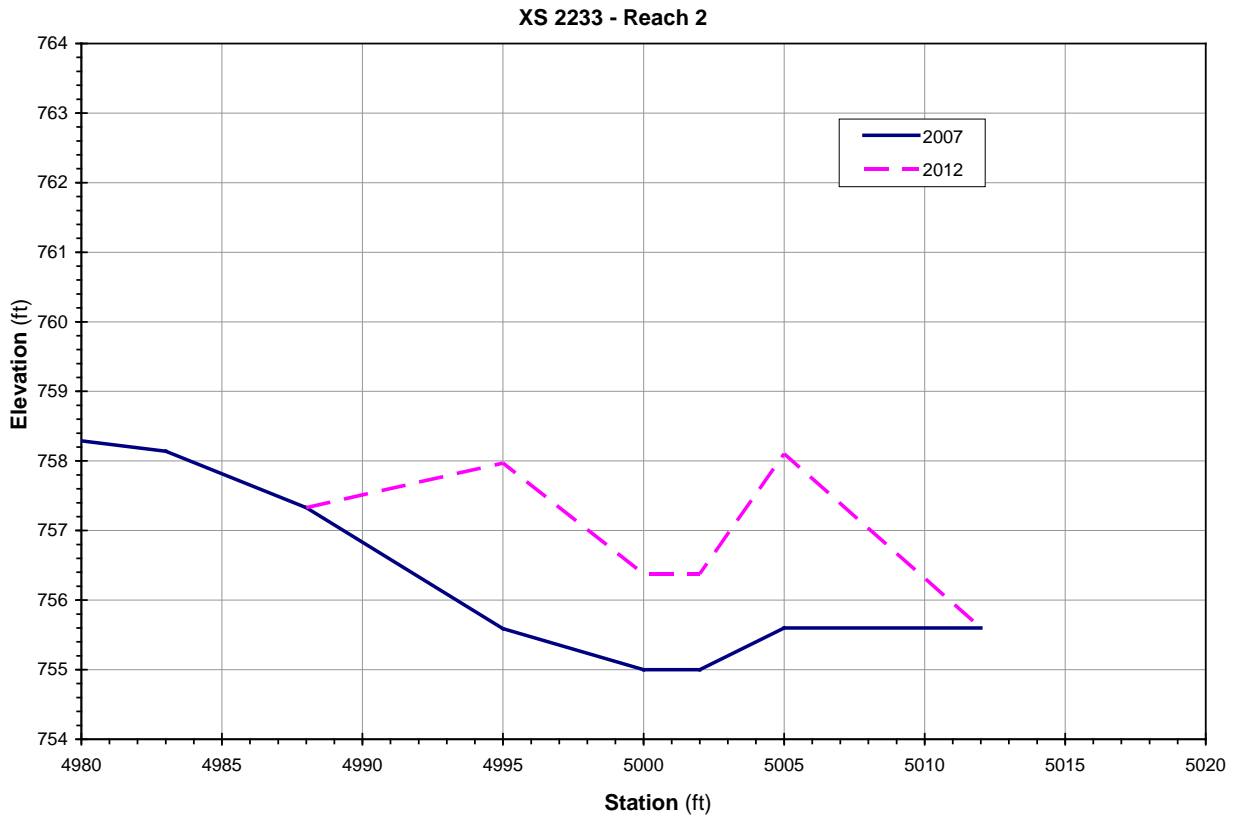
Figure 7. Model cross-section 2233, Reach 2, bed elevation change between 2007 and 2012 due to sediment deposition, Millers Creek, Washtenaw County, Michigan

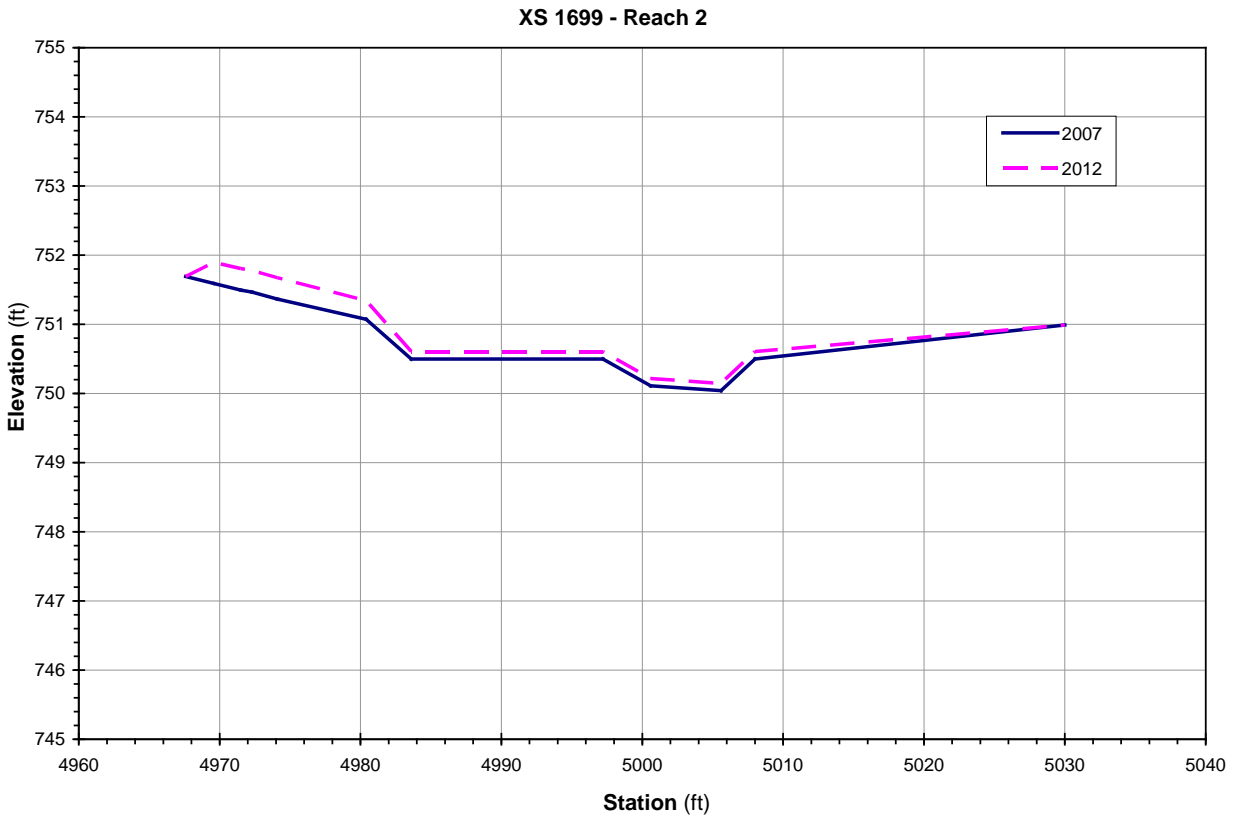
Figure 8. Model cross-section 1699, Reach 2, bed elevation change between 2007 and 2012 due to sediment deposition, Millers Creek, Washtenaw County, Michigan

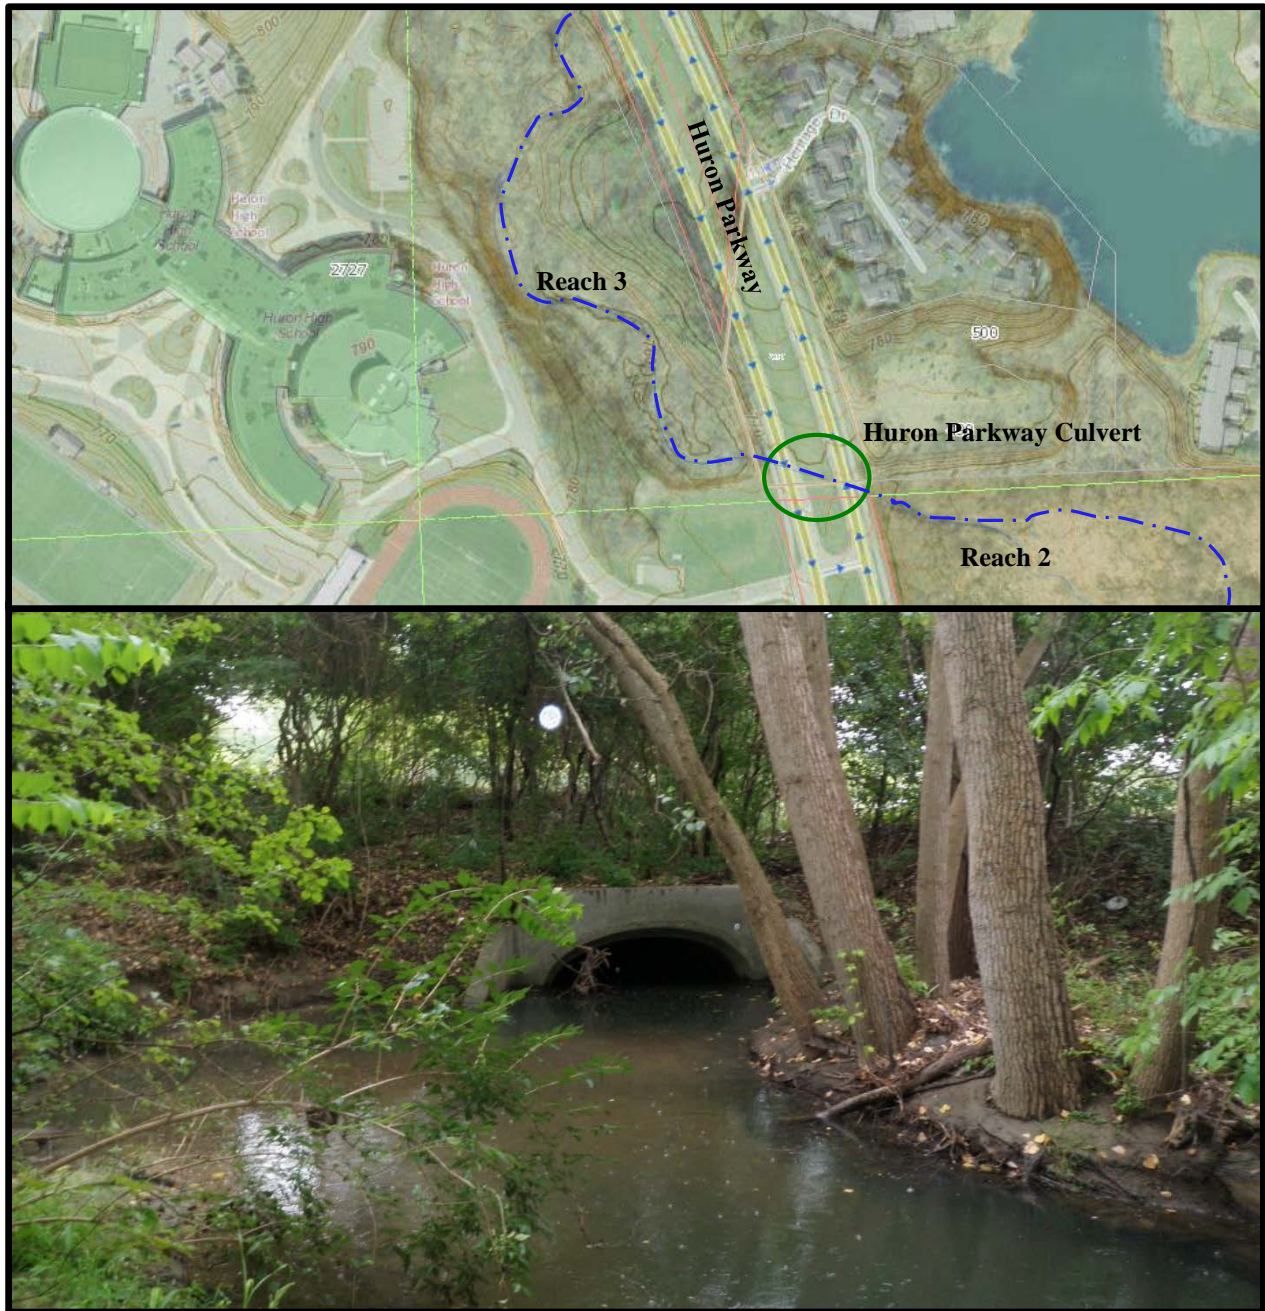
Figure 10. Location of the Huron Parkway Culvert (top) and photo (bottom) of the upstream end of the culvert showing sediment accumulation immediately upstream of the culvert and extending into the culvert.

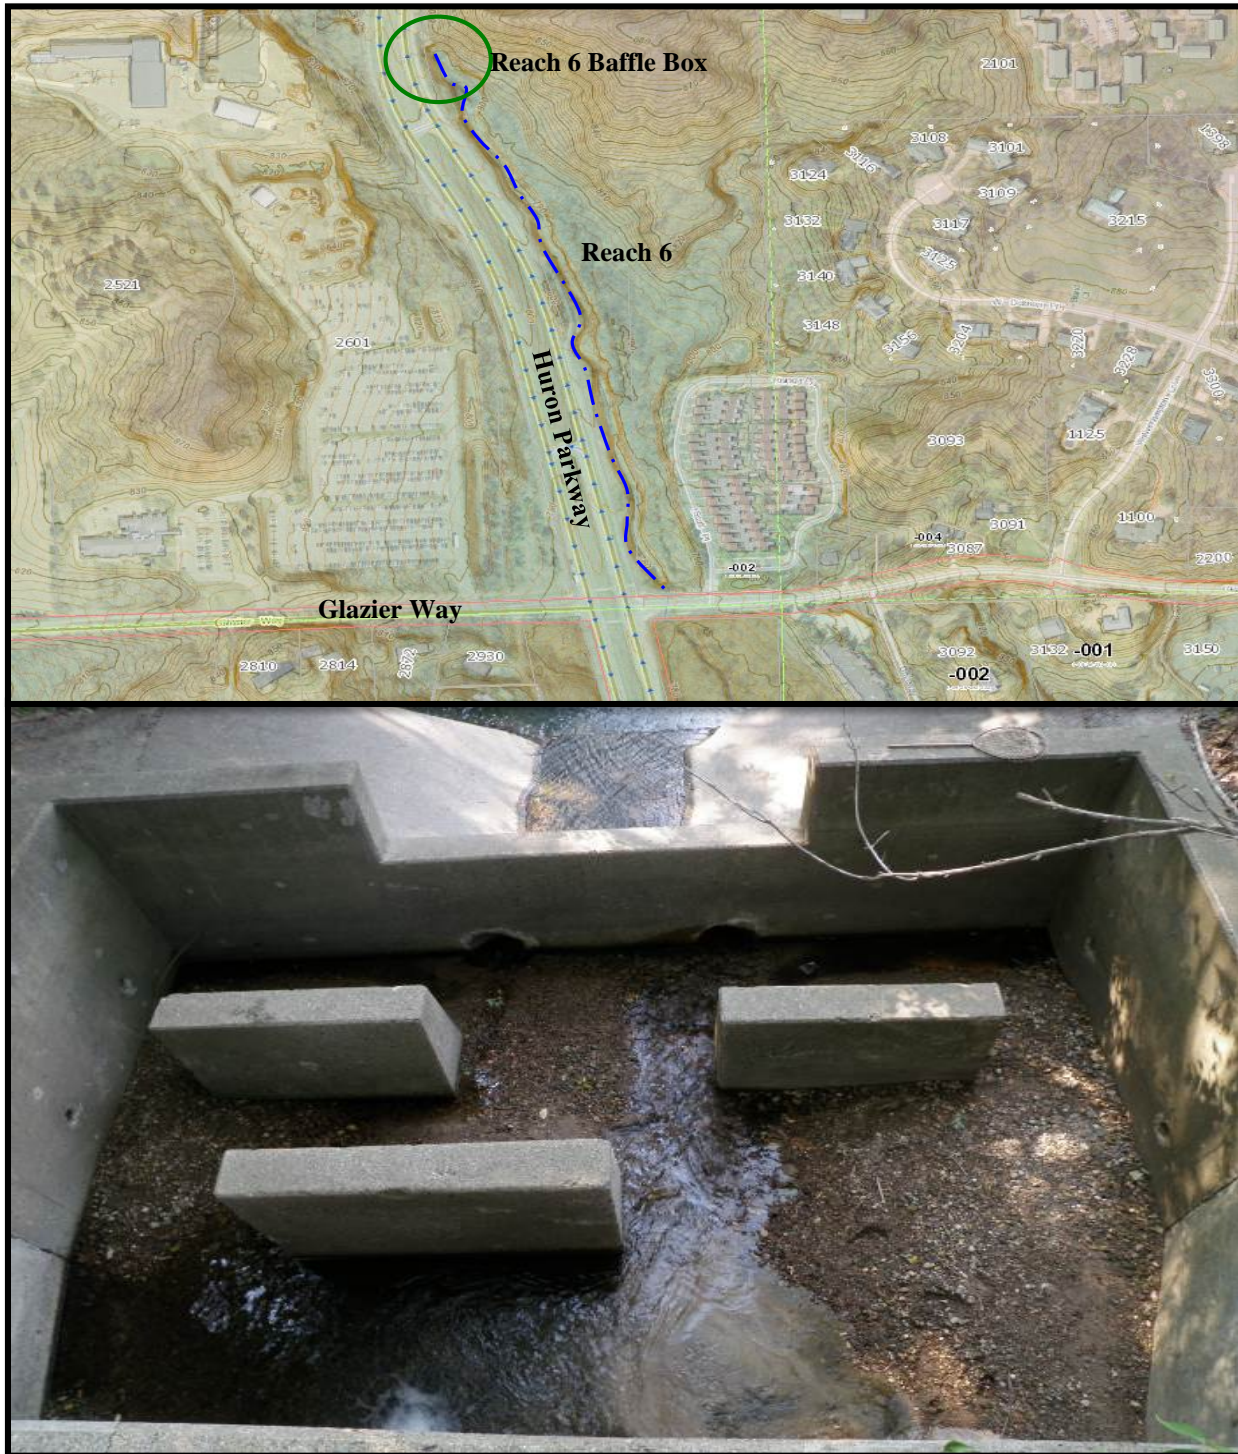
Figure 11. Location of the Reach 6 baffle box (top) and photo (bottom) of the baffle box as viewed from above

The City removes sediment from a concrete baffle box located at the upstream end of Reach 6 (**Figure 11**). The baffle box stores some sediment in the sand to medium gravel size range (coarse-grained bed load material), but has limited storage capacity, with an average sediment depth of approximately one foot and mass of approximately two tons. After sediment removal, the structure fills to its maximum capacity in a short period of time during high flow events. Due to its low storage capacity, removing sediment from the baffle box would not substantially reduce annual sediment deposition in the Ruthven Nature Area (Reach 2). Nonetheless, removing sediment from the baffle box does contribute to overall sediment management goals and may be necessary to maintain proper hydraulic function. This study did not attempt to identify the intended purpose of the structure or analyze its hydraulic function. Given the low storage capacity, the structure would require regular inspection to determine when sediment needs to be removed and sediment removal may be required multiple times annually to maintain sediment storage capacity; quarterly sediment

removal is assumed. Inspections are recommended after the spring high flow period and after substantial precipitation/runoff events.
