Management of Millers Creek Sediment Accumulation Study - Report

Prepared for: The City of Ann Arbor

December 2013

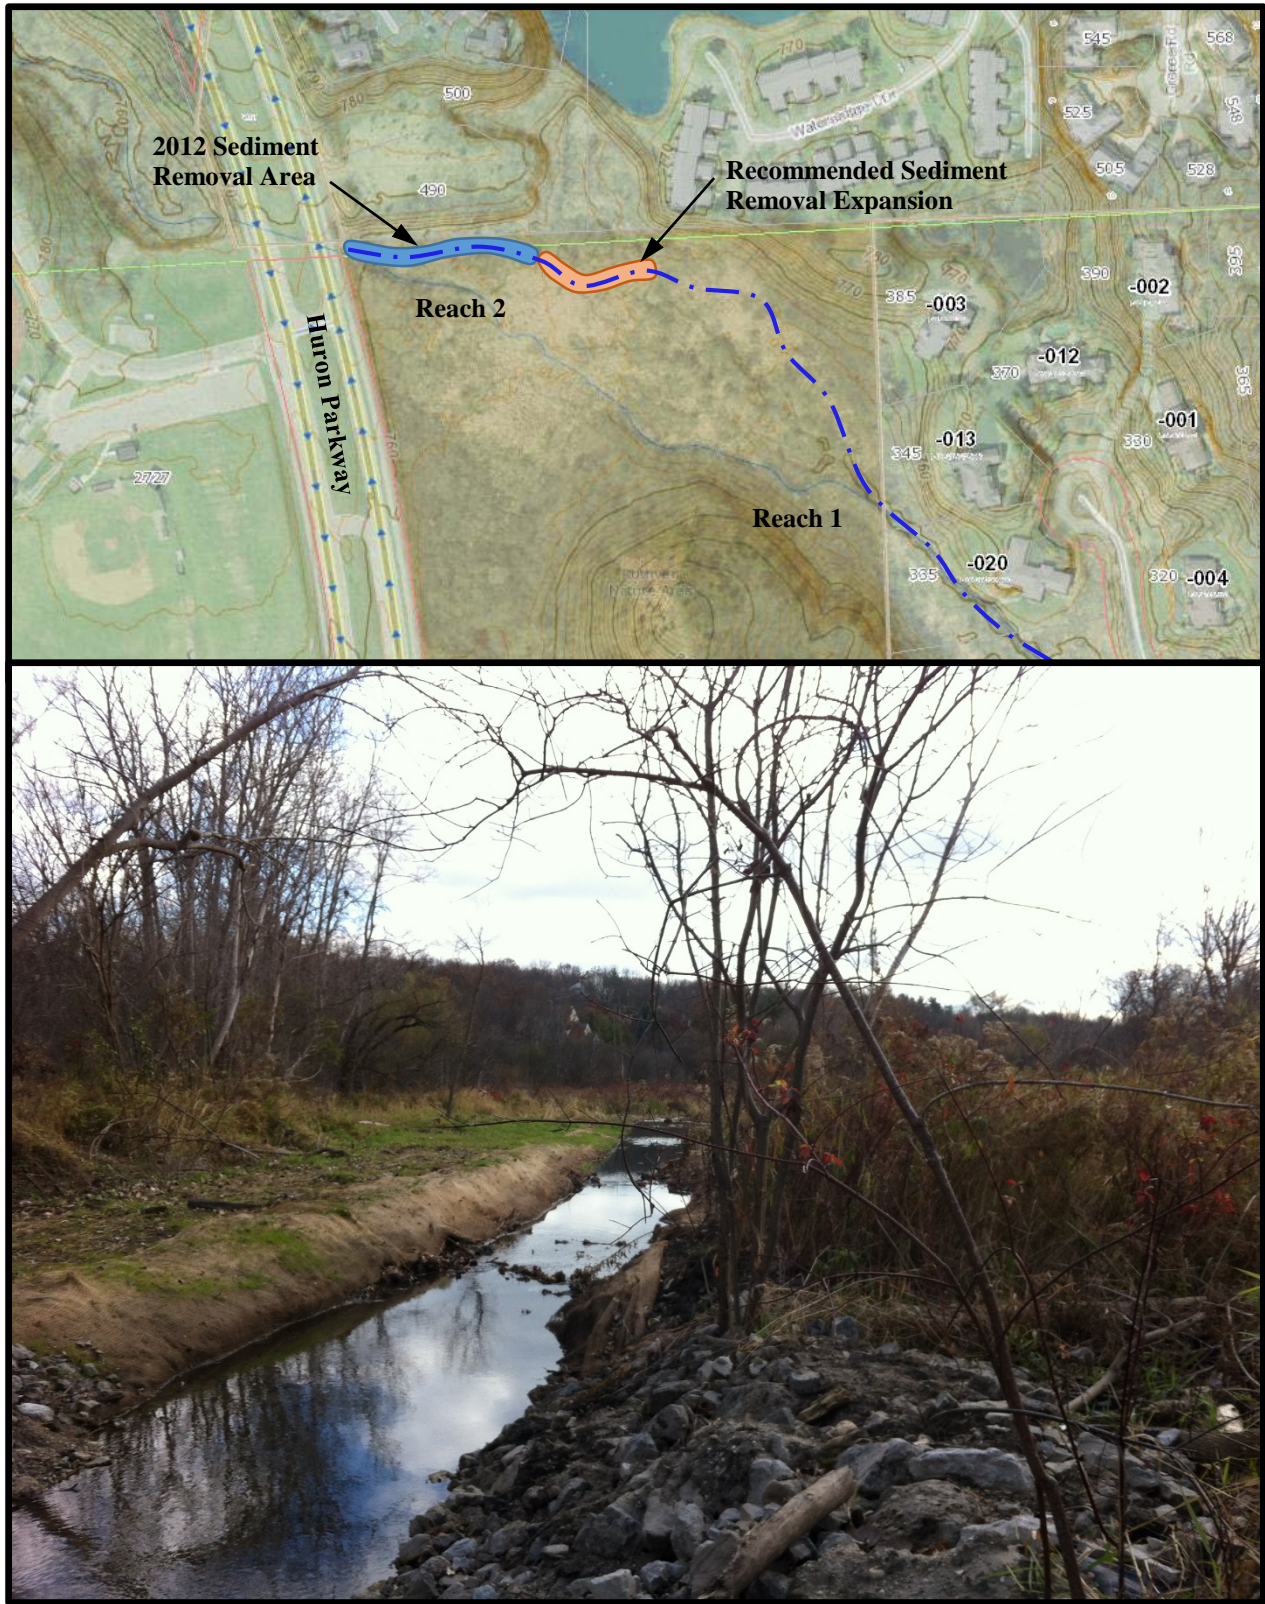
Figure 12. Location of Reach 2 expanded sediment removal (top) and photo (bottom) of sediment removal completed in 2012.

The City removed sediment from the channel of Millers Creek in Reach 2 in late summer of 2012 under a permit from the Michigan Department of Environmental Quality. The sediment removal work extended from the Huron Parkway culvert downstream approximately 325 feet. Sediment removal was planned for this reach because the channel of Millers Creek was still discrete and discernable. Downstream of that point the channel of Millers Creek was braided (i.e. represented by multiple smaller channels) and less discernable. This braided condition existed because of sediment accumulation. Therefore, the sediment removal could be extended downstream approximately 100 feet farther to improve flow conveyance capacity in the Ruthven Nature Area (**Figure 12**). This activity would not decrease the water surface elevation at the Huron Parkway culvert directly or significantly decrease the mass of sediment deposited in Ruthven Nature Area annually, but it could result in improved sediment transport characteristics through Reach 2 by decreasing channel roughness. Channel roughness can cause a backwater condition that increases the upstream water surface elevation. Still, this activity would not result in a dewatering of the Huron Parkway culvert because water surface elevation is controlled by the reach-average slope, which would not be changed by extending the dredging in Ruthven Nature Area in the downstream direction.

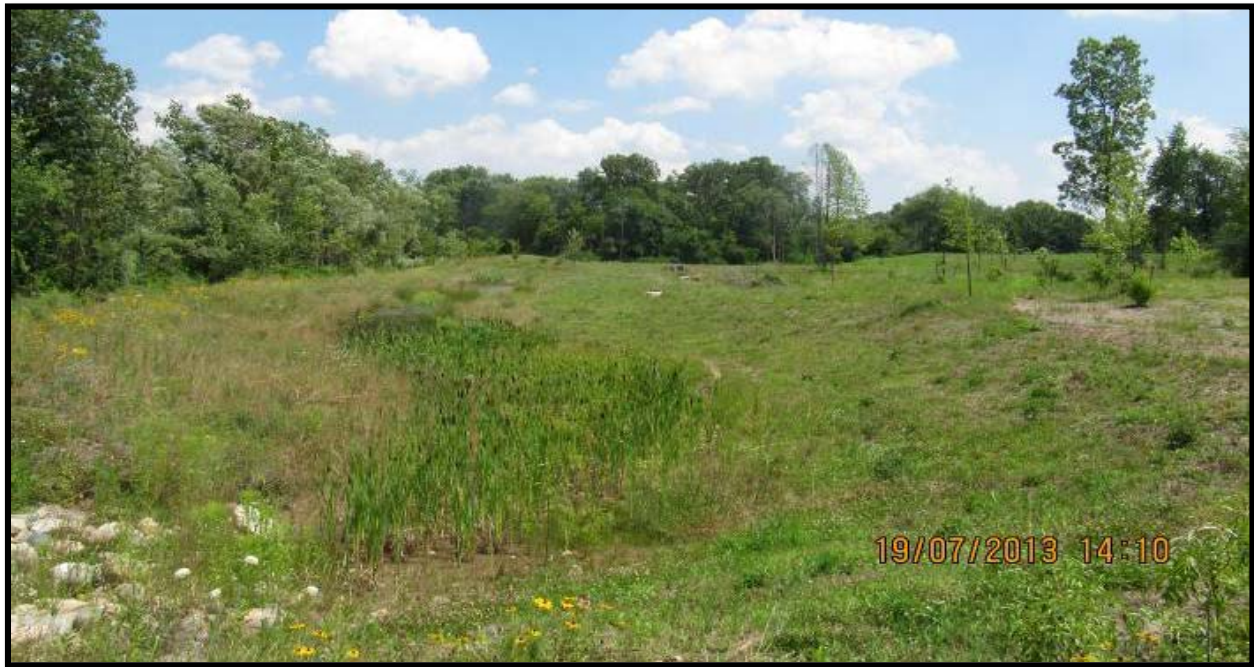
Figure 14-1. County Farm Park sediment forebay (foreground) and stormwater detention basin (background), Ann Arbor, MI.

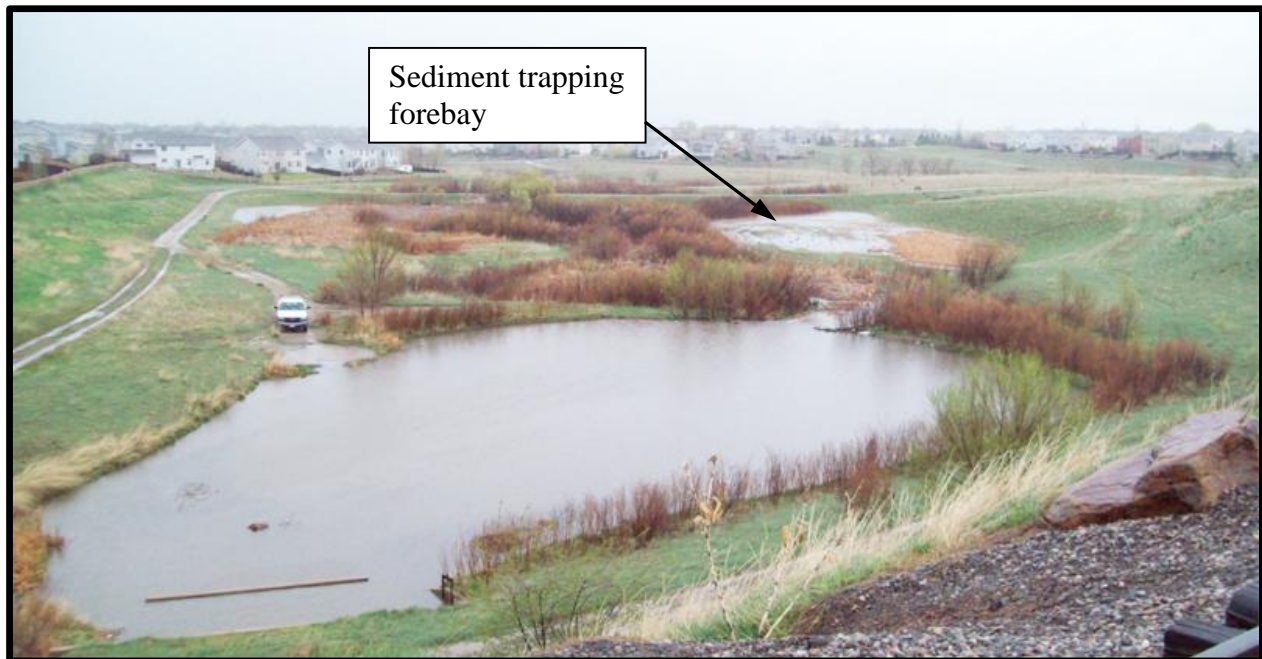
Figure 14-2. Regional Stormwater Detention Basin with Sediment Trapping Forebay, Northglenn, CO.

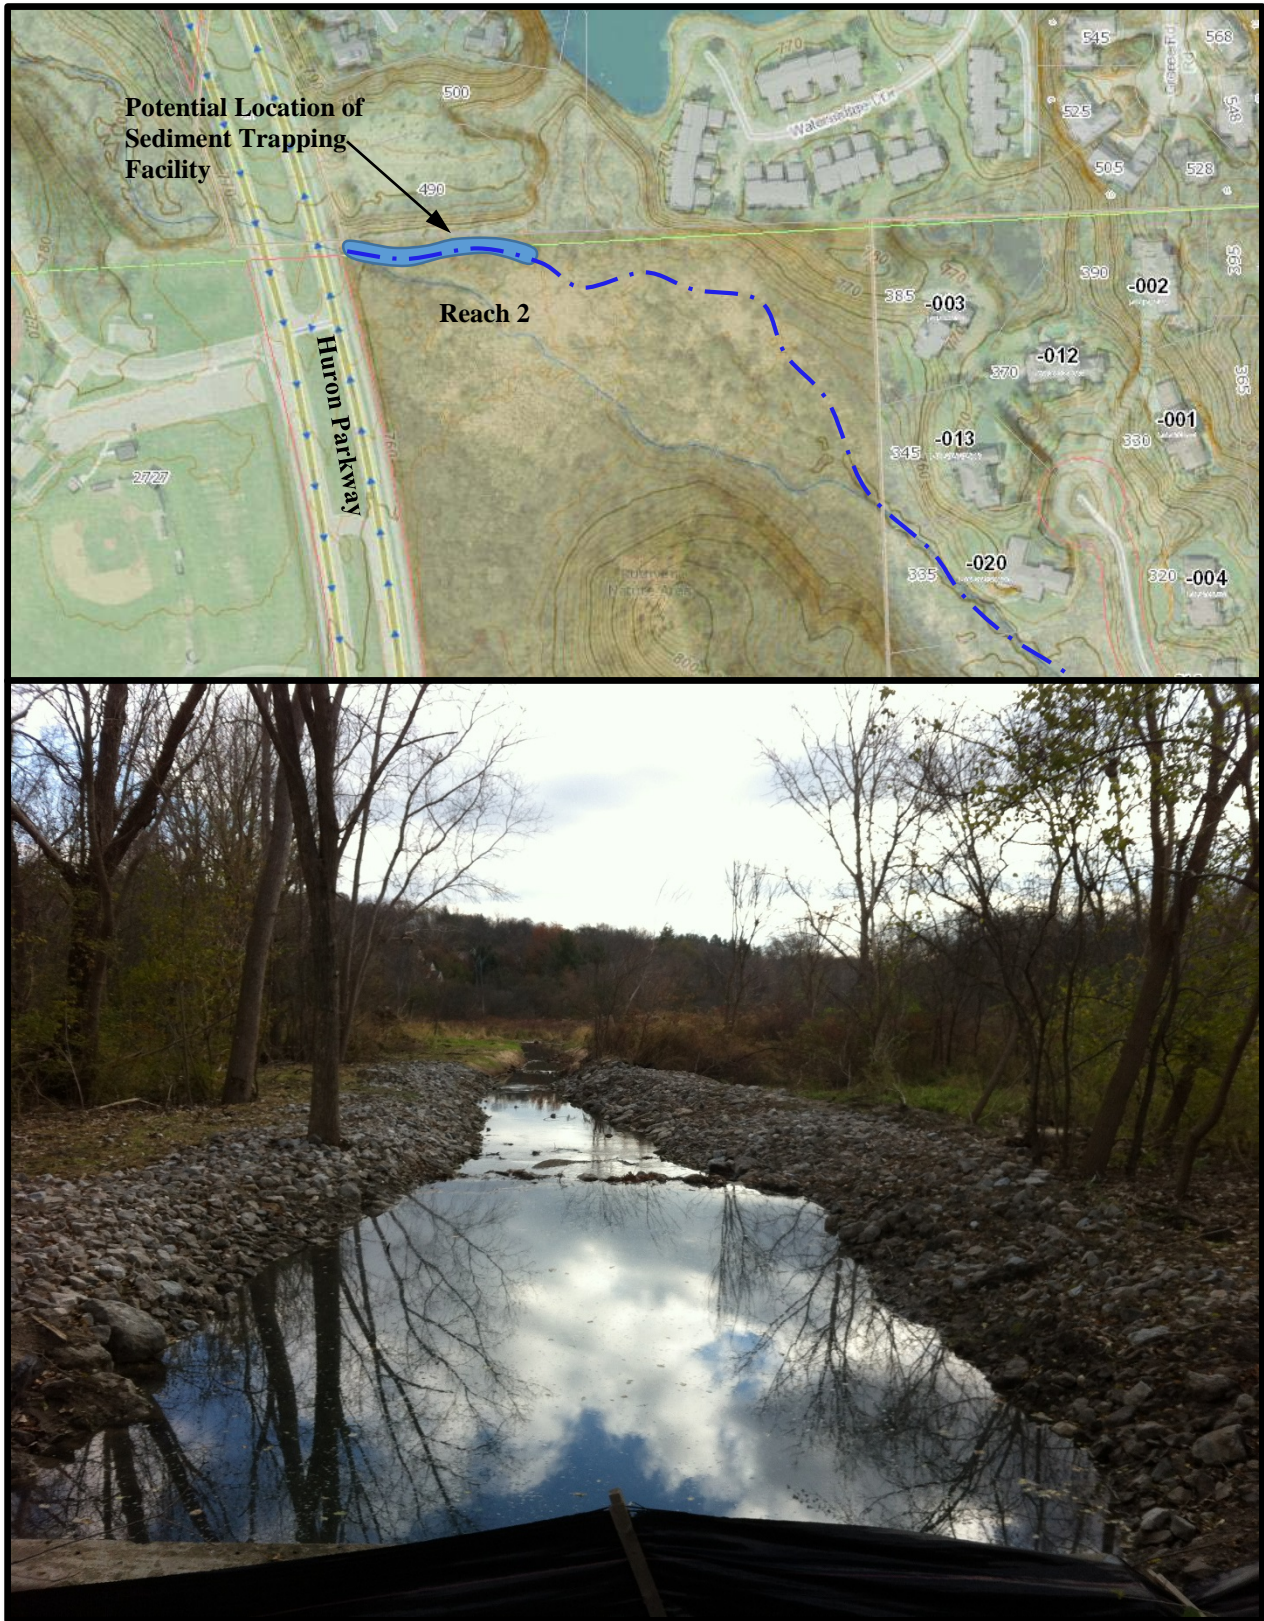
Figure 15. Location of Reach 2 sediment trap-and-removal (top) and photo (bottom) of 2012 sediment removal area.

Alternative one involves periodic sediment removal in Reach 2 where sediment was removed in 2012 under a permit (Table 5.2-2), as an alternative location to Reach 3. Sediment trapping in Reach 2 was recommended in the Millers Creek Watershed Improvement Plan as part of Focus Area #12. Given the City has already removed sediment from this area, it could continue to be used as a long-term regional sediment removal site if desired (**Figure 15**). Land adjacent to Reach 2 is located in the City-owned Ruthven Nature Area. Therefore, land purchase or access agreements with other property owners would not be required. However, due to the presence and extent of wetlands adjacent to the south side of Millers Creek, environmental impacts could be greater than establishment of a trap-and-removal facility in Reach 3. Furthermore, Reach 2 would not be suitable for developing a regional detention facility in concert with the sediment trap. A sediment basin with a capacity equivalent to the annual average rate of deposition (47 tons/year) in Reach 2 is feasible. Therefore, a sediment trap in Reach 2 would have the capacity to trap up to 47/tons per year, and averting the previous flooding problems associated with excessive deposition in Reach 2. However, all of the storage would have to be constructed below the existing bed elevation (created via excavation below the bed only); due to the low relief of adjacent lands relative to the streambank elevation, it would not be feasible to use structures to create a sediment trap by raising the water surface elevation. Reach 3 offers greater design flexibility in this sense. The existing sediment removal area in Reach 2 (**Figure 15**) would require alteration to improve sediment trapping efficiency and facilitate periodic sediment removal. Those alterations would include excavation of the channel and creation of a larger staging and access area along the south side of Millers Creek.

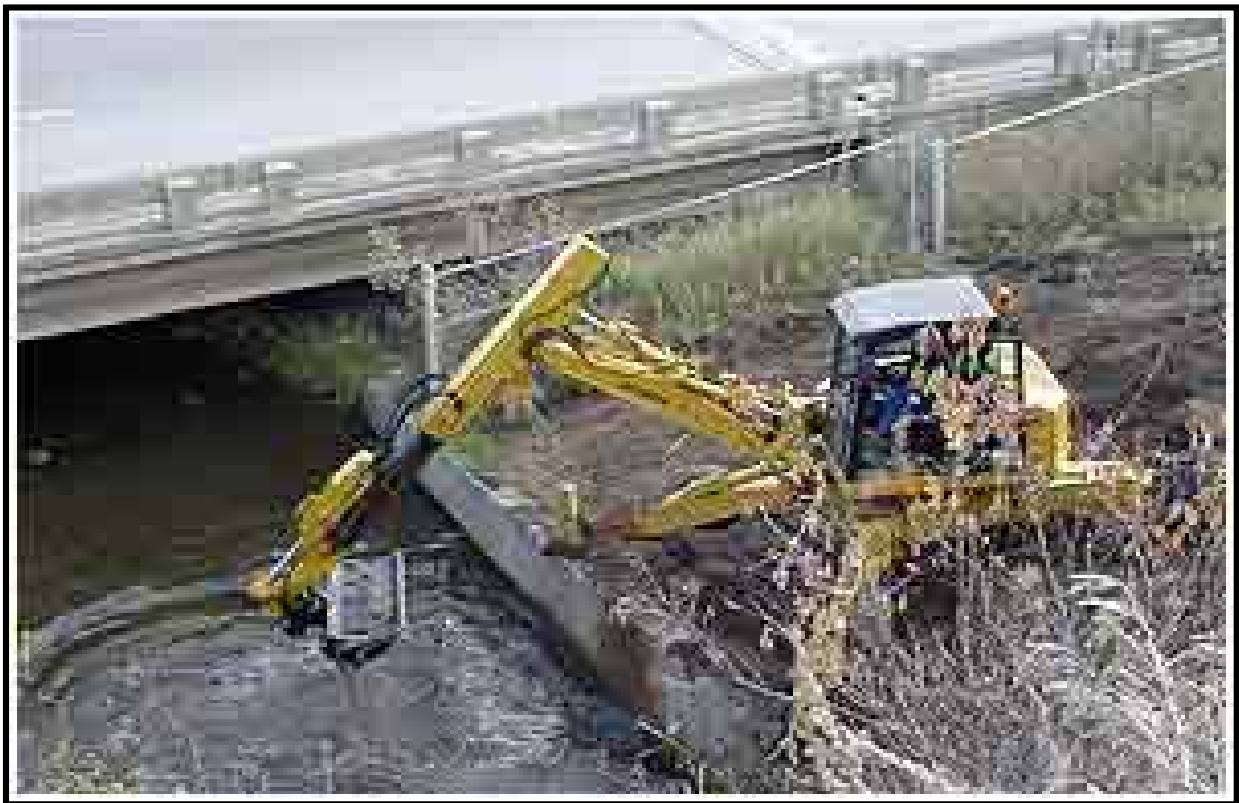
Figure 16. Sediment trap maintenance in Duluth, MN.

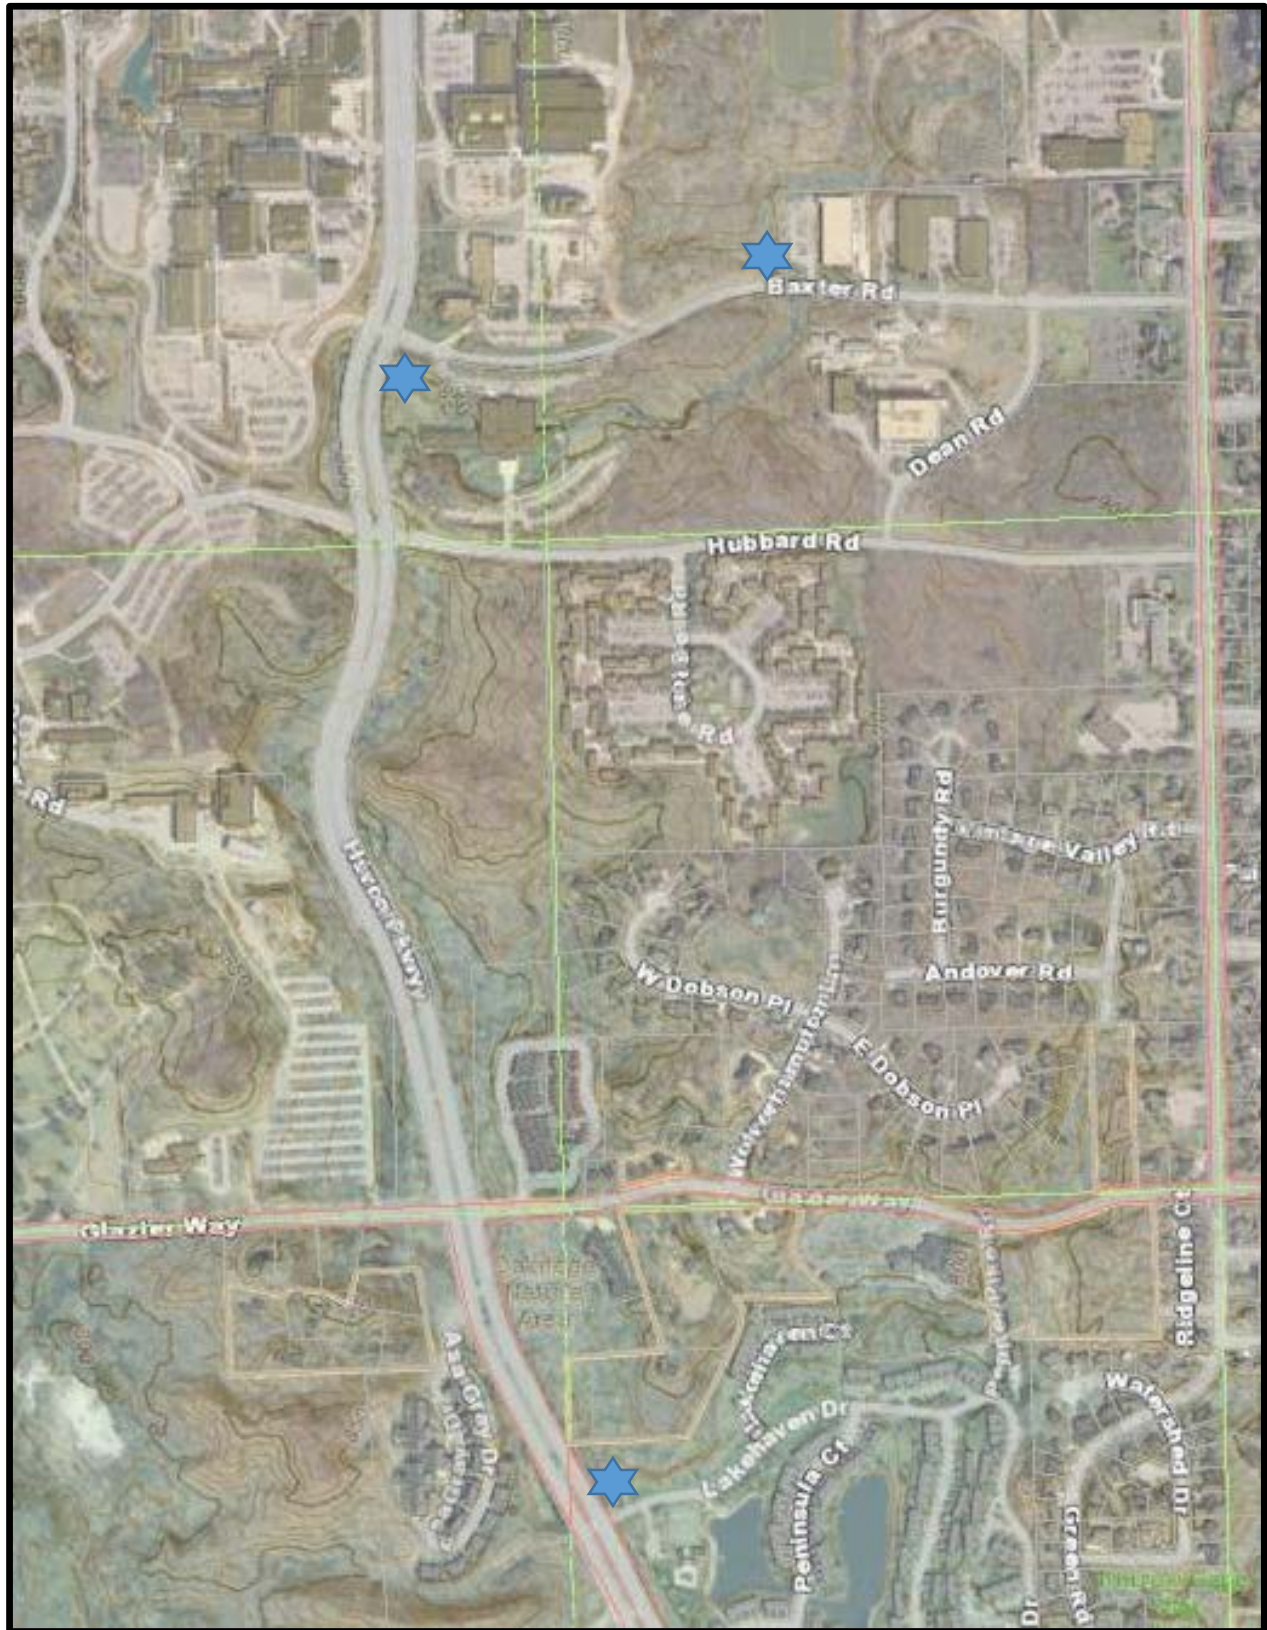
Figure 17. Alternative 2 potential sediment trap locations.

Alternative two is a diffused sediment removal approach based on establishment of up to four smaller sediment trap-and-removal facilities (Table 5.2-2). This approach is used by other municipalities such as Duluth, Minnesota to manage in-stream sediment at multiple locations throughout a watershed (**Figure 16**). The three locations with the best potential include the end of Study Reach 8 at Huron Parkway, the confluence of Study Reaches F and 9, and the confluence of Study Reaches 5 and C (**Figure 17**). The City does not own property at any of these locations. Therefore, land purchase or access agreements would be required. Each facility would consist of a construction pad; excavated sand trap measuring 100 feet in length, 20 feet wide, and 2 feet deep; access; and staging area. It may also be possible to construct sediment traps at some of the locations using structures to raise the water surface. The Reach F/9 facility could trap-and-remove up to 60 tons annually from Reach F, G, and 9. The Reach 8 facility could trap and remove up to 33 tons annually from Reach 8. The Reach 5/C facility could trap and remove 115 tons annually from Reaches 5, 6, 7, and D. All three traps would require maintenance every one to two years; annual inspections would be required. Combined the three facilities could reduce the deposition in Reach 2 by 47 tons/year – the same potential as a regional facility at Reach 3.

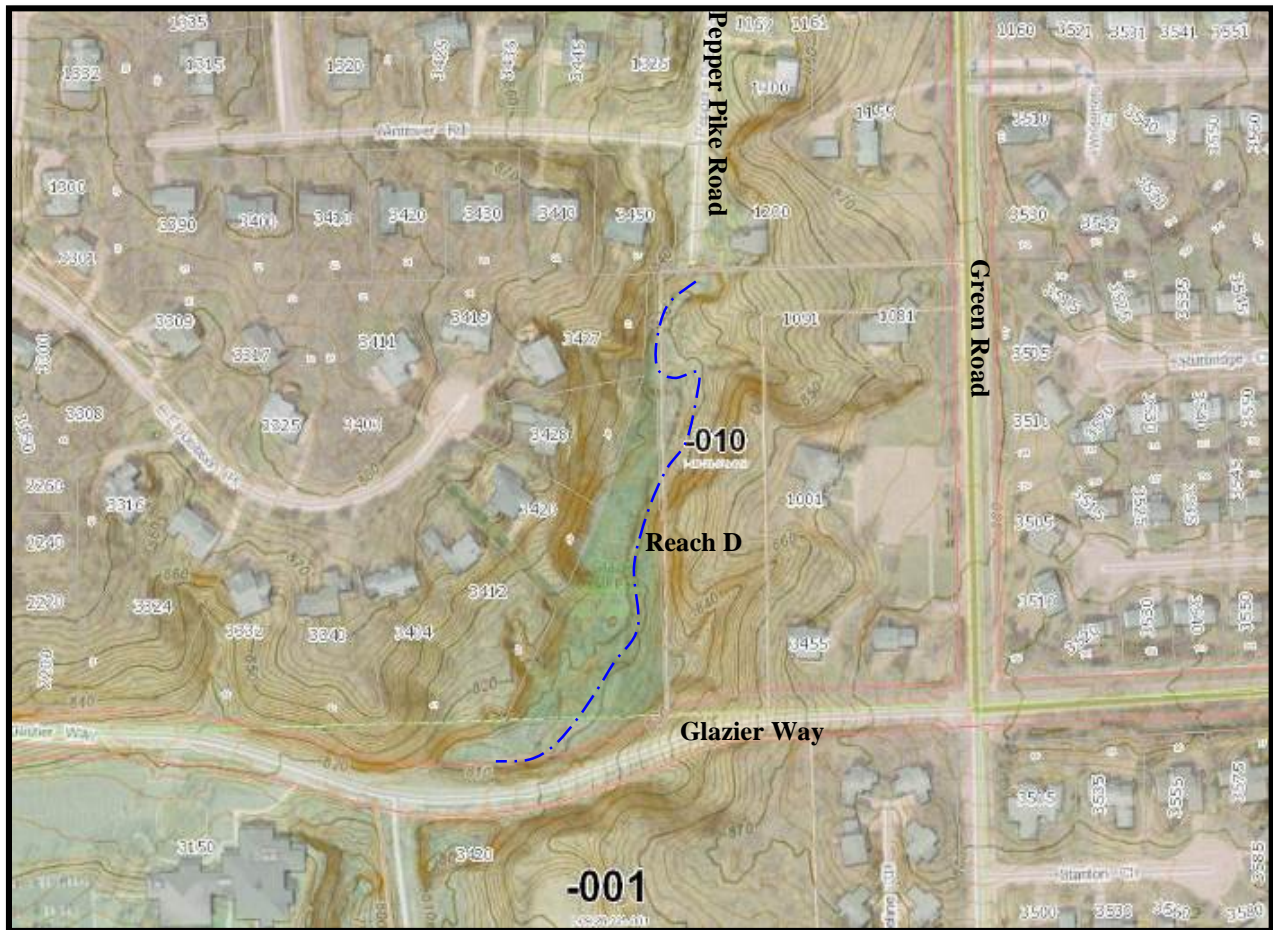
Figure 19. Reach D vicinity map showing north half of Reach D located north of Glazier Way

Reach D is Focus Area #11 in the Millers Creek Watershed Improvement Plan. The Improvement Plan identified “significant bank erosion” in this reach. Reach D is located on property owned by the City of Ann Arbor (Glazier Hill Park) and the First United Methodist Church of Ann Arbor (1001 Green Road). Reach D starts at the end of a large storm sewer that drains most if not all of the northern residential neighborhood (south end of Pepper Pike Street) (**Figure 19**). The energy and volume of flow from the storm sewer has caused extensive bed and bank erosion in Reach D leading to channel enlargement and loss of floodplain connectivity; the worst erosion is located upstream of Glazier Way. However, a road culvert located in the Geddes Lake community is perched six feet above the bed, indicating extensive bed erosion in that area as well. Sediment load from Reach D is accumulating in sections of Reach C, but is also being transported into Millers Creek where it is eventually transported into Reaches 2 and 3. Erosion in Reach D is so extensive that streambank stabilization alone is not a practical approach to reducing the sediment loading. Furthermore, there is limited space to support channel reconstruction. Therefore, channel modifications is the recommended approach to effectively reduce erosion and sediment loading. Structural channel modifications will be necessary due to limited access, limited space, proximity to an adjacent sanitary sewer, steep valley slope, and high energy flow. Applicable structural modifications may include bed grade control structures such as cross-vanes, riffles, and boulder weirs; vertical retaining structures in meanders, and flow deflecting/centering devices. Bank armoring using hard revetments such as riprap will also be required. Extensive clearing along the banks and bank grading will be necessary to stabilize the channel margins. Restoration of Reach D would reduce the amount of sediment deposited at Ruthven over the modeled period by 20.2 tons per year.

The City of Ann Arbor Capital Improvement Plan includes a capital maintenance project in Reach D. The project includes lining the existing sanitary sewer line that parallels Reach D. Depending on access requirements, it may be possible to conduct Reach D restoration work simultaneously with sanitary sewer line work.

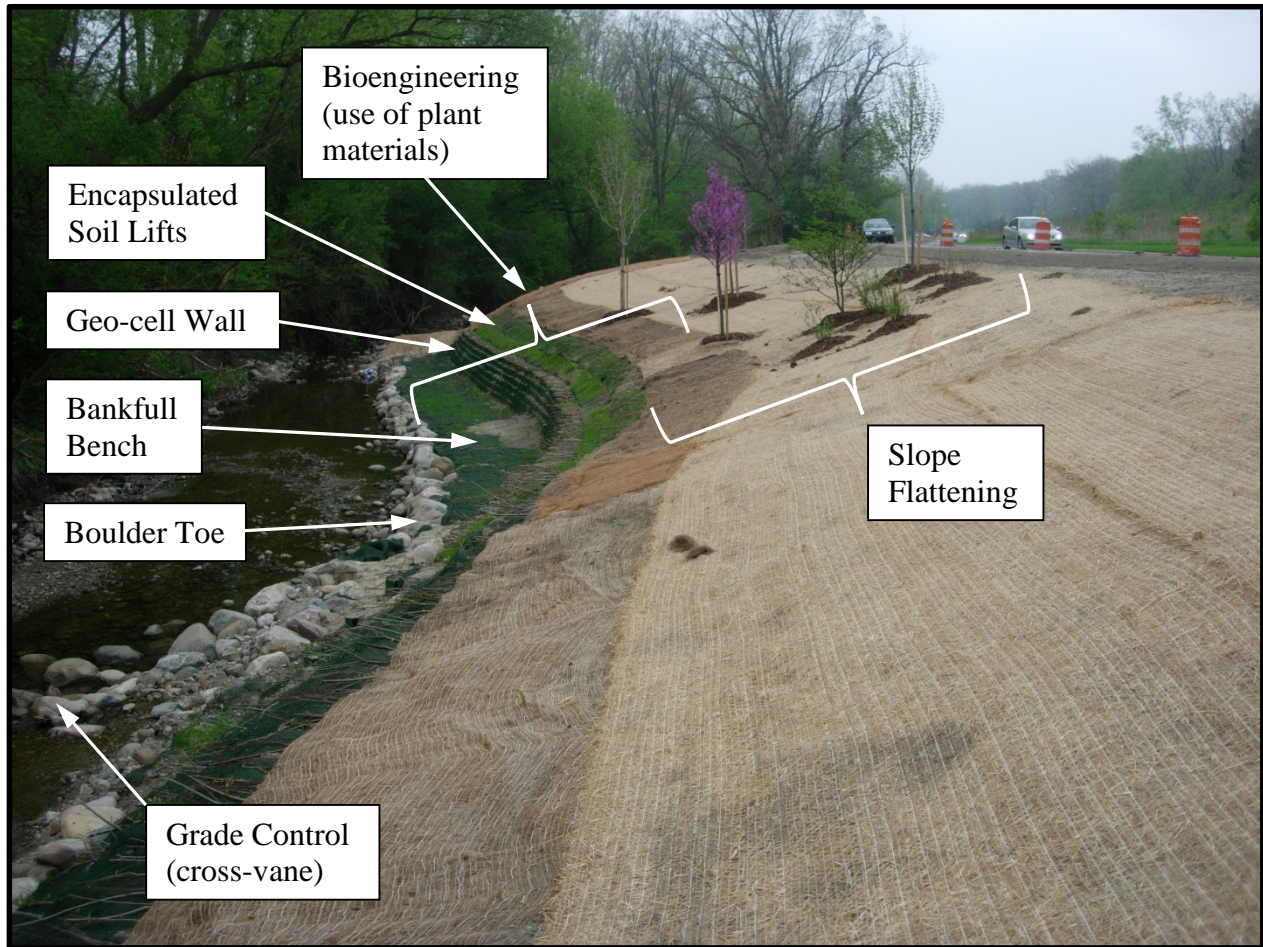
Figure 22. 2007-2009 streambank stabilization in Reach 6 using a combination of effective stabilization techniques

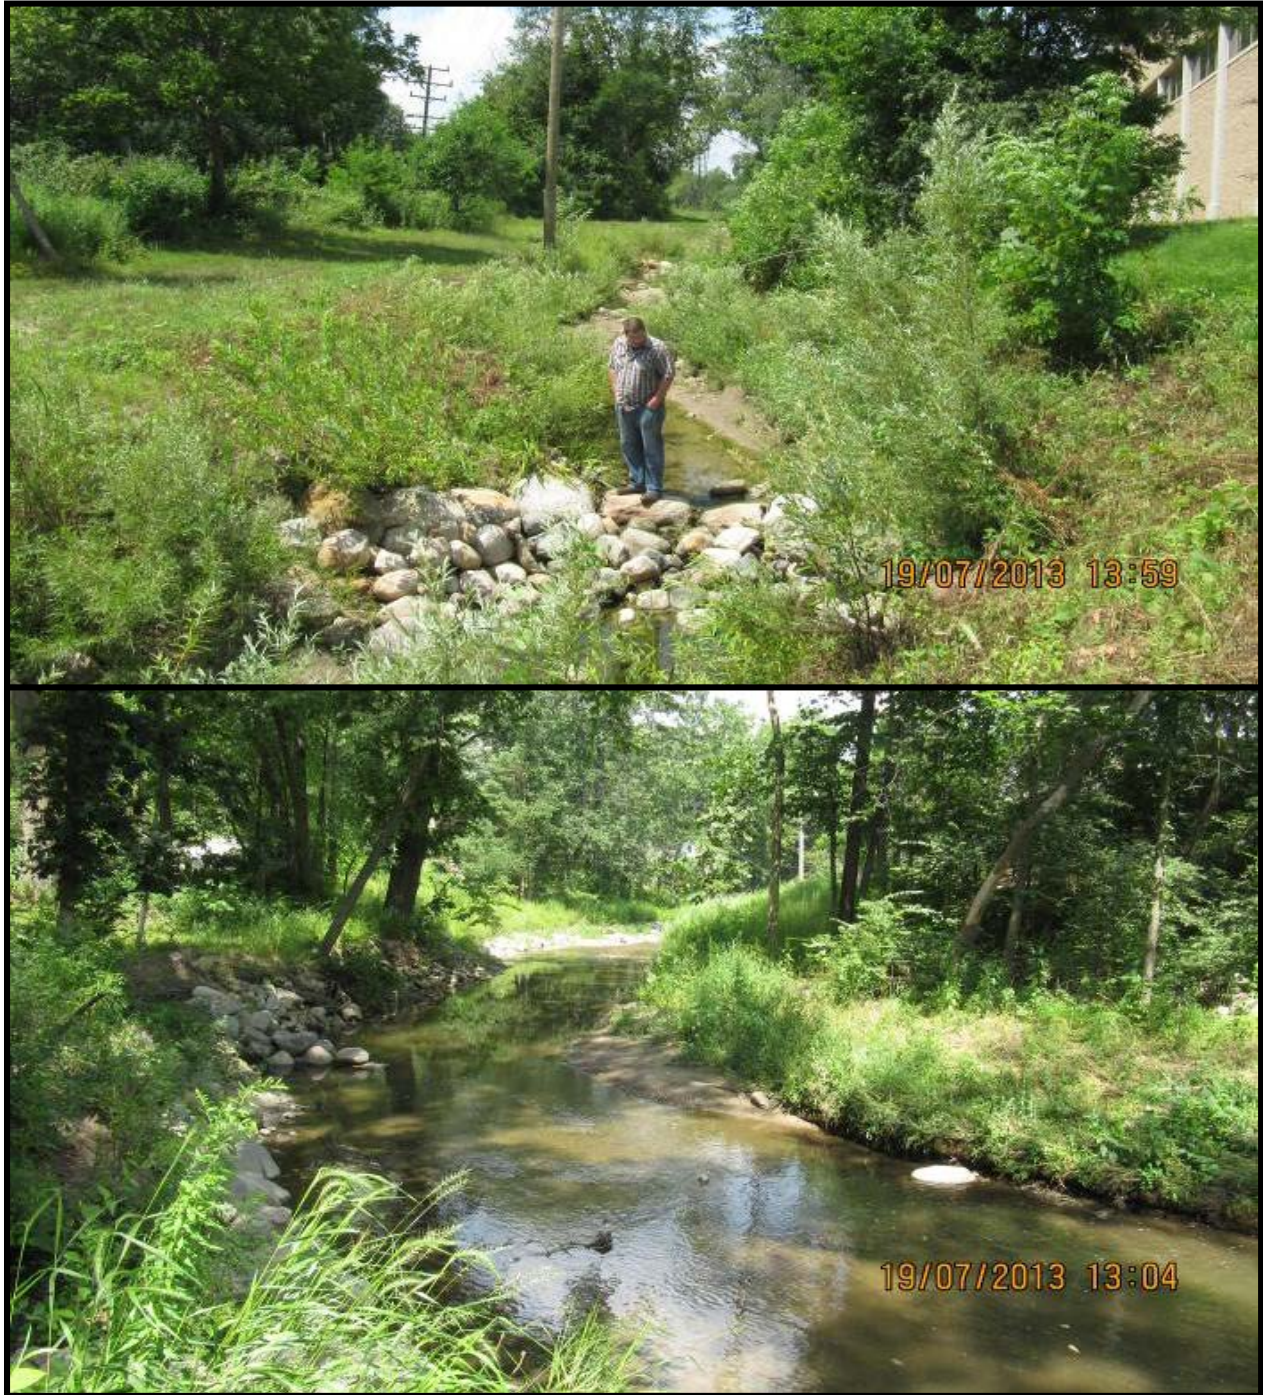
Figure 24. 2012 Mallets Creek channel restoration at County Farm Park (top) and Huron Parkway (bottom) using a combination of bank stabilization techniques and in-stream grade control structures
