Rental Assistance Demonstration (RAD): **PART 2: ENERGY AUDIT**

3681-3689 Platt Road Ann Arbor, Michigan 48108
UPPER PLATT COLONIAL

PROJECT # 8357E-2-96

DATE October 7, 2013

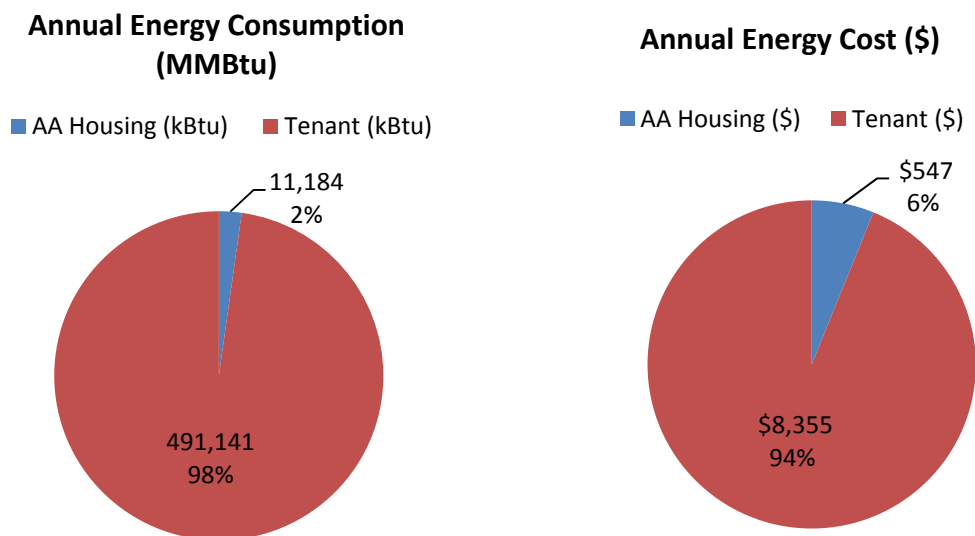
Figure 1. Historical Annual Energy Consumption and Cost

A preliminary energy use assessment was conducted prior to the cost reduction measure analysis. The figure below describes the historical annual energy consumption and cost for the subject property.

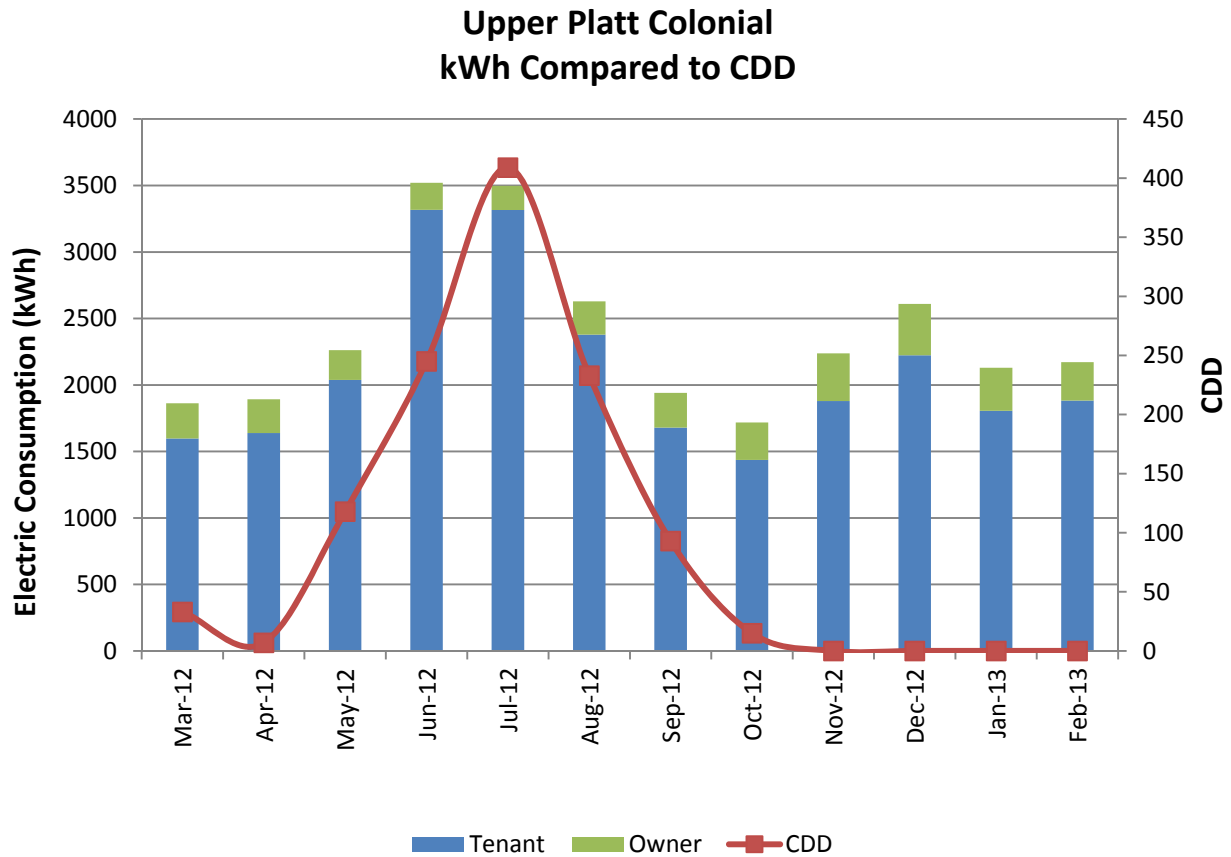
Figure 4. Electricity Consumption Graph

Electricity is supplied and delivered to the subject property by DTE Energy. Historic common area and tenant electrical use compared to cooling degree days is summarized in the following figure:

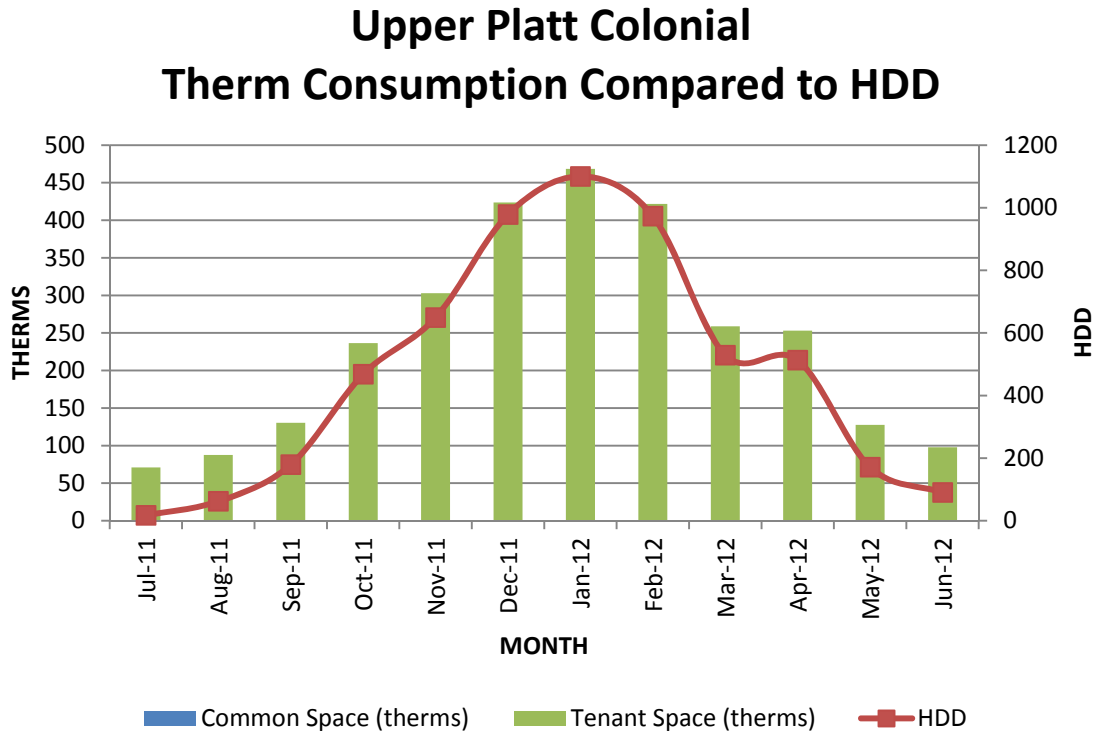
Figure 6. Natural Gas Consumption Graph

Natural gas is supplied and delivered to the subject property by DTE Energy. Historic natural gas use is summarized in the following figures:

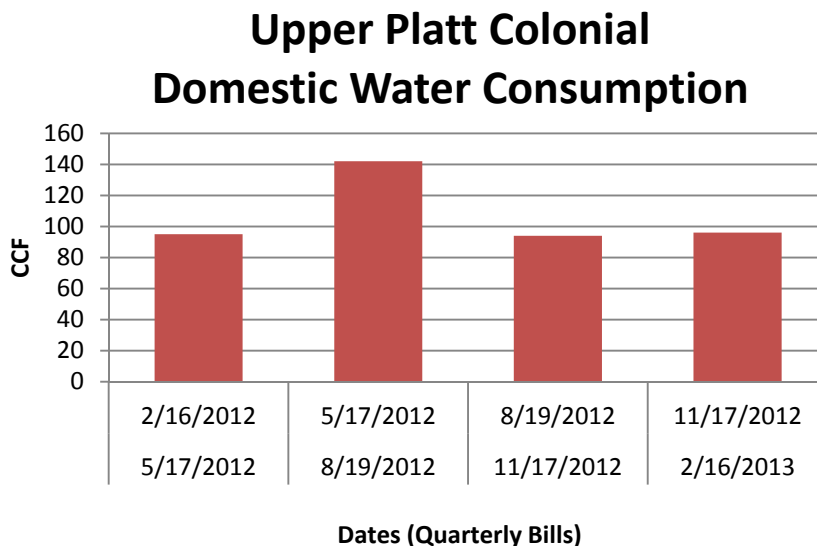
Figure 8. Domestic Water Consumption Graph (Owner)

For the time period covered by client provided records, historic domestic water use is summarized in the following figures.

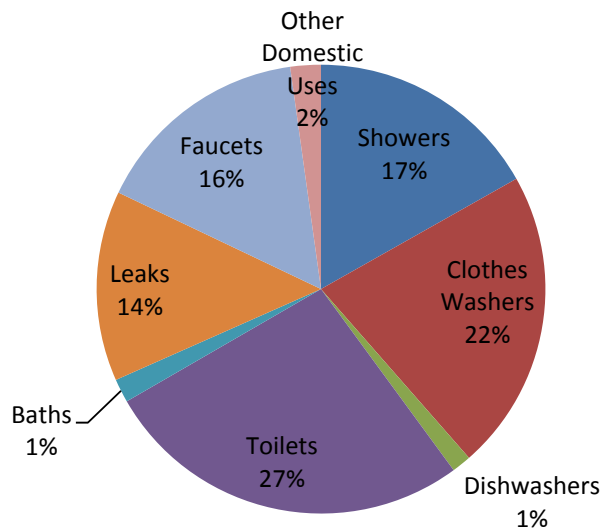
Figure 9. Domestic Water Typical End Use

Figure 8 below shows the REUWS typical domestic water consumption breakdown by end use.

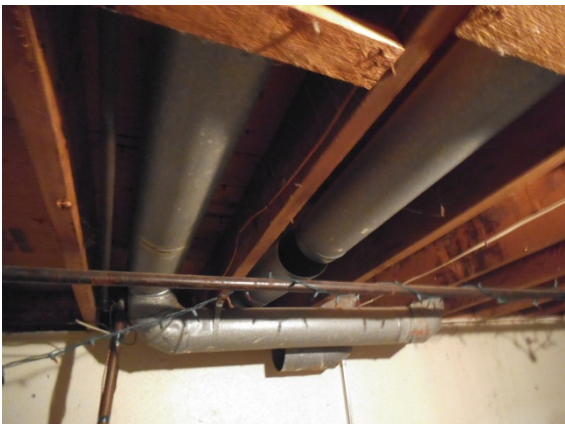
The ductwork in the apartments is approximately 45 years old and possible sources of leakage were observed at the seams and edges of the exposed ductwork. This ECM recommends checking all ductwork for leakage, making required repairs, and wrapping the exposed ductwork in the basements with duct insulation.

To cut energy waste, ducts should be sealed to eliminate any leaks, and then wrapped with insulation. The first step to sealing ducts is to diagnose where the leaks are. This process requires diagnostic tools such as blower doors or pressurization devices and should be done by experienced technicians.

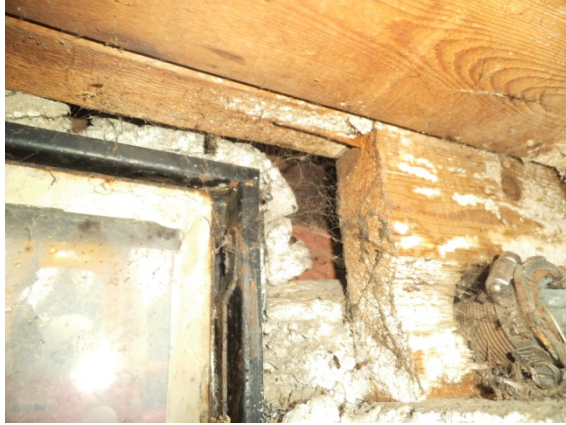
Air leakage was identified to be from and around the windows. The main windows have been recommended for replacement, but the basement windows need attention. The basement has builders grade, steel frame, single pane windows that tilt in. There are two windows per basement that are 32" x 16". There are gaps evident between the window frame and the rough opening that airs leaks through. The tilt mechanism is broken on many of the windows, and leakage between the sash and frame also. These windows should be air sealed (or replaced if budget allows).

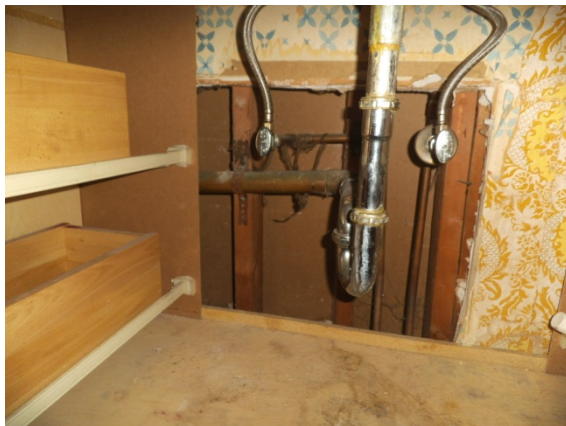
There is a very significant air bypass located in the upstairs bathroom behind the vanity. This was the single largest point of leakage identified during the blower door test. This should be air sealed complete. Best solution would involve removing the vanity, covering the open wall cavity with wall board, and reinstall vanity.

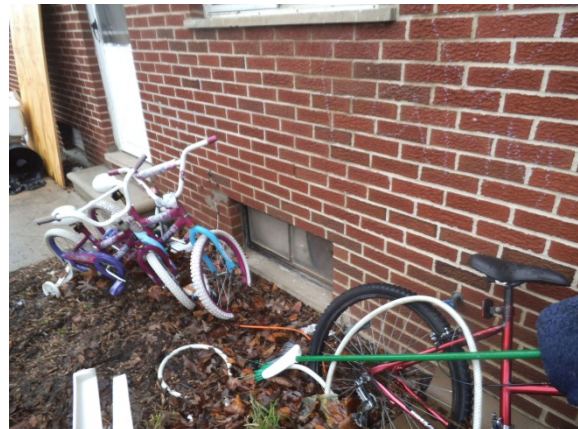
The basement has builders grade, steel frame, single pane windows that tilt in. There are two windows per basement that are 32" x 16". There are gaps evident between the window frame and the rough opening that air leaks through. The tilt mechanism is broken on many of the windows, and leakage between the sash and frame also.

Photo 6: Basement slider windows

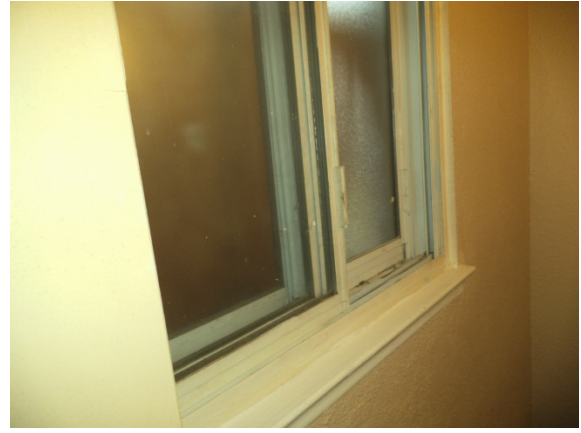
The windows are aluminum-framed single-pane glazed sliding units with exterior storm windows. The window units are in poor overall condition. Some of the exterior sashes are missing, seals are worn or non-existent, and they are not energy efficient. The sealant and caulking observed between the outside perimeter of the aluminum frame and the adjacent aluminum siding is in poor condition.

Photo 14: Typical horizontal sliding window frame

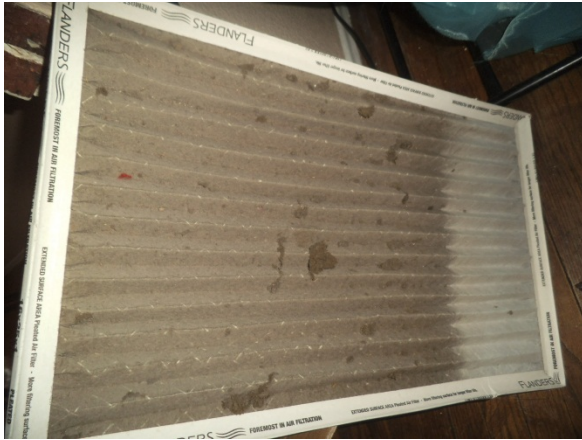
Photo 13: Old furnace filter

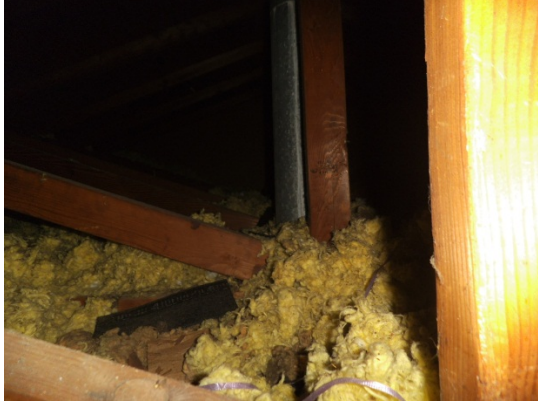
The primary roofs are steeply sloped gable roofs. The roofs are finished with asphalt shingles over asphalt-saturated paper. The shingle color is black. The attic is insulated with eight inches of loose-fill fiberglass insulation. The estimated insulation value is R-20. Ventilation of the attic areas is soffit to ridge, with additional gable vents at each end of the building.

Photo 13: Fiberglass blown insulation in attic

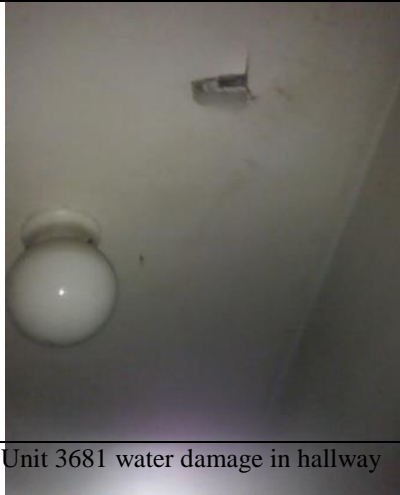
Photo #23: Unit 3681 water damage in hallway

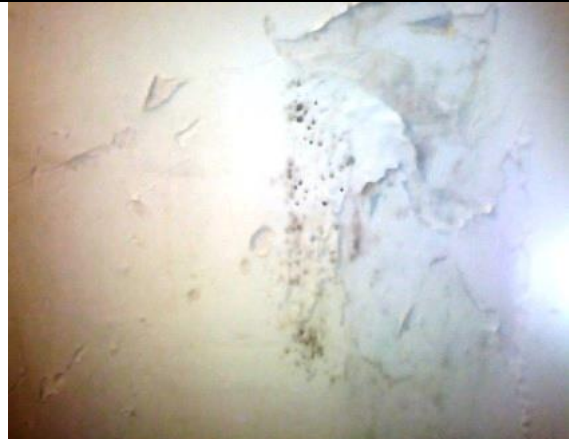
Photo #24: Unit 3681 water damage in basement

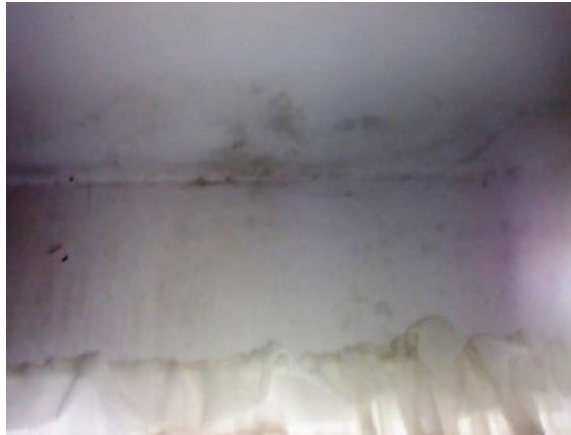
Photo #25:	Unit 3681 Water damage in bathroom
------------	------------------------------------

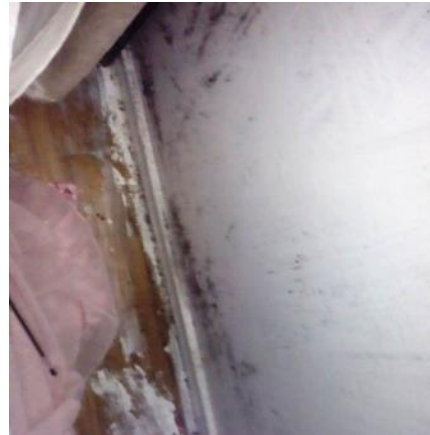
Photo #26:	Unit 3681 Moisture damage in bedroom 1
------------	--

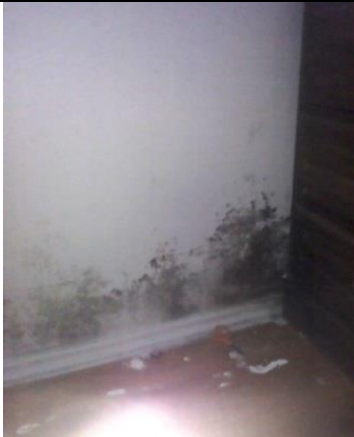
Photo #27:	Unit 3681 Moisture damage in bedroom 2
------------	--

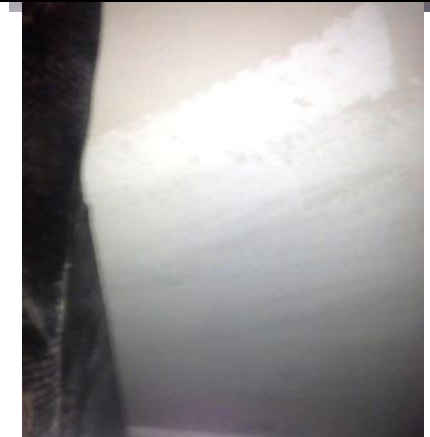
Photo #28:	Unit 3681 Moisture damage in bedroom 3 covered with paint
------------	---

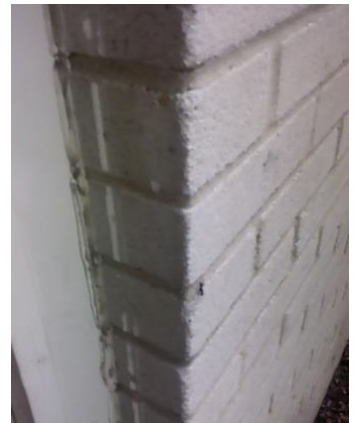
Photo #29:	Carpenter ant crawling up doorway of unit 3681 with all the moisture damage.
------------	--

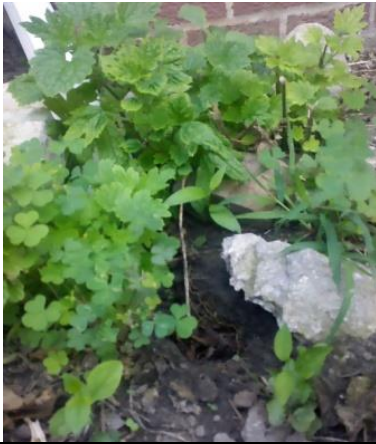
Photo #31:	Bottom of downspout missing. Water pools against foundation here.
------------	---

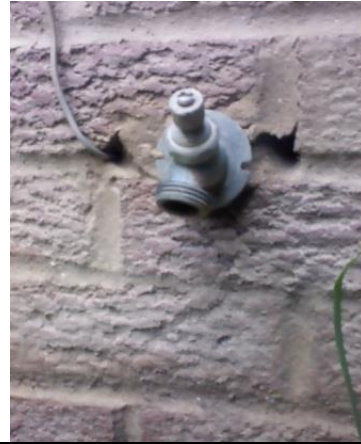
Photo #32:	Potential entry point for pests.
------------	----------------------------------

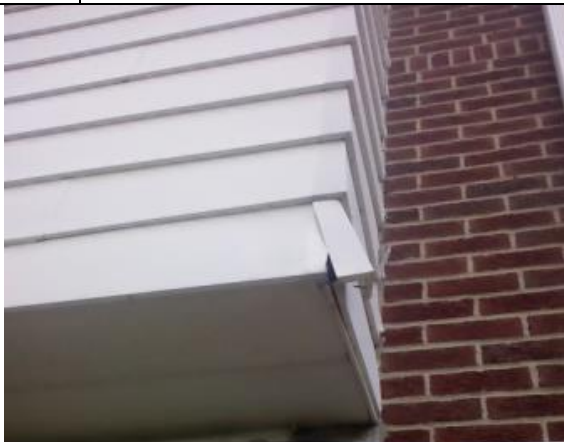
Photo #33:	Corner siding piece pulled away. Provides potential entry point for pests.
------------	--

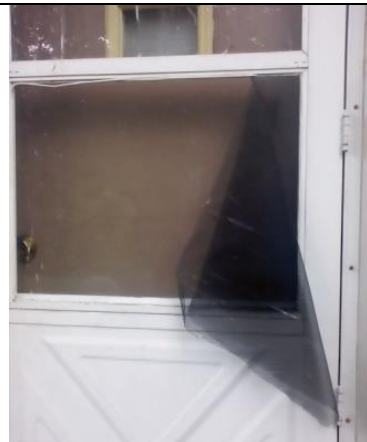
Photo #34:	Damaged screen should be replaced to prevent pest entry.
------------	--

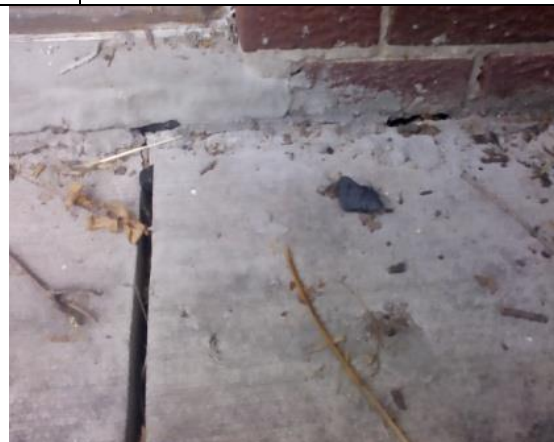
Photo #36:	Expansion joints between concrete slabs and building should be sealed to prevent pest issues.
------------	---
