**RE: Phase II Environmental Site Assessment Report
Swift Lane Development
1514 & 1520 White Street, 1521 State Street,
701, 707, 713 & 719 Henry Street
Ann Arbor, Washtenaw County, Michigan
Environmental Consulting Solutions, LLC
Project N100-0010**

PHASE II ENVIRONMENTAL SITE ASSESSMENT REPORT

**SWIFT LANE DEVELOPMENT
1514 & 1520 WHITE STREET, 1521 STATE STREET,
701, 707, 713 & 719 HENRY STREET
ANN ARBOR, WASHTENAW COUNTY, MICHIGAN**

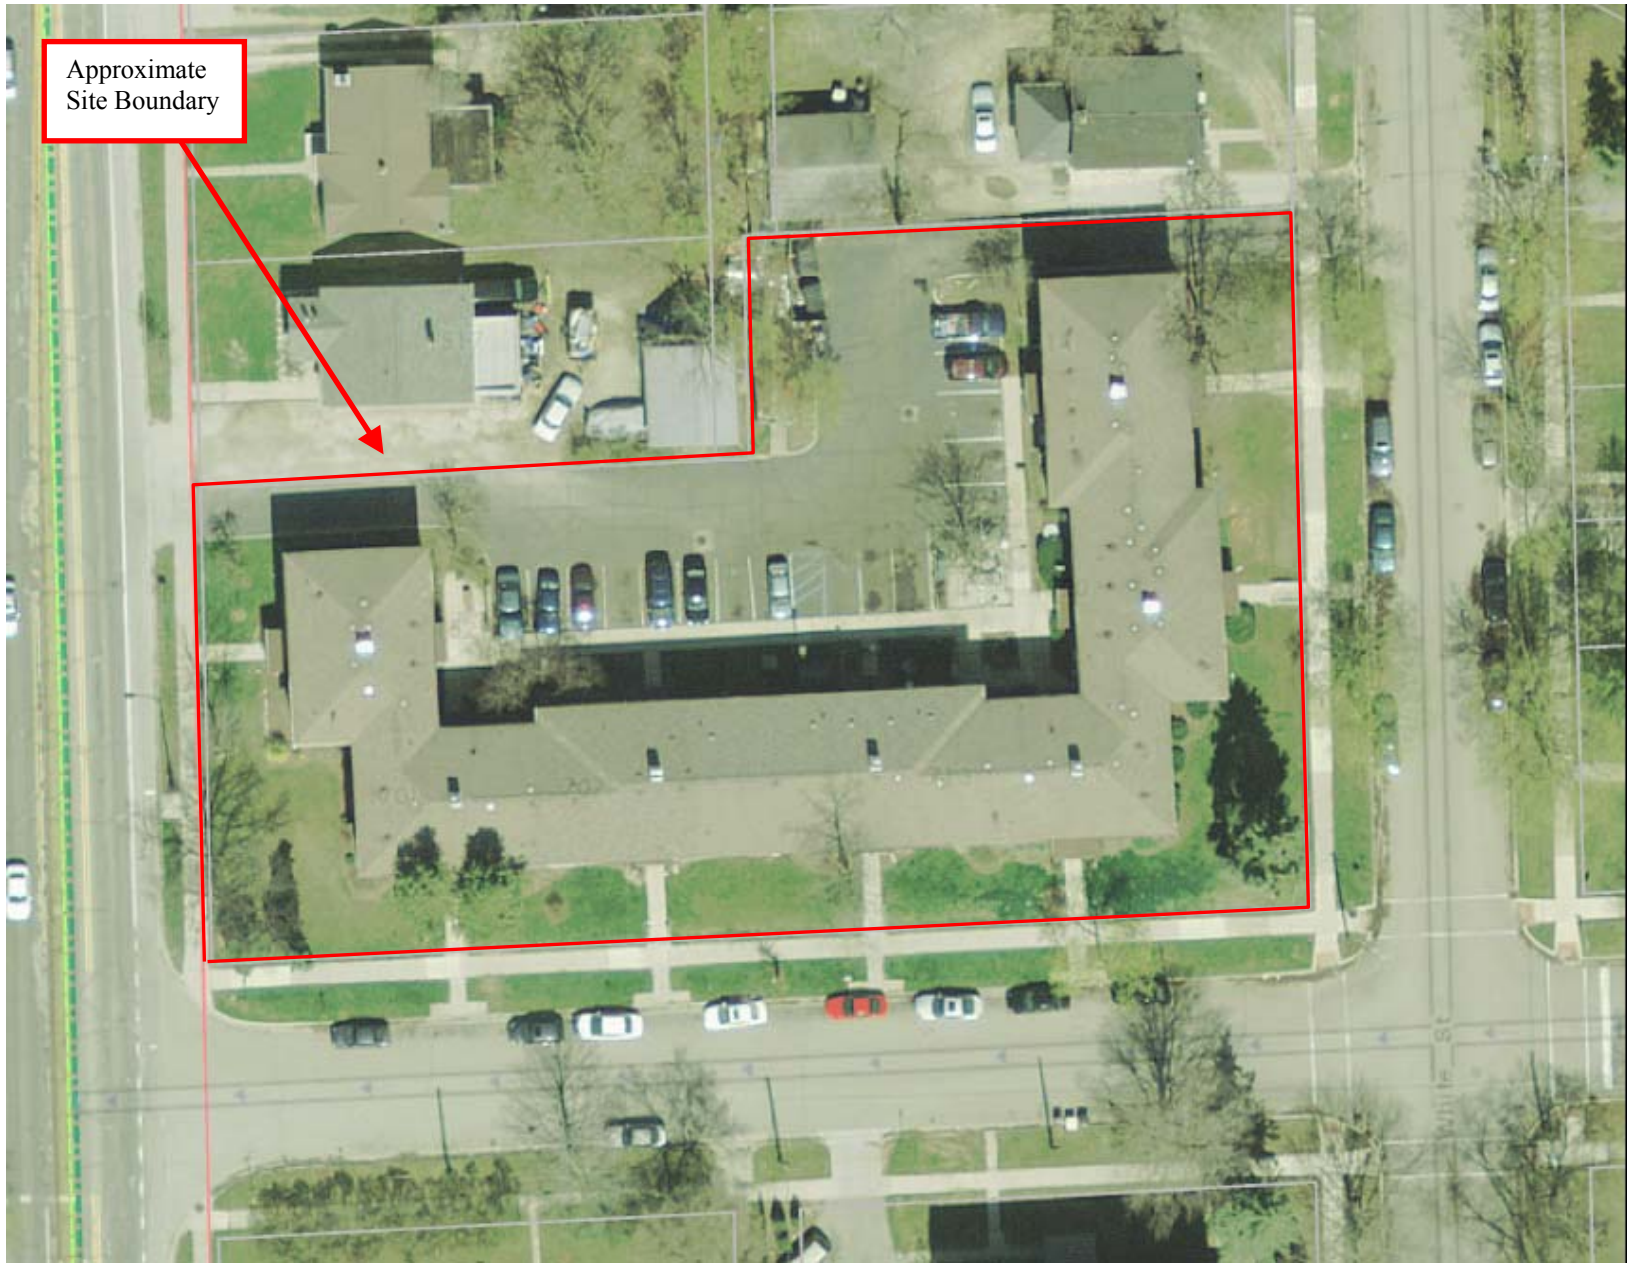
Approximate
Site Boundary

Refer to Figure 1 for a Site Location Map and to Figure 2 for an Aerial Site Map.

The Subject Property is developed as a multi-family community consisting of an apartment building, associated parking areas, and landscaping. The apartments are contiguous and located along White Street, State Street and Henry Street. Parking is situated along the north side of the building complex, with vehicle access from State Street and White Street. The adjoining properties to the north, south and east are residential. A University of Michigan campus building and parking adjoins the site to the west. The Site is presented in Figure 2, Aerial Site Map, which depicts the general features observed at the Site.

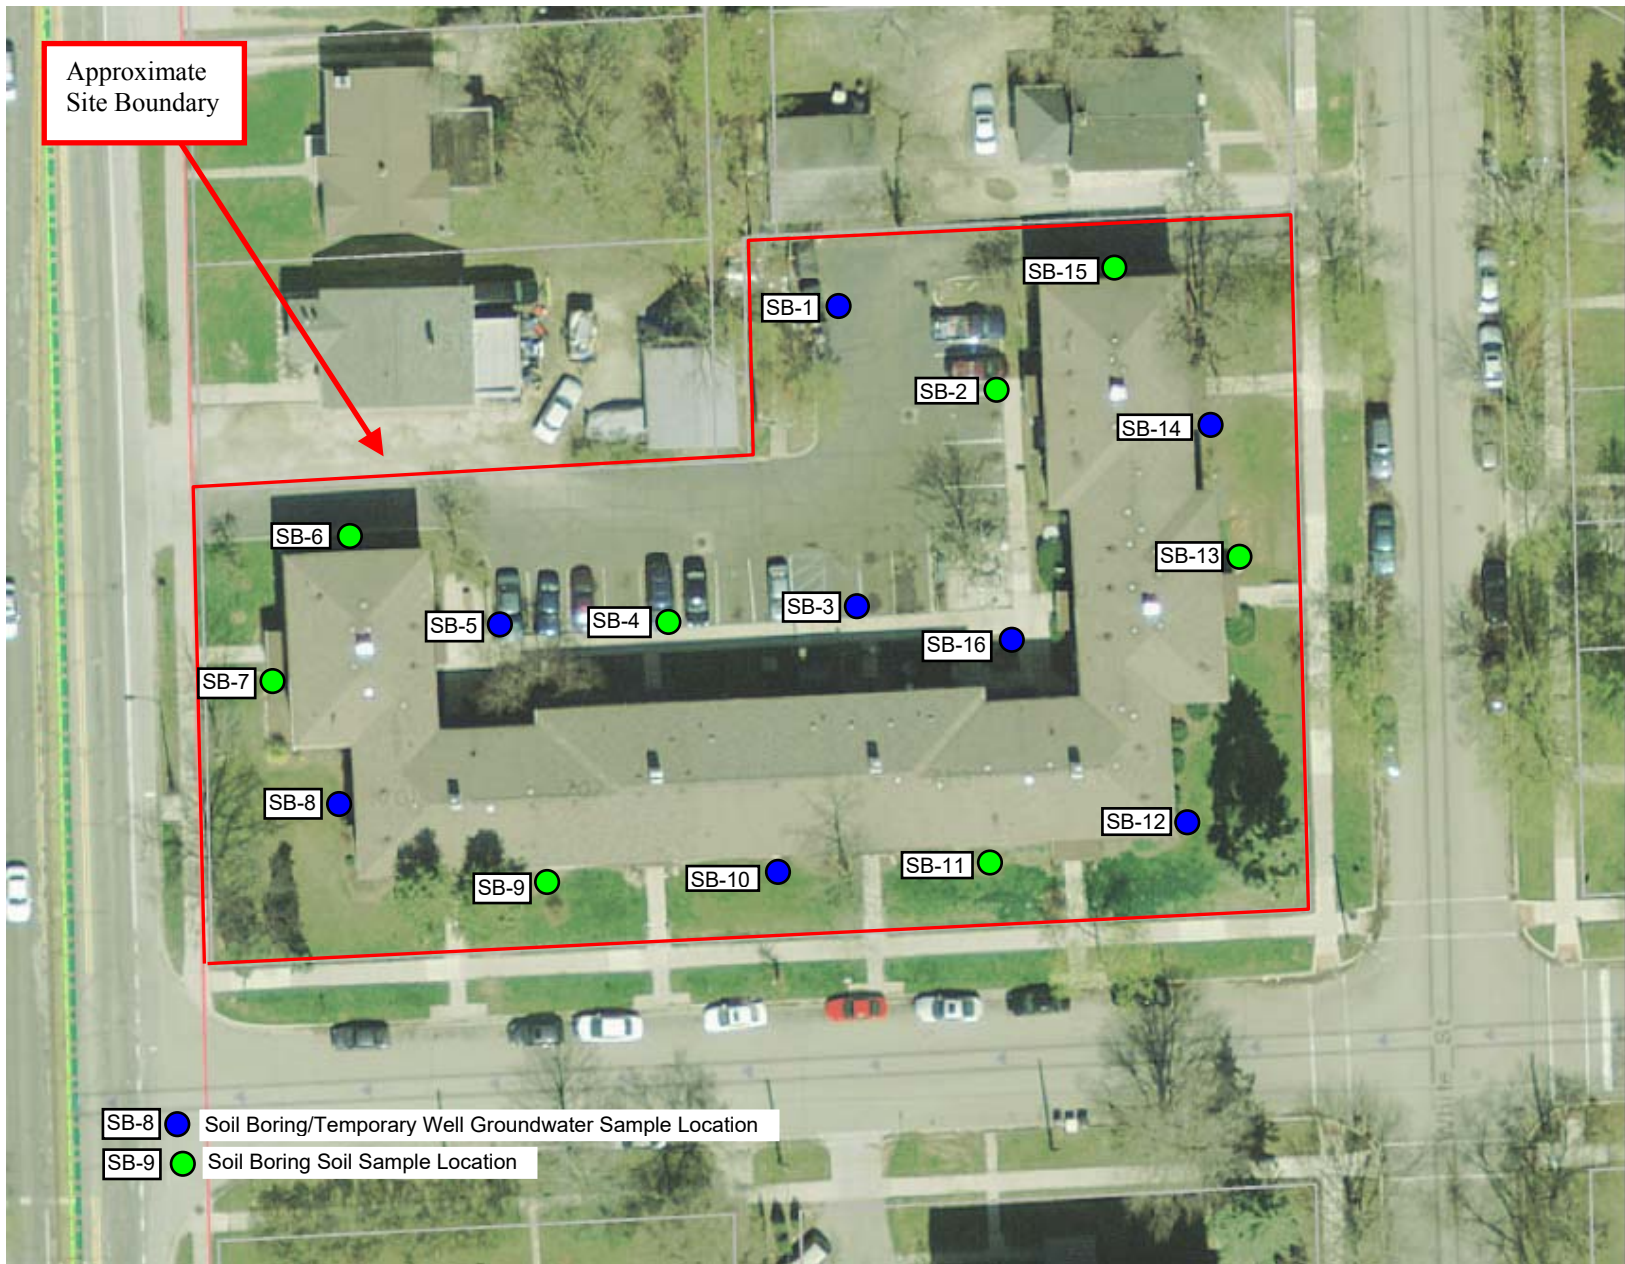
Refer to Figure 3 for a Site Map depicting the soil boring and temporary monitoring well locations.

The locations of the soil borings are depicted on Figure 3: Soil Sample/Boring Locations Map.

See Figure 3 for soil boring locations. See Appendix B for soil boring logs.

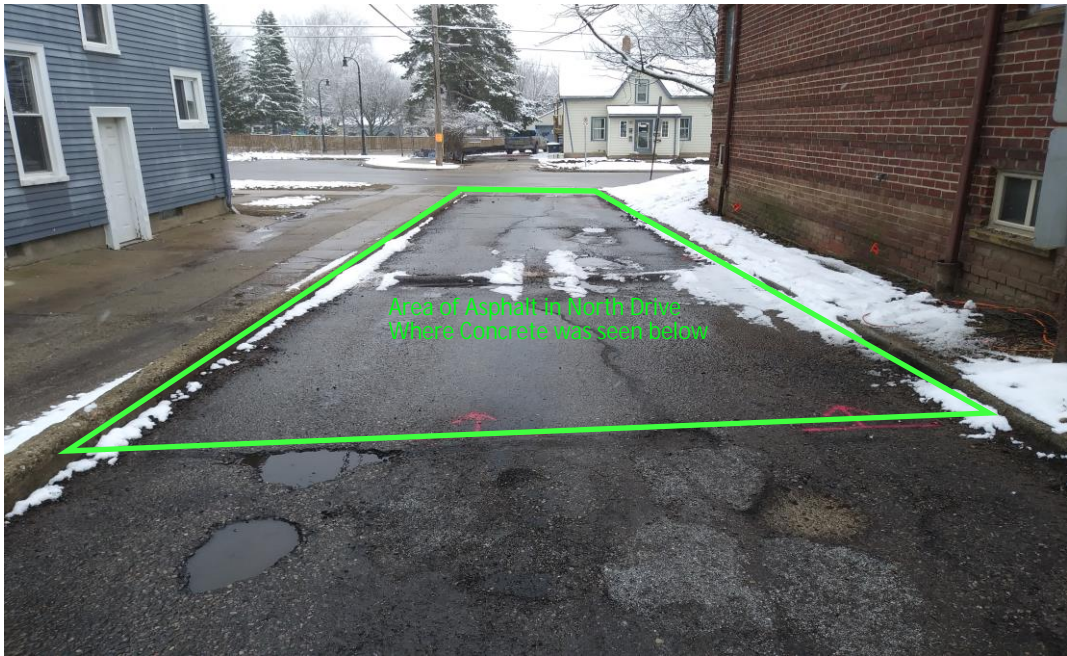
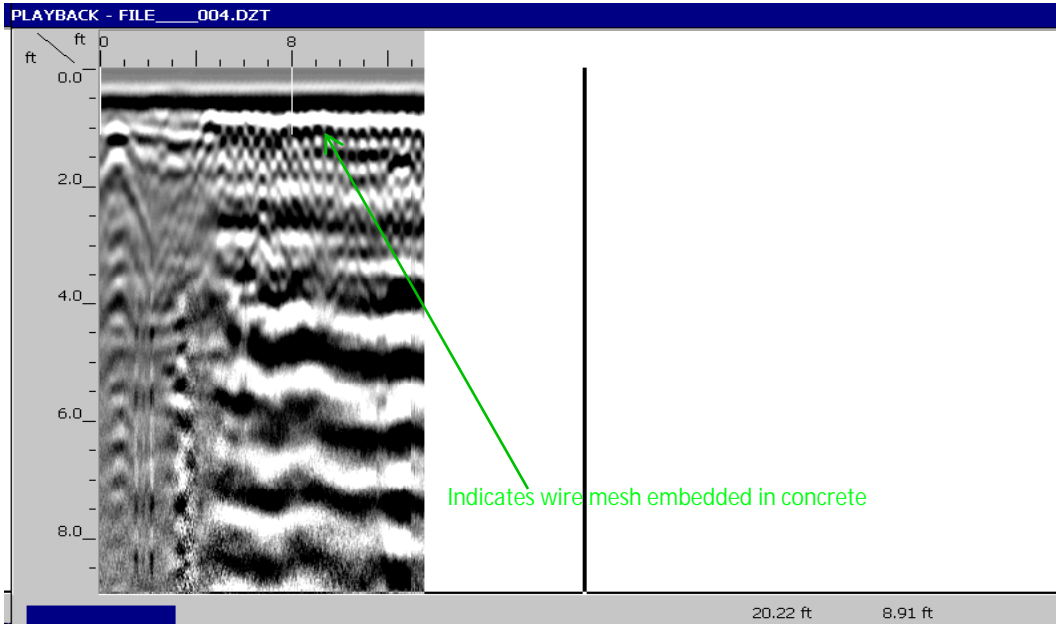
Photo & Data Image of N. Drive where Concrete was Determined Below Asphalt

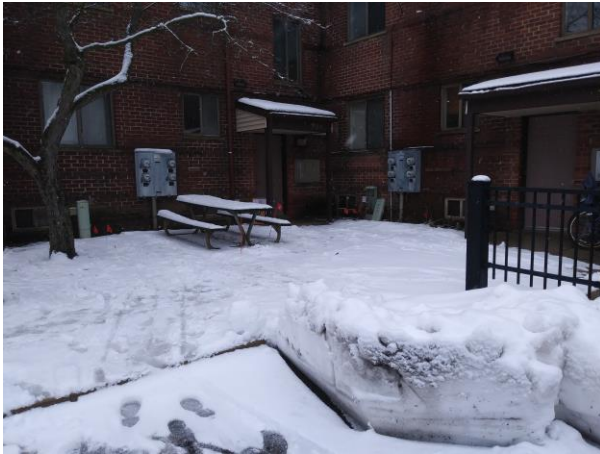
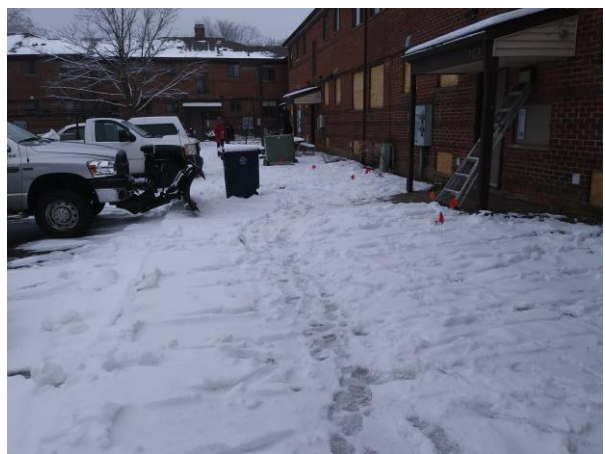
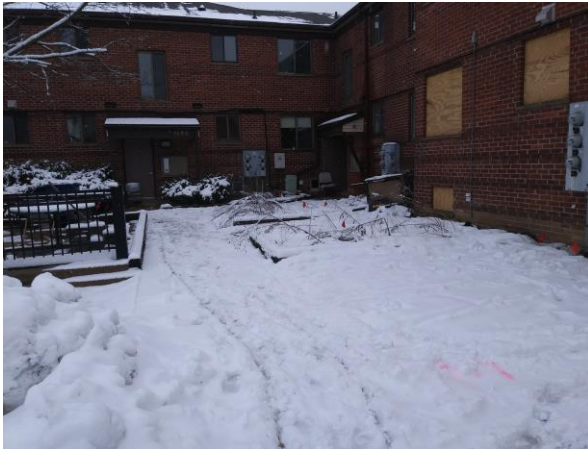
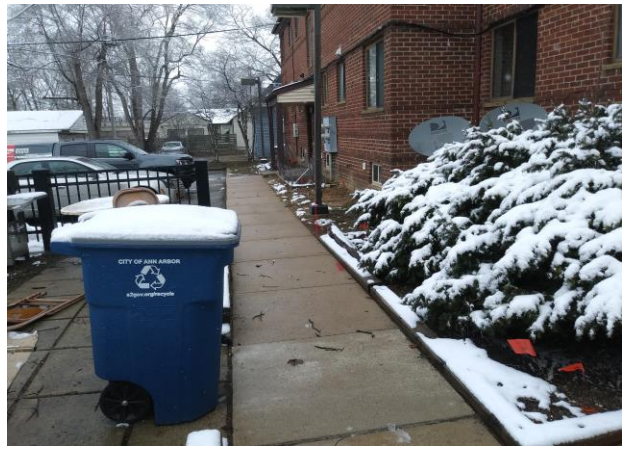
At this property, our scans were limited by reinforced concrete, snowfall in the courtyard area, saturated soil conditions, building debris, trees & loaded utilities in green space area of the courtyard. Refer to the photographs for the project specific limitations.

Photos from Courtyard Indicating the Limitations
