Rental Assistance Demonstration (RAD): **PART 2: ENERGY AUDIT**

1020-1042 Pennsylvania Avenue, Ann Arbor, Michigan 48103
HILLSIDE MANOR

PROJECT # 8359E-2-96

DATE October 7, 2013

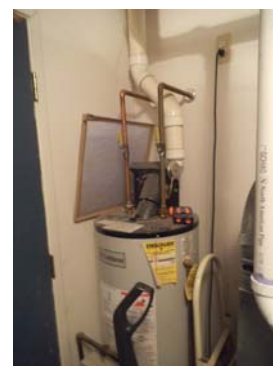
A water heater keeps water continually heated to a specific, set temperature. As the water loses heat through the tank walls during periods of non-use, the burner or heating element has to reheat the water. An insulation jacket will reduce the heat loss and, as a result, the energy required to maintain the hot water temperature and the water heater will not need to cycle as often. The insulation jacket enables the heater to bring the water up to temperature

Uninsulated HW pipe/tank

quicker, too, saving additional energy. Certain manufacturers may prohibit this on newer models. Please consult the tank manufacturer for newer models.

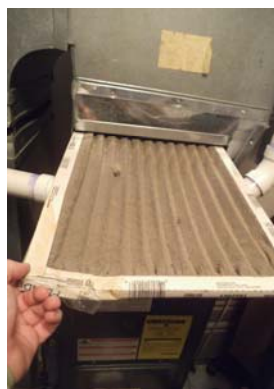
It should be noted that in Unit 1020, the filter located in the return air duct was likely older than 9 months.

Filter @ 1020 Pennsylvania

As furnace filters get dirty, they become more efficient at catching dust up to a certain point. Then, if the furnace filter is not changed, it will begin to restrict airflow. This causes your furnace to work much harder to heat and cool your home because it must run longer, thus using more electricity.

A furnace filter pulls a majority of unwanted particles from the indoor air. Examples are mold spores, pet dander, household dust, smoke, pollen, dust mites and smog. Regular filter change is an easy way to reduce energy consumption. A dirty filter will force your system to work harder to push air through the filter, while a clean one will allow the air travel more freely. The filter also keeps the coils and the heat exchanges in your system clean, minimizing maintenance issues and extending the life of the equipment. It will also help maintain peak performance of the furnace or air conditioner.

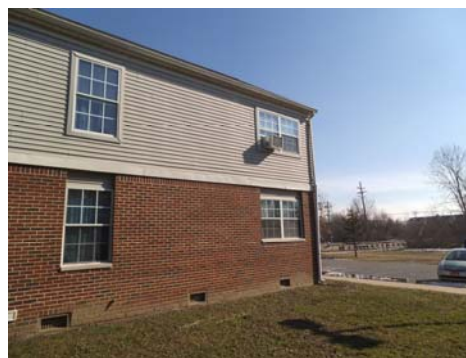
These windows are generally considered standard efficiency for age of construction. It was noted that the double hung windows with operable sash have allowed residents to utilize window air conditioners, and it appears that most leave their units installed throughout the winter months.

Second floor AC unit

However, because the audit team recognizes that this may not be realistic for each tenant, the team recommends utilizing insulated window air conditioner covers. There are two types of covers, indoor and outdoor. The outdoor covers protect air conditioners from insects, rodents, and other animals, in addition to sealing the unit and preventing drafts and excessive heat loss. These outdoor covers are preferred, as they will protect the units and increase their overall efficiency if they are well-maintained.

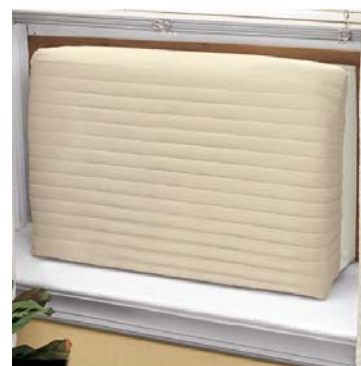
Sample indoor cover for second story

These units may not be appropriate for tenants living on the second floor, as this would require the use of a ladder and a more sophisticated handyperson. For these units the team recommends utilizing an indoor insulated cover. These indoor covers can be installed in tandem with exterior covers when applicable.

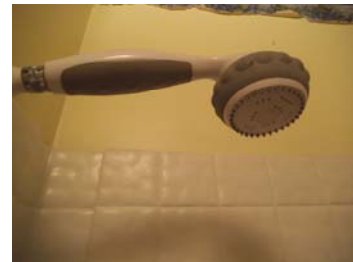
Showerhead @ 1020

In some areas, water and sewer rates have increased dramatically over the past few years and are rivaling the cost of energy. Reducing water use through conservation strategies can generate significant cost savings. These strategies include implementing low flow shower heads and faucet aerators.

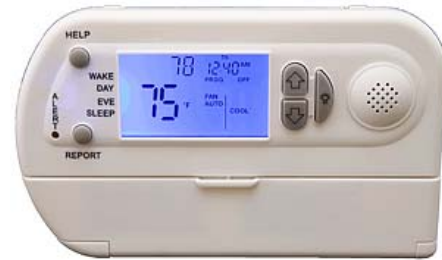
Currently, control of the furnace heat in each home is by a digital thermostat located in the hallway. Please note that although the thermostat observed during the site visit (and possibly others) is electronic with a digital display, it is not programmable.

VIP Series Talking Thermostat

It is recommended that a programmable thermostat is installed to control the heat. The programmable thermostats would allow a nighttime setback to be employed, thereby saving energy on heating during overnight hours.

Because the thermostat is controlled by the resident, a “tamper-proof” type design should be considered. Tenant or resident energy education is crucial when replacing manual thermostats with temperature limiting programmable thermostats. At the time of installation, tenants and residents should be informed about why the thermostats were selected and how they operate.

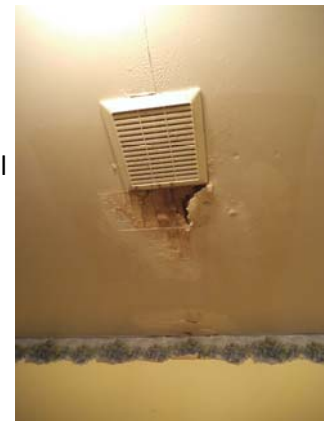
It should be noted that there may be a persistent leak in the bathroom above unit 1020, as there is signs of moisture which is degrading the ceiling and could cause additional problems for the Owner and tenant if leak is not addressed.

Water damage creating air pathways

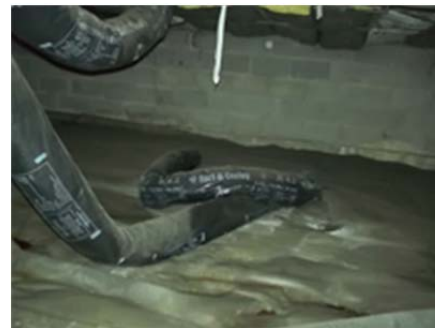
Crawl Space

This is the condition the audit team found at Hillside Manor Apartments. In this design, often fiberglass batts – R-19 or greater – are used for floor insulation. Unfaced batts avoid moisture problems in the insulation because they don’t have a vapor barrier to trap moisture coming either from the ground or indoors. These unfaced batts are often held in place with lath, stapled twine, or wire insulation supports. Most importantly perhaps, these batts should be installed so they touch the underside of the floor. Any gaps will allow convective loops or currents to carry away heat before the insulation can do its job.

One method for consideration would be the application of a spray-foam urethane insulation, which could provide both the necessary insulation levels and an additional air infiltration barrier. This extra benefit is particularly relevant for this building, as the audit team observed significant leakage at the subject unit inspected.

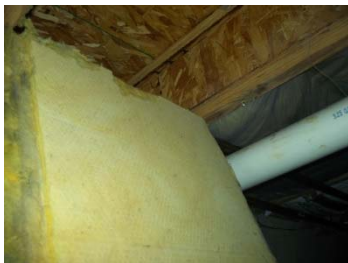
The audit team believes the **originally installed insulation may be substantially displaced or poorly installed** in several locations in each of the subject buildings. For this reason, the audit team recommends a detailed inspection of the current condition of existing insulation, and the evaluation of replacement with properly installed insulation rated at R-30 or better. This would conform to current energy standards in Michigan, and increase the overall energy efficient performance of these facilities.

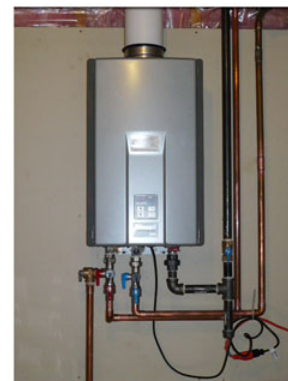
A new standard efficiency 40-gallon gas water heater has a current minimum Energy Factor of 0.59, due to inefficiencies of combustion, a central flue carrying heat away with combustion exhaust, and a continuous gas pilot light, as well as standby losses through insulation and thermo-siphoning.

This ECM recommends on-demand tankless hot water heaters (Energy Factor of .82 or greater). This represents a 15% percent energy savings compared to a standard efficiency gas water heater.

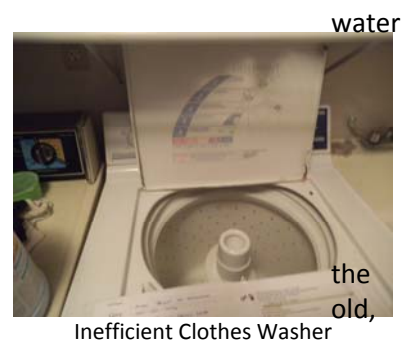
Typically, residents are responsible for providing their own washers and dryers. This reduces a first cost for the housing commission – however, residents appear to be installing/utilizing cheapest functioning units available. These units are often very and extremely inefficient. This results in high electrical energy consumption, but even greater water consumption.

Because the Owner of the property is responsible for paying the utility, the audit team believes an investigation into high efficiency clothes washers may be a sound investment for the Ann Arbor Housing Commission.

In the past few years, the change in design and operation of the clothes washer units has allowed the consumer to reduce water usage and drying time. Typical high-efficiency washers use 27 gallons of water per load. In contrast, conventional models that were built from 1980 to the late nineties consumed between 43 and 51 gallons of water per load.

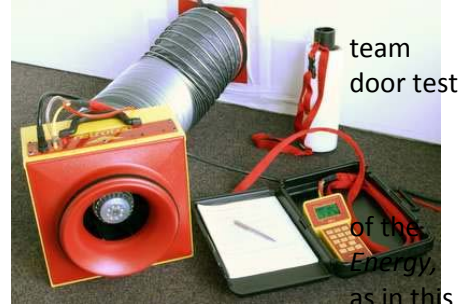
Diagnostic testing equipment for ducts

It is recommended that unconnected duct joints are repaired and leaky duct joints are sealed and insulated to meet or exceed current energy codes. Duct mastic used with fabric webbing is the best material for sealing ducts.

A pre and post duct blaster test is recommended to quantify the impact of a potential improvement, and verify the quality of any work performed.

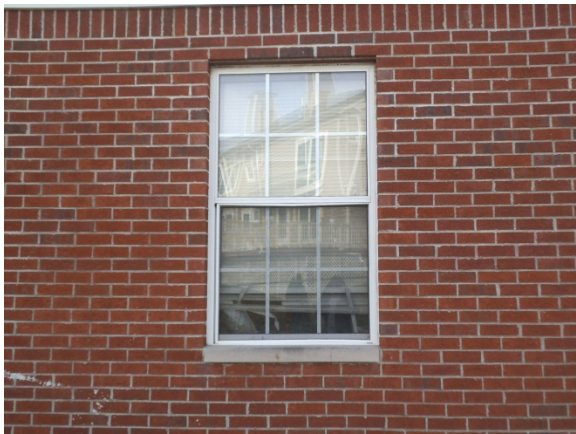
The apartment windows appear to be white vinyl clad aluminum, double hung, double pane glazing with decorative muntin bars between glazing at each sash. These windows appear to be thermally broken and in fair condition.

Photo 5: Typical style window of each unit

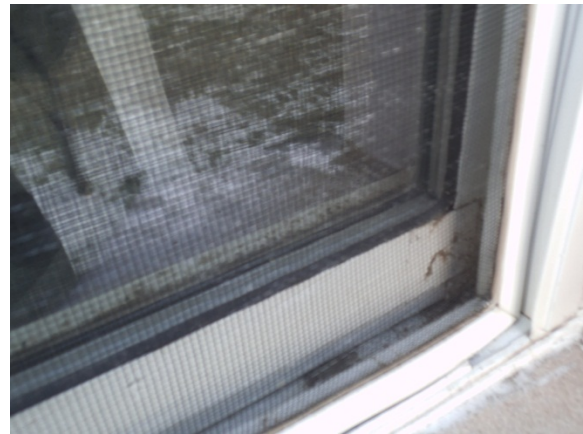
Photo 6: Exterior view of window frame

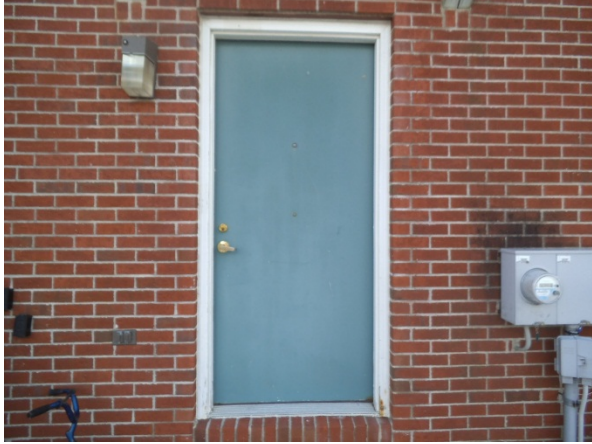
It appears that this lighting is not functioning properly. The tenants at the unit investigated have observed that exterior lighting is not on in the evening, often creating challenges for in-home nursing assistants trying to find the unit at night.

Photo 7: Typical side door and exterior lighting

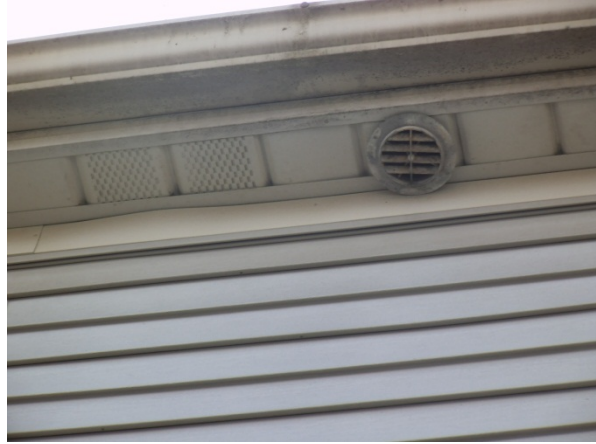
Photo 8: Soffit vents above second floor of building

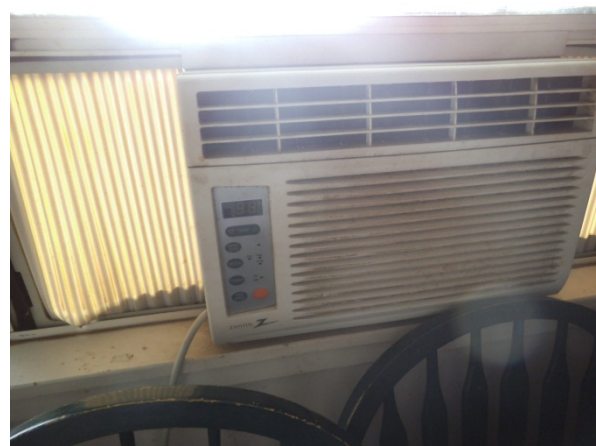
During the cooling season, five of the tenants use personal window air conditioning units to supply cold air to the units, but there is no evaporator coil (central cooling) installed at any apartments. Currently, there are ten window air conditioners in the subject property. Three of the tenant units have one air conditioner, one of the tenants has three air conditioners, and the other tenant has four air conditioners within the tenant space. These air conditioners are considered standard efficiency units and are approximately 3 years old. It is believe that most of the units are rated at 1 to 1.5 tons and operate throughout the summer months.

Photo 10: Window air-conditioning unit

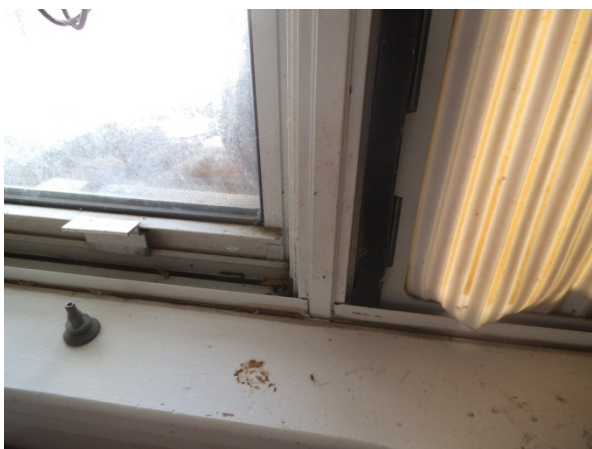
Photo 11: Interior window frame of typical window

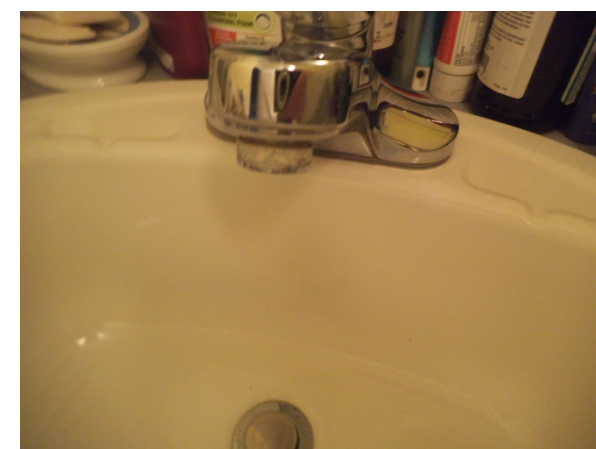
Photo 12: Bathroom faucet with aerator

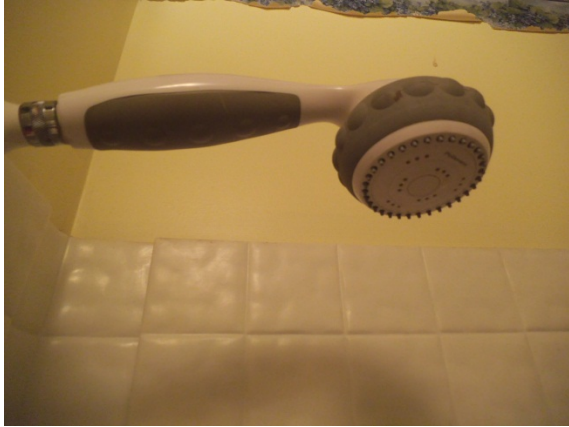
Photo 13: Standard efficiency showerhead

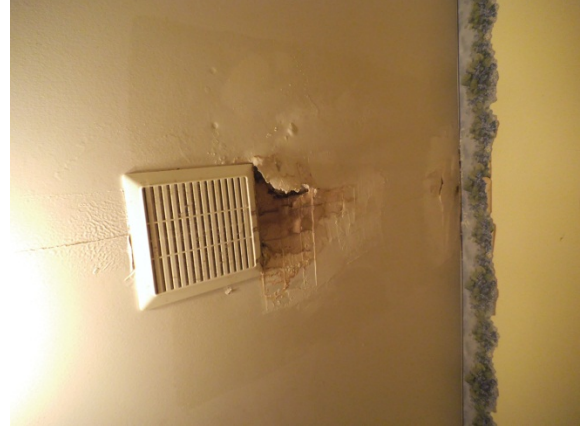
Photo 14: Bathroom exhaust fan (water damage)

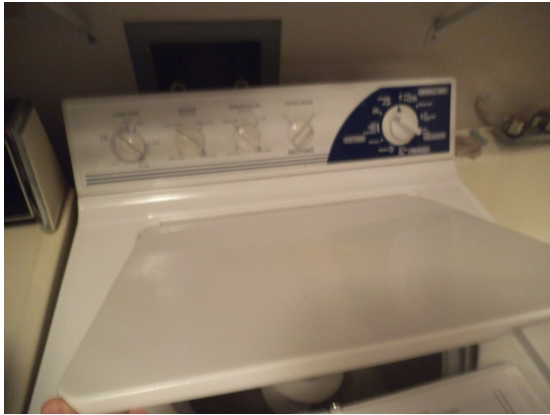
Each apartment unit also supplies an electric hook up (vent, water, and electricity) for a washer and dryer in the laundry room. Typical washers and dryers observed during field investigations were standard or substandard efficiency units.

Photo 15: Clothes washer in mechanical room

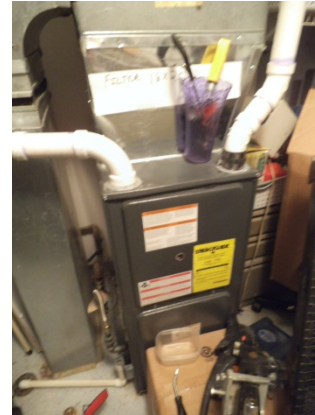
Photo 16: High Efficiency Furnace in mechanical rm.

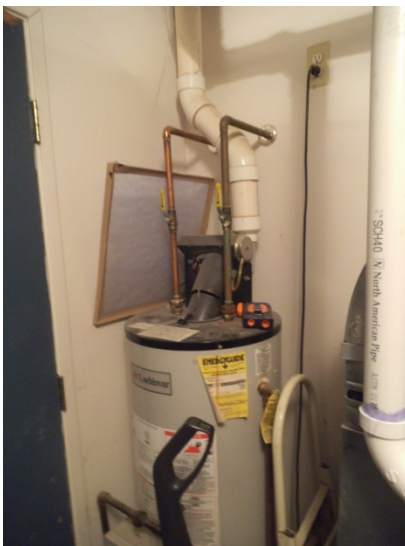
Photo 17: DHW tank in mechanical room

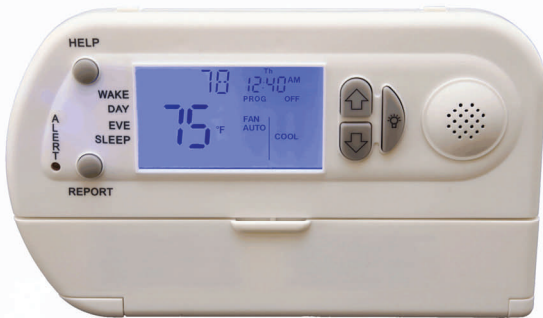
The **NEW VIP 3000** is a full featured universal multi-stage talking thermostat that can control most 24 Vac AC and Heating Systems including the newest multi-stage (up to 3H and 2C) gas, oil and electric furnaces, air conditioners and heat pump / dual fuel (hybrid) systems with 1 or 2 stage compressors and auxiliary heat. The VIP 3000 has enhanced speech functions and optional auto-changeover

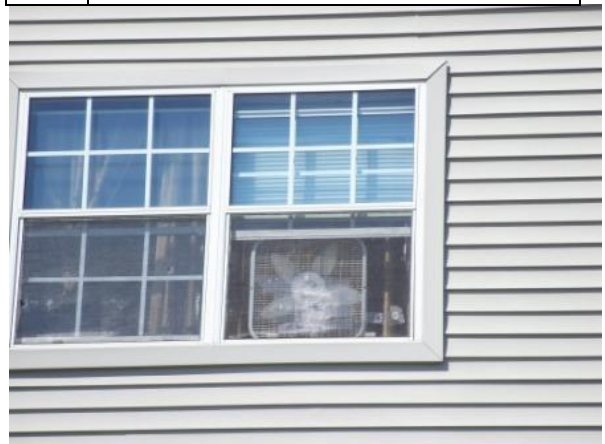
Photo #18:	Damaged window screens
------------	------------------------

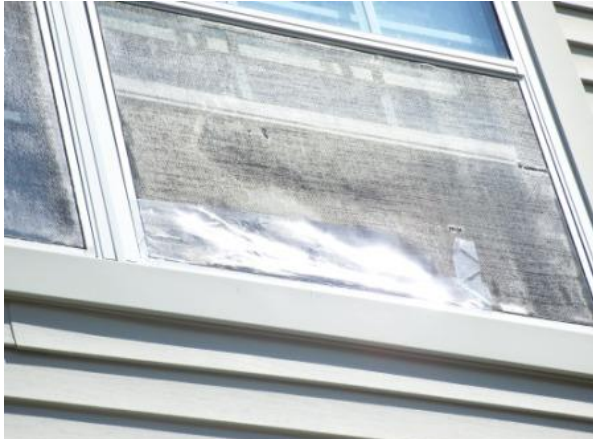
Photo #19:	Damaged window screens (there is tape over holes currently)
------------	---

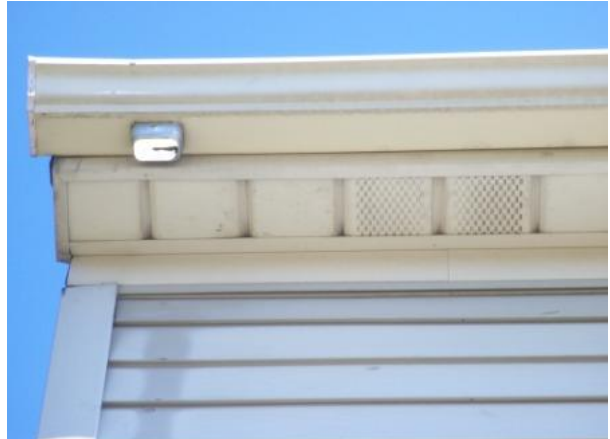
Photo #190:	Missing downspout
-------------	-------------------

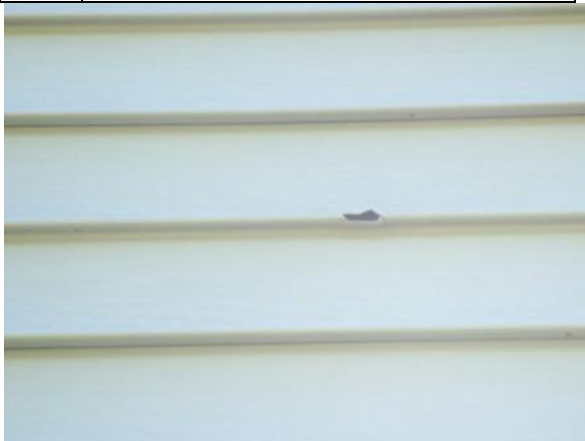
Photo #21:	Holes in siding, potential entry point
------------	--

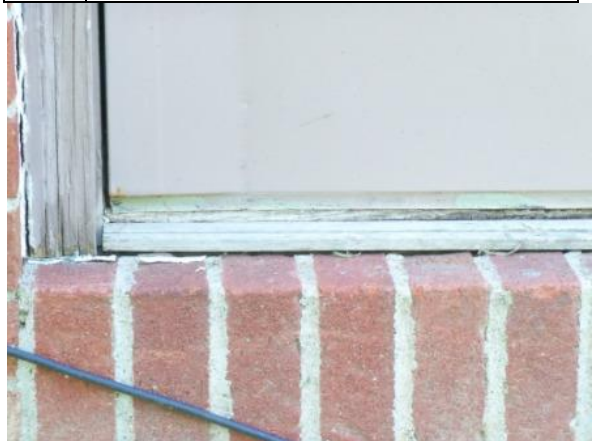
Photo #22:	Gap around door, potential entry point
------------	--

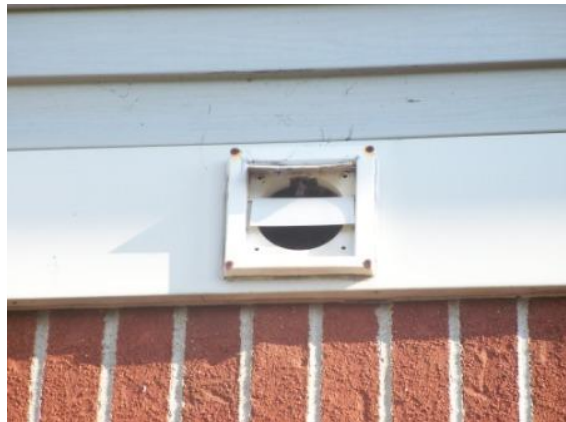
Photo #23:	Damaged dryer vent, Potential entry point
------------	---

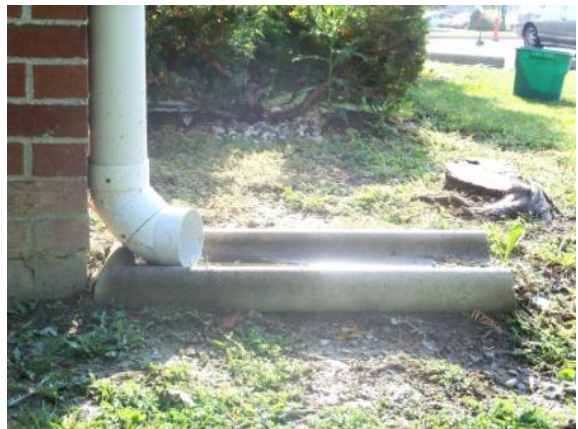
Photo #24:	Downspout not sloping away from building. Water will pool at foundation.
------------	--

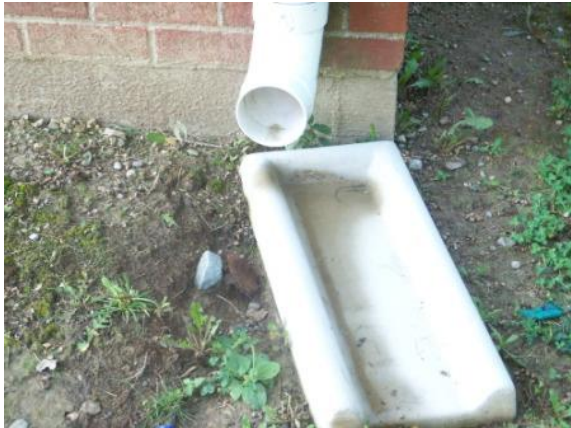
Photo #25:	Offset downspout, water will pool at foundation.
------------	--

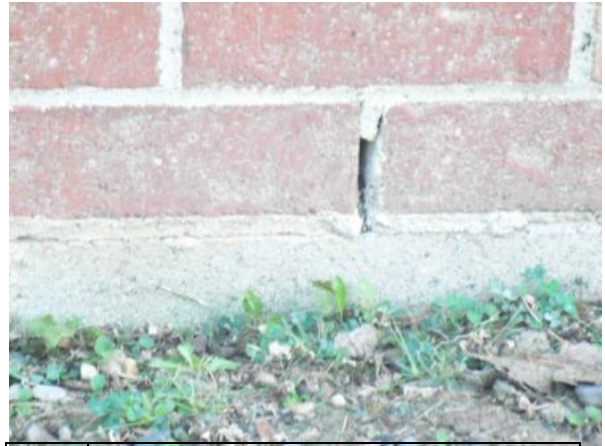
Photo #26:	Weep holes should have screen in them to prevent pest entry.
------------	--
