**2012
BRIDGE INSPECTION PROGRAM**

TREATMENT PLANT DRIVE OVER HURON RIVER

CITY OF ANN ARBOR

Prepared by
DLZ Michigan, Inc.
1425 Keystone Avenue
Lansing, MI 48911

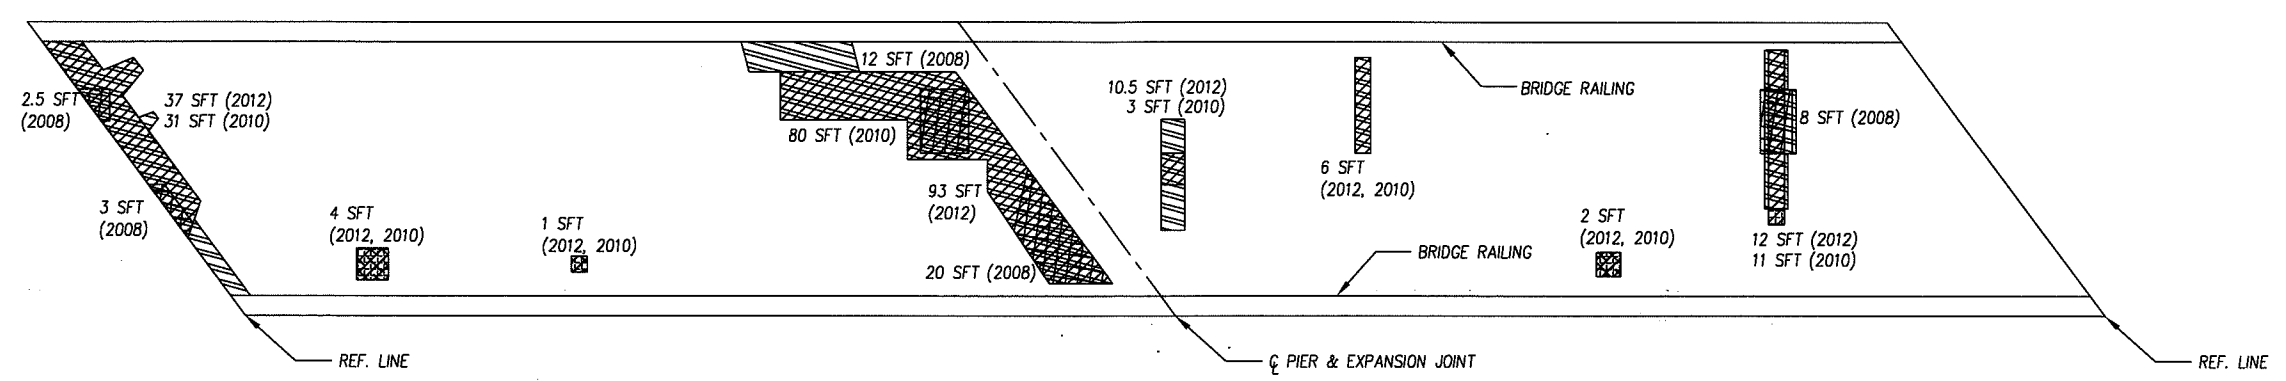
TREATMENT PLANT DRIVE DECK
DELAMINATION SURVEY

The concrete deck is in fair condition. There are multiple cracks, delaminations, spalls, and concrete patches present, totaling approximately 8.5% of the deck area (Photos 7-12). The bottom side of the deck has over 5% of the total area containing transverse and longitudinal cracks with efflorescence, some delaminations, and rust stains (Photos 17-19).
