**City of Ann Arbor
Lower Town Mobility Study
Road Safety Audit**

FINAL REPORT

July 2020

Road Safety Audit

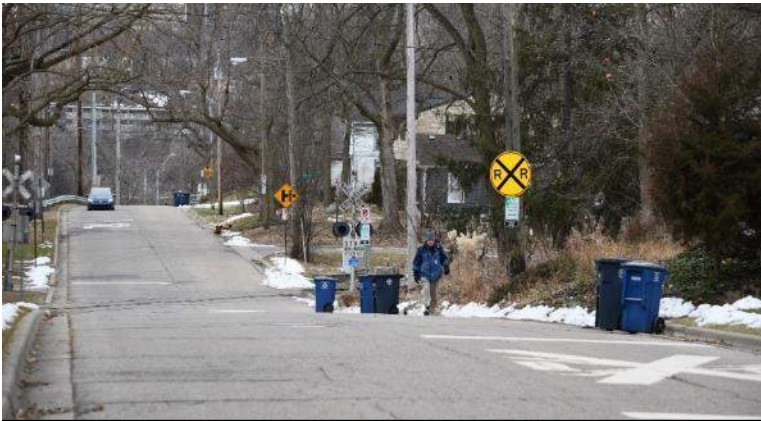
- There is a lack of sidewalk connectivity along Traver Road, Broadway Street, and Barton Drive.
- In many cases desire paths, a.k.a. goat trails, are apparent showing that pedestrians are active in this area but do not have a dedicated place to walk.
- Traver Road is near the AAPS Northside STEAM school and students may use this street when walking to school, but do not have a safe place to do so.

Figure 15: Pedestrian Walking in Roadway Due to Absence of Sidewalk

- Traver Road: Construct sidewalk between John A Wood Street and Barton Drive, filling the sidewalk gap on the west side of the road. This could be accomplished by removing on-street parking along the northwest side of Traver and using the resultant space for a sidewalk and greenbelt separation from the travel lanes.

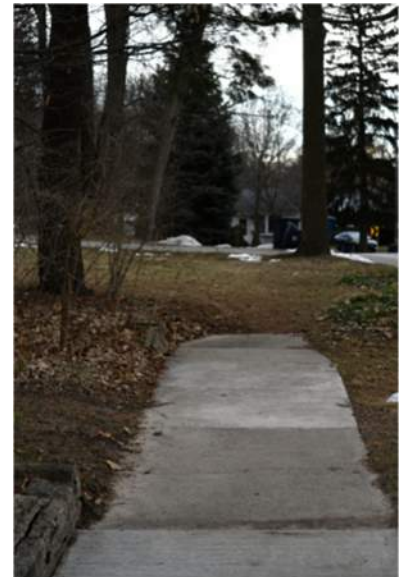
Figure 17: Sidewalks End Without Advance Notice to Users

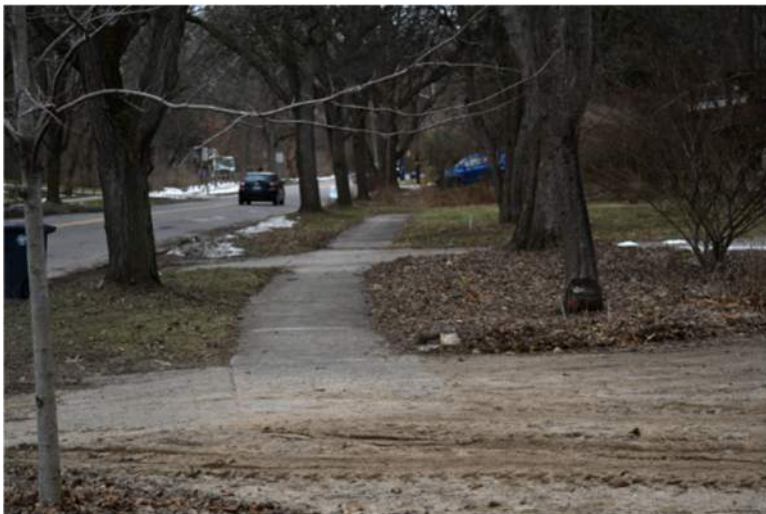
Figure 16: Isolated Sidewalk Segments Not Continuous with the Rest of the Network

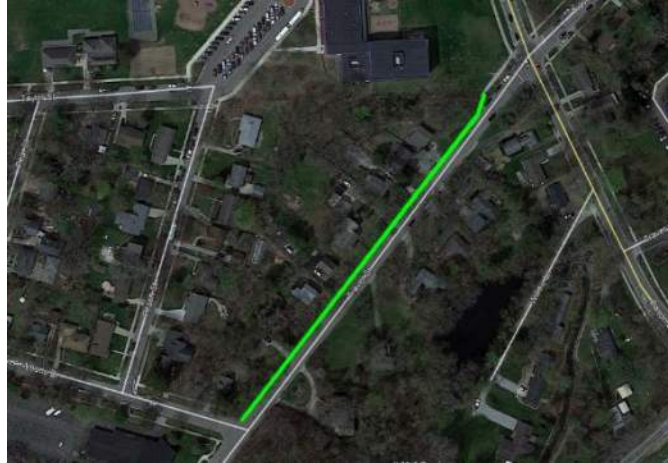
Figure 18: Traver Rd Sidewalk Gap Between John A Wood and Barton Dr

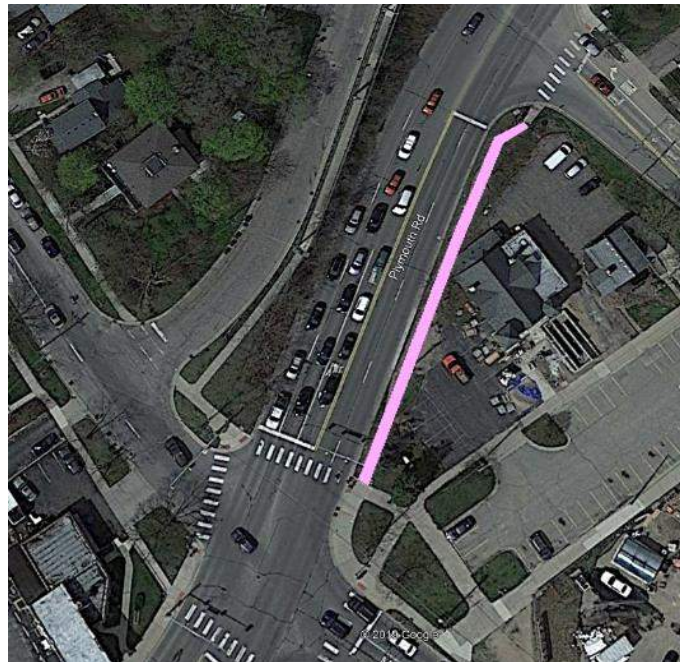
Figure 19: Broadway St Sidewalk Gap Between Plymouth Rd and Maiden Ln

- Broadway Street: Fill the sidewalk gap from Maiden Lane to Broadway Street/Plymouth Road intersection on east side of roadway.

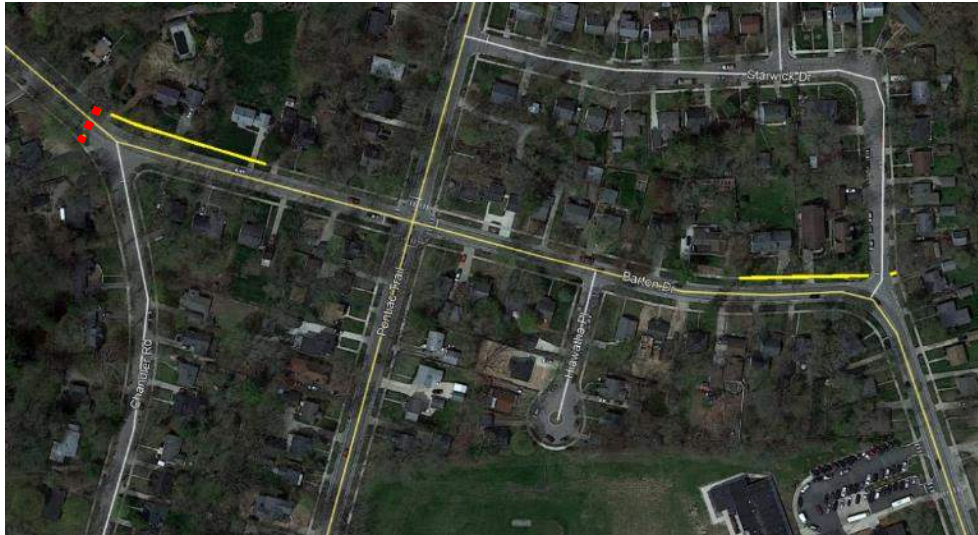
Figure 20: Barton Dr Sidewalk Gaps West of Starwick Dr and East of Chandler Rd. Proposed Crossing of Barton Dr West of Chandler Rd.

- Barton Drive: Fill the sidewalk gaps near Starwick Drive and Chandler Road to connect to the existing sidewalks.
- Barton Drive: Provide a connection from north to south to access the boardwalk at Brede Place

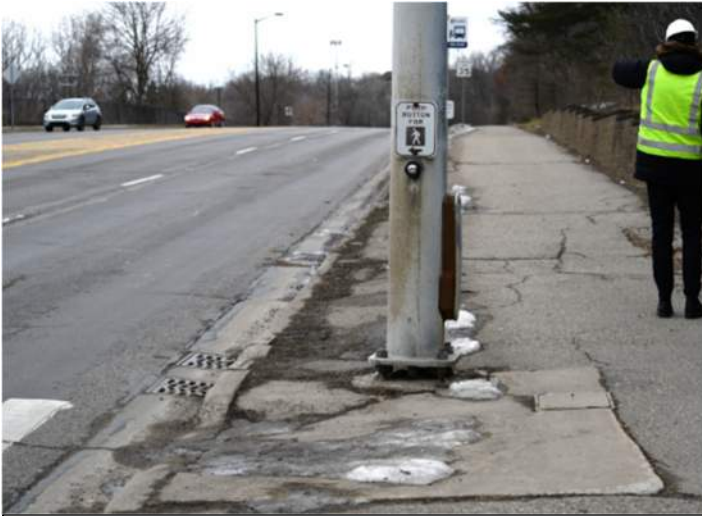
- Many of the ramps in the Lower Town Study Area are not ADA compliant.
- This includes:
 - Ramps lacking tactile strips
 - Incorrect geometry
 - Impediments from railroads
 - No ramps at some crossings

Figure 21: Crossing Ramp Lacking Detectable Warning

- Upgrade all non-ADA compliant ramps to meet ADA requirements.
- Some items that need to be improved include:
 - Grades
 - Crossing Push-Button Locations with appropriate level landings
 - Adding Truncated Domes
 - Providing Landing Areas
 - Providing Curb Drops

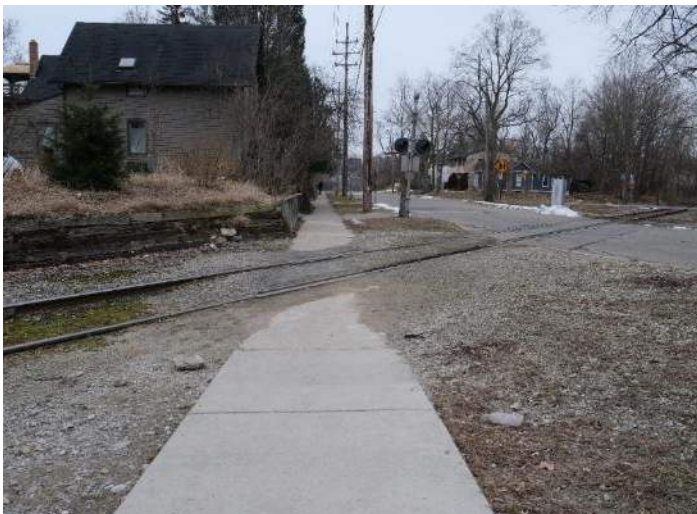
Figure 22: Sidewalk Does Not Continue Through Railroad Crossing

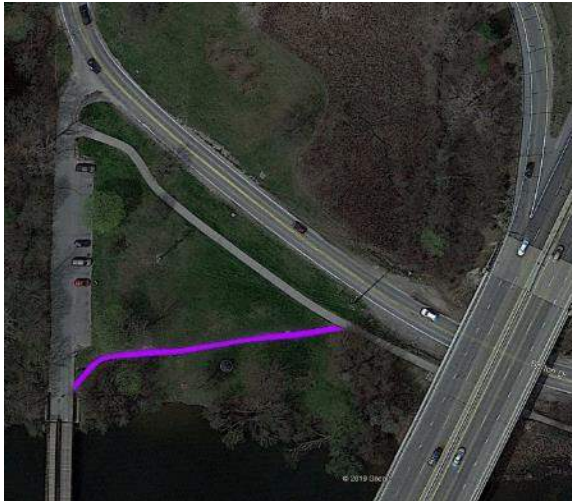
Figure 26: Desire Line from Barton Dr to Huron Bridge Park

- Provide sidewalk or pathway connections to accommodate the actual travel patterns of pedestrians

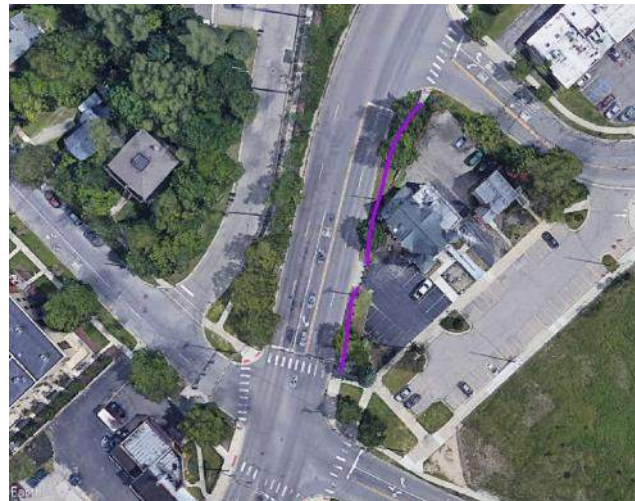
Figure 27: Desire Line Along Broadway St from Plymouth Rd to Maiden Ln

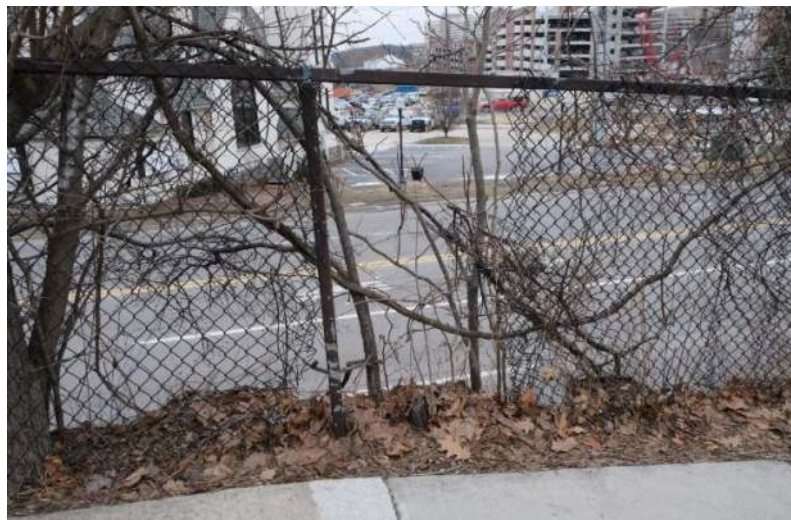
- A number of locations contained gaps in fences and railings that exist along sidewalks and could be a hazard for those walking alongside.
- Some appear to be forced by pedestrians looking for a shortcut down a steep slope

Figure 29: Gap in Fence Along Traver St Near Moore St

- Fill gaps in railings to keep pedestrians from falling
- Replace fencing in areas as needed

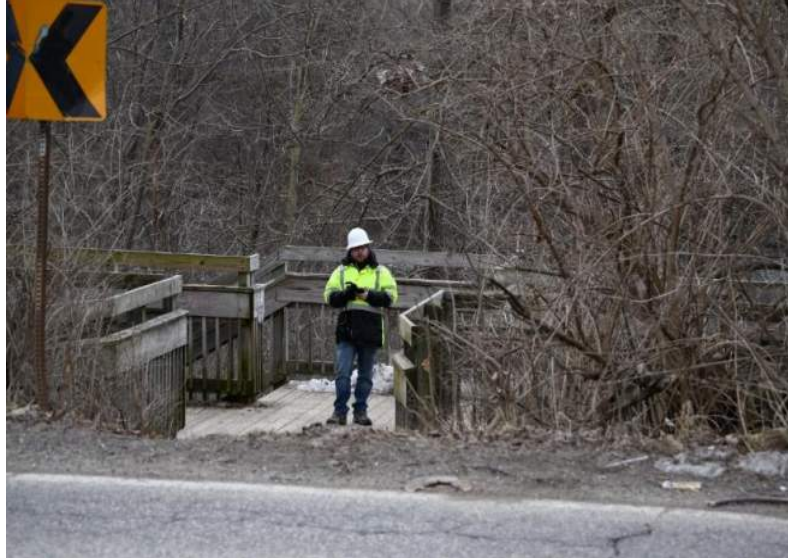
- A mid-block access point to the Barton Drive boardwalk is hidden along the curve between Brede Place and the M-14 entrance/exit ramp.
- This access point is difficult for pedestrians to find and nearly impossible to see for passing motorists.

Figure 30: Mid-block Access to Boardwalk Along South Side of Barton Dr

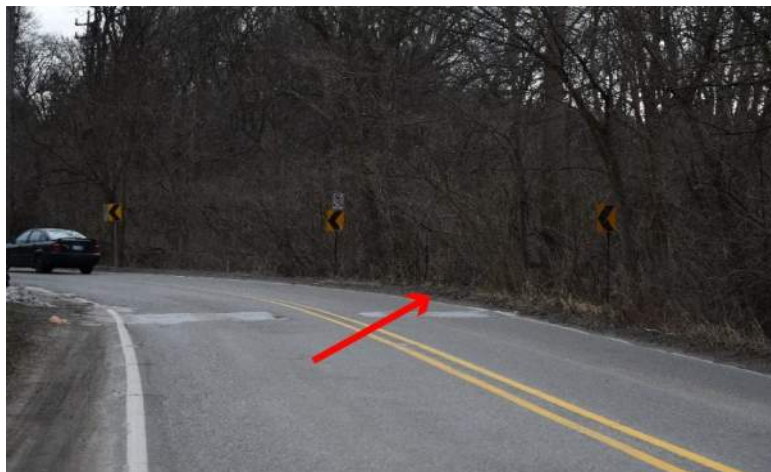
Figure 31: Location of Mid-block Access to Boardwalk Along Curve of Barton Dr

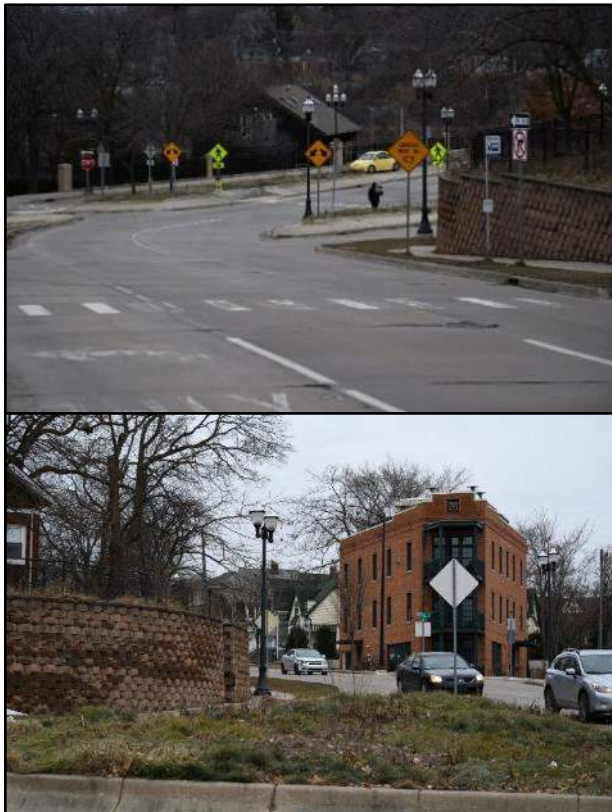
- Vehicles traveling northbound on Division Street toward the Broadway Bridge are coming downhill and traveling faster than the posted 25 mph speed limit.
- This is a highly active bicycle and pedestrian route with a number of midblock crossings, bike facilities, and transit stops in the general vicinity.
- The dedicated on-street bike lane for northbound Division St ends less than 300' from the junction with Beakes St, Broadway St, Carey St, Detroit St and High St.
- Visibility around the curve may be blocked by the retaining wall.

Figure 36: Retaining wall as sight distance obstruction. Top view as seen by drivers NB on Division; bottom view as seen by pedestrians.

- The intersection of Division Street with Carey Street, Detroit Street, Broadway Street, Beakes Street and Summit Street should be reconfigured to improve safety, slow vehicles down, and make pedestrian crossing easier.
- The northern pedestrian crossing at Carey Street should be relocated to enhance visibility (from red box to yellow box in image)
- Add in road gateway treatments R1-6 to crossing areas
- Narrow the lanes to slow vehicles down

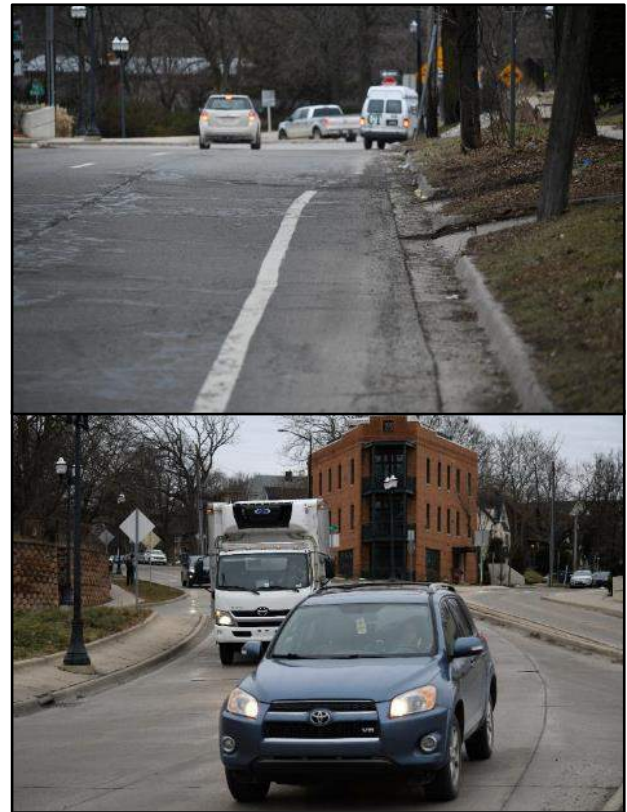
Figure 37: Geometric constraints related to NB Division St joining Broadway St. Dedicated On-street bike lane ends just prior to start of steep down-grade and sharp horizontal curve.

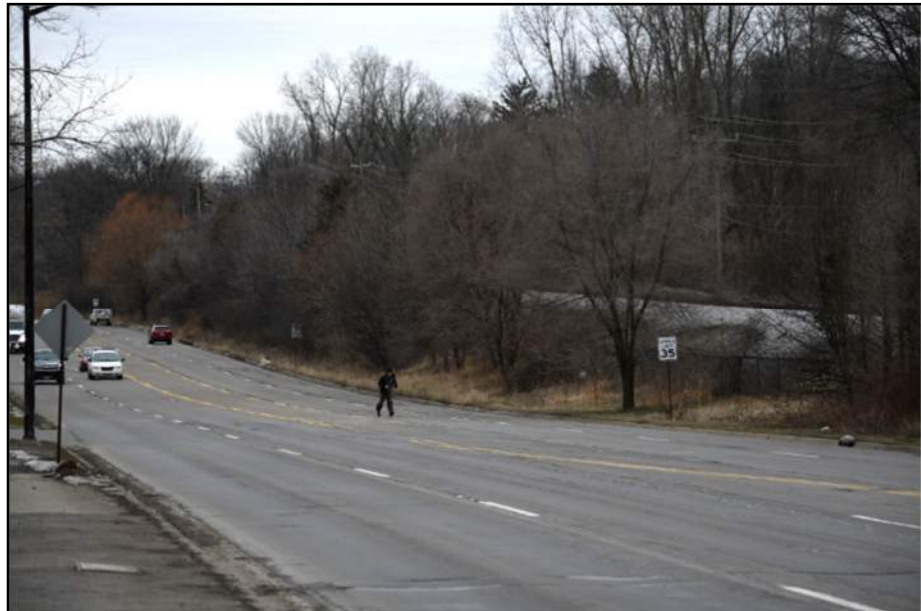
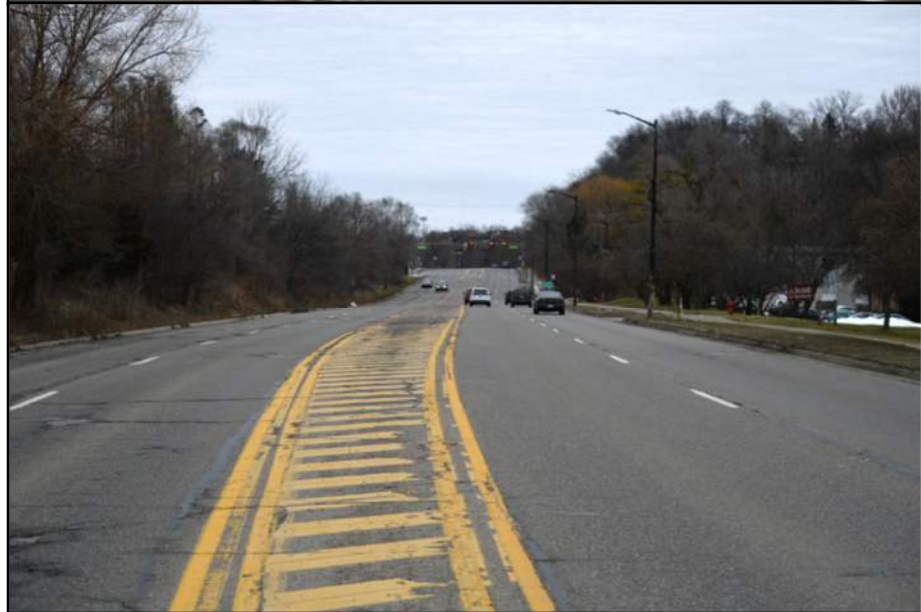
- Posted speed limits along Plymouth Road from Barton Drive to Broadway Street appear to be low.
- Traffic data shows prevailing speeds of 45+ mph in both directions along Plymouth Road

Figure 43: The speed limit posting for Plymouth Rd is not commiserate with the roadside environment.

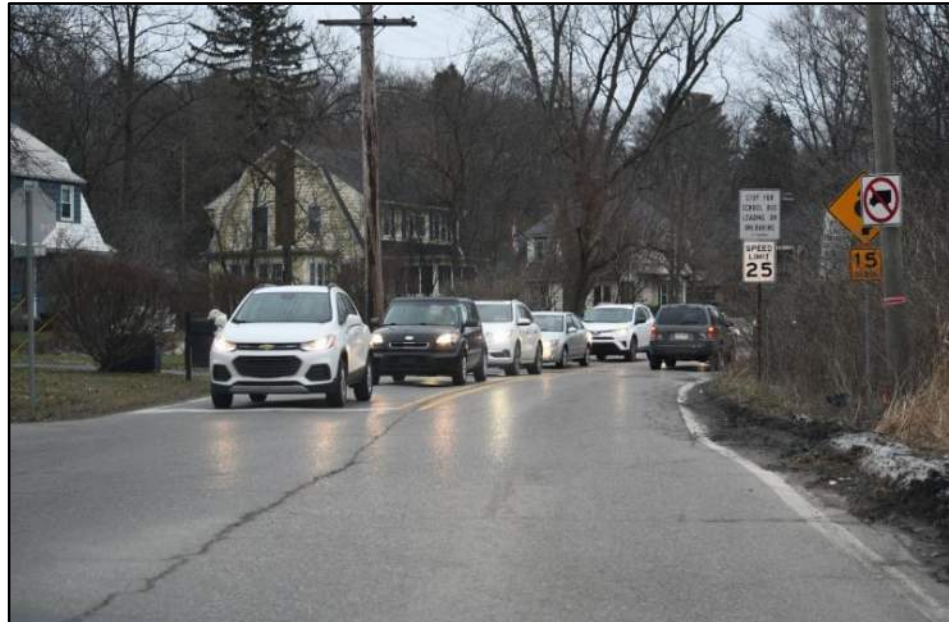
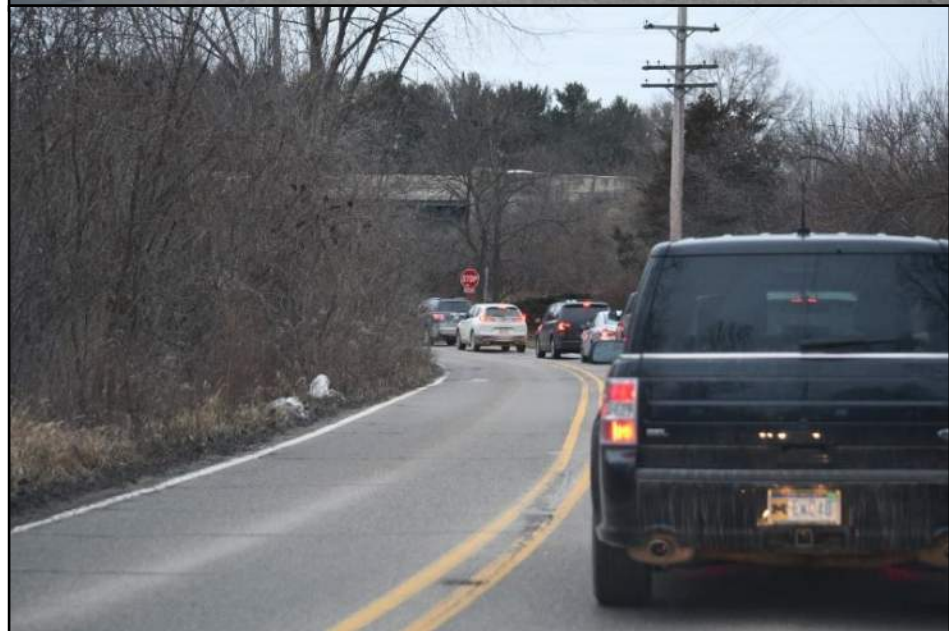
- During the PM peak hour, traffic seeking to enter NB M-14 freeway face critical lack of adequate gaps, resulting in vehicles queuing back down the ramp and spilling over to westbound Barton Drive.

Figure 44: Queues on Barton Dr due to traffic seeking to enter EB M-14 generating backups down the ramp.

- Close or relocate interchange from Barton Drive.
- Redesign interchange to current standards to allow for vehicle acceleration lane, rather than a stop sign, when entering NB M-14.

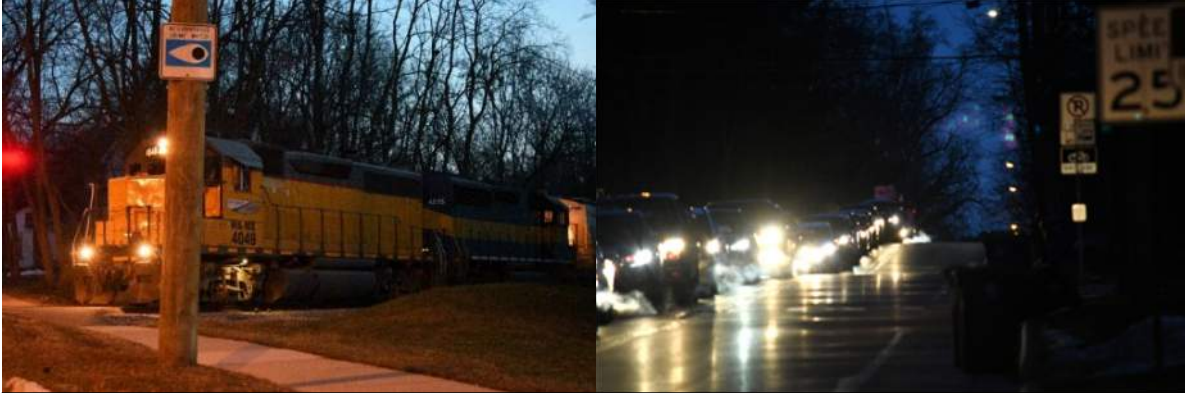
- Multiple locations within the Study Area experience congestion when freight trains pass through.
- Backups happen at Barton Drive, Traver Road, Pontiac Trail, and Moore Street.

Figure 46: The Ann Arbor Railroad freight train routinely impact the a.m. commuter period, resulting in significant queues that take protracted time to clear.

- Review and potentially add traffic signal pre-emption
- Review vehicle storage needs during train events
- Consider an ITS-based changeable message signs for NB and SB M-14 tied to a RR pre-emption to advise drivers of train's presence and advise them to find alternate routes.

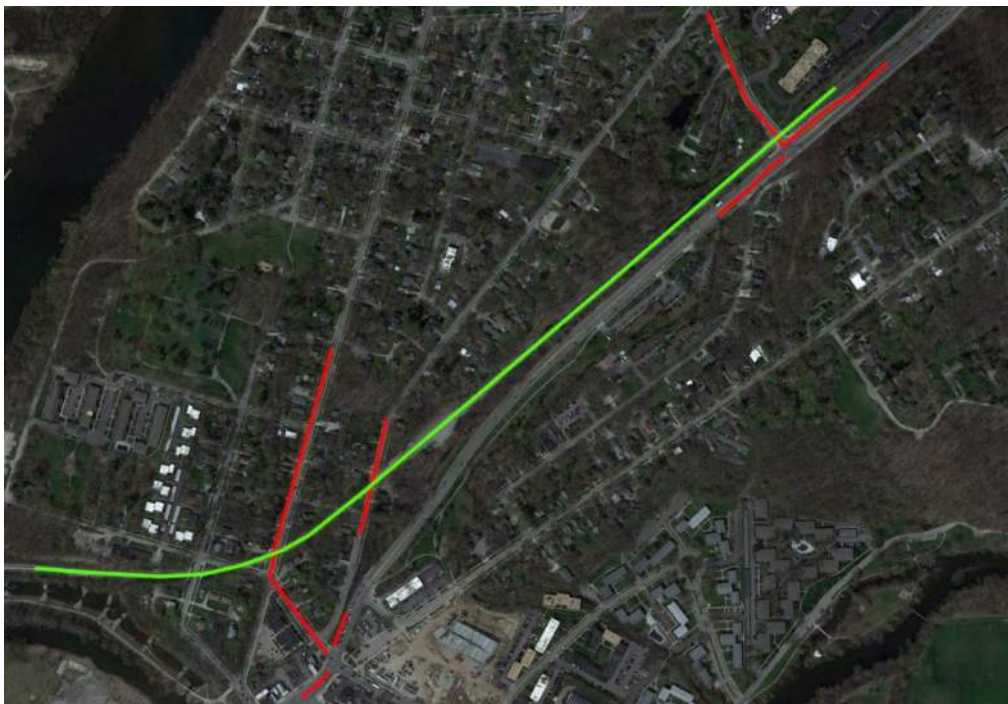
Figure 47: A train consisting of about 60 freight cars (green line) would block all the rail crossings in Lower Town, leading to extensive backups (red lines).

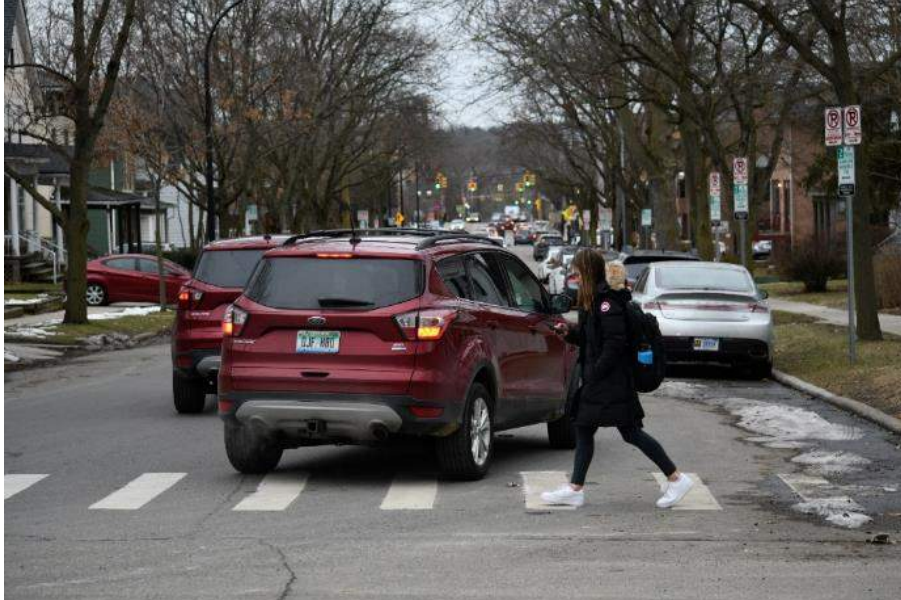
Figure 49: The offset (about 34') between the east and west legs of Catherine St leads to potential conflicts with pedestrians.

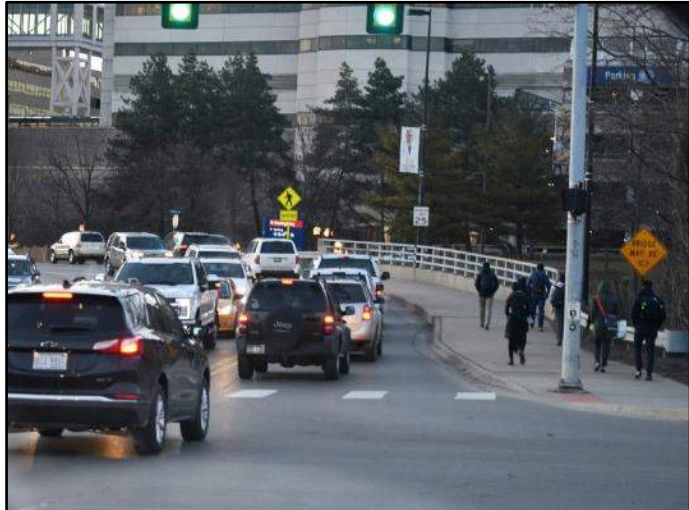
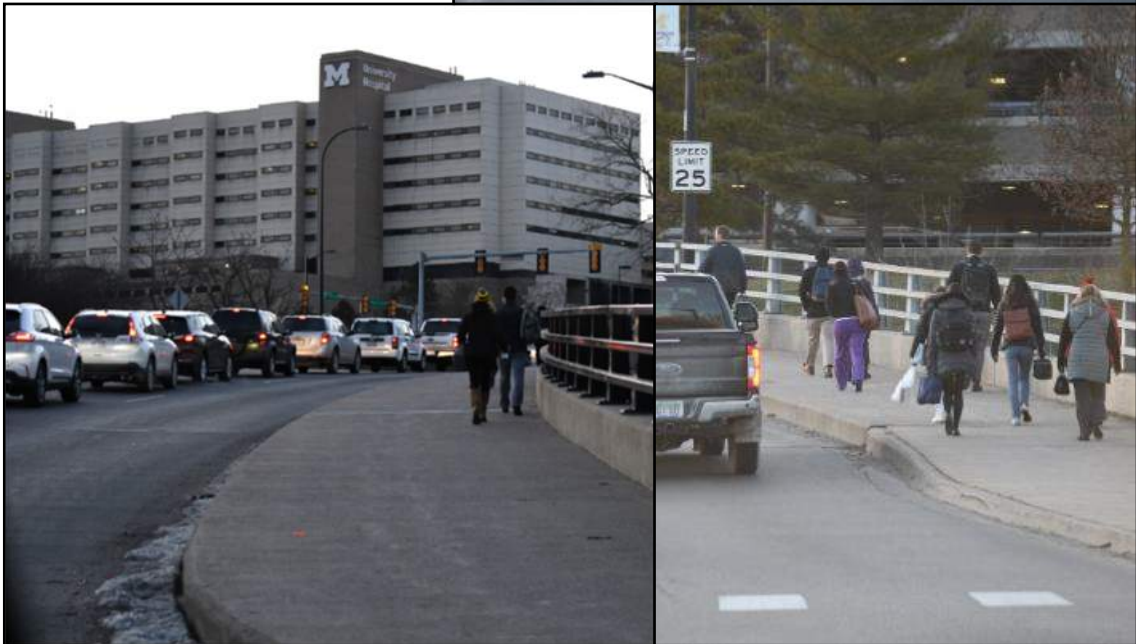
- Throughout the day, heavy traffic and pedestrian volumes exist at the intersection of Maiden Lane and Fuller Road due to patients, visitors, employees, and students accessing the University of Michigan Medical Campus.

Figure 50: Pedestrian traffic along Maiden Ln, crossing Fuller Rd and along E. Medical Center Dr is substantial for significant periods of the day.

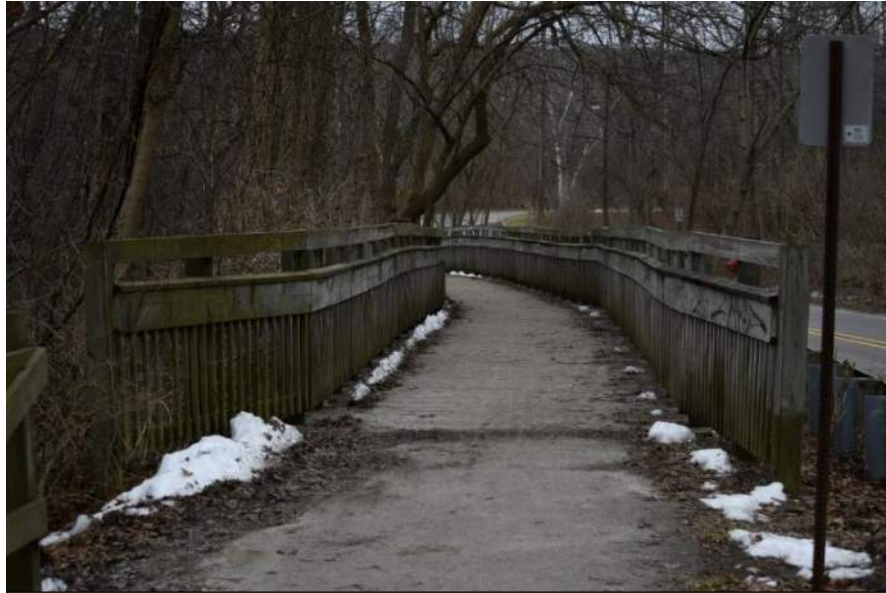
Figure 51: Shared use path boardwalk along Barton Drive, between Longshore Drive and M-14, does not meet the design standards for width. Clear width of path between railings is less than 10'. Should be ~14' per AASHTO guidelines.

- Add bike lanes to Barton Drive from Pontiac Trail to Huron Bridge Park
- Add bike lane to Broadway Street bridge or adjust light pole pillars to be flush with the bridge's sidewalk.
- Widen bike lanes adjacent to parking areas by reducing travel lane width and delineating limits to the parking area.
- Increase enforcement and citations of obstacles blocking bike lanes

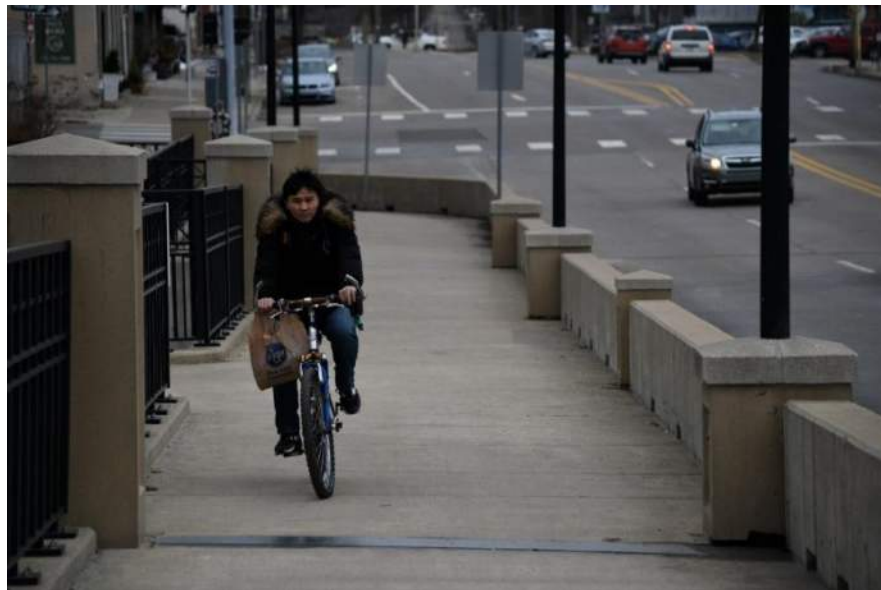
Figure 52: Broadway Street bridge has poor visibility around the curve at Division Street and concrete pillars holding light poles extend too far into the travel way. Concrete fillers should be placed to eliminate the protrusions of the bridge and lighting posts, presenting a smooth barrier face to cyclists.

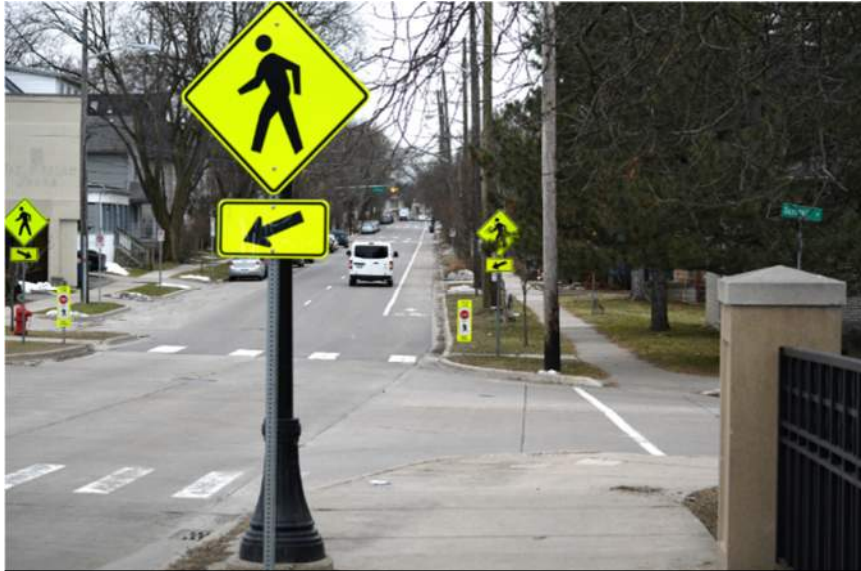
Figure 57: The transition from the Division Street bike lane to the Broadway Street Bridge shared use path is not continuous or marked. The Division Street bike lane ends before Carey Street and there is not an easy entrance for bikes to enter the bridge path.

- Extend bike lanes with a dotted line (similar to what has been installed on S. 7th Street) or use sharrow markings through intersections

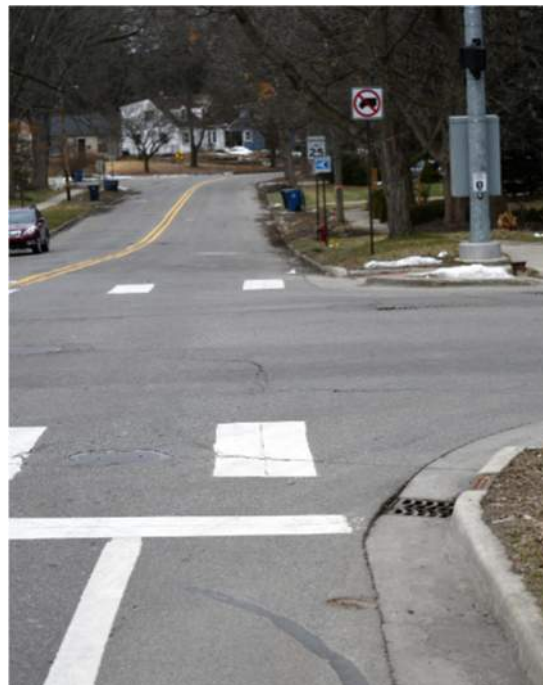
Figure 58: At the intersection of Barton Drive and Pontiac Trail, the bike lanes on Barton Drive west of the intersection do not continue and no guidance is provided for bicyclists.

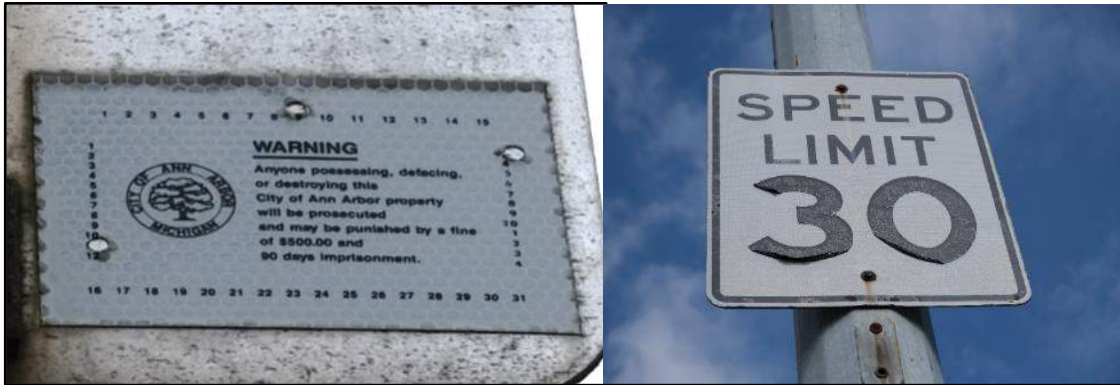
Figure 73: There are older signs throughout the Study Area that lack adequate retro-reflectivity, making them hard to see at night.

Figure 76: Inventory all signs in the study area and upgrade signs as needed.

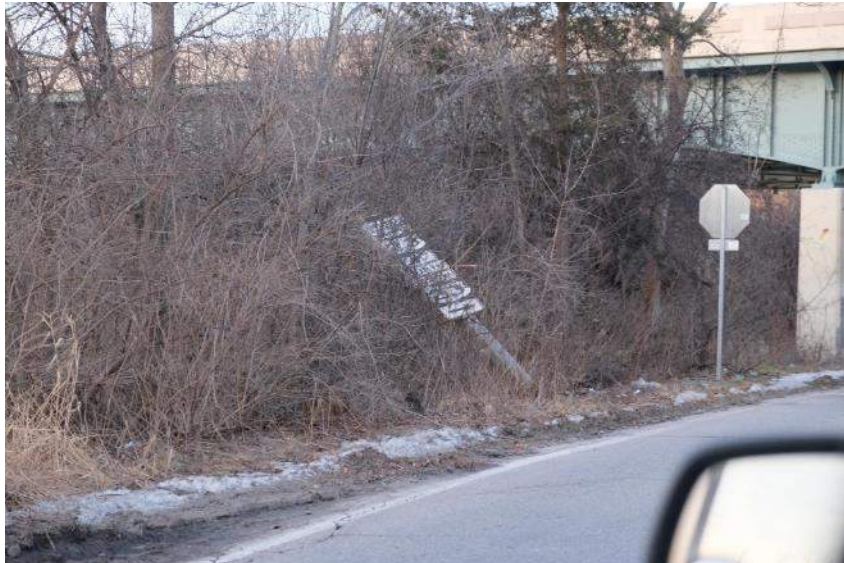
Figure 74: Some signs, including one at Barton Drive and the M-14 entrance, have been knocked over.

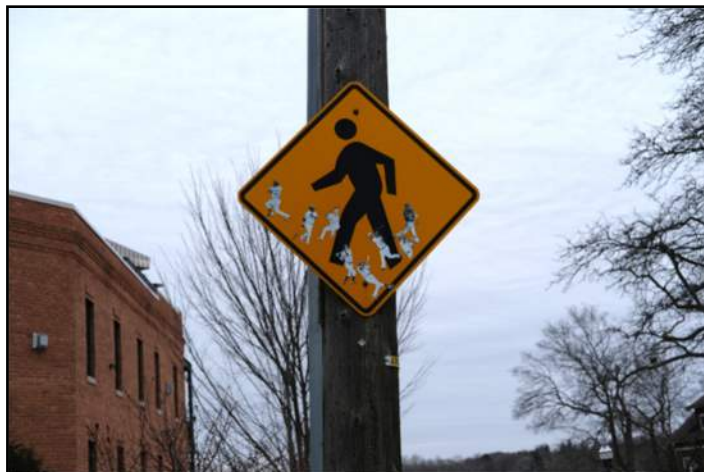
Figure 75: Some signs have been vandalized.

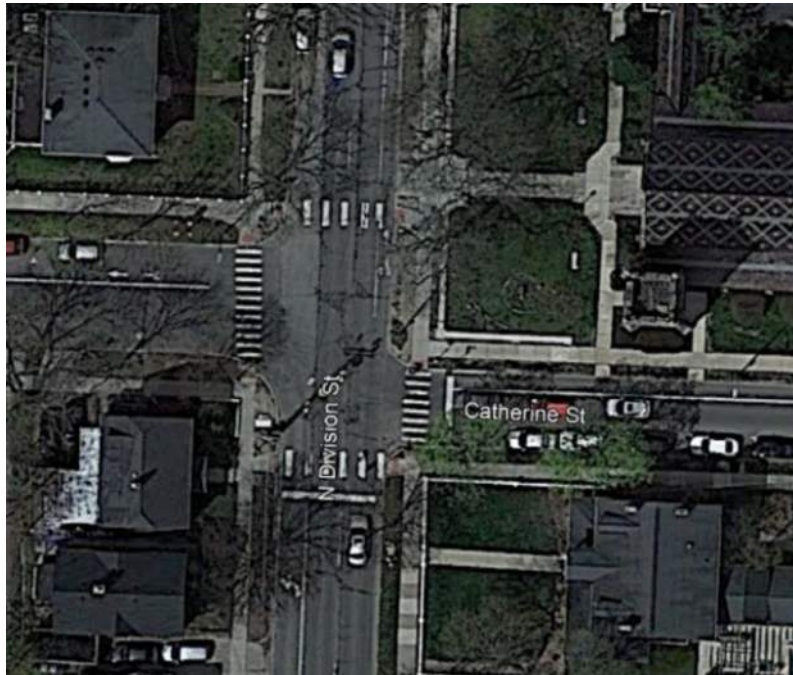
Figure 82: The offset of Catherine St at Division St is problematic for pedestrians. This is particularly true for WB vehicles turning right from Catherine Street onto Division Street to see pedestrians crossing the northern leg of the intersection.

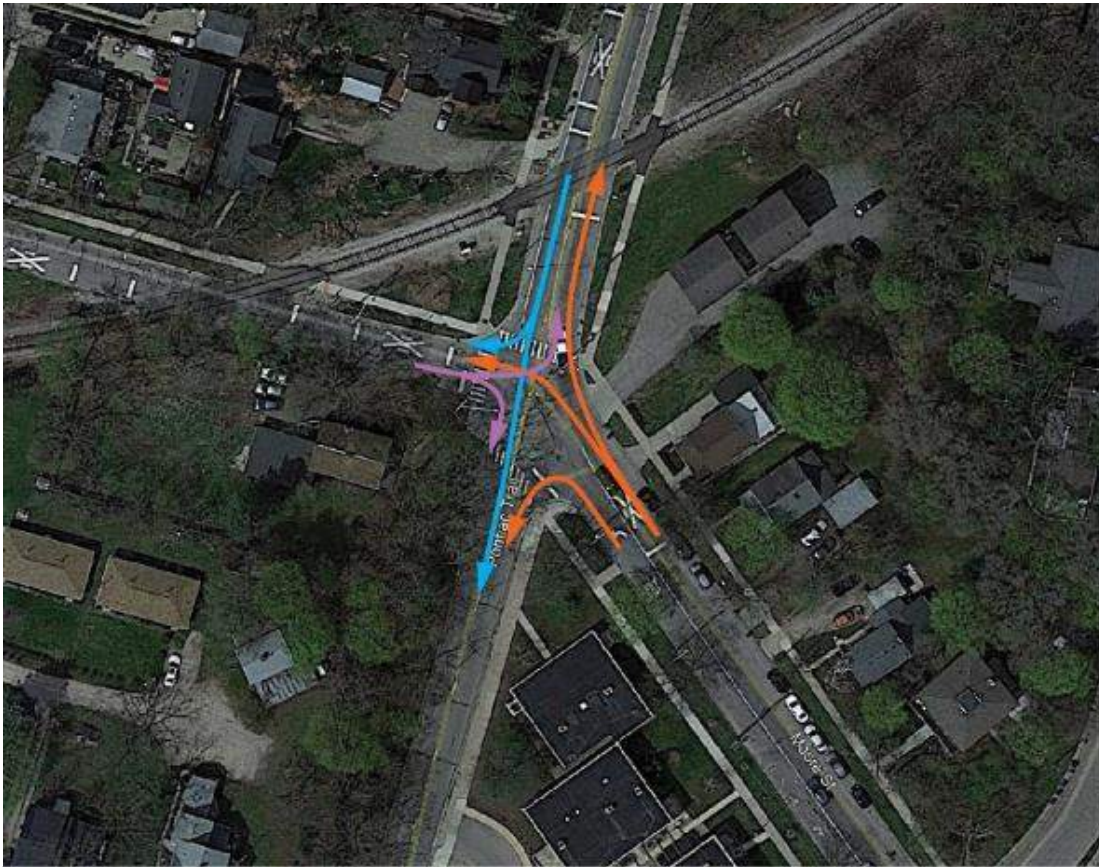
- Skewed intersection with main route northbound turning through the intersection
- One-way pair for southern legs of intersection to access/come from Plymouth Road/Broadway Street
- Unusual traffic control devices, including flashing yellow and red signals facing Moore Street
- Railroad tracks located just north of the intersection
- Wrong way movements observed by team

Figure 90: The south and east legs of intersection are one-way streets. Various allowed movements are depicted.

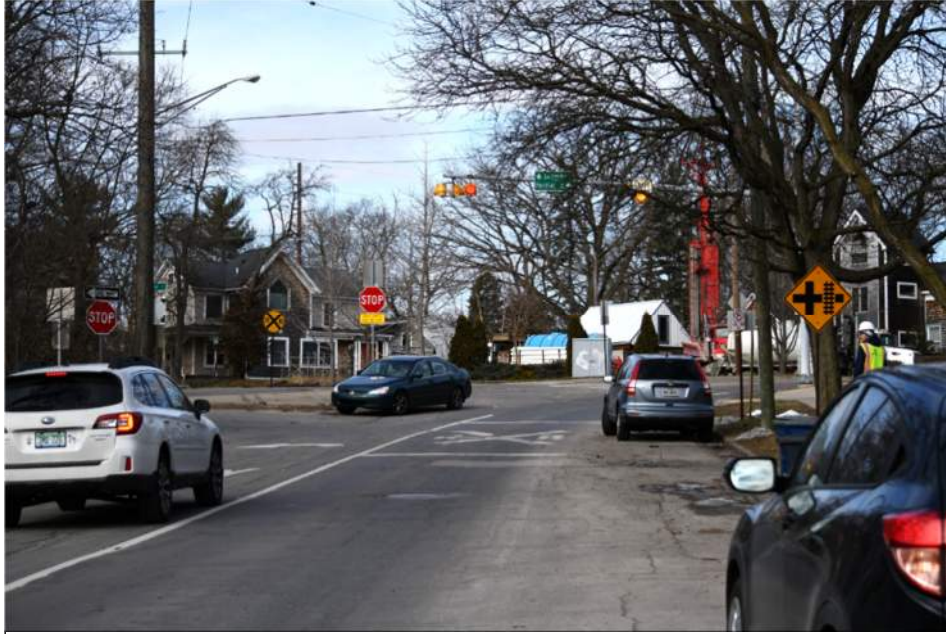
Figure 91: View for WB Moore St approaching Pontiac St at skewed angle. Southbound vehicle heading the wrong direction down Moore St.

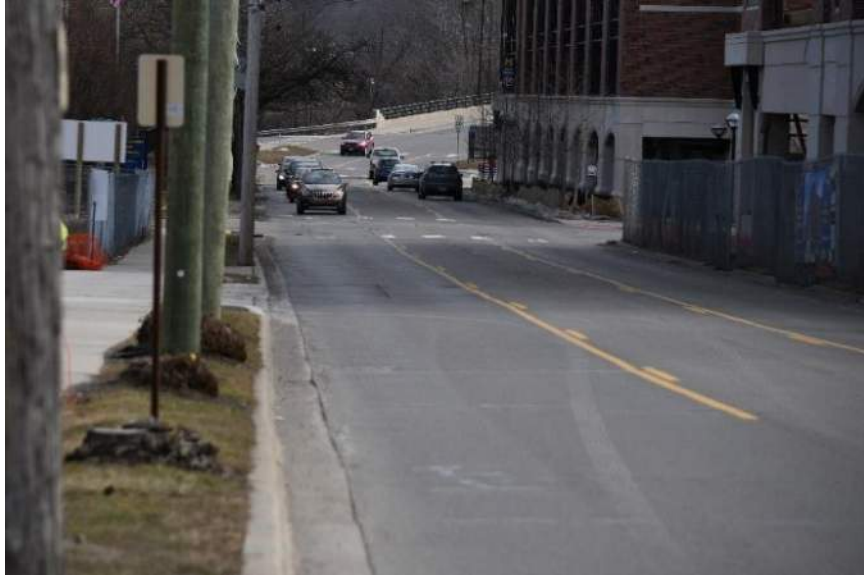
Figure 96: Maiden Lane – Typical section is 3 vehicle lanes, no parking allowed, no bike lanes, sidewalk both sides, overhead utilities along north side.

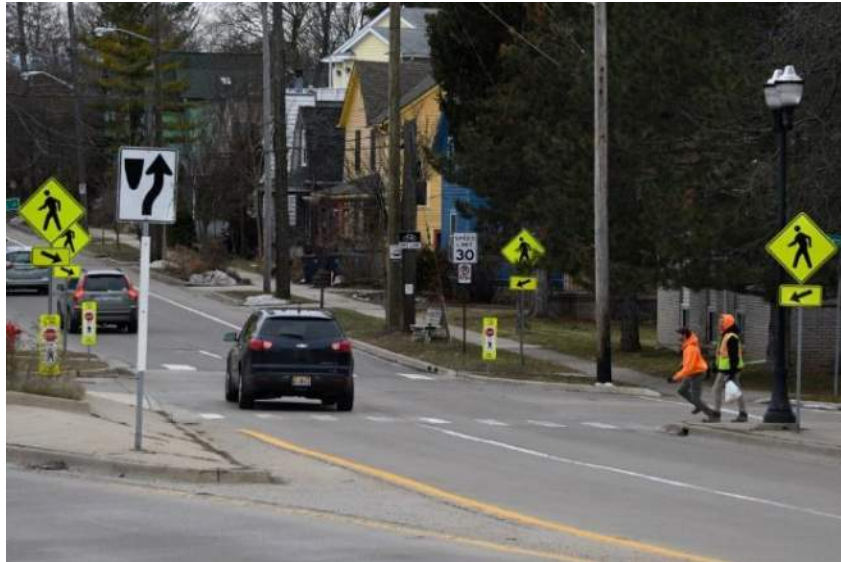
- Confusing geometrics at the intersection of Division Street, Broadway Street, Beakes Street, Summit Street, Detroit Street and Carey Street
 - Visibility around existing retaining walls
 - Steep grades

Figure 101: Vehicle speeds are high as SB Division transitions to Beakes. This leads to concerns for pedestrians crossing the roadways.

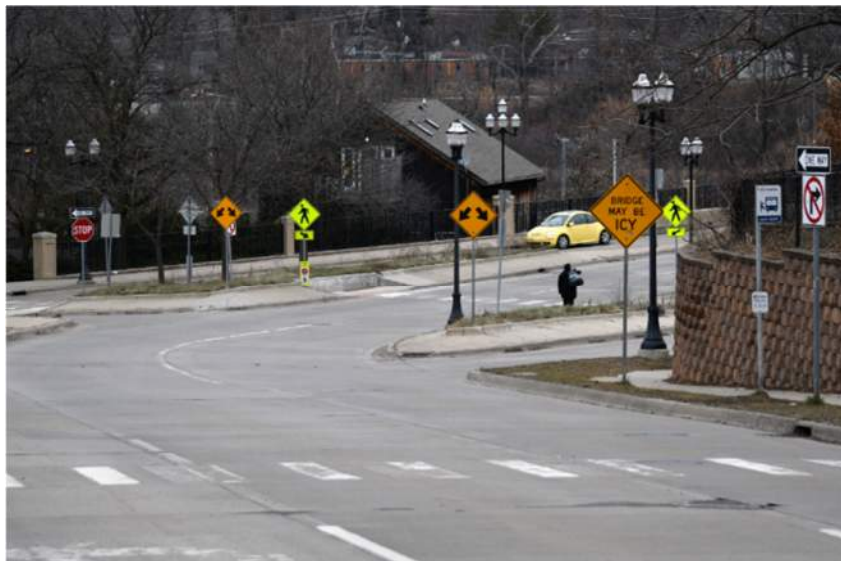
Figure 102: Vehicle speeds are also high as NB Division turns onto Broadway. This, combined with limited sight distance, raises concerns for pedestrians crossing the roadways.

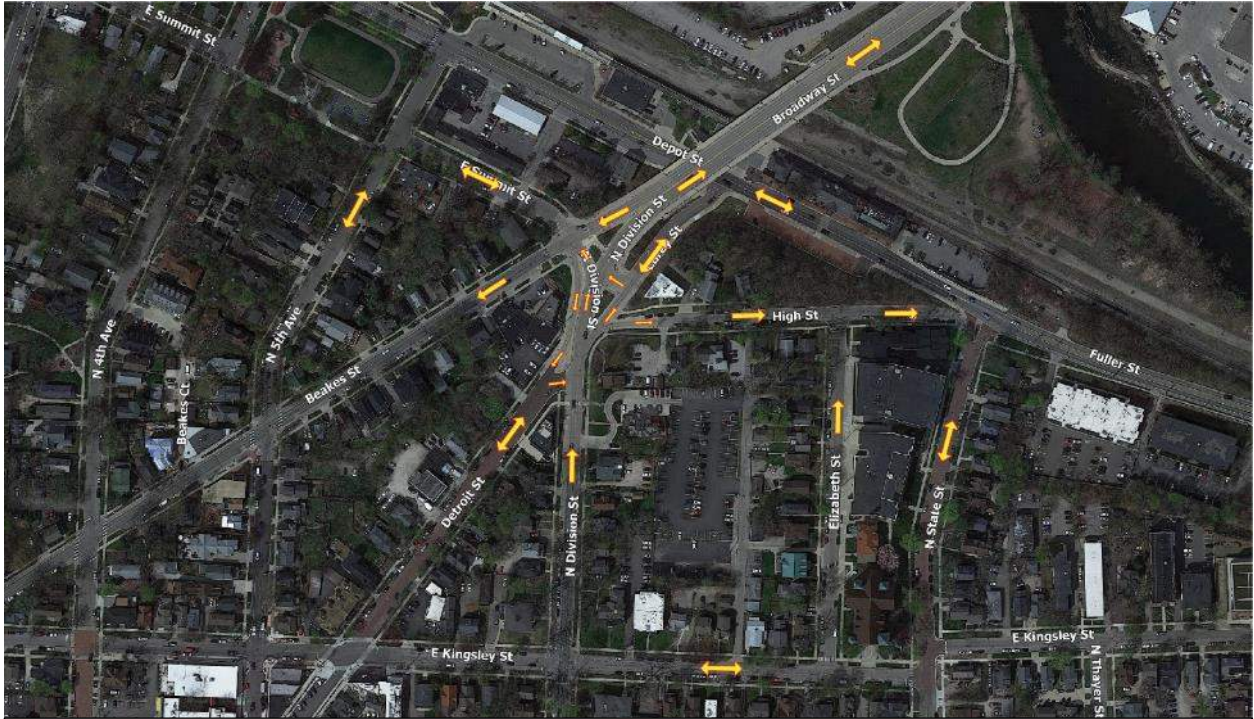
Figure 103: Overview of the area just north of Kerrytown, showing pattern of one-way and two-way streets.

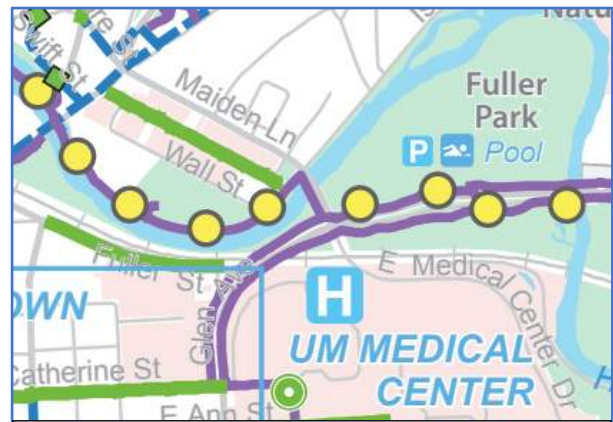
Figure 108: Contributing to the high pedestrian volumes are the shared use pathways and the connection to the Border to Border trail.

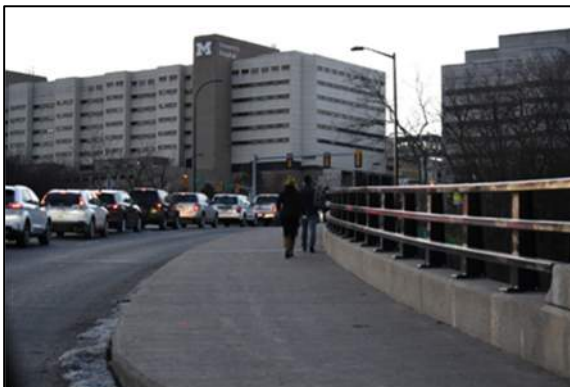
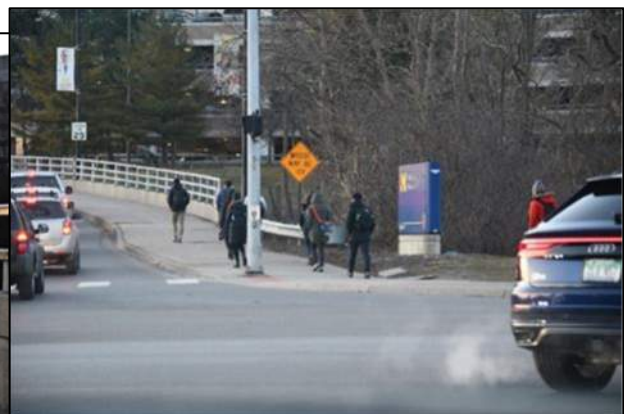
Figure 109: Intersection features high pedestrian volumes from various groups accessing the hospital campus. Volumes are highest during the hospital shift change.

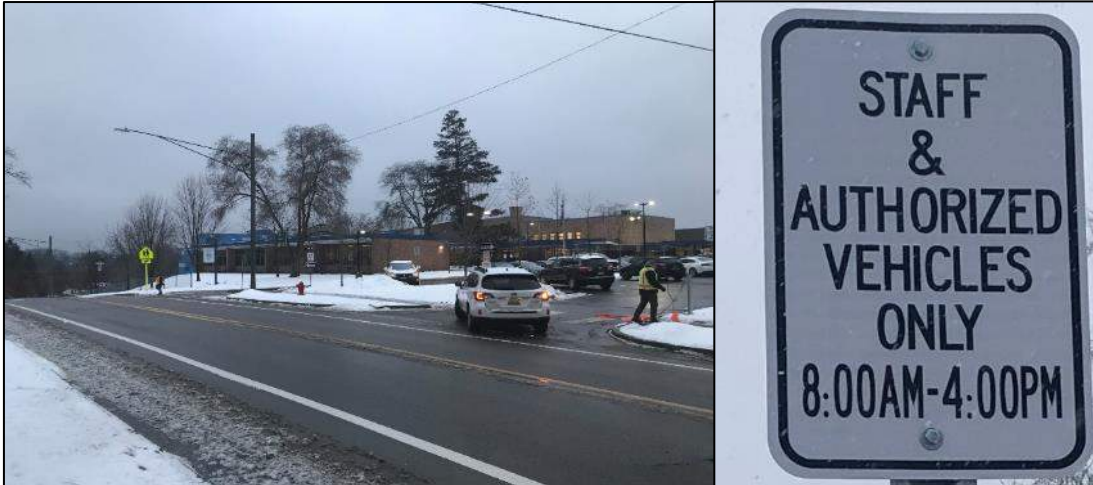
- Northside STEAM is located along Barton Drive, a busy route into Ann Arbor, and is typically congested with vehicle traffic from both school parents and commuters. This congestion leads to tardy students, especially when the AA Railroad freight train blocks traffic in the neighborhood.

Figure 112: Parent vehicles dropping off students are kept off site and are directed to remote lots near the school where they can park and walk with their children to school. A volunteer guard is stationed to help direct parents who are allowed to park in the designated lots.
