**City of Ann Arbor
Lower Town Mobility Study
Road Safety Audit**

FINAL REPORT

July 2020

Road Safety Audit

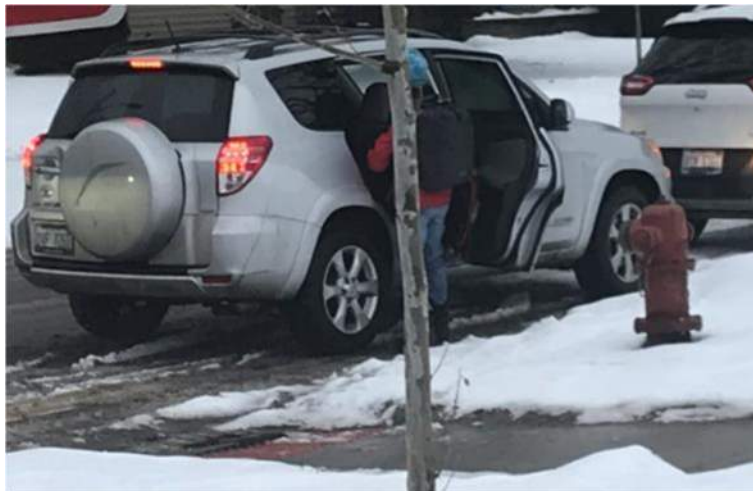
Figure 115: Since parents are forced to the outside of the campus, there is little space for them to quickly drop off older children that can walk up to the school building by themselves. Parents typically drop off on the side streets in the parking lane.

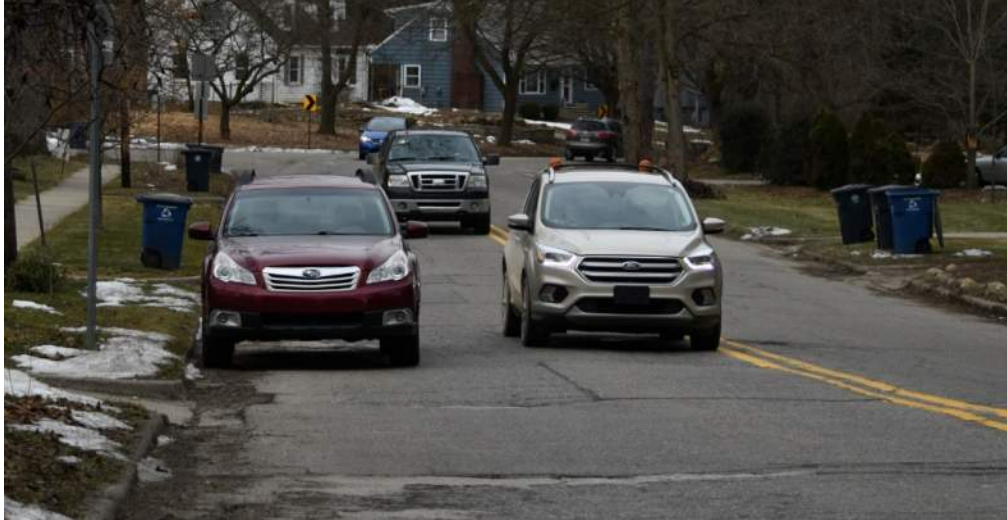
Figure 122: Parking is allowed along Barton Drive in the block west of Pontiac Trail. Due to traffic congestion along Barton Drive, it may be more appropriate to restrict on-street parking in this area and provide a right-turn lane for the eastbound approach to Pontiac Trail.

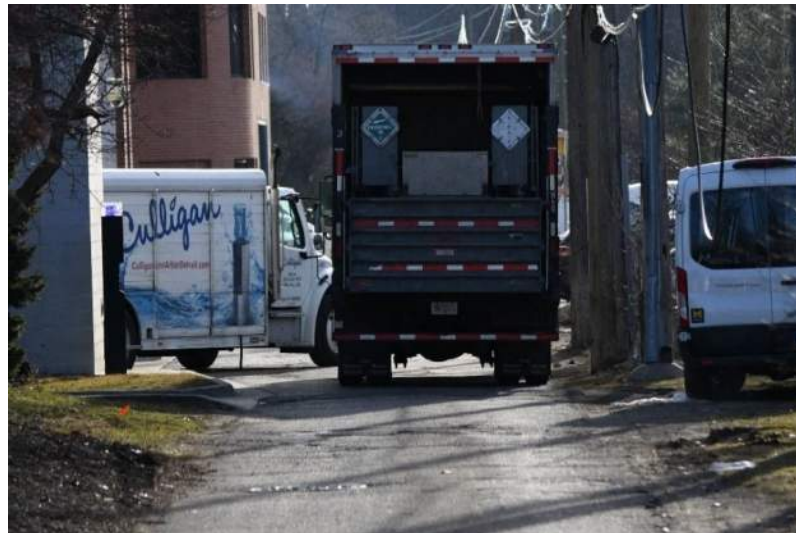
Figure 128: There is no direction on how Canal Street should function, and it has largely been unimproved. The street is very narrow and does not easily allow for two vehicles to pass each other side by side. Should be considered for posting as one-way.
