Michigan SHPO Architectural Properties Identification Form

Street Address		106 North Thayer Street (801 East Huron Street)			
City/Township, State, Zip Code		City of Ann Arbor, Michigan, 48104			
County		Washtenaw County			
Assessor's Parcel #		09-09-28-209-001			
Latitude/Longitude (to the 6 th decimal point)		Lat:42.282916		Long: -83.736401999999998	
Ownership	Private <input checked="" type="checkbox"/>	Public-Local <input type="checkbox"/>	Public-State <input type="checkbox"/>	Public-Federal <input type="checkbox"/>	Multiple <input type="checkbox"/>

Survey Date	11/14/2023	Recorded By	Megan Funk	Agency Report #	
-------------	------------	-------------	------------	-----------------	--

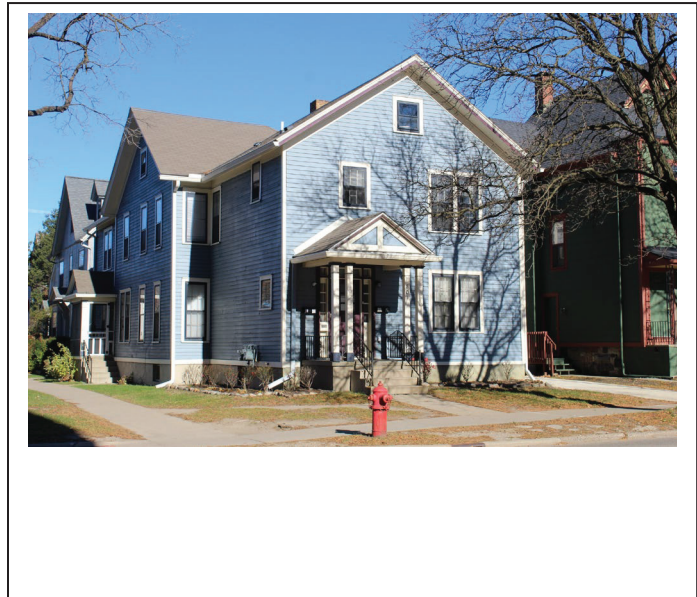
Construction Date	1890	
Architectural Style	Vernacular	
Building Form	Irregular	
Roof Form	Cross-gable	
Roof Materials	Asphalt	
Exterior Wall Materials	Wood:Weatherboard	
Foundation Materials	Concrete	
Window Materials	Wood	
Window Type	Six-over-six	
Outbuildings	Yes <input type="checkbox"/>	No <input checked="" type="checkbox"/>
Number/Type:	NA

The vernacular-style house stands on the northeast corner of the intersection of the two streets and has entrances on both its south and west elevations. It is a two-and-one-half story, wood-frame house with an irregular footprint created by ca. 1900 additions on the north and east. The house has a concrete foundation, wooden siding, and cross-gabled asphalt shingle roof with modest eaves. The primary entrance is on the south elevation (East Huron Street) and consists of a small gabled porch with paired square columns, iron railings, a concrete deck, and concrete steps. The gable is finished with simple half-timbering. The entry door has a grid of six lights and is surrounded by sidelights and a transom. East of the porch is a paired, six-over-six, double-hung, wooden sash window. The second story is lit by an individual and a paired window with six-over-six, double-hung, wooden sashes and the gable is lit by a one-over-one, double-hung sash window. A large gable projects slightly from the west elevation (North Thayer Street) and is lit by individual and paired windows like those on the façade. The north addition repeats the scale and form of the south (front) half of the house, making the west elevation appear symmetrical, except for the placement of windows and a screened porch that is set in the crook of the west gable and addition. The porch resembles the front porch. The east addition has a shallow-pitched roof and is accessed by a stoop and entry door on its south elevation. A large, centrally placed, brick chimney rises from the east slope of the roof.

The house is recommended for inclusion as a contributing resource to the National Register-eligible Old Fourth Ward Historic District under Criterion C due to its integrity of location, design, setting, materials, workmanship, feeling, and association.

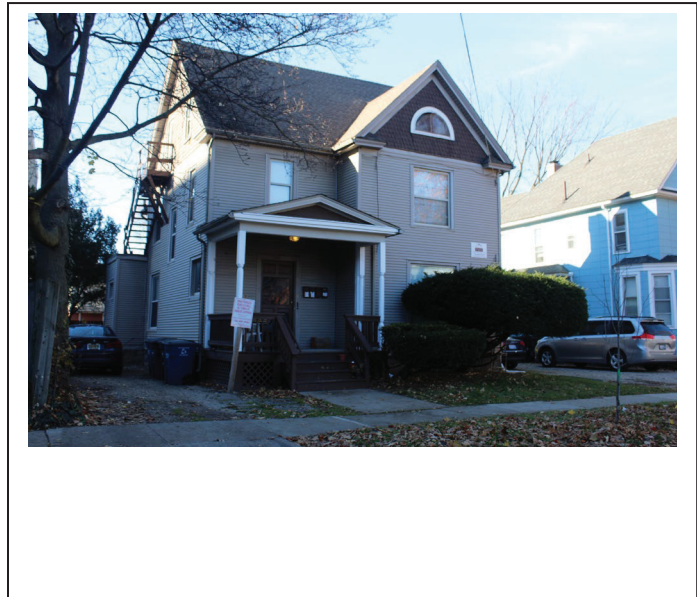
Construction Date	1897	
Architectural Style	Queen Anne	
Building Form	Rectangular	
Roof Form	Side-gable	
Roof Materials	Asphalt	
Exterior Wall Materials	Synthetics:Vinyl	
Foundation Materials	Stone	
Window Materials	Wood	
Window Type	One-over-one	
Outbuildings	Yes <input type="checkbox"/>	No <input checked="" type="checkbox"/>
Number/Type:	NA

The Queen Anne-style residence at 109 North Thayer Street is on the west side of the road between East Huron Street to the south and East Ann Street to the north. It is a two-and-one-half story, wood-frame house with a roughly rectangular footprint, a cut stone foundation, vinyl siding, and a side-gabled asphalt shingle roof. An interior chimney rises near the juncture of the side-gabled roof and a rear-gabled wing. The asymmetrical façade is composed of a slightly projecting gable on the north and a one-story, gable-roofed porch on the south. The porch projects forward of the gabled section and shelters an entry door with a large center light. The porch is supported by turned posts and finished with a simple post-and-rail balustrade. The gabled section is lit by a large, one-over-one, double-hung, wooden sash window on each story and a half-moon window in the gable. The front gable and side gables are all finished with wooden shingles in a fish scale pattern. Above the porch is a smaller one-over-one, double-hung, wooden sash window. Additional one-over-one, double-hung, wooden sash windows light the north and south (side) elevations as well as single-pane windows, and a shallow bay window on the north elevation. A pre-1975, two-story, flat-roofed addition is offset from the northwest corner of the house and a staircase rises along the south elevation to a third-story apartment.

The house is recommended for inclusion as a contributing resource to the National Register-eligible Old Fourth Ward Historic District under Criterion C due to its integrity of location, design, setting, workmanship, feeling, and association.

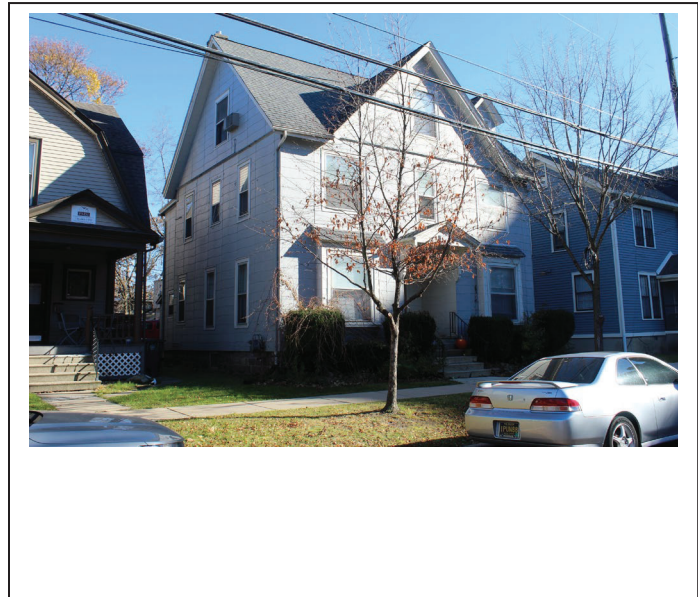
Construction Date	1895	
Architectural Style	Vernacular	
Building Form	Rectangular	
Roof Form	Cross-gable	
Roof Materials	Asphalt	
Exterior Wall Materials	Asbestos	
Foundation Materials	Stone	
Window Materials	Wood	
Window Type	One-over-one	
Outbuildings	Yes <input type="checkbox"/>	No <input checked="" type="checkbox"/>
Number/Type:	NA

The vernacular-style residence at 110 North Thayer Street is on the east side of the road between East Huron Street to the south and East Ann Street to the north. It is a two-and-one-half story, wood-frame house with a rectangular footprint, a cut stone foundation, and a side-gabled asphalt shingle roof with lower forward and rear gables. The house is clad with painted asbestos shingles adhered in a grid pattern. Every other column in the grid is slightly raised and offset vertically creating depth and evoking the appearance of a stone façade with shallow pilasters. At the center of the façade is a recessed entrance that shelters an entry door with a large light in its upper half. Concrete steps access the porch and a small gable supported by brackets partially shelters the steps. Flanking the entrance are two shed-roofed bay windows with large one-over-one, double-hung, wooden sash windows. The upper façade contains two large windows, like those below but flush with the façade, that flank a small, one-over-one, double-hung, wooden sash window. Similar windows light the large forward gable and a small gabled dormer set south of the large gable as well as the north and south (side) elevations. Two shed-roofed additions flank a staircase on the east (rear) elevation and an interior brick chimney rises near the north elevation.

The house is recommended for inclusion as a contributing resource to the National Register-eligible Old Fourth Ward Historic District under Criterion C due to its integrity of location, design, setting, workmanship, feeling, and association.

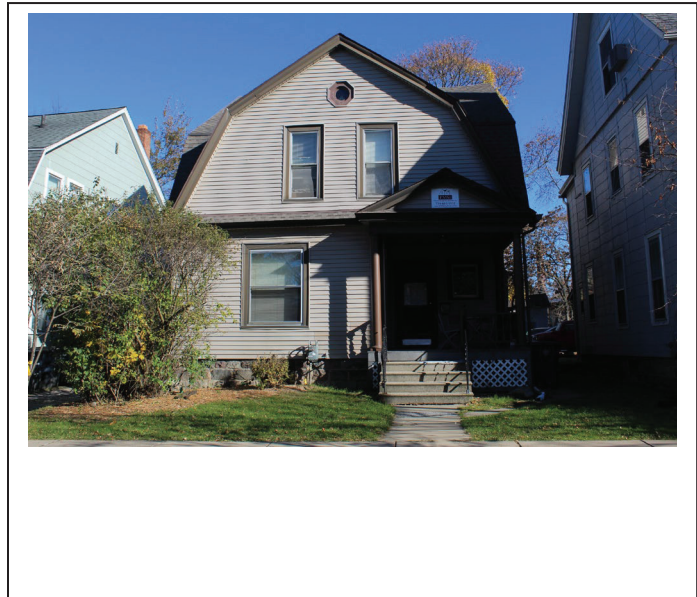
Construction Date	1904	
Architectural Style	Dutch Colonial	
Building Form	Rectangular	
Roof Form	Cross-gable	
Roof Materials	Asphalt	
Exterior Wall Materials	Synthetics:Vinyl	
Foundation Materials	Stone	
Window Materials	Wood	
Window Type	One-over-one	
Outbuildings	Yes <input checked="" type="checkbox"/>	No <input type="checkbox"/>
Number/Type:	1-Garage

The residence at 114 North Thayer Street is on the east side of the road between East Huron Street to the south and East Ann Street to the north. It is a one-and-one-half story, wood-frame, Dutch Colonial-style house with a rectangular footprint, a cut stone foundation, vinyl siding, and a cross-gambrel asphalt shingle roof. The asymmetrical façade contains a recessed entrance on the south that is sheltered by a gabled porch and projects slightly beyond the façade. It is supported by slender Tuscan columns and finished with a turned post balustrade. The wooden entry door has a large light in its upper half and is flanked on the south by a small window that may contain stained glass. North of the porch is a large, one-over-one, double-hung, wooden sash window. A modest asphalt shingled pent roof spans the façade between the first and second stories. Above, two one-over-one, double-hung, wooden sash windows and a small circular window light the upper story and attic. The north and south (side) elevations are lit by similar double-hung windows as well as a paired bay window on the north elevation.

The house is recommended for inclusion as a contributing resource to the National Register-eligible Old Fourth Ward Historic District under Criterion C due to its integrity of location, design, setting, workmanship, feeling, and association.

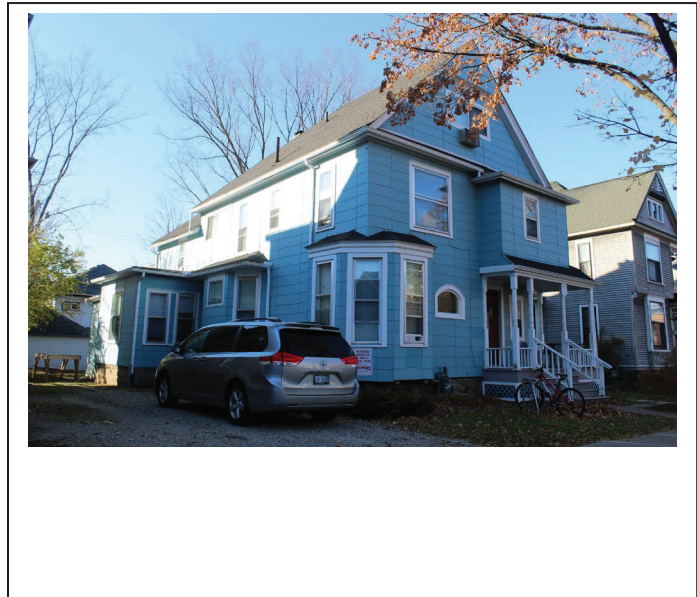
Construction Date	1895	
Architectural Style	Queen Anne	
Building Form	Rectangular	
Roof Form	Front-gable	
Roof Materials	Asphalt	
Exterior Wall Materials	Asbestos	
Foundation Materials	Stone	
Window Materials	Wood	
Window Type	One-over-one	
Outbuildings	Yes <input type="checkbox"/>	No <input checked="" type="checkbox"/>
	Number/Type: NA

The Queen Anne-style residence at 117 North Thayer Street is on the west side of the road between East Huron Street to the south and East Ann Street to the north. It is a two-and-one-half story, wood-frame house with a roughly rectangular footprint, a cut stone foundation, wooden sash windows, and a front-gabled asphalt shingle roof. The house is clad with asbestos shingles adhered in a grid pattern with every other column slightly raised and offset vertically. The pattern gives the impression of shallow pilasters while also emphasizing horizontal qualities. An interior chimney rises from a two-story, rear-gabled wing, near where it meets the primary roof. The façade is composed of a small porch that projects slightly beyond the east (façade) and north (side) elevations. The porch has a hipped roof, turned posts, and a simple balustrade. It shelters a double-leaf entry door with single-pane lights above panels. North of the door is a one-over-one, double-hung sash window. Above the porch, a section of the façade projects forward and contains an off-center, double-hung sash window. On the first story, the south half of the façade consists of an arched window and a cut-away-bay window that wraps the southeast corner of the house. Above, is a large, double-hung sash window and in the gable is a vinyl, sliding-pane window and wall A/C unit. One-over-one, double-hung sash windows light the north and south (side) elevations and other windows include a cut-away-bay on the south elevation and a few sliding-pane windows. An open lean-to protects a basement door on the north elevation and a small, one-story addition constructed before 1975 projects from the south elevation.

The house is recommended for inclusion as a contributing resource to the National Register-eligible Old Fourth Ward Historic District under Criterion C due to its integrity of location, design, setting, workmanship, and association.

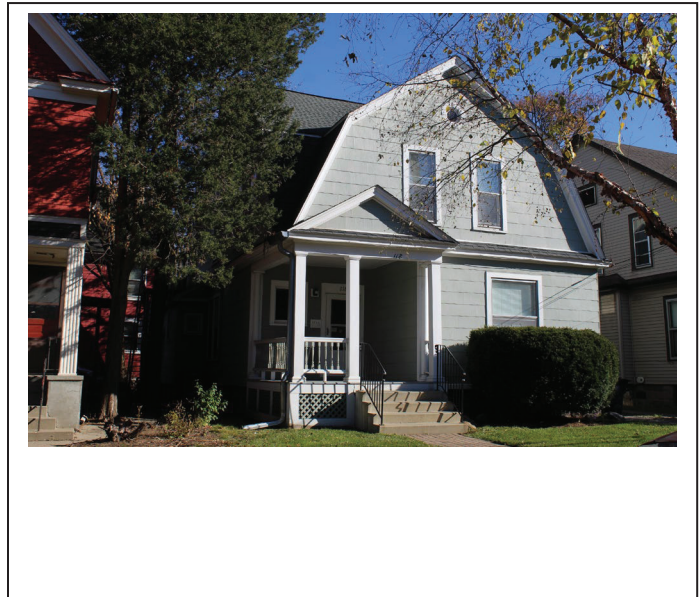
Construction Date	1904	
Architectural Style	Dutch Colonial	
Building Form	Rectangular	
Roof Form	Cross-gable	
Roof Materials	Asphalt	
Exterior Wall Materials	Asbestos	
Foundation Materials	Stone	
Window Materials	Wood	
Window Type	One-over-one	
Outbuildings	Yes <input type="checkbox"/>	No <input checked="" type="checkbox"/>
Number/Type:	NA

The residence at 118 North Thayer Street is on the east side of the road between East Huron Street to the south and East Ann Street to the north. It is a one-and-one-half story, wood-frame, Dutch Colonial-style house with a rectangular footprint, a cut stone foundation, asbestos siding, and a cross-gambrel asphalt shingle roof. The asymmetrical façade contains a recessed entrance on the north that is sheltered by a gabled porch and projects slightly beyond the façade. It is supported by square columns and finished with a turned post balustrade. The screened entry door is flanked on the north by a small window that may contain stained glass. South of the porch is a large, one-over-one, double-hung, wooden sash window. A modest asphalt shingled pent roof spans the façade between the first and second stories. Above, two one-over-one, double-hung, wooden sash windows and a small circular window light the upper story and attic. The north and south (side) elevations are lit by similar double-hung windows as well as two bay windows, one on each side elevation.

The house is recommended for inclusion as a contributing resource to the National Register-eligible Old Fourth Ward Historic District under Criterion C due to its integrity of location, design, setting, workmanship, feeling, and association.

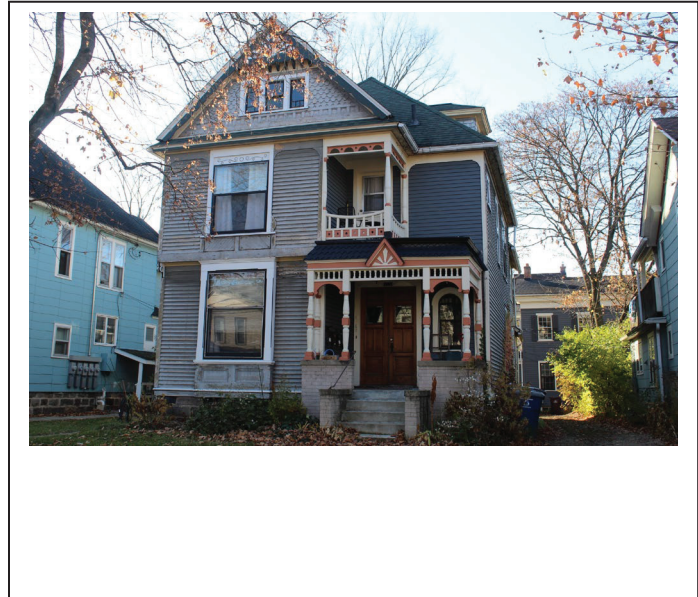
Construction Date	1894
Architectural Style	Queen Anne
Building Form	Rectangular
Roof Form	Cross-gable
Roof Materials	Asphalt
Exterior Wall Materials	Wood:Weatherboard
Foundation Materials	Stone
Window Materials	Wood
Window Type	One-over-one, bay
Outbuildings	Yes <input type="checkbox"/> No <input checked="" type="checkbox"/>
Number/Type:	NA

The Queen Anne-style residence at 119 North Thayer Street is on the west side of the road between East Huron Street to the south and East Ann Street to the north. It is a two-and-one-half story, wood-frame house with a roughly rectangular footprint, a cut-stone foundation, wooden siding, wooden sash windows, and a gable-on-hip asphalt shingle roof. The façade contains two large one-over-one sash windows, one on each story, on the south half and a small, inset entry porch topped with a balcony on the north half. The upper sash of the first story window is stained glass. The entry porch has a shallow, mansard roof and both it and the balcony are finished with turned wooden posts, spindles, and sawn work. The entry porch shelters a double-leaf, wooden entry door, and arched window. An off-set front gable is finished with shaped shingles and has a tripled window with detailed, fixed sashes that flank a one-over-one, double-hung sash. Single fixed-pane and individual and paired double-hung windows light the side elevations as well as a cut-away-bay window on the south elevation and a small hip-roofed dormer window on the north slope of the roof. There is also a small one-story section that projects midway along the south elevation and contains a secondary entrance.

The house is recommended for inclusion as a contributing resource to the National Register-eligible Old Fourth Ward Historic District under Criterion C due to its integrity of location, design, setting, materials, workmanship, feeling, and association.

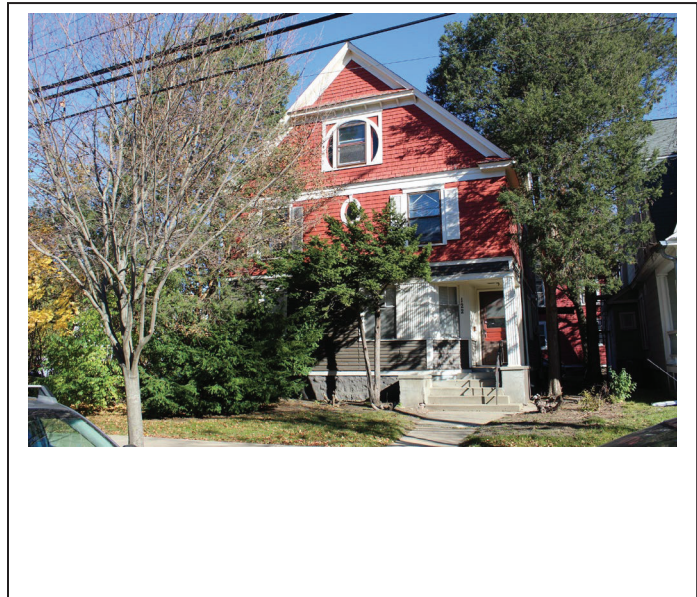
Construction Date	1905	
Architectural Style	Queen Anne	
Building Form	Rectangular	
Roof Form	Cross-gable	
Roof Materials	Asphalt	
Exterior Wall Materials	Wood:Weatherboard	
Foundation Materials	Stone	
Window Materials	Wood	
Window Type	Single-hung w/transom, one-over-one, two-over-two	
Outbuildings	Yes <input type="checkbox"/>	No <input checked="" type="checkbox"/>
Number/Type:	NA

The residence at 122 North Thayer Street is on the southeast corner of the intersection of North Thayer Street and East Ann Street. It is a two-and-one-half story, wood-frame house with a rectangular footprint, a painted cut stone foundation, and a front-gable roof with lower side gables and asphalt shingles. The house is clad with wooden siding on the first story and wooden shingles on the second story and gable. The façade contains a small porch inset in the southwest corner and supported by a fluted, square column at the corner. It shelters a wooden entry door with a large single pane over horizontal panels and a single-pane, single-hung, wooden sash window with a two-pane transom. Two similar windows light the first story of the façade. Two evenly spaced double-hung wooden sash windows with shutters light the second story. The windows have a single-pane sash below a sash with a large diamond. A small oval window with a keystone is set between them and the gable is lit by a one-over-one, double-hung, wooden sash window set in a round window. The round window is outlined by a frame square that is painted white to contrast with the red shingles. A pent roof with simple brackets shelters the window. The first story of the north elevation (Ann Street) is lit by two ribbons of two-over-two, horizontal pane, double-hung, wooden sash windows. The east ribbon has four windows, and the west has three. Double-hung wooden sash windows light the second story and gable. The second story windows have shutters. An interior end brick chimney rises from the west slope of the north gable. A one-story concrete block addition that may hide stairs and mechanical equipment extends from the east (rear) elevation and there is a second floor entry door. Single and paired one-over-one, double-hung, wooden sash windows light the elevation.

The house is recommended for inclusion as a contributing resource to the National Register-eligible Old Fourth Ward Historic District under Criterion C due to its integrity of location, design, setting, materials, workmanship, association, and feeling.

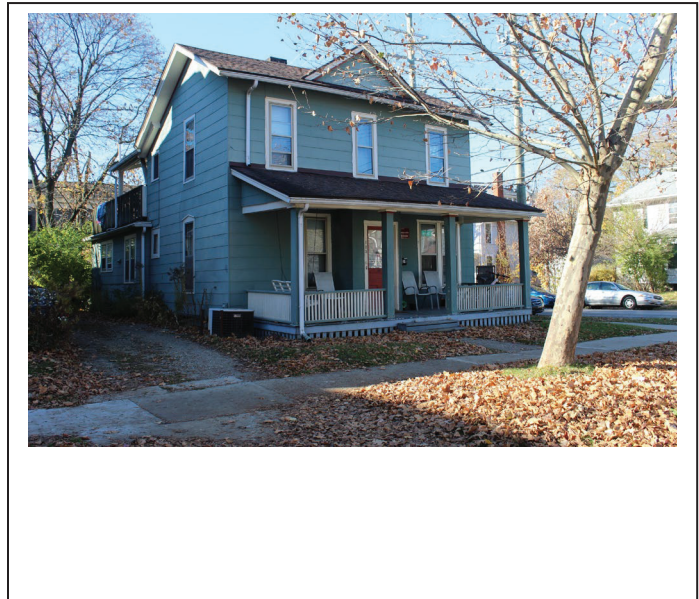
Construction Date	c. 1890	
Architectural Style	Vernacular	
Building Form	Rectangular	
Roof Form	Side-gable	
Roof Materials	Asphalt	
Exterior Wall Materials	Asbestos	
Foundation Materials	Concrete	
Window Materials	Wood	
Window Type	One-over-one	
Outbuildings	Yes <input type="checkbox"/>	No <input checked="" type="checkbox"/>
Number/Type:	NA

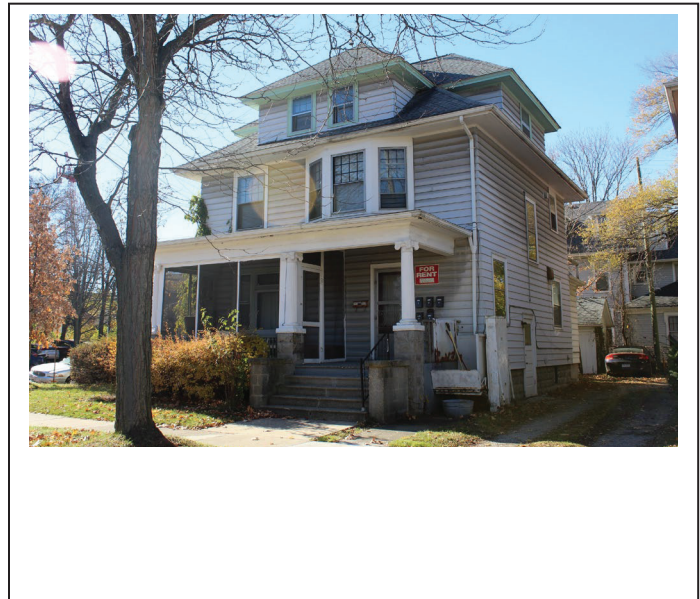
Construction Date	1912	
Architectural Style	American Foursquare	
Building Form	T	
Roof Form	Hip	
Roof Materials	Asphalt	
Exterior Wall Materials	Metal: Aluminum	
Foundation Materials	Concrete	
Window Materials	Wood	
Window Type	Bay, twelve-over-one, nine-over-one, six-over-one, one-over-one	
Outbuildings	Yes <input checked="" type="checkbox"/>	No <input type="checkbox"/>
Number/Type:	1-Shed

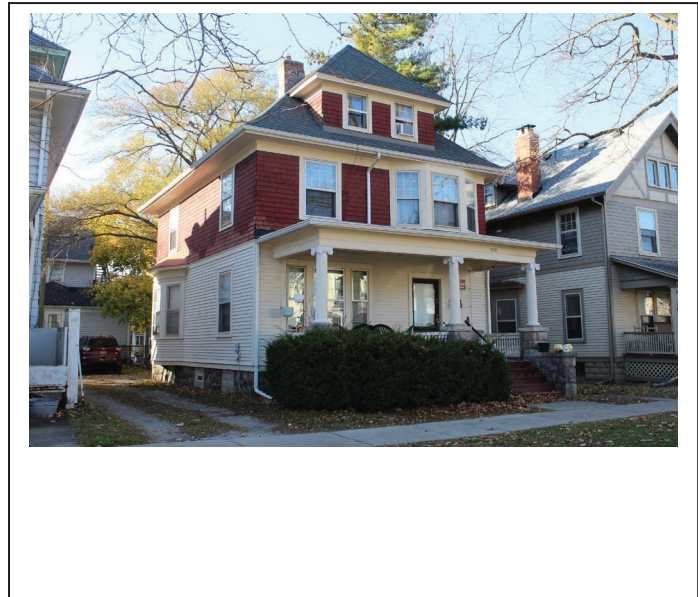
Construction Date	1911	
Architectural Style	American Foursquare	
Building Form	Rectangular	
Roof Form	Hip	
Roof Materials	Asphalt	
Exterior Wall Materials	Wood: Weatherboard	
Foundation Materials	Stone	
Window Materials	Wood	
Window Type	Bay, 12/1, 9/1, 6/1, 1/1	
Outbuildings	Yes <input type="checkbox"/>	No <input checked="" type="checkbox"/>
Number/Type:	NA

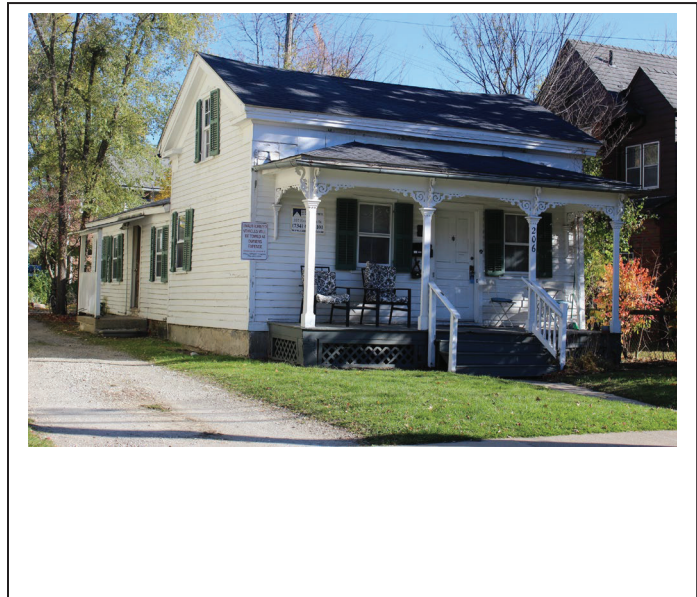
Construction Date	1853	
Architectural Style	Greek Revival	
Building Form	Rectangular	
Roof Form	Side-gable	
Roof Materials	Asphalt	
Exterior Wall Materials	Wood: Weatherboard	
Foundation Materials	Other	
Window Materials	Wood	
Window Type	Two-over-two	
Outbuildings	Yes <input checked="" type="checkbox"/>	No <input type="checkbox"/>
Number/Type:	1-Garage

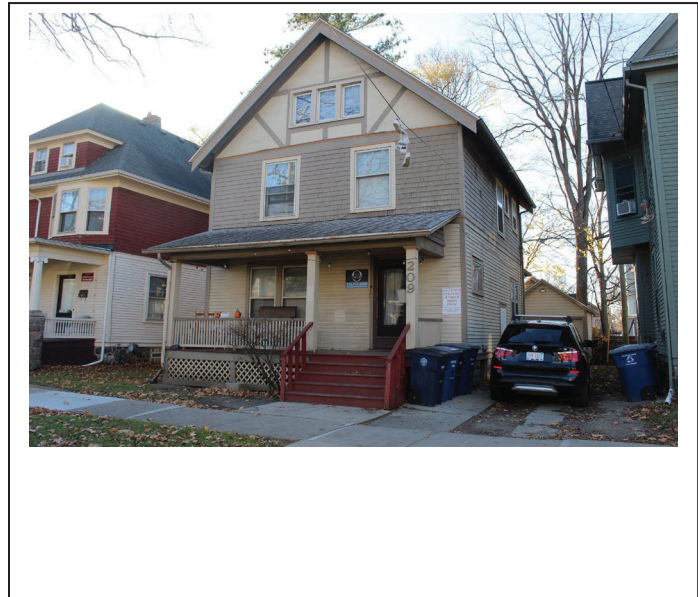
Construction Date	1912	
Architectural Style	Vernacular	
Building Form	Rectangular	
Roof Form	Front-gable	
Roof Materials	Asphalt	
Exterior Wall Materials	Wood: Weatherboard	
Foundation Materials	Concrete	
Window Materials	Wood	
Window Type	One-over-one, eight-over-one, fixed	
Outbuildings	Yes <input checked="" type="checkbox"/>	No <input type="checkbox"/>
Number/Type:	1-Garage

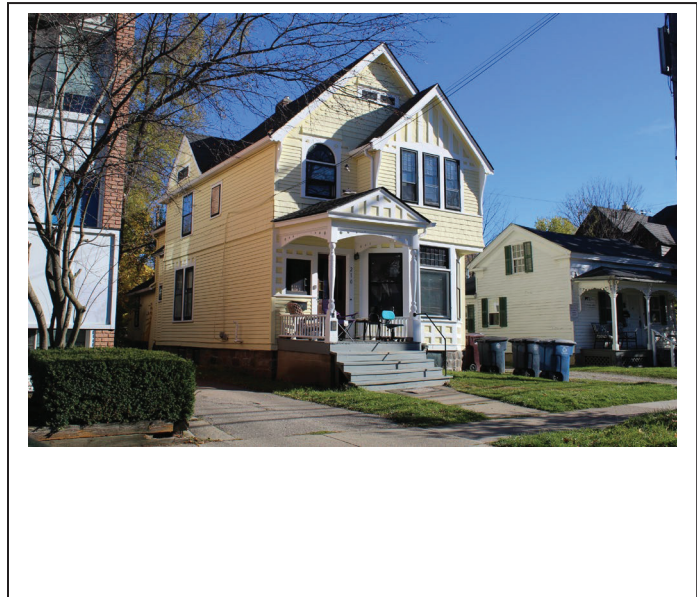
Construction Date	1888	
Architectural Style	Queen Anne	
Building Form	T	
Roof Form	Cross-gable	
Roof Materials	Asphalt	
Exterior Wall Materials	Wood: Weatherboard	
Foundation Materials	Stone	
Window Materials	Wood	
Window Type	Multi-pane over single pane, One-over-one	
Outbuildings	Yes <input checked="" type="checkbox"/>	No <input type="checkbox"/>
Number/Type:	1-Garage

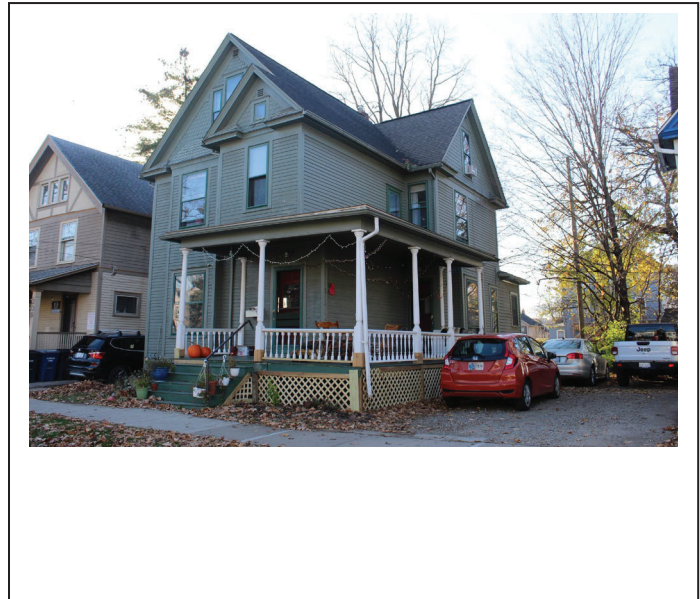
Construction Date	1902	
Architectural Style	Queen Anne	
Building Form	Rectangular	
Roof Form	Cross-gable	
Roof Materials	Asphalt	
Exterior Wall Materials	Wood:Weatherboard	
Foundation Materials	Stone	
Window Materials	Wood	
Window Type	One-over-one	
Outbuildings	Yes <input type="checkbox"/>	No <input checked="" type="checkbox"/>
Number/Type:	NA

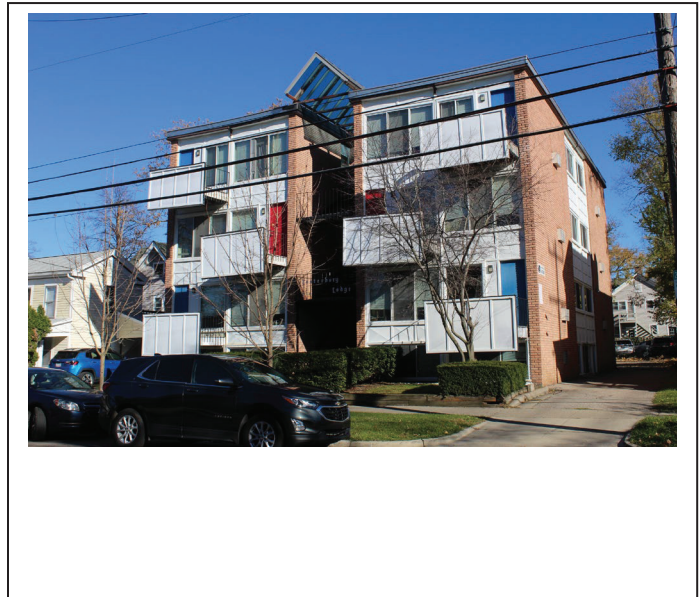
Construction Date	1962	
Architectural Style	Modern Movement	
Building Form	Rectangular	
Roof Form	Flat	
Roof Materials		
Exterior Wall Materials	Metal	
Foundation Materials	Concrete	
Window Materials	Metal	
Window Type	Fixed, Sliding	
Outbuildings	Yes <input type="checkbox"/>	No <input checked="" type="checkbox"/>
Number/Type:	NA

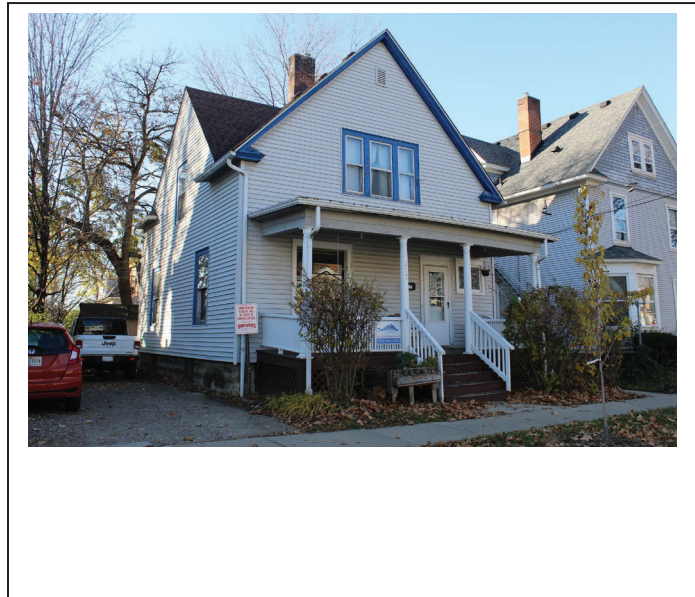
Construction Date	1908	
Architectural Style	Colonial Revival	
Building Form	Rectangular	
Roof Form	Cross-gable	
Roof Materials	Asphalt	
Exterior Wall Materials	Synthetics:Vinyl	
Foundation Materials	Concrete	
Window Materials	Wood	
Window Type	One-over-one	
Outbuildings	Yes <input checked="" type="checkbox"/>	No <input type="checkbox"/>
Number/Type:	1-Shed

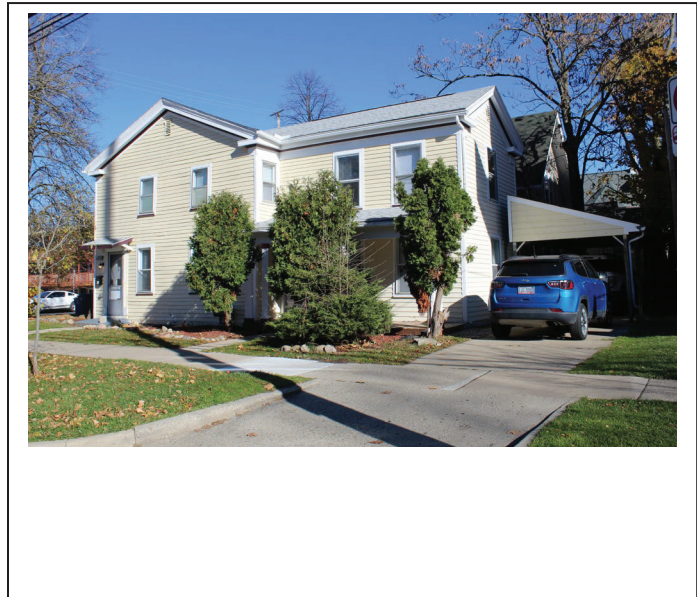
Construction Date	1837	
Architectural Style	Colonial Revival	
Building Form	L	
Roof Form	Front-gable	
Roof Materials	Asphalt	
Exterior Wall Materials	Wood:Weatherboard	
Foundation Materials		
Window Materials	Wood	
Window Type	One-over-one	
Outbuildings	Yes <input type="checkbox"/>	No <input checked="" type="checkbox"/>
Number/Type:	NA

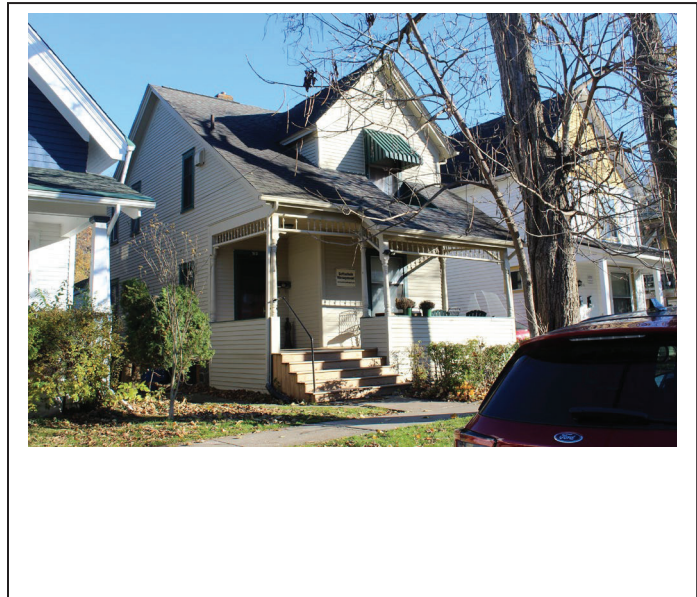
Construction Date	1885	
Architectural Style	Mixed/Altered	
Building Form	Rectangular	
Roof Form	Side-gable	
Roof Materials	Asphalt	
Exterior Wall Materials	Wood:Weatherboard	
Foundation Materials	Stone	
Window Materials	Wood	
Window Type	One-over-one	
Outbuildings	Yes <input type="checkbox"/>	No <input checked="" type="checkbox"/>
Number/Type:	NA

The residence at 312 North Thayer Street is on the east side of the street and faces west. It is a one-and-one-half story, wood-frame house with a rectangular footprint created by a side-gabled, asphalt shingle roof with an offset front gable and a full-width, rear-gabled section. The house is clad with wooden siding and has a cut-stone foundation. Its façade is spanned by a one-story, full-width porch sheltered by the generous forward slope of the roof, supported by turned posts, and encompassed by a low wall clad with siding. A spindle work frieze spans the eave around the porch. Below the porch is an entry door to the north of a projecting section. The projecting section aligns with the forward-facing gable and contains a large, one-over-one, single-hung, wooden sash window. A smaller, double-hung sash window with a metal-framed screen and metal shed awning is located directly above the lower window. The window is partially inset in the forward slope of the roof. One-over-one, double-hung, wooden sash windows light the north and south elevations and an interior brick chimney rises from the peak of the rear gable. A small porch or addition extends from the rear elevation.

The house is recommended for inclusion as a contributing resource to the National Register-eligible Old Fourth Ward Historic District under Criterion C due to its integrity of location, design, setting, materials, workmanship, association, and feeling.

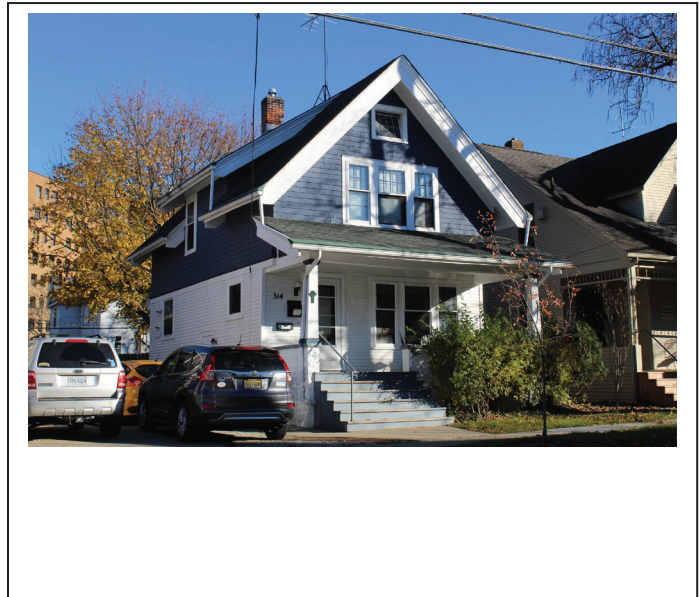
Construction Date	1920
Architectural Style	Bungalow/Craftsman
Building Form	Rectangular
Roof Form	Front-gable
Roof Materials	Asphalt
Exterior Wall Materials	Wood
Foundation Materials	Concrete
Window Materials	Wood
Window Type	Eight-over-one, six-over-one, eight-pane hopper
Outbuildings	Yes <input type="checkbox"/> No <input checked="" type="checkbox"/>
Number/Type:	NA

The Craftsman-style residence at 310 North Thayer Street is on the east side of the street and faces west. It is a one-and-one-half story, wood-frame house with a rusticated concrete block foundation and a rectangular footprint. It has a front-gabled, asphalt shingle roof with shed-roofed, pop-up dormers and is clad with wooden siding on the first story and wooden shingles on the upper story and in the gable. The façade is spanned by a one-story, full-width, shed-roofed porch supported by battered posts that rest on a low, rusticated, concrete block wall. The porch is accessed by wide, wooden steps and shelters a wooden entry door with a large single-pane light in the upper half. South of the door is a tripled window with six-over-one, double-hung, wooden sashes that flank an eight-over-one, double-hung, wooden sash. The gable is lit by an identical window centered below an eight-pane, wooden sash, hopper window in the peak. The forward edge of the gable is finished with wide, bargeboard. The north and south (side) elevations are lit by individual and paired, double-hung, wooden sash windows; small, a multi-pane window; and a ribbon window. There is a secondary entry door on the north elevation and a brick chimney that rises near the crest of the north dormer.

The house is recommended for inclusion as a contributing resource to the National Register-eligible Old Fourth Ward Historic District under Criterion C due to its integrity of location, design, setting, materials, workmanship, association, and feeling.

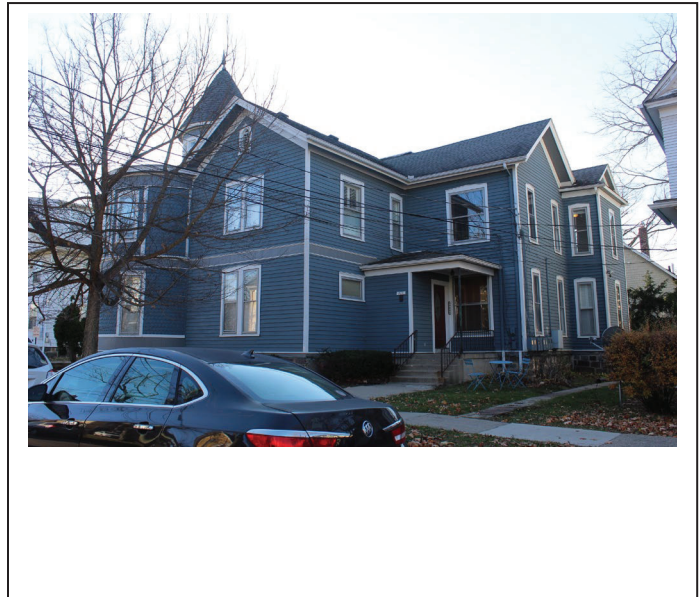
Construction Date	c. 1880	
Architectural Style	Queen Anne	
Building Form	Irregular	
Roof Form	Front-gable	
Roof Materials	Asphalt	
Exterior Wall Materials	Wood	
Foundation Materials	Stone	
Window Materials	Wood	
Window Type	One-over-one, fixed	
Outbuildings	Yes <input type="checkbox"/>	No <input checked="" type="checkbox"/>
Number/Type:	NA

The Queen Anne-style residence at 315 North Thayer Street is on the west side of the road between Catherine Street to the south and Lawrence Street to the north. It is a two story, wood-frame house with an irregular footprint created by a curved wing at the southeast corner and a north wing. The house has a cut-stone foundation, wooden siding and shaped shingles, wooden sash windows, and a front-gabled asphalt shingle roof. A curved section at the corner of the house may have originally been a porch. It is lit by one-over-one, double-hung sash windows. The second story of this section has turned posts inset in its surface, possibly a relic of the original porch. Inset from the curved wall is a turret with a conical roof. Ribbons of fixed-pane windows light the turret. A wooden staircase extends from the rear of the curved wing. The front gable has a paired, double-hung window on each story. A one-story entry porch is set in the crook of the north elevation and north wing. It has a hipped roof, is supported by a metal post at the corner, and shelters an entry door and large one-over-one, double-hung window. Additional one-over-one, double-hung windows light the north and south (side) elevations. An interior brick chimney rises from the rear half of the house.

The house is recommended for inclusion as a contributing resource to the National Register-eligible Old Fourth Ward Historic District under Criterion C due to its integrity of location, design, setting, materials, workmanship, association, and feeling.

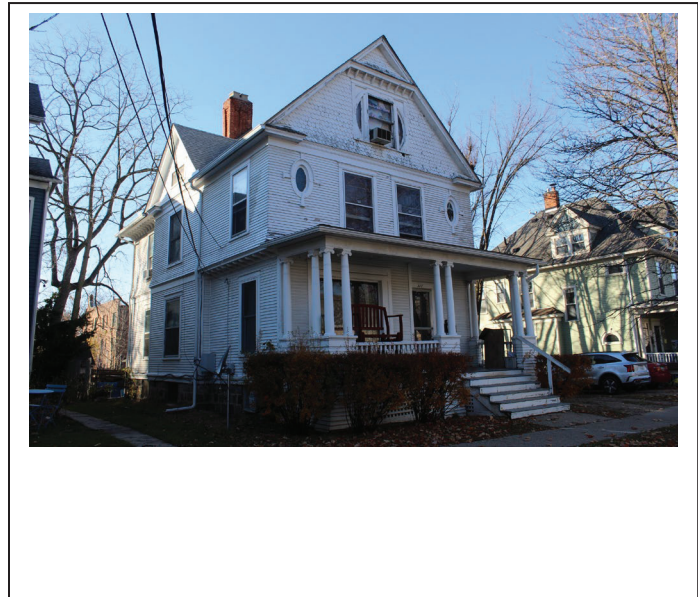
Construction Date	1901	
Architectural Style	Queen Anne	
Building Form	Rectangular	
Roof Form	Front-gable	
Roof Materials	Asphalt	
Exterior Wall Materials	Wood: Weatherboard	
Foundation Materials	Stone	
Window Materials	Wood	
Window Type	Picture, one-over-one, oval	
Outbuildings	Yes <input type="checkbox"/>	No <input checked="" type="checkbox"/>
Number/Type:	NA

The residence at 317 North Thayer Street is on the west side of the road between Catherine Street to the south and Lawrence Street to the north. It is a two-and-one-half story, wood-frame house with a rectangular footprint, a cut stone foundation, wooden sash windows, and a front-gable roof with lower side gables and asphalt shingles. The house is clad with wooden siding and has wooden shingles in the gable. The façade is spanned by a full-width, hip-roofed porch supported by paired and tripled columns with Ionic capitals and encompassed by a turned-post balustrade. It shelters a large single-pane window and a screened entry door. Four windows light the second story façade. The center windows are double-hung and have lower sashes with two vertical panes and upper sashes with a large diamond. The windows are flanked by small oval windows with a wide frame and keystones that radiate like the points of a compass. The gable is lit by a one-over-one, double-hung sash window set in a round window. The round window is set in a square frame. A shallow pent roof with simple brackets shelters the window. The north and south (side) elevations are lit by single-pane and double-hung sash windows, some with diamond-shapes in the sash. An interior brick chimney rises from the rear half of the house.

The house is recommended for inclusion as a contributing resource to the National Register-eligible Old Fourth Ward Historic District under Criterion C due to its integrity of location, design, setting, materials, workmanship, association, and feeling.

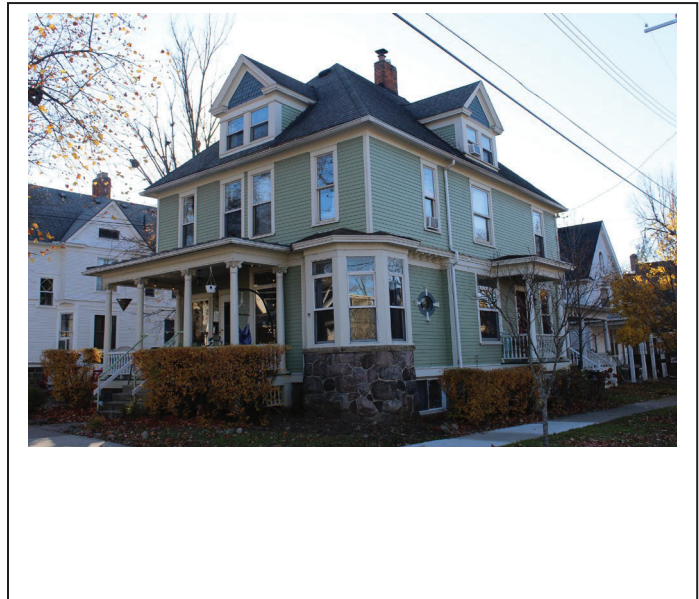
Construction Date	1890	
Architectural Style	American Foursquare	
Building Form	Rectangular	
Roof Form	Hip	
Roof Materials	Asphalt	
Exterior Wall Materials	Wood: Weatherboard	
Foundation Materials	Stone	
Window Materials	Wood	
Window Type	Oval, arch, one-over-one	
Outbuildings	Yes <input type="checkbox"/>	No <input checked="" type="checkbox"/>
Number/Type:	NA

The residence at 321 North Thayer Street is on the southwest corner of the intersection of North Thayer Street and Lawrence Street and faces east. It is a two-and-one-half story, wood-frame house with a rectangular footprint, a cut stone foundation, wooden siding, wooden sash windows, and a hipped roof with gabled dormers and asphalt shingles. The façade is spanned by a partial-width, hip-roofed porch supported by unfluted columns with Ionic capitals and encompassed by a turned-post balustrade. It shelters two entry doors on the south and a large single-pane window with a stained glass transom. North of the porch is a three-sided bay window that wraps the northeast corner. The base of the window is stone and extends to the ground. The upper story of the façade contains four one-over-one, double-hung sash windows with the center windows set close together and the outer windows set apart. Gabled dormers on the east (front), north, and south (side) slopes of the roof are finished with shaped shingles and have paired, one-over-one, double-hung sash windows. Additional one-over-one, double-hung sash windows as well as single-pane, arched, and oval windows light the side elevations. A small porch that shelters a secondary entrance is located on the north elevation and an interior brick chimney rises from the crest of the roof.

The house is recommended for inclusion as a contributing resource to the National Register-eligible Old Fourth Ward Historic District under Criterion C due to its integrity of location, design, materials, workmanship, association, and feeling.

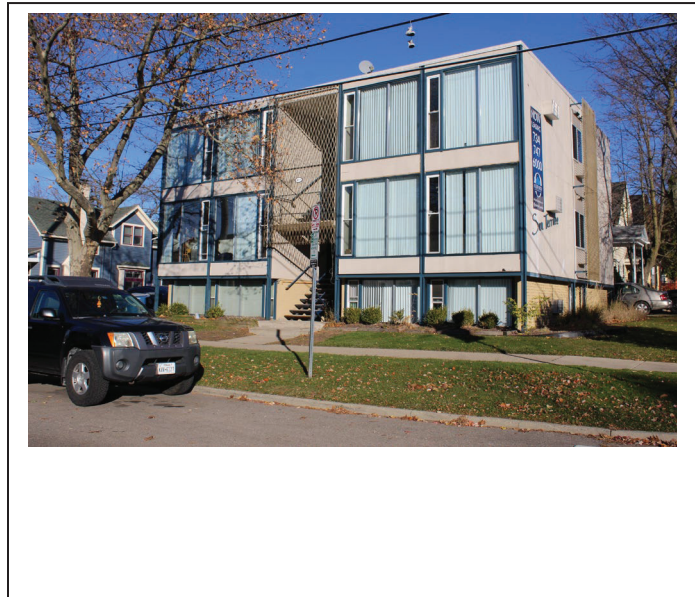
Construction Date	1960	
Architectural Style	Modern Movement	
Building Form	Rectangular	
Roof Form	Flat	
Roof Materials		
Exterior Wall Materials	Metal	
Foundation Materials	Concrete	
Window Materials	Metal and vinyl	
Window Type	Fixed, one-over-one	
Outbuildings	Yes <input type="checkbox"/>	No <input checked="" type="checkbox"/>
Number/Type:	NA

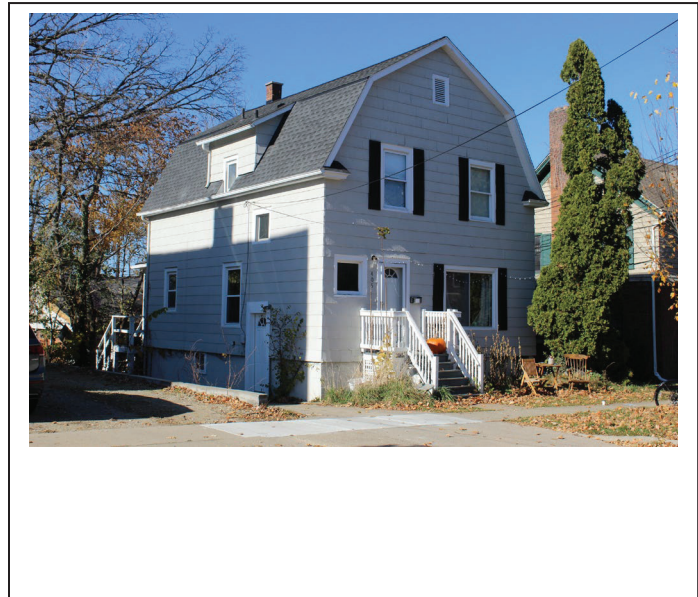
Construction Date	1978	
Architectural Style	Dutch Colonial	
Building Form	Rectangular	
Roof Form	Other	
Roof Materials	Asphalt	
Exterior Wall Materials	Asbestos	
Foundation Materials	Concrete	
Window Materials	Vinyl	
Window Type	One-over-one, sliding	
Outbuildings	Yes <input type="checkbox"/>	No <input checked="" type="checkbox"/>
Number/Type:	NA

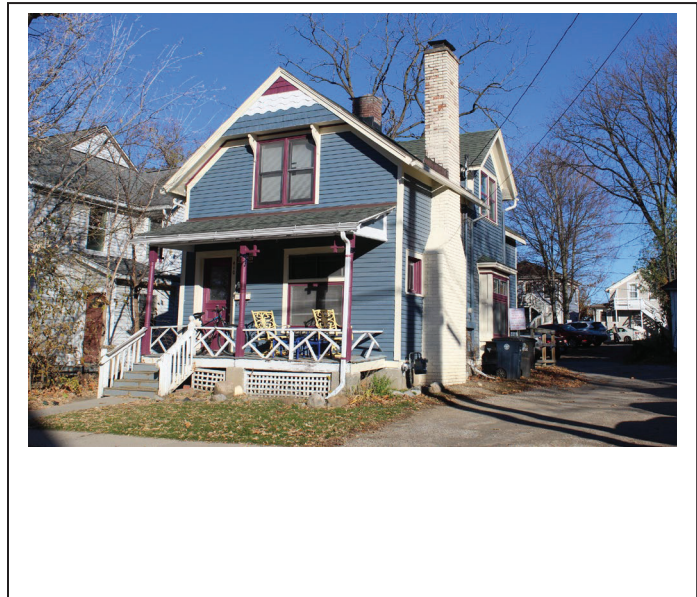
Construction Date	1888	
Architectural Style	Queen Anne	
Building Form	Rectangular	
Roof Form	Front-gable	
Roof Materials	Asphalt	
Exterior Wall Materials	Wood:Weatherboard	
Foundation Materials	Concrete	
Window Materials	Wood	
Window Type	Fixed, one-over-one	
Outbuildings	Yes <input type="checkbox"/>	No <input checked="" type="checkbox"/>
Number/Type:	NA

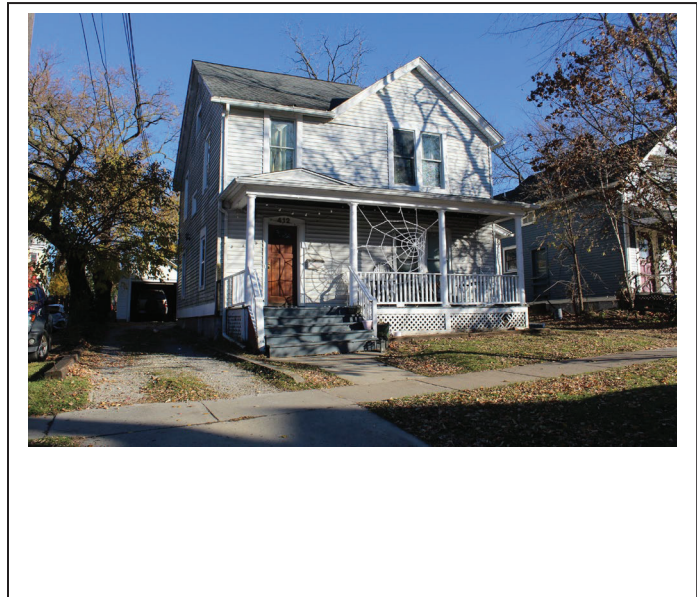
Construction Date	1870	
Architectural Style	Vernacular	
Building Form	Rectangular	
Roof Form	Other	
Roof Materials	Asphalt	
Exterior Wall Materials	Synthetics:Vinyl	
Foundation Materials	Concrete	
Window Materials	Wood	
Window Type	Fixed, one-over-one	
Outbuildings	Yes <input checked="" type="checkbox"/>	No <input type="checkbox"/>
Number/Type:	1-Garage, 1-Shed

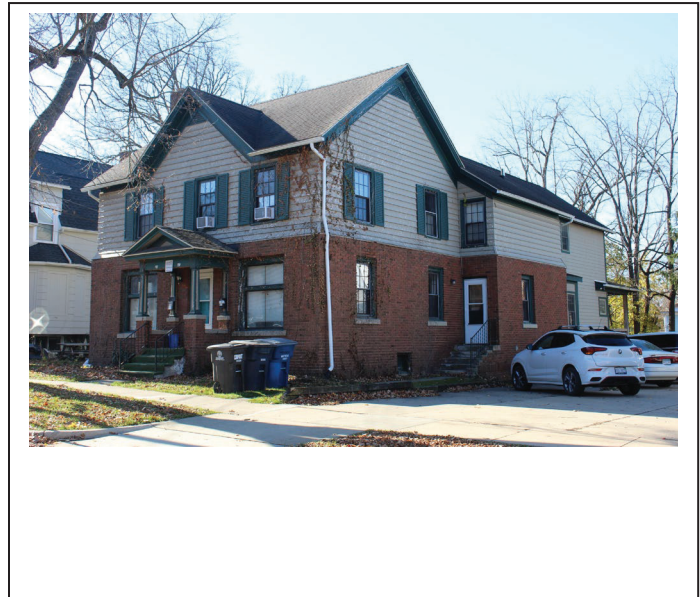
Construction Date	1902	
Architectural Style	Colonial Revival	
Building Form	Irregular	
Roof Form	Side-gable	
Roof Materials	Asphalt	
Exterior Wall Materials	Brick	
Foundation Materials		
Window Materials	Wood	
Window Type	Fixed, six-over-six	
Outbuildings	Yes <input type="checkbox"/>	No <input checked="" type="checkbox"/>
Number/Type:	NA
