**Re: Pre-Demolition Asbestos Containing Material Survey
1514 & 1520 White Street, 1521 State Street, and 701, 707,
713 & 719 Henry Street, Ann Arbor, Michigan
ECS Project N100-0010**

ASBESTOS CONTAINING MATERIALS ASSESSMENT

White State Henry
1514-1520 White, 1521 State, 701-719 Henry
Ann Arbor, Michigan

1478-18001

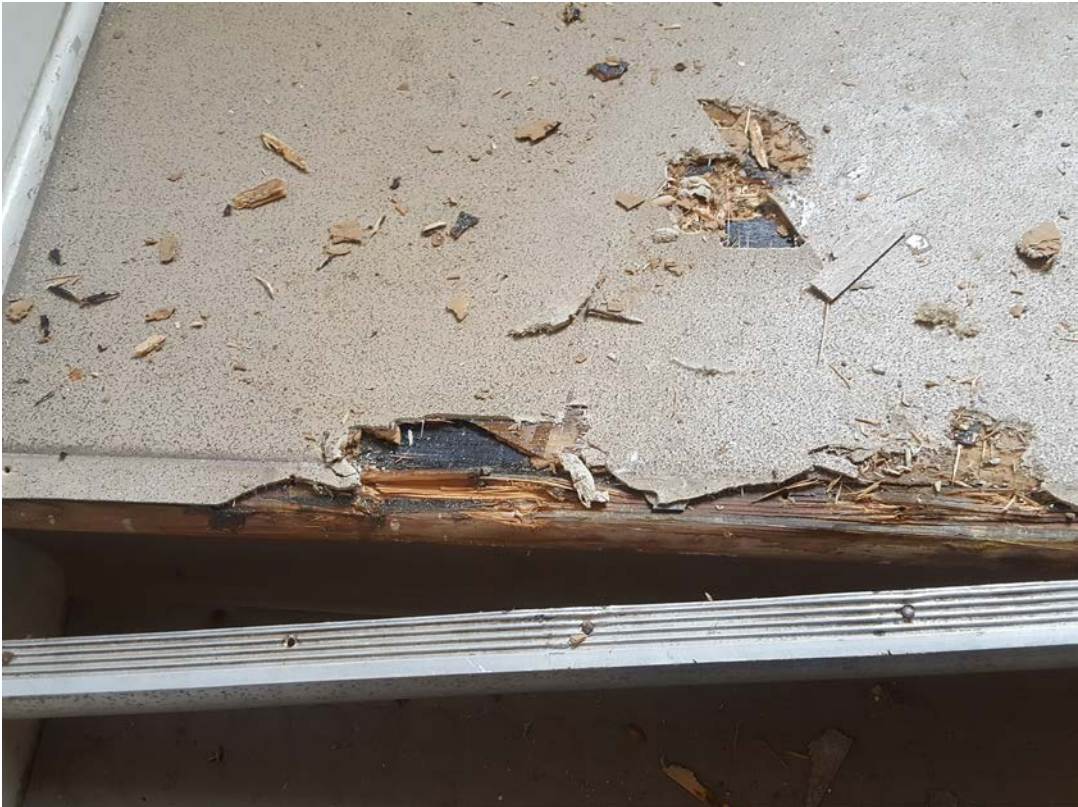
Site Name:	White State Henry	Project Number:	1478-18001
Street Address:		City, State, Zip:	Ann Arbor, MI
Photo Number: 1

Photographer: Jef Fox			
Date: March 6-8, 2018			
Description: View of ACM tan w/ black spec linoleum			
Photo Number: 2

Asbestos containing materials were identified that will require special handling and disposal for the demolition activities.

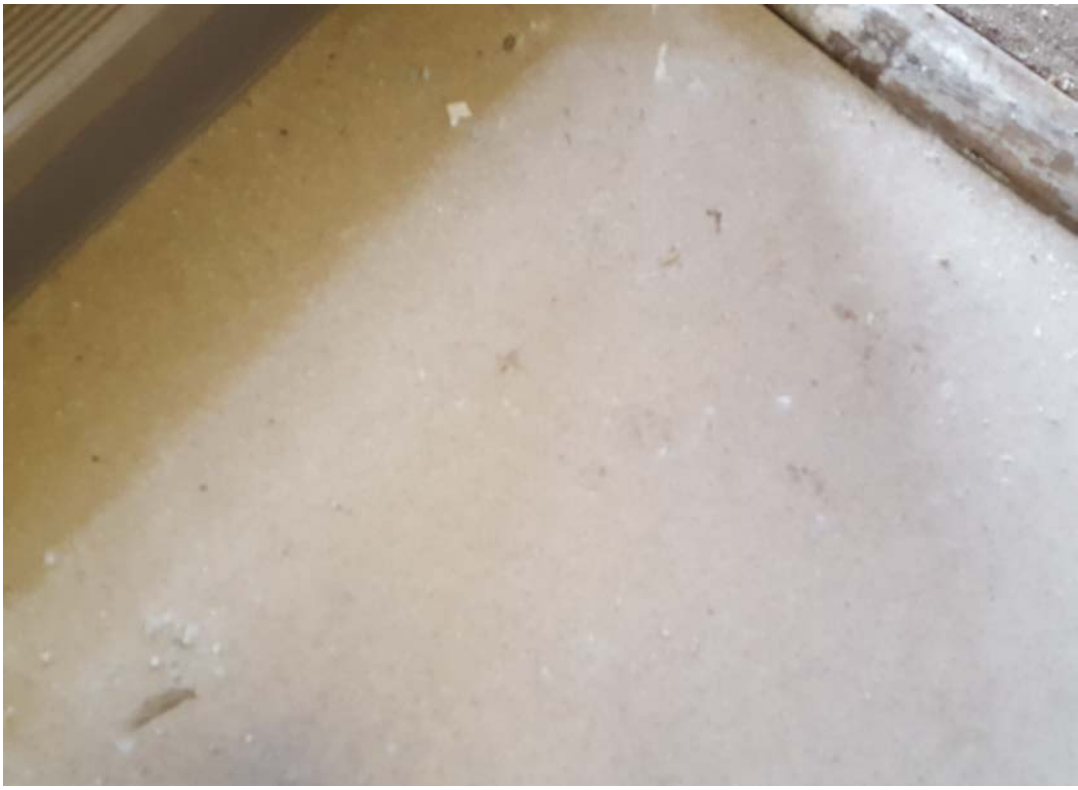
Photographer: Jef Fox			
Date: March 6-8, 2018			
Description: View of ACM tan white spec linoleum

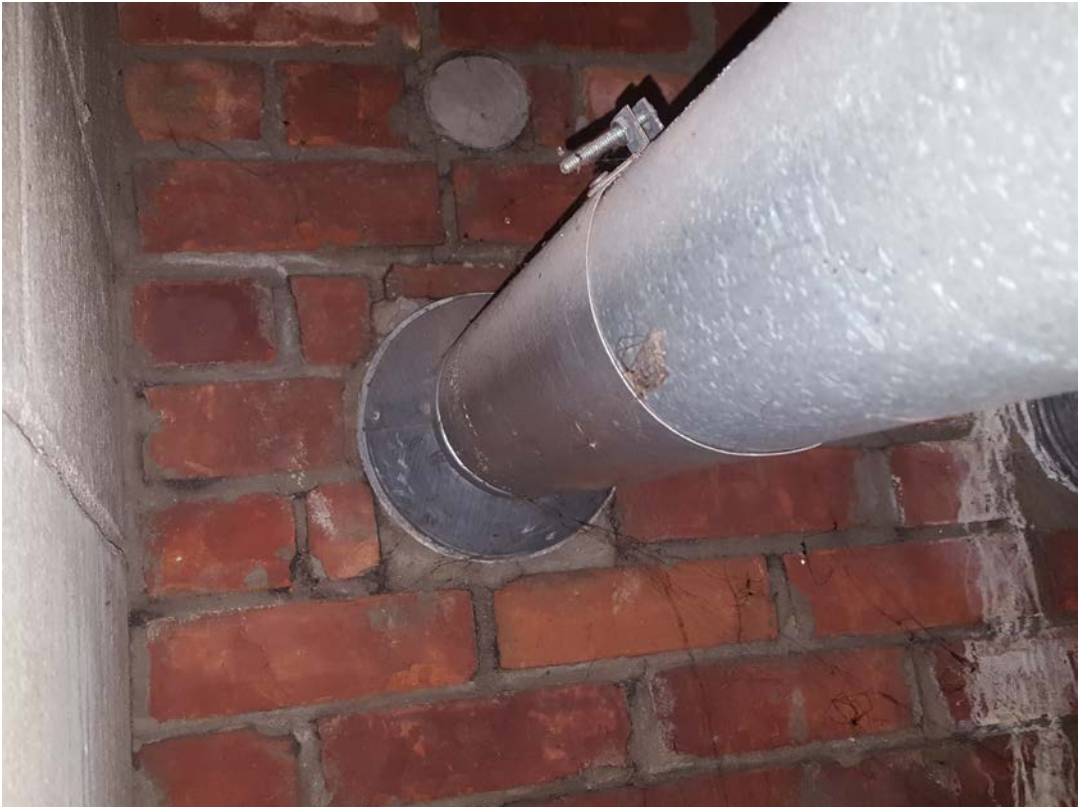
Site Name:	White State Henry	Project Number:	1478-18001
Street Address:		City, State, Zip:	Ann Arbor, MI
Photo Number: 3

Photographer: Jef Fox			
Date: March 6-8, 2018			
Description: View of ACM chimney mortar			
Photo Number: 4	 		
Photographer: Jef Fox			
Date: March 6-8, 2018			
Description: Inside view of White Henry State
