Rental Assistance Demonstration (RAD): PHYSICAL CONDITION ASSESSMENT

2702-2760 Hikone Drive, Ann Arbor, Michigan 48108

PREPARED FOR Norstar Development USA, LP

DATE February 21, 2014

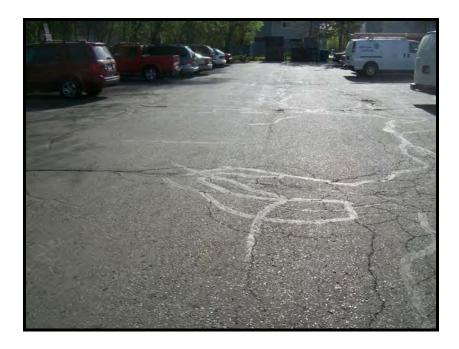
PHOTOGRAPH NO. 5: TYPICAL VIEW OF SUBJECT PROPERTY PARKING LOT

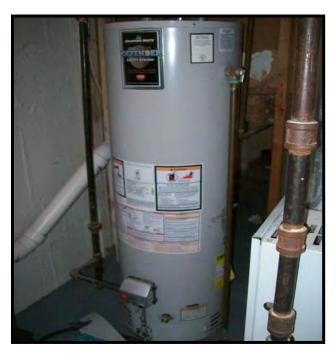
PHOTOGRAPH NO. 9: TYPICAL VIEW OF HOT WATER HEATERS IN TENANT UNITS

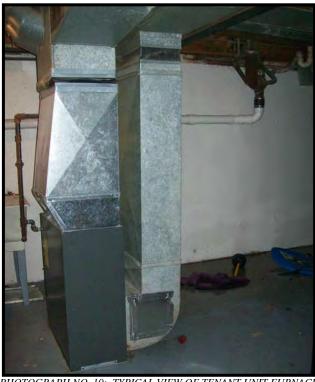
PHOTOGRAPH NO. 10: TYPICAL VIEW OF TENANT UNIT FURNACE

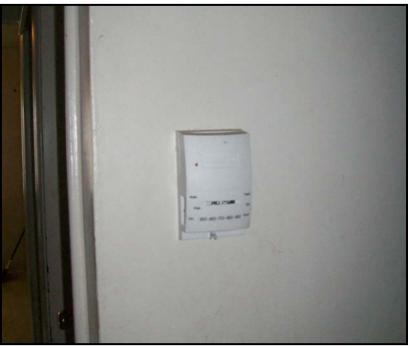
PHOTOGRAPH NO. 18: TYPICAL VIEW OF TENANT UNIT THERMOSTAT
