# NARROW GAUGE CREEK INSPECTION

Prepared By: Hubbell, Roth & Clark  
September 2024

ANN ARBOR  
**WATER**

# NARROW GAUGE CREEK INSPECTIONS

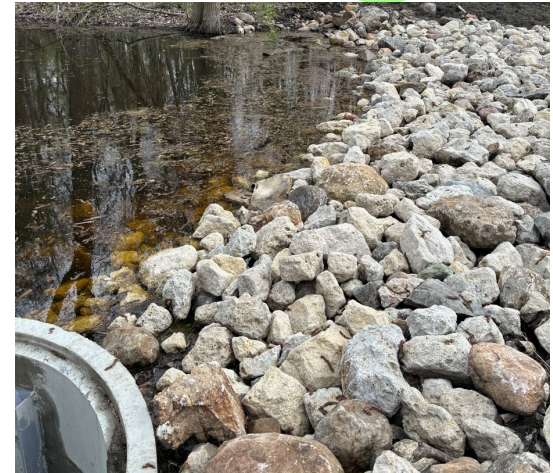
Photo 1 Direction: Northeast

Photo 2: Stone Toe

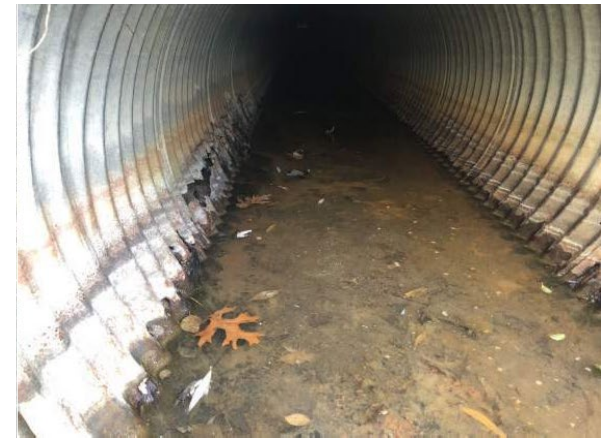
Photo 1 Direction: Facing Upstream

Photo 2 Direction: Facing Upstream

The above photos contain a culvert crossing in severe condition under Green Rd. The crossing is made of a Corrugated Metal Pipe with a bituminous surface (asphalt or tar).

### Severe Condition:

- Cracks
- Breaks
- Rust spots
- Debris buildup upstream

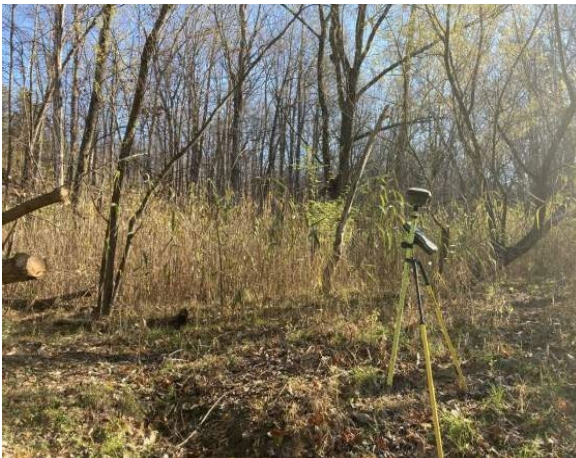
Photo 1 Direction: East

Photo 2 Direction: East

- Treat or remove invasive species.

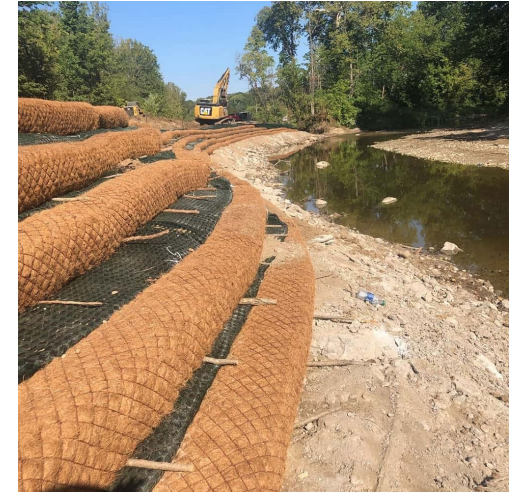
Photo 2: Wattle Logs
